**NATIONAL TRANSPORTATION SAFETY BOARD**

Group Chairman's Factual Report

**AIR TRAFFIC CONTROL FACTUAL REPORT**

CEN19MA190

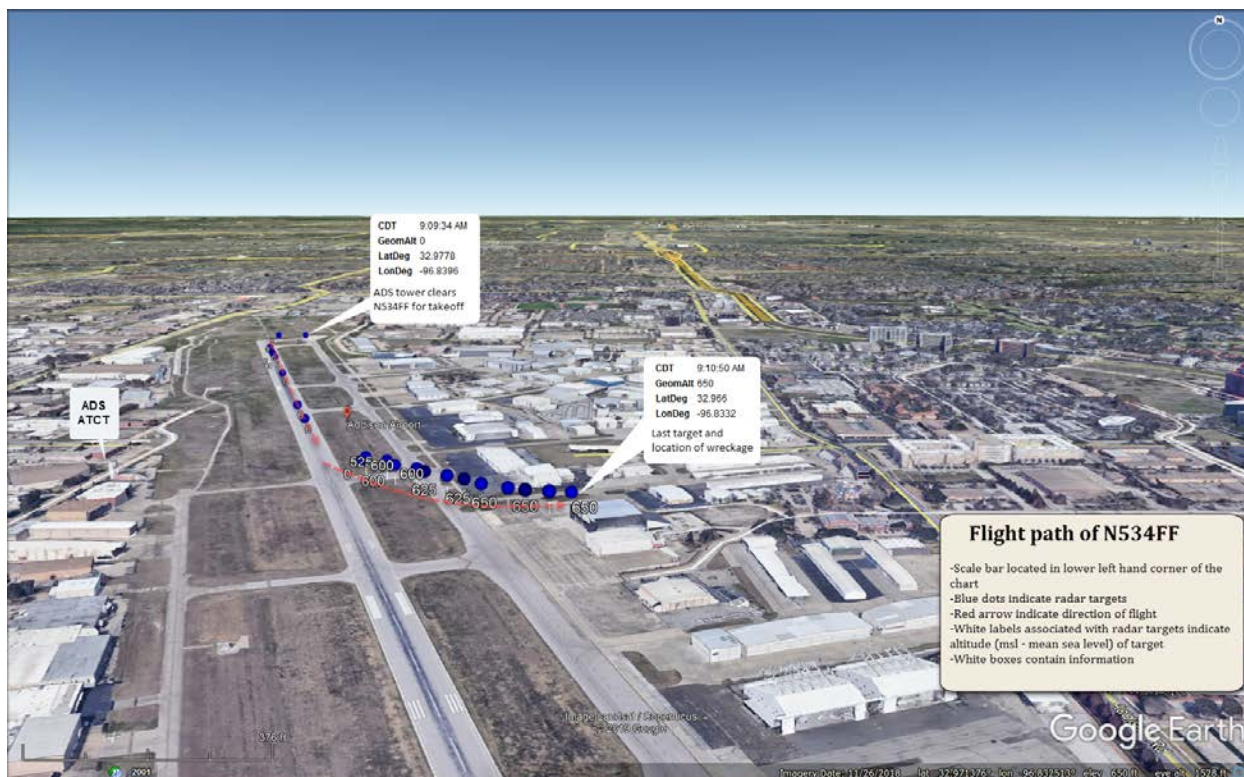
Figure 1 is a screenshot of N534FF's flight track from the time the pilot was issued the takeoff clearance by ADS local controller until the last radar target. The screenshot depicts the location of ADS ATCT relative to accident site. The radar data is overlaid on a Google Earth map.

Figure 1. Flight track of N534FF overlaid a Google Earth map.
