**NATIONAL TRANSPORTATION SAFETY BOARD**

**Group Chairman's Factual Report**

**AIR TRAFFIC CONTROL FACTUAL REPORT**

DCA19MA086

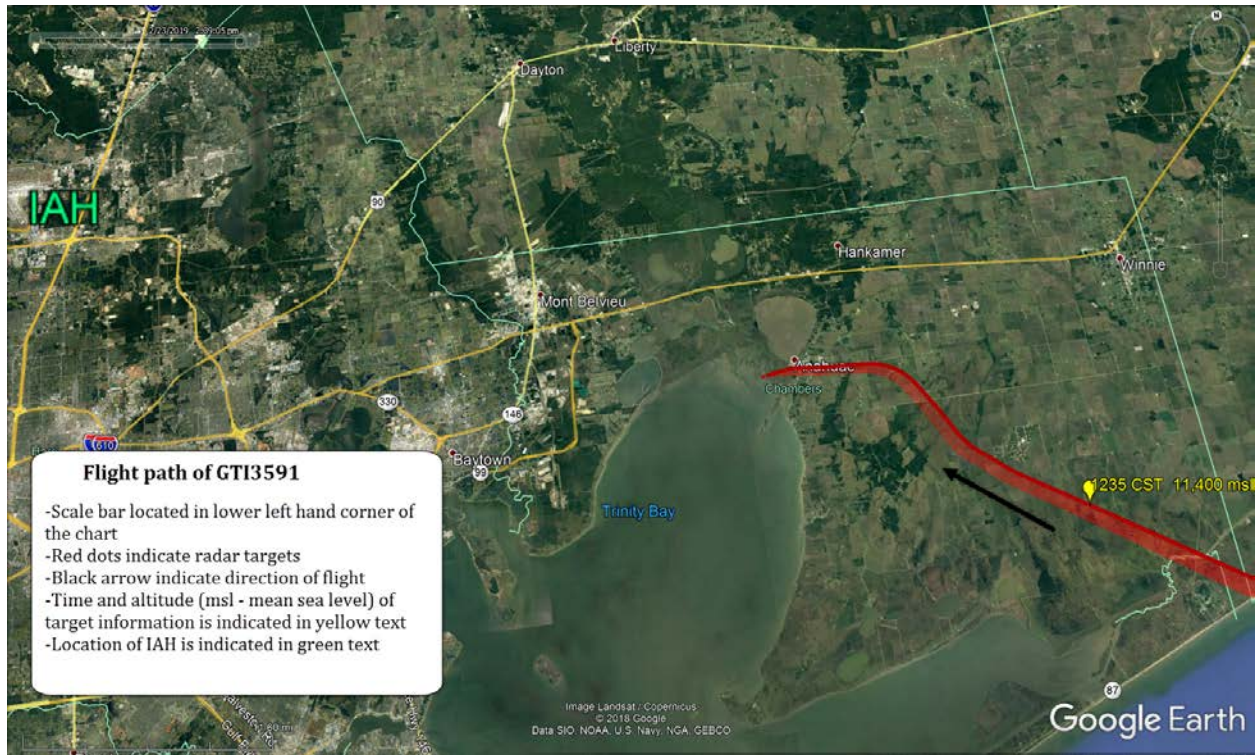
Figure 3. Radar graphic depicts the location of GTI3591 when the pilot checked in with the final controller.
