NATIONAL TRANSPORTATION SAFETY BOARD

Specialist's Report

AIR TRAFFIC CONTROL

WPR20FA034

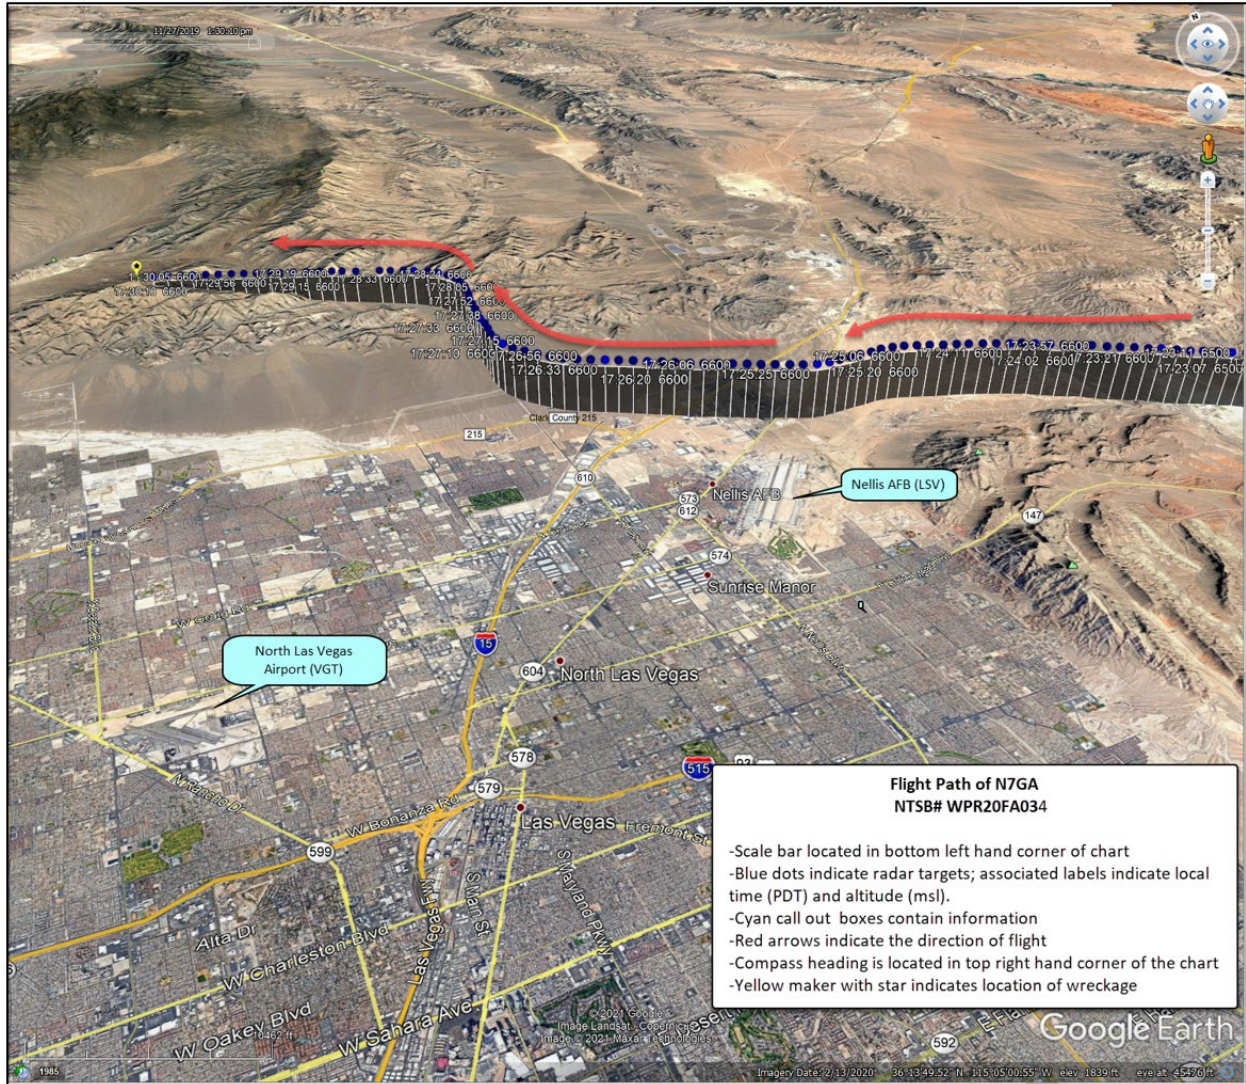
At 1728:03, the controller instructed the pilot, “N7GA, altitude your discretion.” The pilot responded with his call sign. Radar data indicated that N7GA was at 6,600 feet at the time of that transmission. Figure 2 is a screen capture¹² from Google Earth illustrating a profile view of N7GA’s altitude relative to the surrounding terrain, and the altitude profile of the airplane for the preceding 5 minutes.

Figure 2. Screen capture from Google Earth illustrating the accident airplane’s altitude relative to the terrain.

At 1729: 52, the pilot stated, “We’re getting a low altitude alert for N7GA, we gotta turn left.”
