Fire Research Laboratory
BUREAU OF ALCOHOL, TOBACCO, FIREARMS AND EXPLOSIVES
6000 Ammendale Road
Beltsville, MD 20705-1250

Laboratory Report

Date of Report: April 18, 2024
Lab Number: [REDACTED]
Reference: [REDACTED]
Title of Investigation: Fire - Spirit of Boston
Type of Exam: Engineering – Analysis

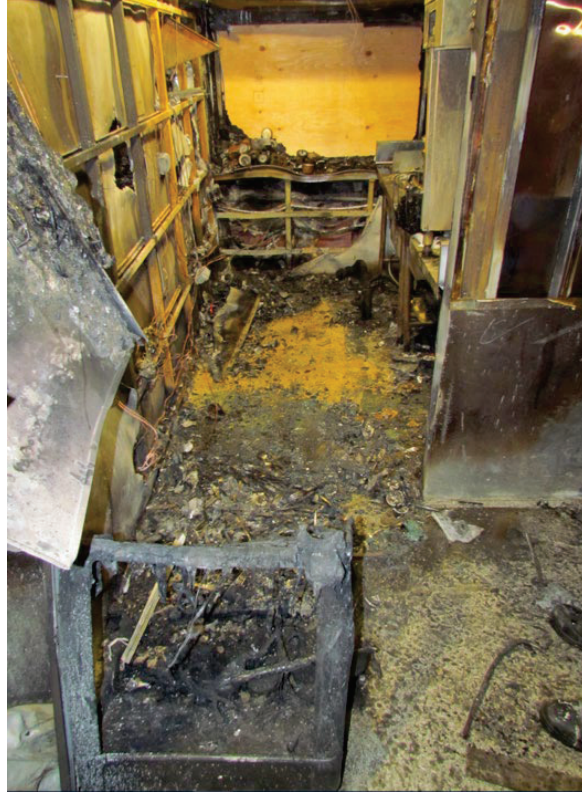
Figure 1: Room of fire origin, image rotated 90 degrees [Photo by SA/CFI H [REDACTED]] (187727_748130.JPG)

On March 24, 2023, a fire occurred aboard the Spirit of Boston dinner cruise ship. The fire scene examination determined that the fire originated in the port side aft wait station (Figure 1). The wait station contained plastic service items and was used as a staging area for food service [1]. Figure 2 shows a Sterno can resting on its side embedded at the bottom of resolidified plastic recovered from the room of origin. Figure 3 shows undamaged Sterno cans recovered from the Spirit of Boston.

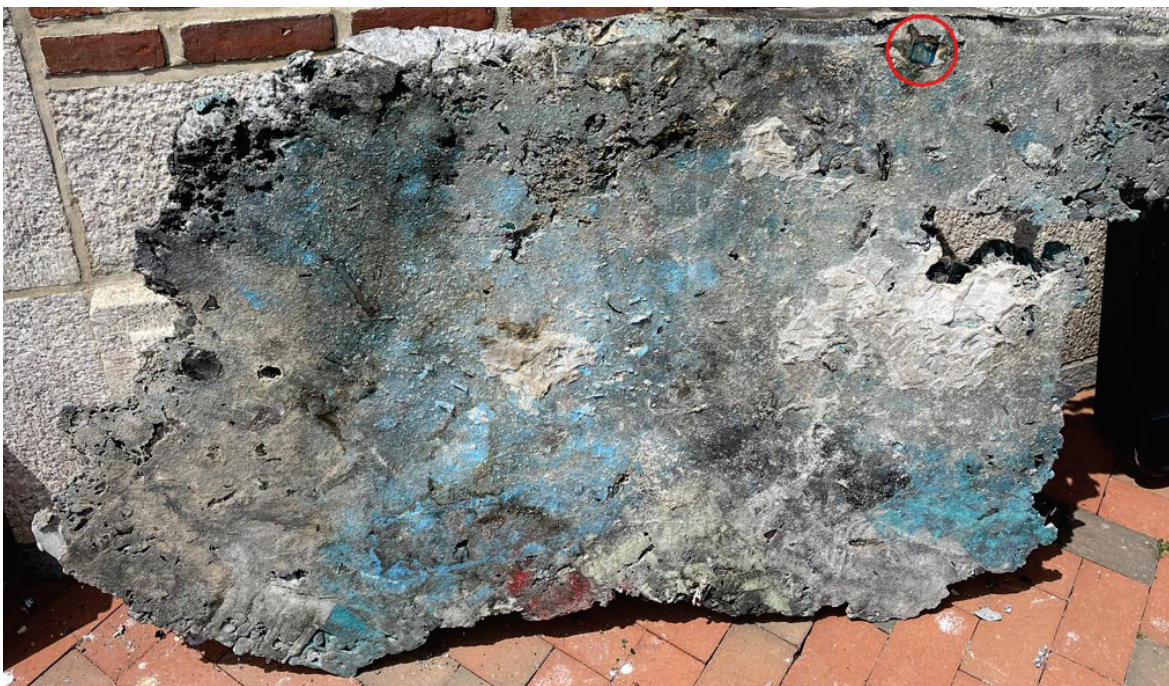
Figure 2: Bottom side of resolidified plastic recovered from room of fire origin, Sterno can resting on its side is circled in red, "Origin 3" cropped, [Photo by SA/CFI H [REDACTED]] (187727_748776.PNG)

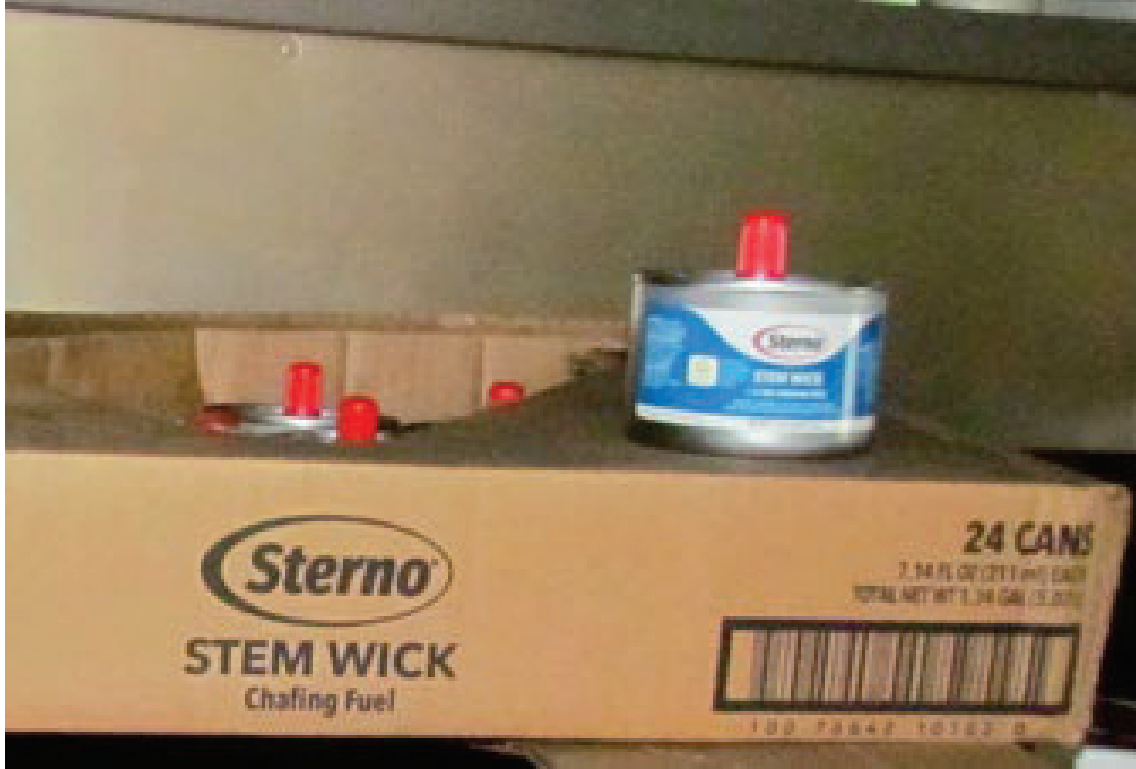
Figure 3: Undamaged Sterno cans recovered from the Spirit of Boston [Photo by SA/CFI H [REDACTED]] (187727_748150.JPG)

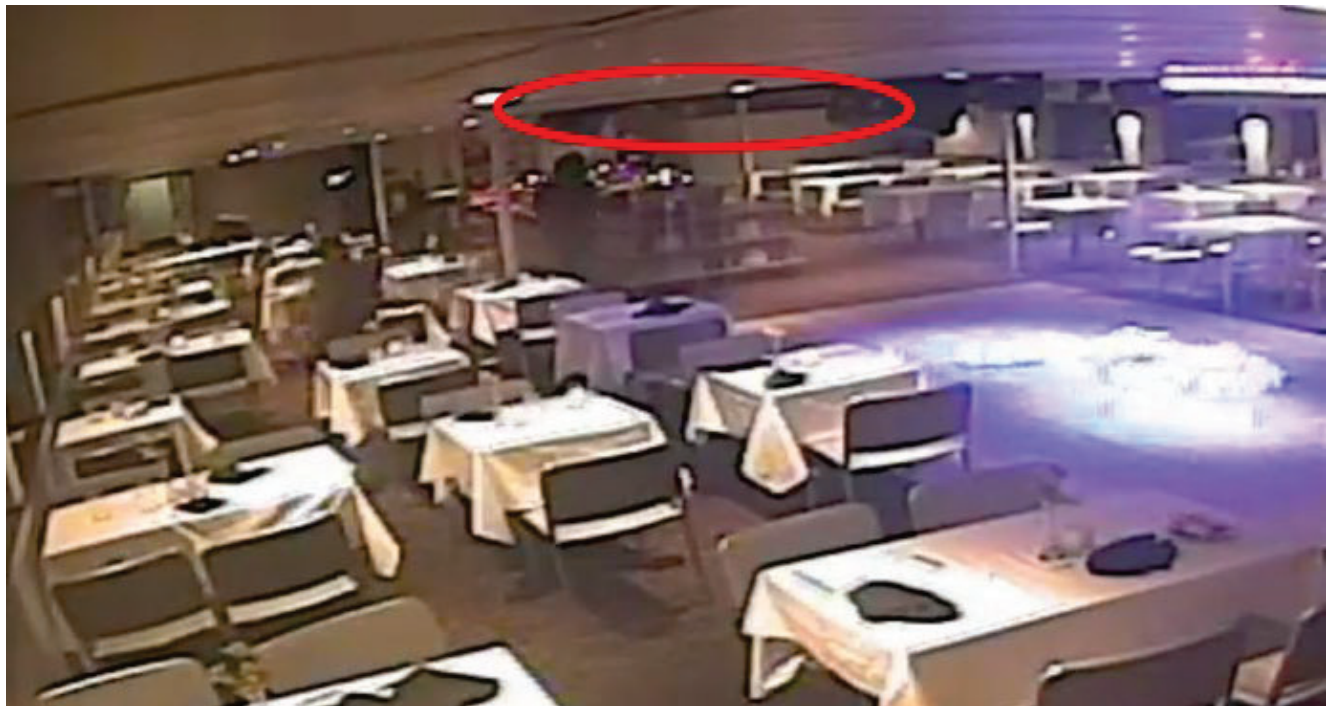
Figure 4: Screenshot of video channel “CH04.h264” from camera aboard the Spirit of Boston prior to fire. Red ellipse marks the location of visible smoke on security camera.

In a phone conversation on October 17, 2023, SA/CFI H [REDACTED] stated that smoke was observed by witnesses and on video camera being pushed out of the room of fire origin and over the pony wall shown in Figure 4 [2].

Screenshots from a master video for Experiments 1 through 4 and Experiments 6 and 7 are presented in Figure 45 through Figure 50 and show the time at which “Heavy” smoke was visible. The master video consists of six different time synchronized test videos. Table 7 provides a location and description of the individual videos used in the master video and their perspective as it relates to the fire aboard the Spirit of Boston. The camera view in the middle of the top row in Figure 45 through Figure 50 was taken from the same perspective as the camera view in the dining area looking towards the wait station aboard the Spirit of Boston. (See Figure 4.)

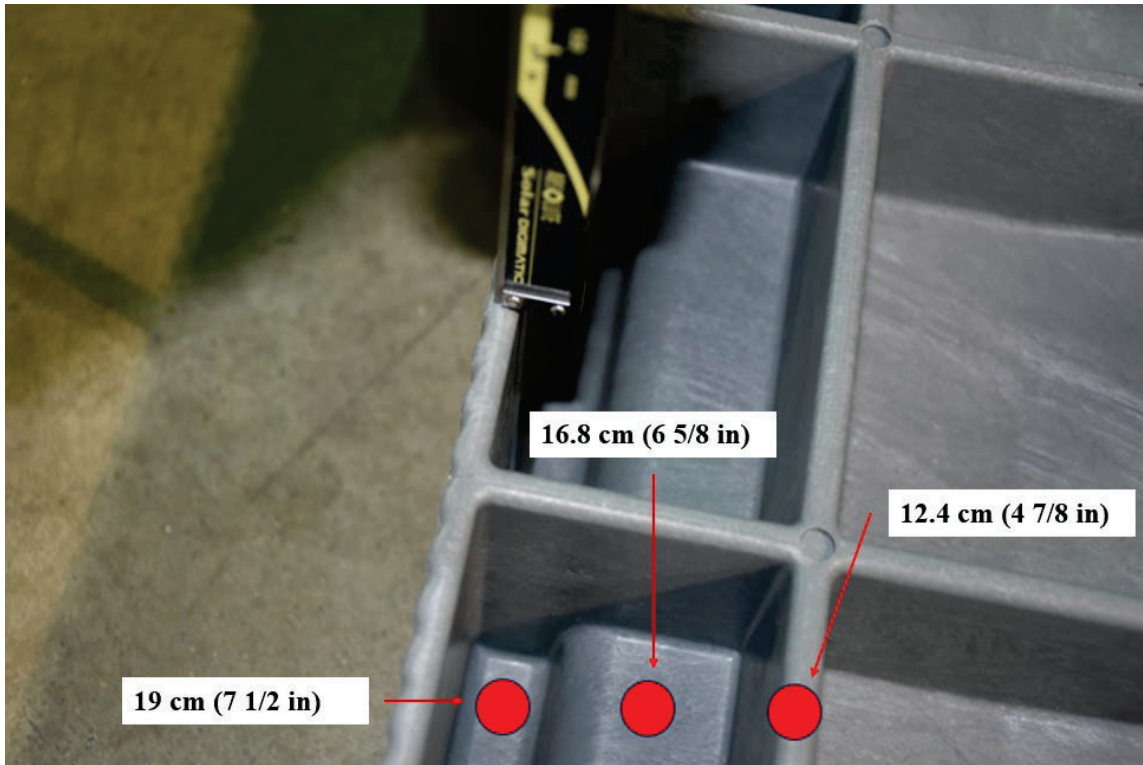
Figure 8: Close-up of bottom of plastic dolly annotated with three red dots corresponding to measurement locations (361138_1341111. JPG)

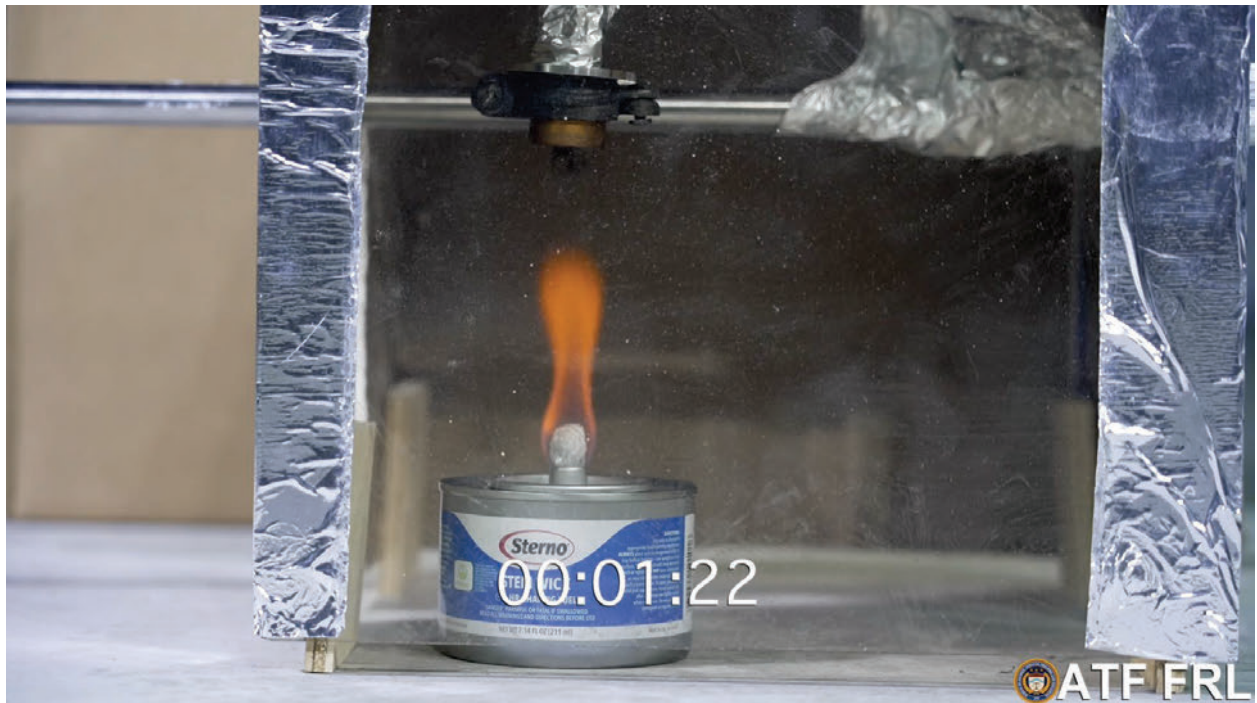
Figure 9: Phase 1, Test 4, Sterno can upright, Screen shot from video (361138_Master_1345552)

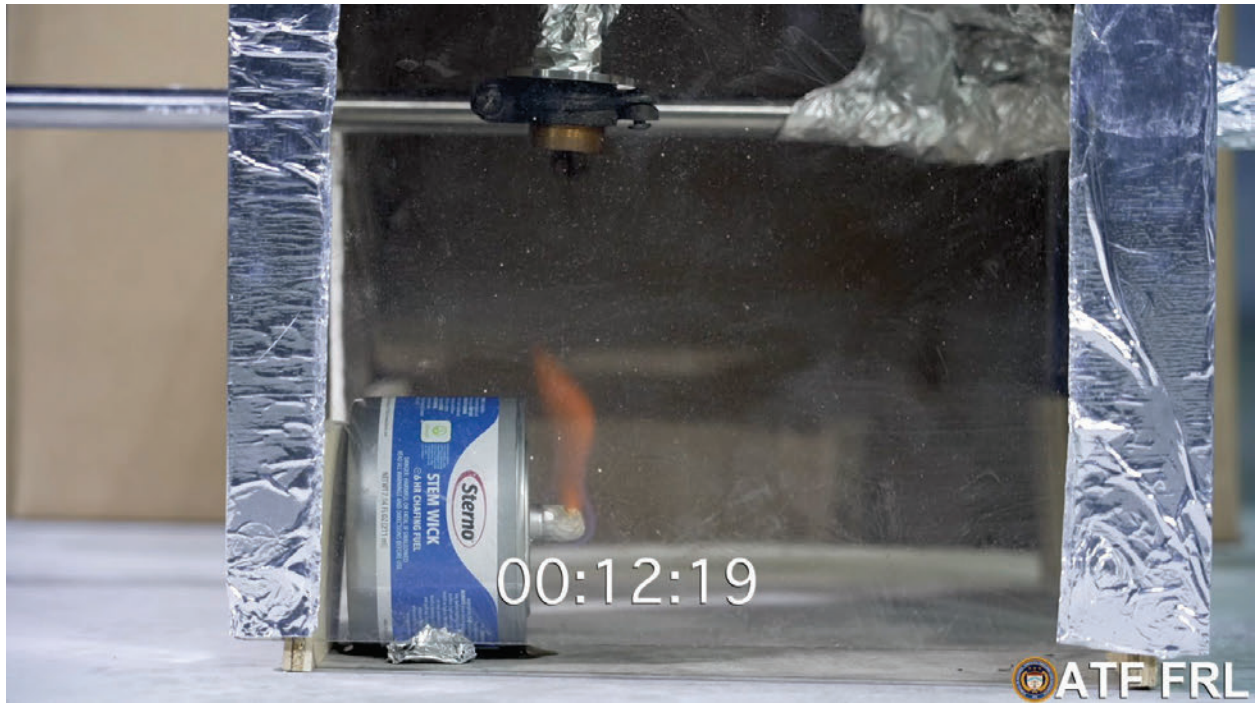
Figure 10: Phase 1, Test 4, Sterno can on side, Screen shot from video (361138_Master_1345552)

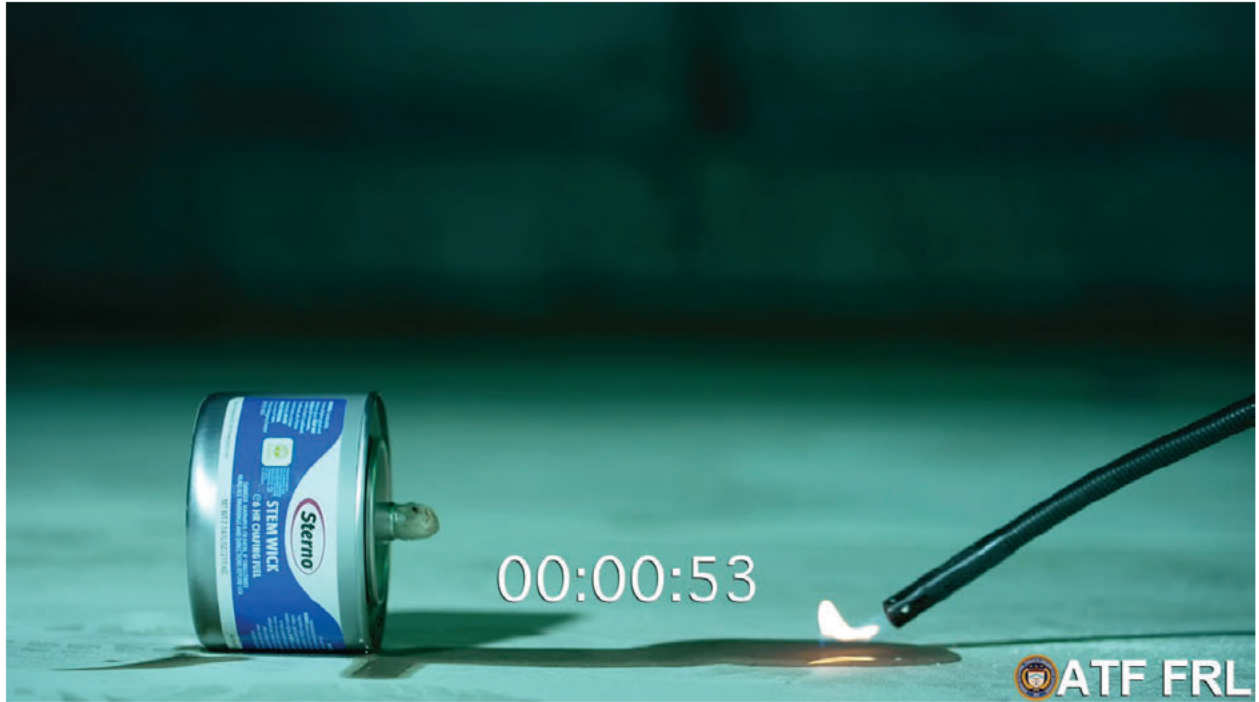
Figure 11: Phase 1, Test 6, Screen shot from video, Attempted ignition of spilled Sterno fuel when can placed on side (361154_Master_1345572)

Experiment 6 was conducted to evaluate the ignitability of spilled Sterno chafing fuel using a stick lighter (Figure 11). Experiment 7 was conducted to document the burning time of a Sterno can after all liquid fuel was poured out of the can. Experiments 8 through 12 were conducted to document the propensity of lit Sterno cans dropped to the ground to remain lit. Figure 12 is representative of the test set-up for Experiments 8 through 12. The tests conducted in Phase 1 are summarized in Table 1.

Experiment 6 was conducted to evaluate the ignitability of spilled Sterno chafing fuel using a stick lighter. Multiple attempts at ignition were made by holding the flame in contact with the surface of the spill. No ignition occurred during this experiment.

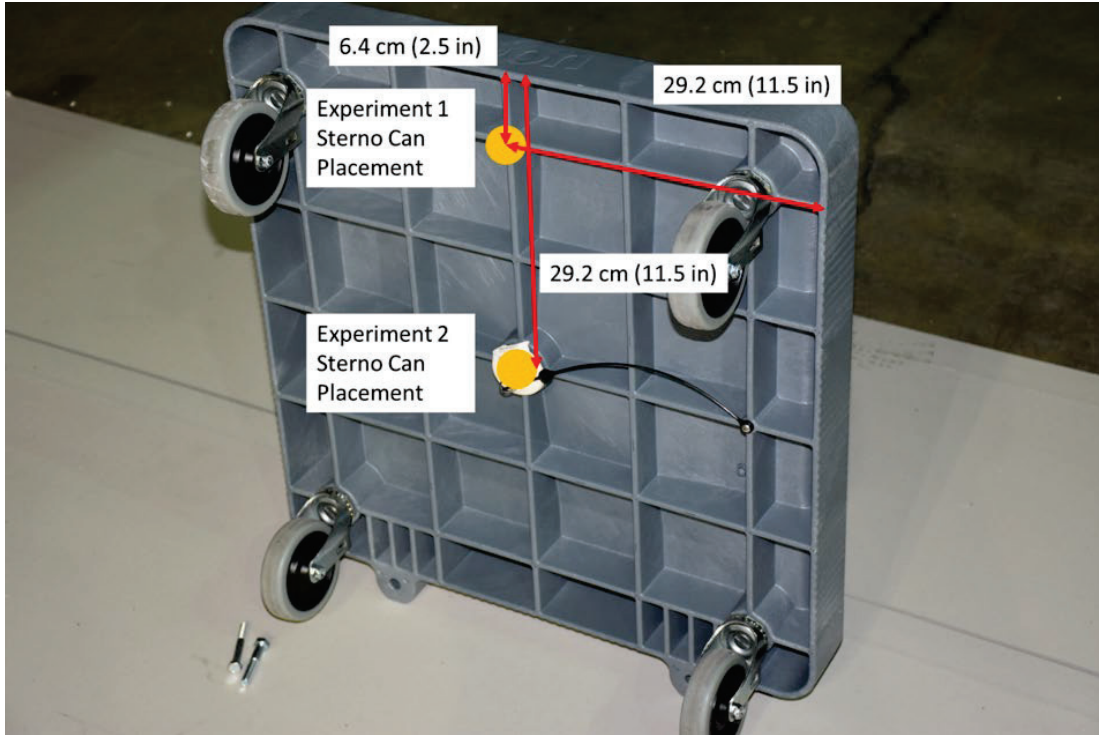
Figure 13: Sterno Can Location Phase 2, Experiments 1 and 2 (361099_1337658.JPG annotated)

Table 2 provides experimental details for the four experiments conducted in this phase. Experiments 1 and 2 were conducted by placing a Sterno can beneath a dolly. Figure 13 shows where the Sterno cans were placed for Experiments 1 and 2.

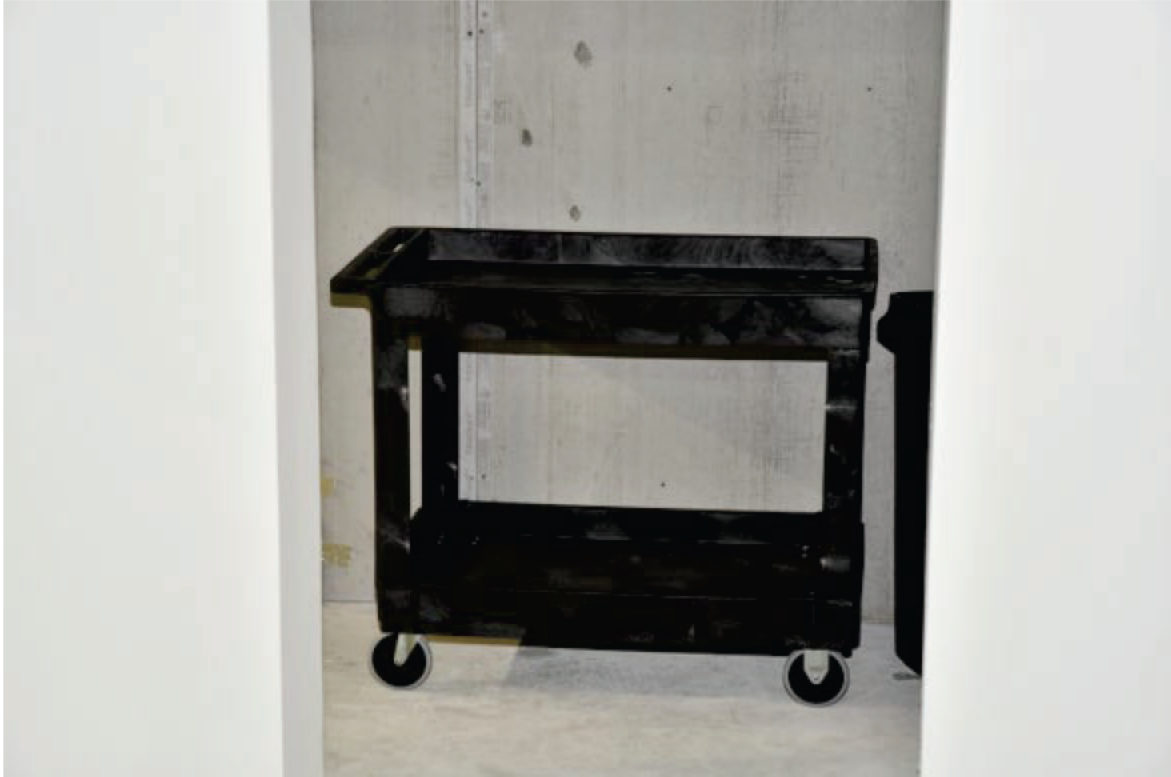
Figure 22. Utility Cart (361029_1338427.JPG)

The utility cart was composed of black polyethylene and measured 91 cm × 61 cm × 79 cm (36 in. long × 24 in. wide × 31.25 in. high) (Figure 22). Four 13 cm (5 in.) casters were affixed to the bottom four corners of the lower shelf.

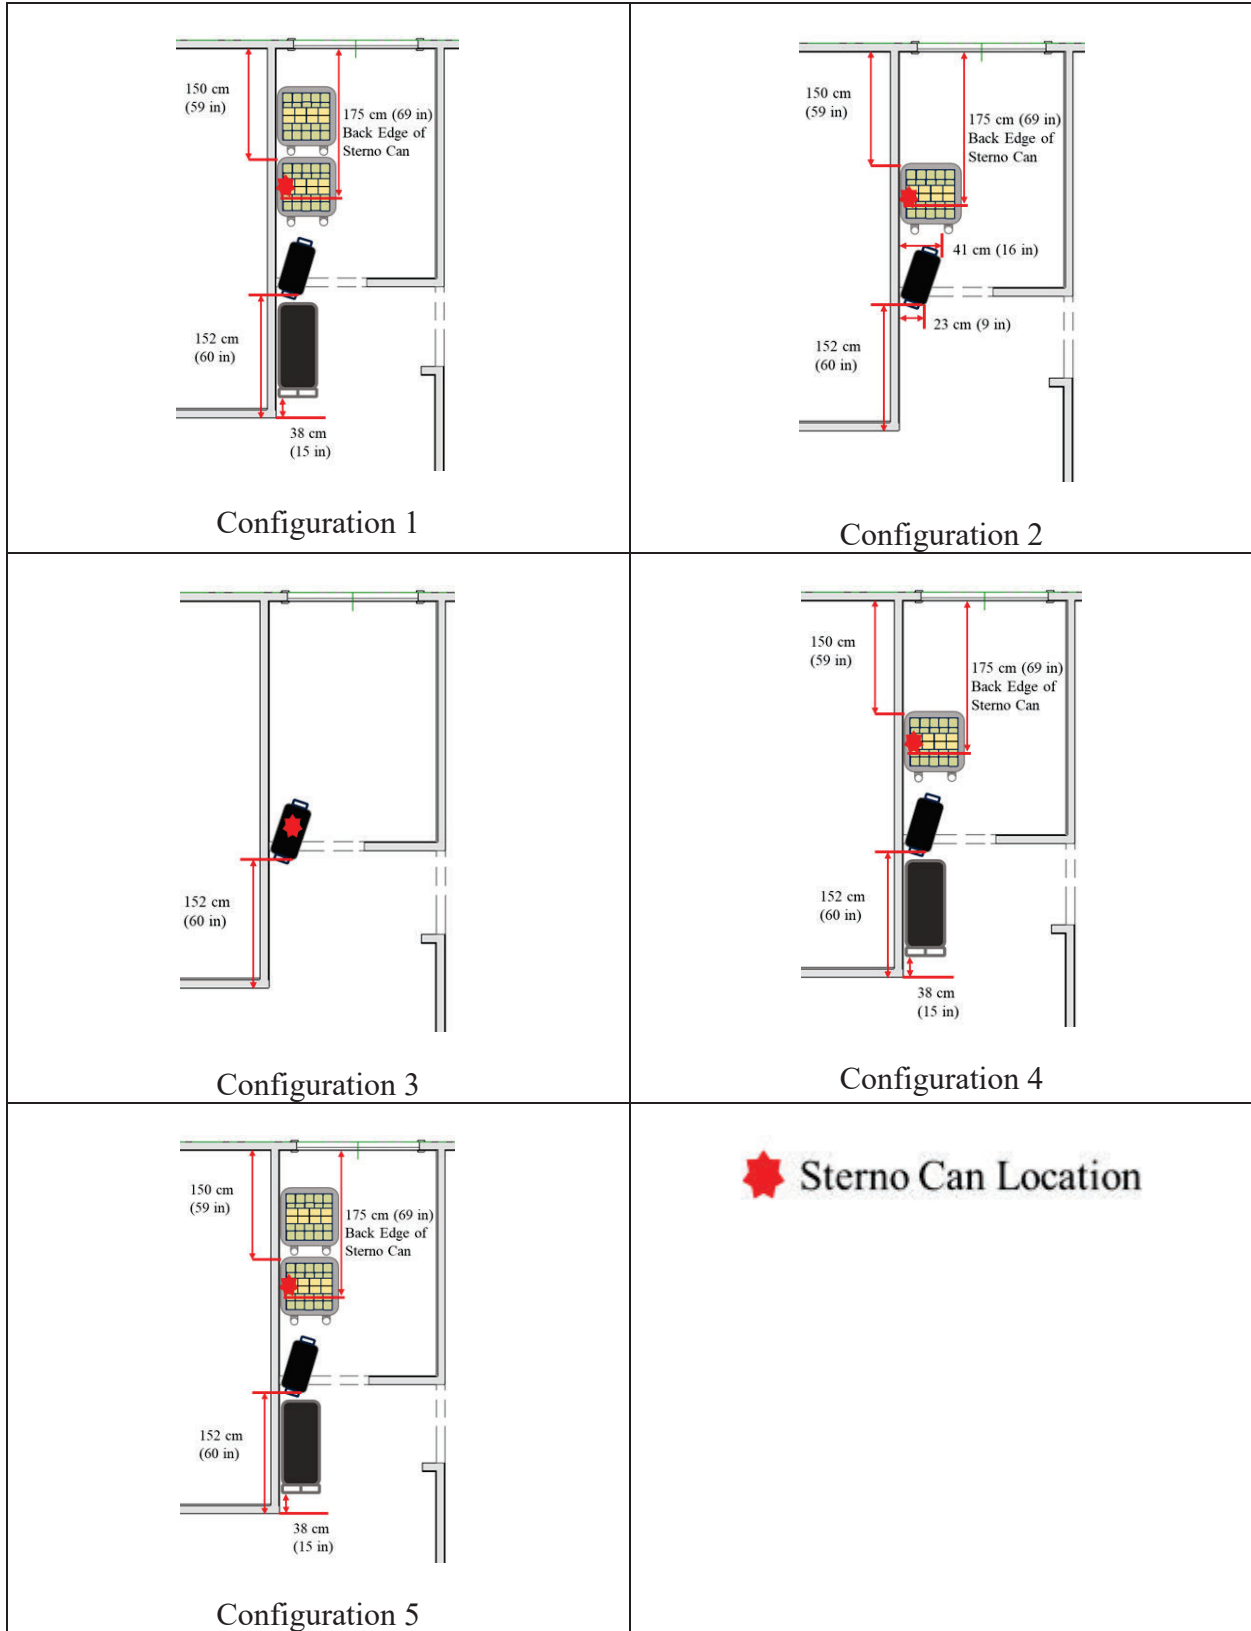
Figure 25: Fuel configuration for Phase 3 testing [5]

Five different fuel configurations were used during this testing and are summarized in Table 3. Schematics showing each fuel configuration are presented in Figure 25. At the start of each experiment, other than Experiment 5, the Sterno can was lit and placed on its side in a position with the wick facing away from the wait station doorway. Each experiment began when the dolly cart was set in position over top of the lit Sterno can.

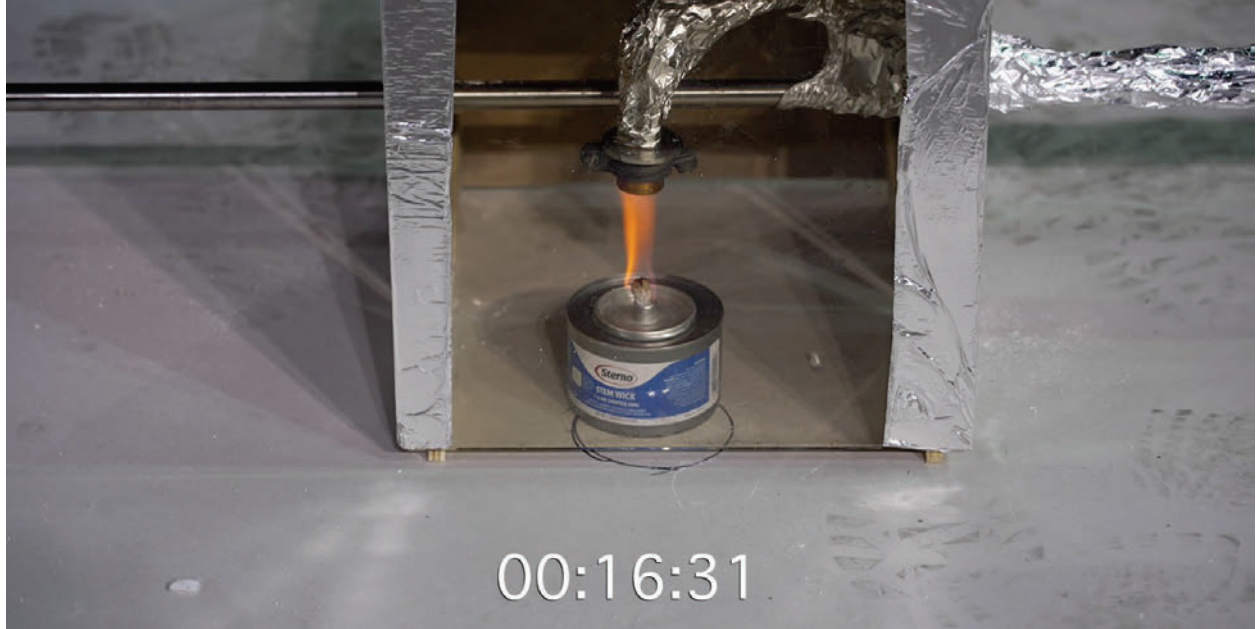
Figure 26: Phase 1, Test 4 (361082_Master_1345480)

Experiments 2 through 5 incorporated a box enclosure around the Sterno can in an attempt to limit air movement. Figure 26 shows a screen capture of video from Experiment 4 with the enclosure in place and Figure 27 shows the experiment without the enclosure. The enclosure had a dramatic effect on flame height and position as well as measured heat fluxes, which were much higher with the enclosure in place. Figure 28 is a chart of heat flux versus time for Test 4 and shows the difference in fluxes for the can in an upright position versus laying on its side. Table 4 and Figure 28 show that for the same measurement height, heat fluxes were much higher when the can was in an upright position than resting on its base. Table 4 also shows that heat fluxes decrease in magnitude with increasing distance between the flame and heat flux transducer. This trend is consistent with the heat flux measurements made above a paraffin wax candle [6].

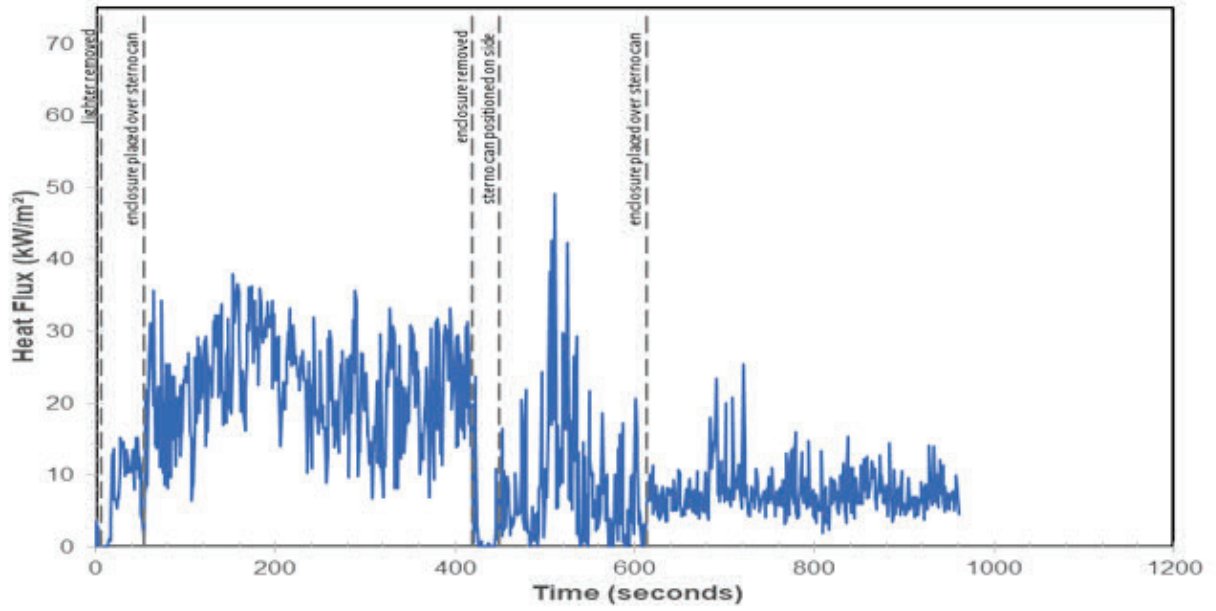
Figure 28: Phase 1, Test 4, Heat flux versus time

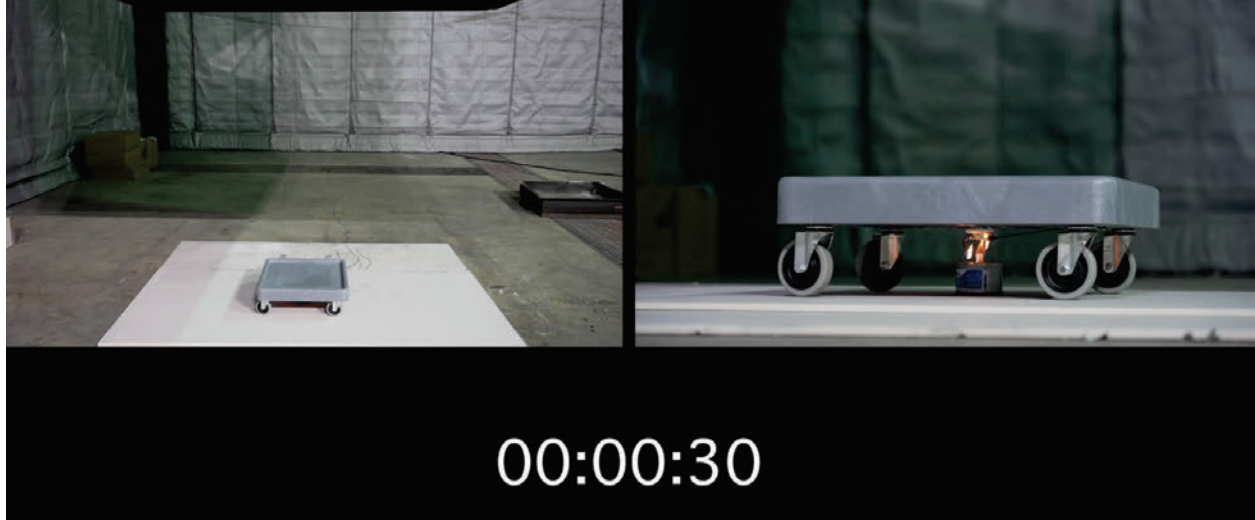
Figure 32: Phase 2, Test 2, Ignition of plastic dolly (361101_Master_1345483)

Figure 32 shows ignition of the plastic dolly 30 seconds after it was exposed to flame in Experiment 2. (Note, the flame from a stick lighter was held to the Sterno can's wick for 13 seconds into the test.) The first part of the dolly to ignite appeared to be the rubber plug under which the Sterno can was placed. Figure 33 shows when the first drip occurred at 1:14 (m:ss). Dripping did not occur until flame spread from the rubber plug to the plastic part of the dolly. Figure 34 shows the dolly burning at peak fire size at 11:20 (mm:ss). The peak fire size time was based on visual observation. Peak HRR was 853 kW and occurred at 11:40 (mm:ss) based on analysis of data. Based on the test results from Phase 1 for measured heat flux, had the Sterno

can be placed on its side or in an area of the dolly where plastic was further away from the flame, the times for dolly ignition, first drips and peak HRR would most likely have been longer.

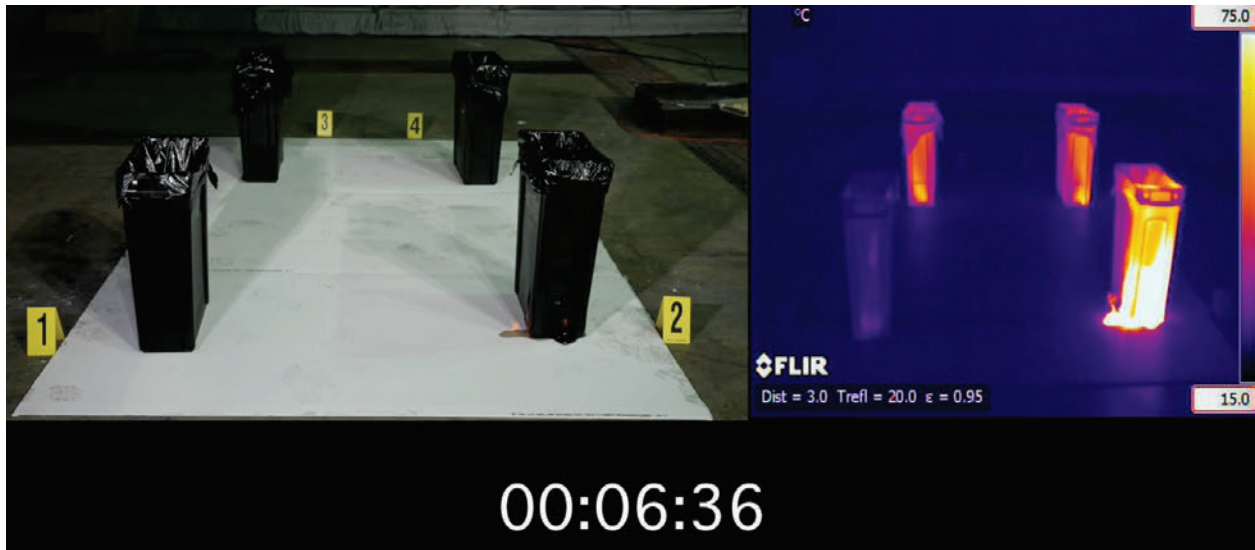
Figure 35: Phase 2, Test 3, Flame outside of trashcan 2 (361142_Master_1345553) [4]

Experiments 3 and 4 were conducted by placing a lit Sterno can into the contents of a Rubbermaid Slim Jim 23 gallon trash can. Figure 35 is a screenshot of video from Experiment 3 and shows when fire spread from the interior to the exterior of one of the four trashcans, which occurred at 6:36 (mm:ss) post ignition. At this time a portion of the chafing fuel that had spilled to the exterior of the can was burning. Figure 36 shows the trashcan burning at peak fire size 23:59 (mm:ss) after ignition.

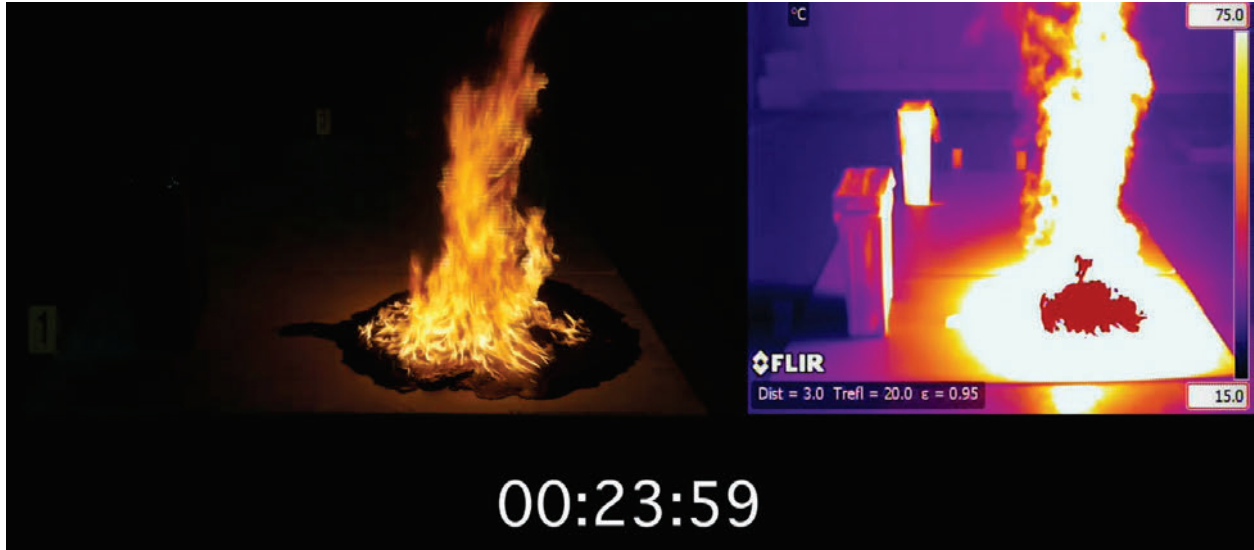
Figure 36: Phase 2, Test 3, Peak burning based on visual observation (361142_Master_1345553) [4]

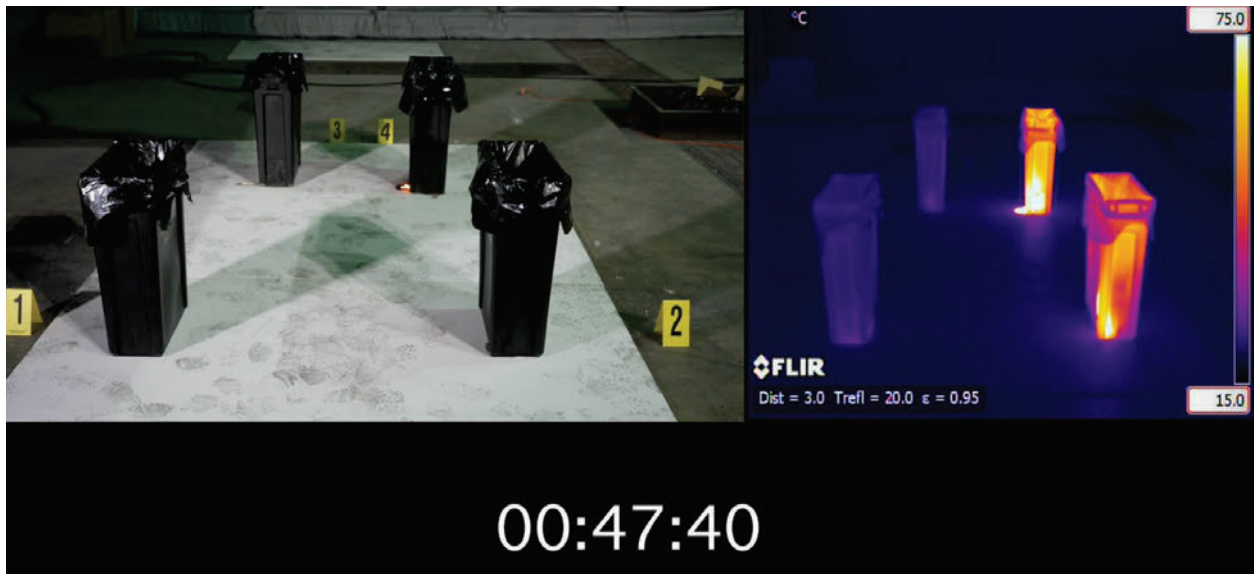
Figure 37: Phase 2, Test 4, Flame outside of trashcan 3 (361155_Master_1345575) [4]

Figure 37 is a screenshot of video from Experiment 4 and shows when fire spread from the interior to the exterior of one of the four trashcans, which occurred at 47:40 (mm:ss) post ignition. At this time a portion of the chafing fuel that had spilled to the exterior of the trash can was burning.

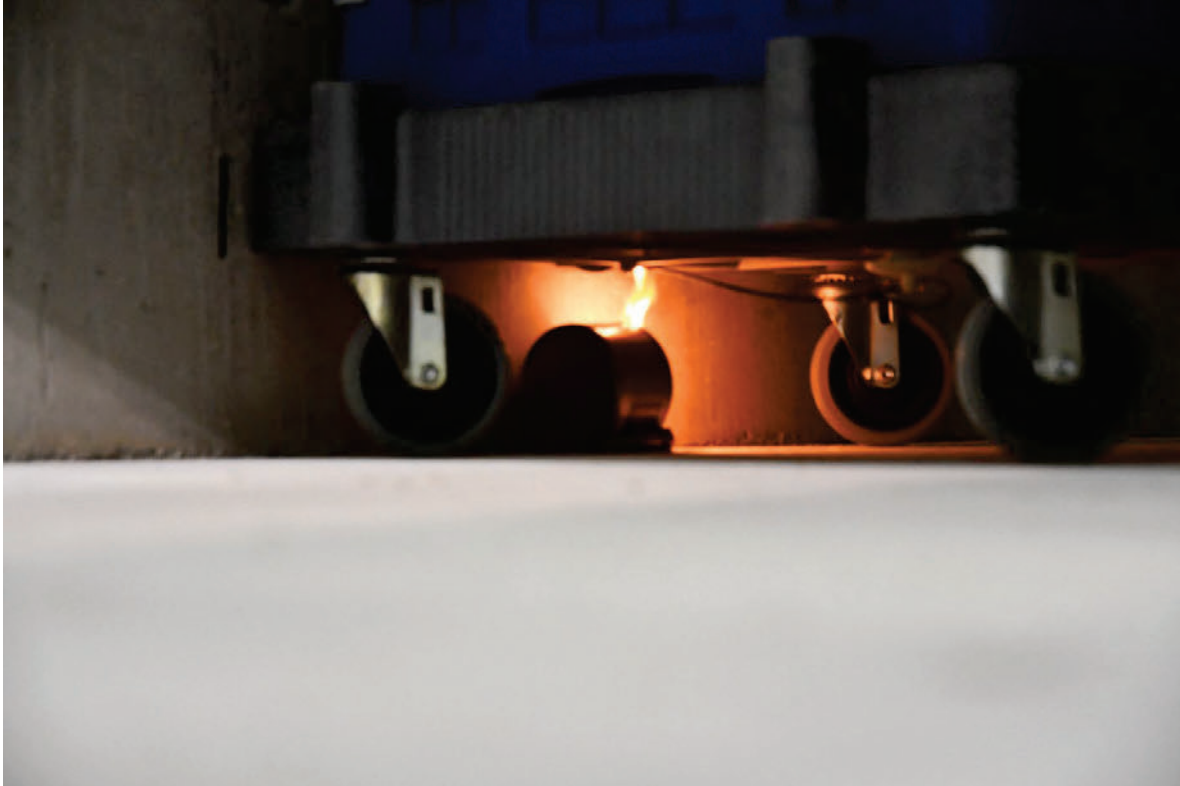
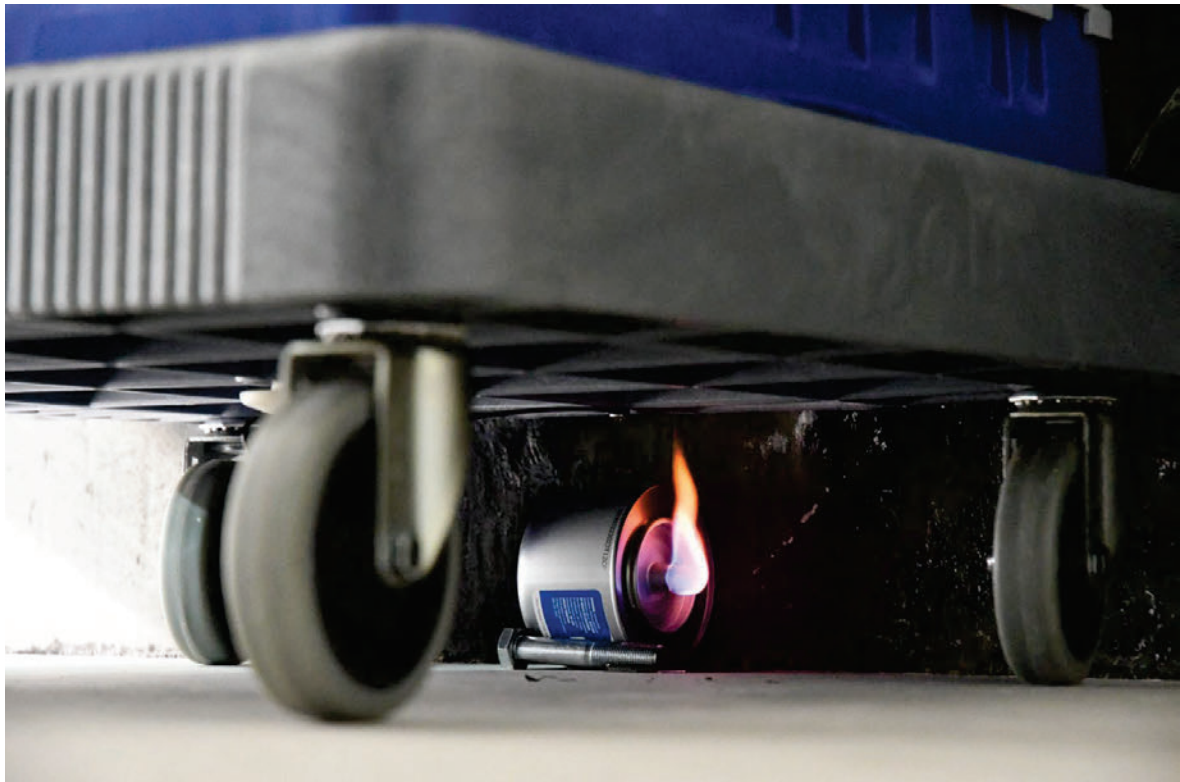
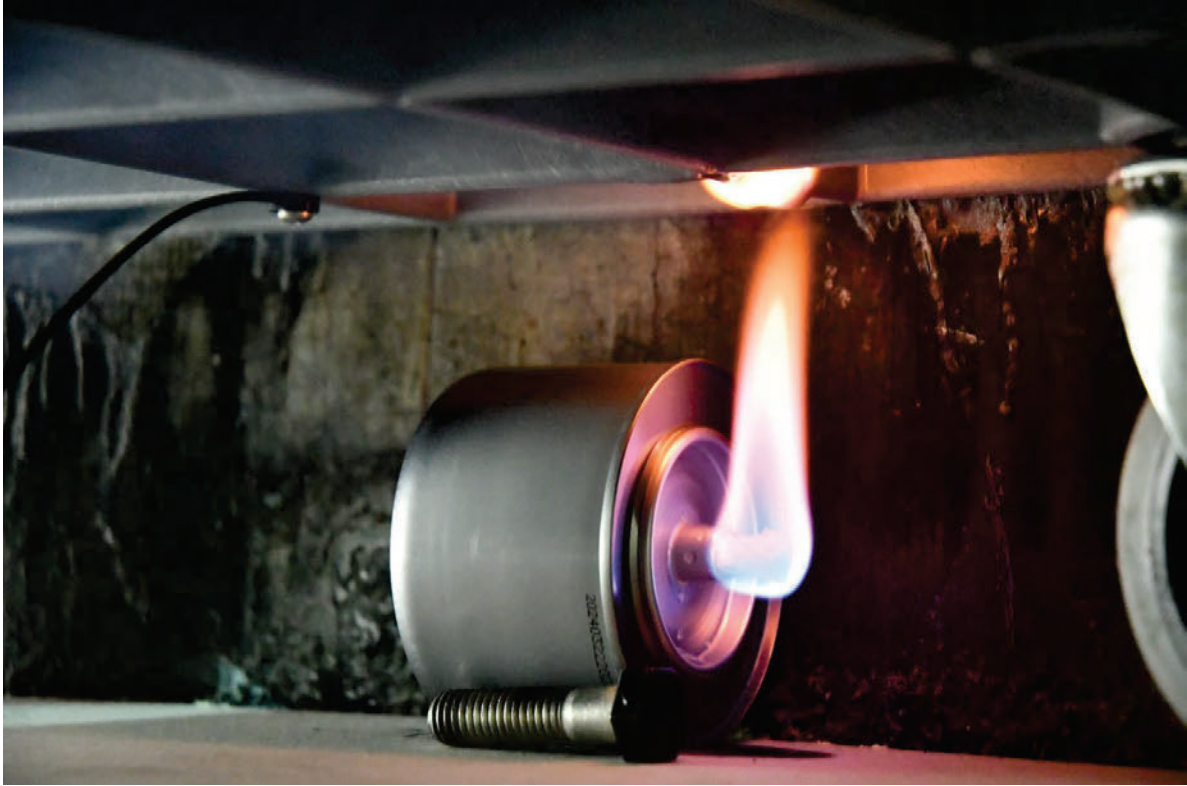
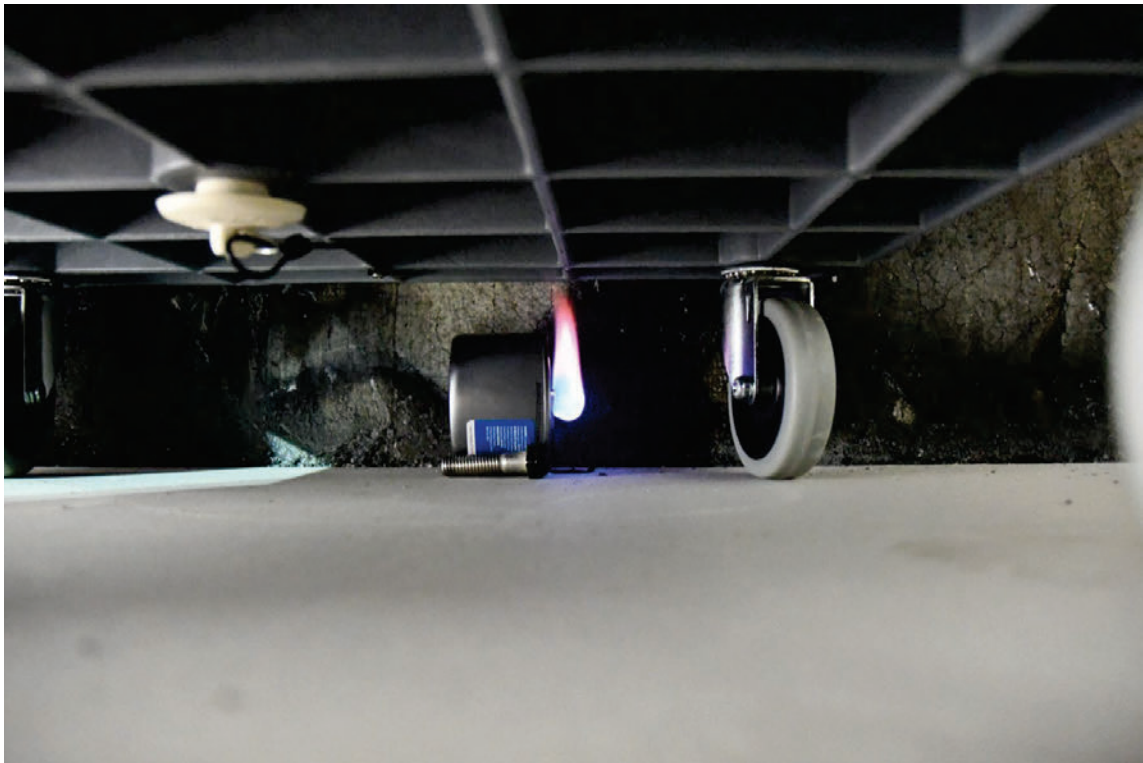
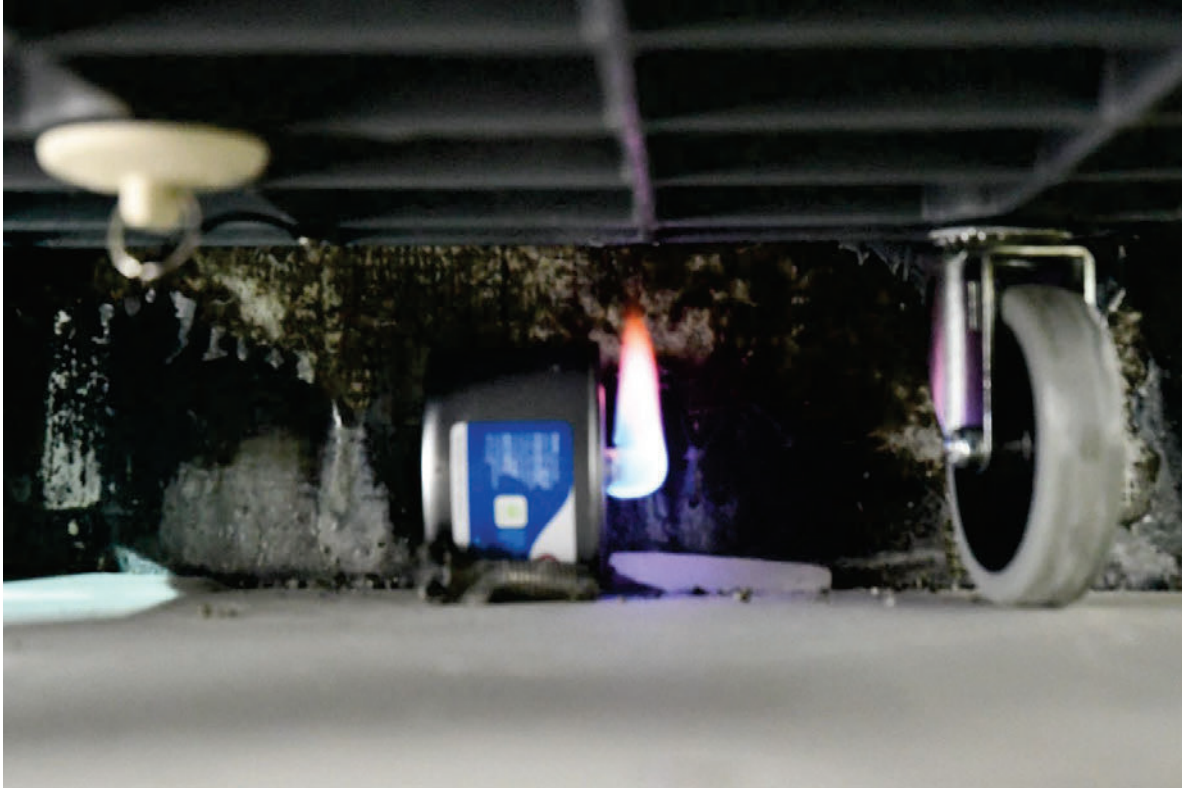
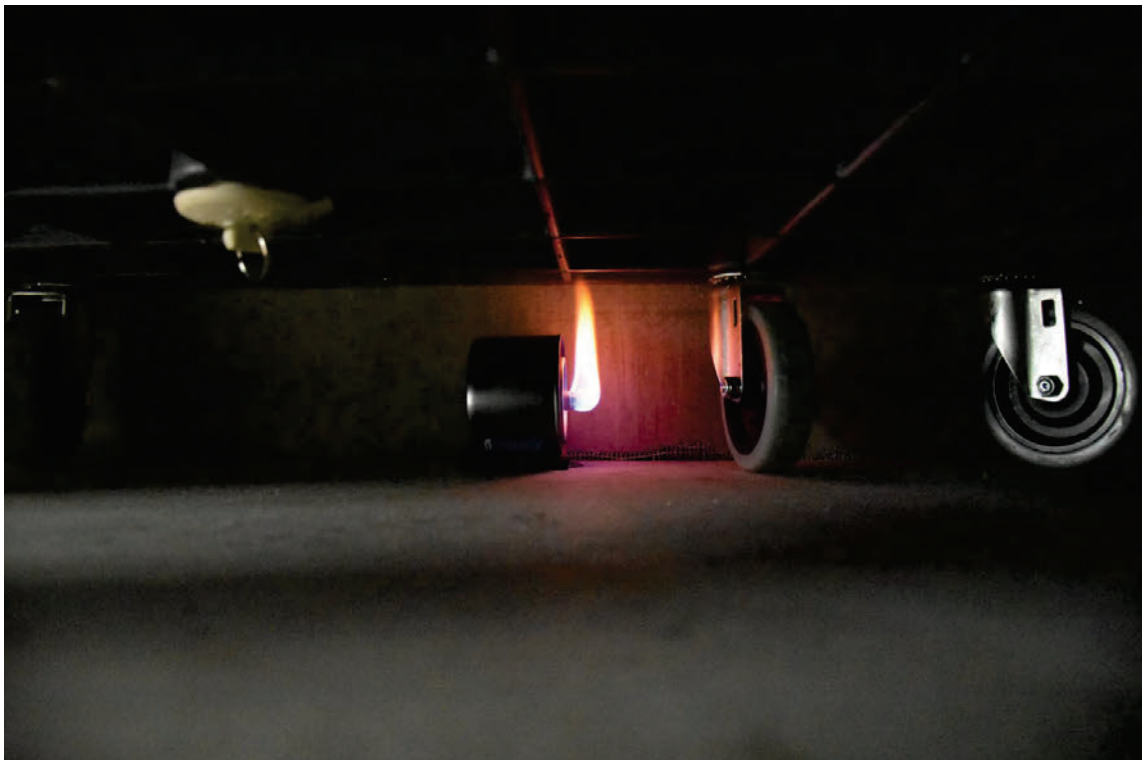
Figure 38: Phase 3, Test 1, Sterno can placement (361029_1338520.JPG)

Figure 39: Phase 3, Test 2, Sterno can placement (361118_1339184.JPG)

Figure 40: Phase 3, Test 3, Sterno can placement (361119_1339535.JPG)

Figure 41: Phase 3, Test 4, Sterno can placement (361120_1339698.JPG)

Figure 42: Phase 3, Test 6, Sterno can placement (361123_1339996. JPG)

Figure 43: Phase 3, Test 7, Sterno can placement (361143_1341584. JPG)

Figure 38 through Figure 43 are photographs showing the location of the lit Sterno can beneath the plastic dolly at the start of Experiments 1 through 4 and Experiments 6 and 7. In some experiments the flame was closer to one of the protrusions at the bottom of the dolly, and in others the flame was under one of the square recesses created by protrusions.
