Fire Research Laboratory
BUREAU OF ALCOHOL, TOBACCO, FIREARMS AND EXPLOSIVES
6000 Ammendale Road
Beltsville, MD 20705-1250

Laboratory Report

Date of Report: April 18, 2024
Lab Number: [REDACTED]
Reference: [REDACTED]
Title of Investigation: Fire - Spirit of Boston
Type of Exam: Engineering – Analysis

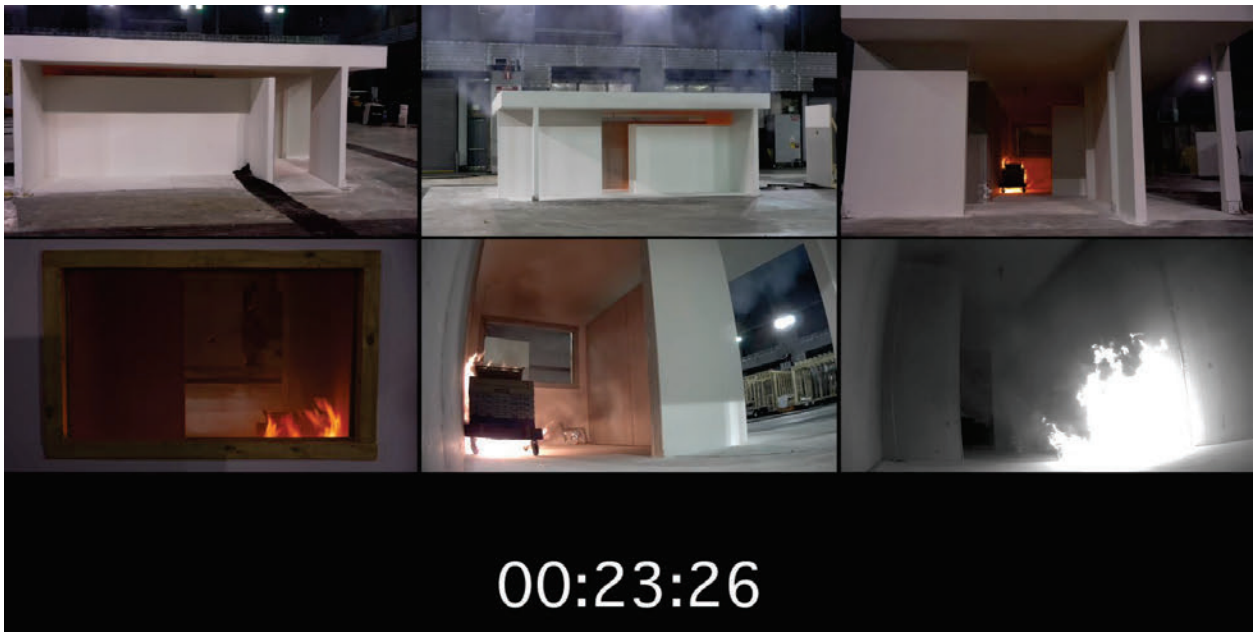
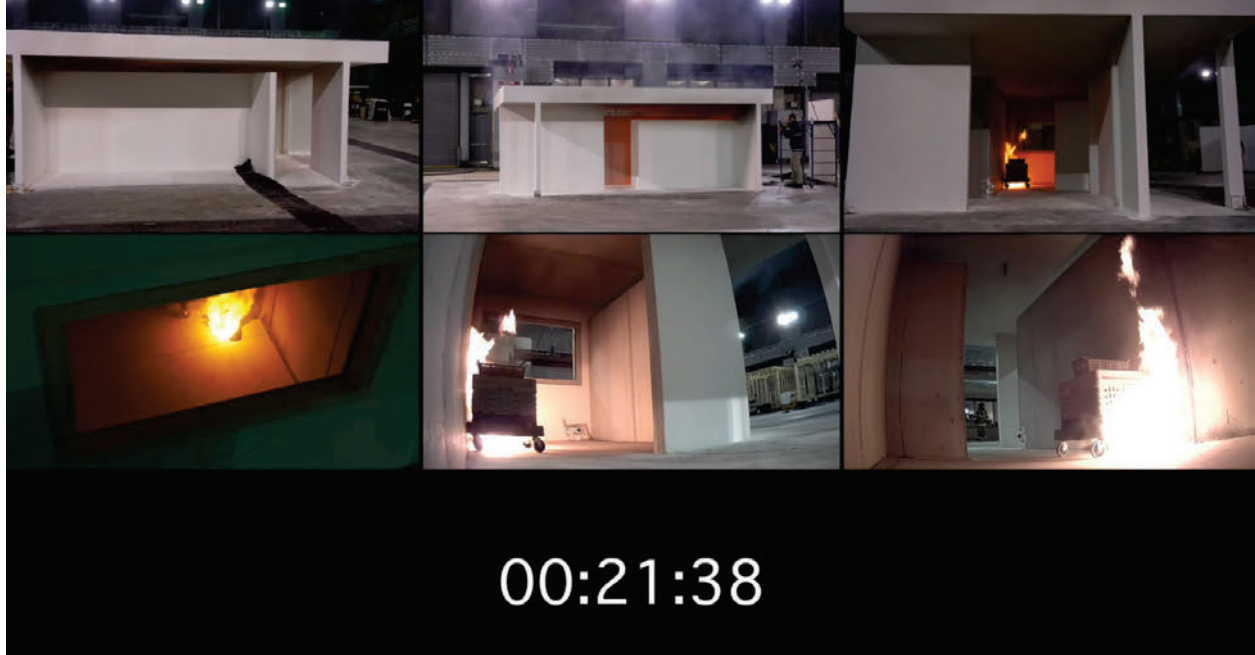
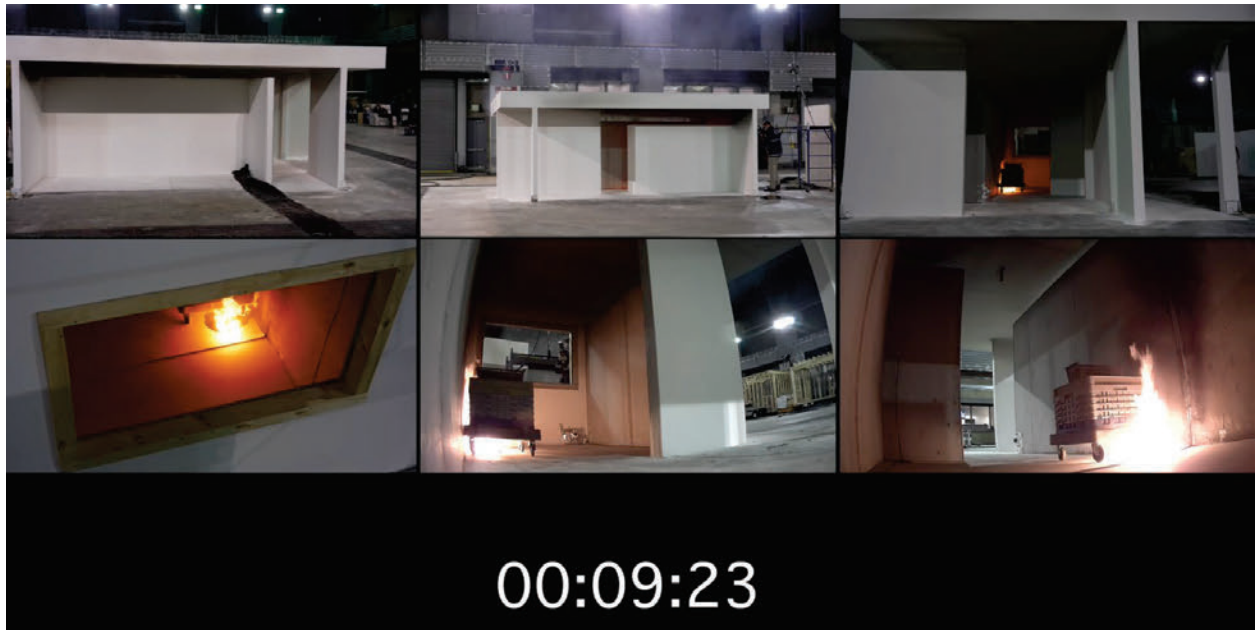
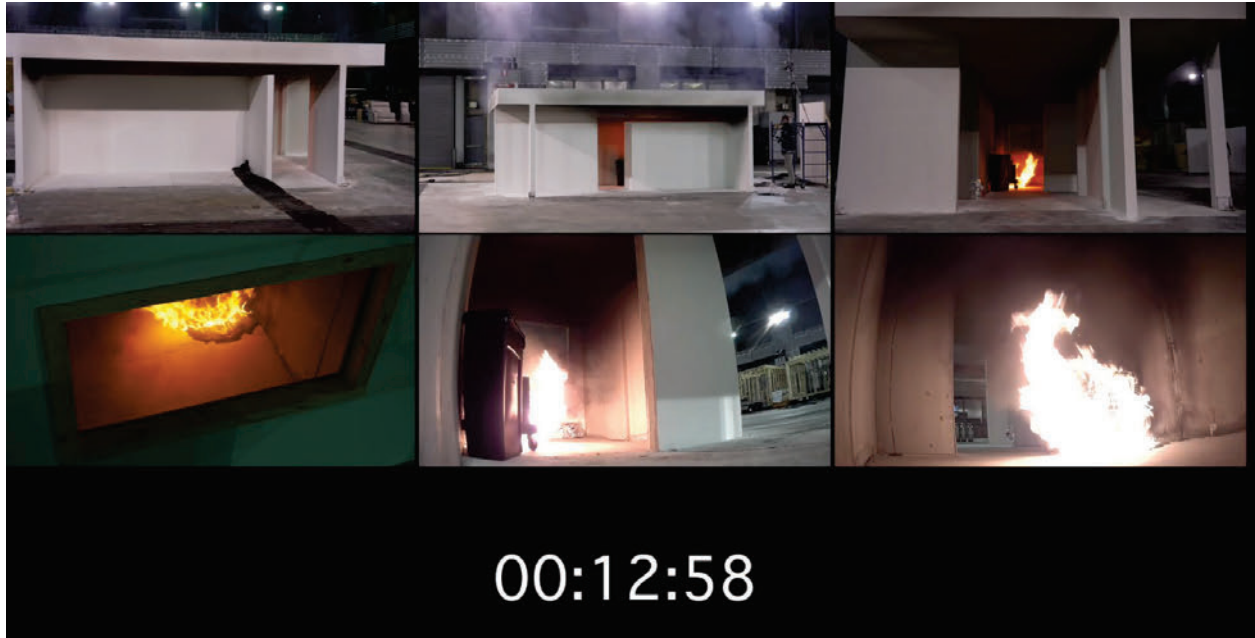
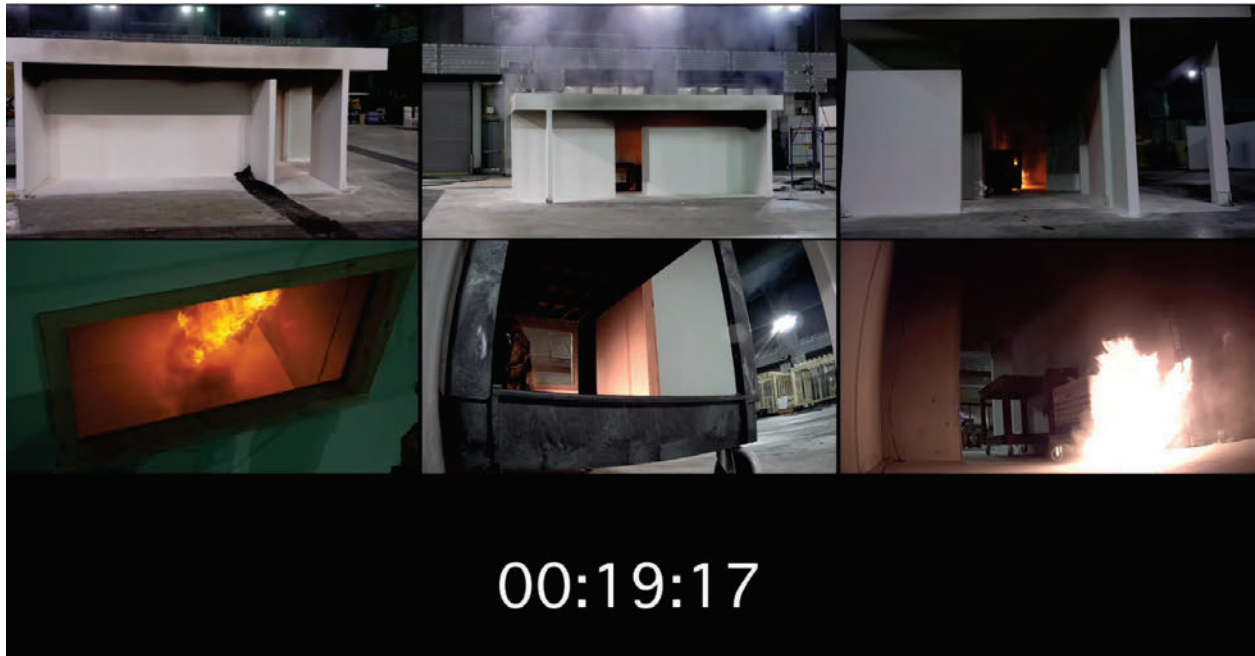
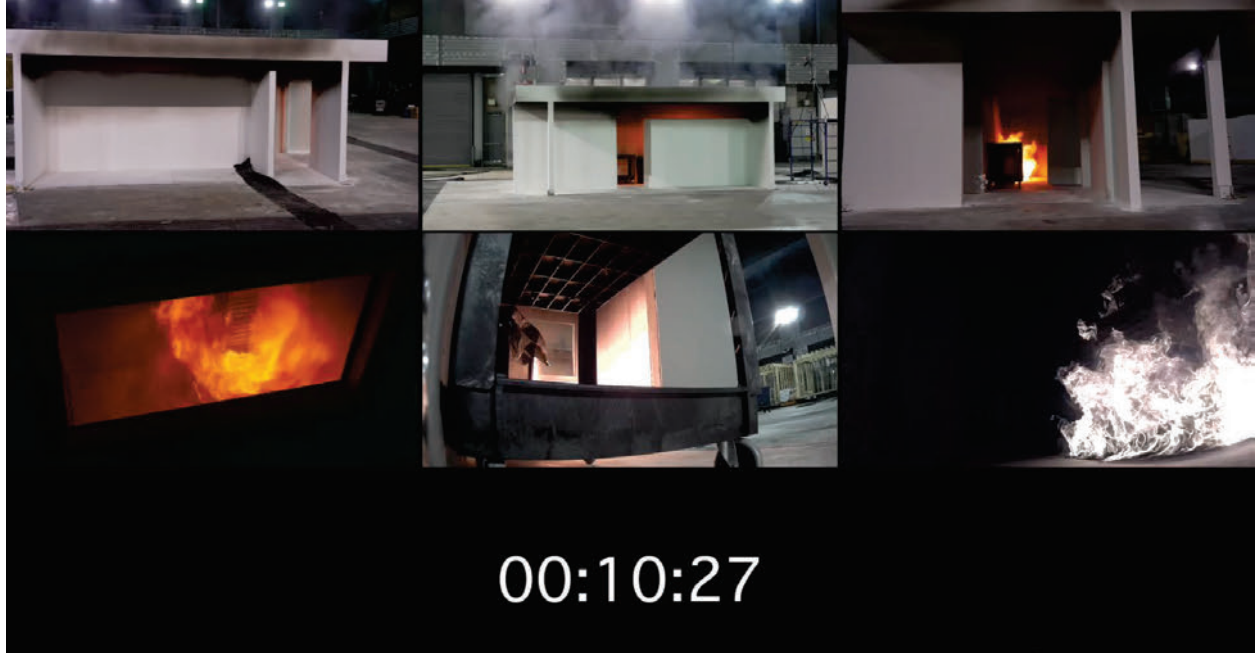
Figure 45: Phase 3, Test 1 (361029_Master_1345478)

Figure 46: Phase 3, Test 2 (361118_Master_1345484)

Figure 47: Phase 3, Test 3, Sterno can repositioned at 167 seconds post ignition to ensure that the flame was in contact with plastic ribbing under dolly cart (361119_Master_1345485)

Figure 48: Phase 3, Test 4 (361120_Master_1345486)

Figure 49: Phase 3, Test 6 (361123_Master_1345488)

Figure 50: Phase 3, Test 7 (361143_Master_1345554)

Screenshots from a master video for Experiments 1 through 4 and Experiments 6 and 7 are presented in Figure 45 through Figure 50 and show the time at which “Heavy” smoke was visible. The master video consists of six different time synchronized test videos. Table 7 provides a location and description of the individual videos used in the master video and their perspective as it relates to the fire aboard the Spirit of Boston. The camera view in the middle of the top row in Figure 45 through Figure 50 was taken from the same perspective as the camera view in the dining area looking towards the wait station aboard the Spirit of Boston. (See Figure 4.)

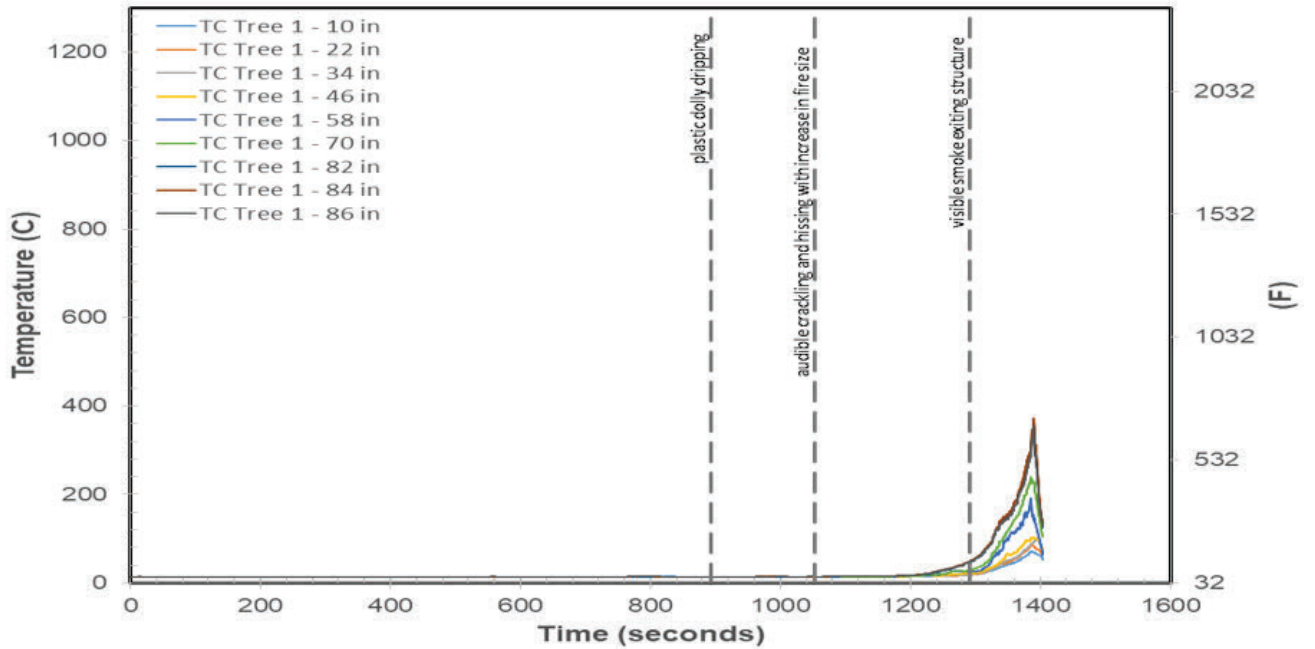
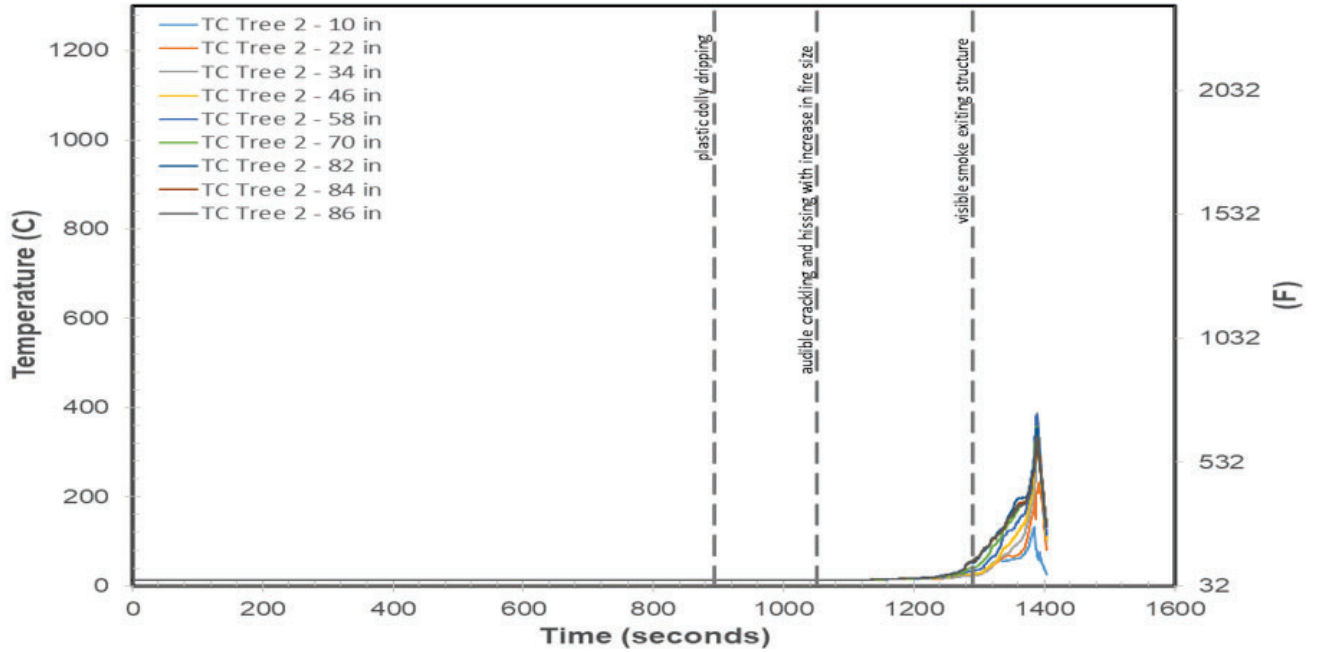
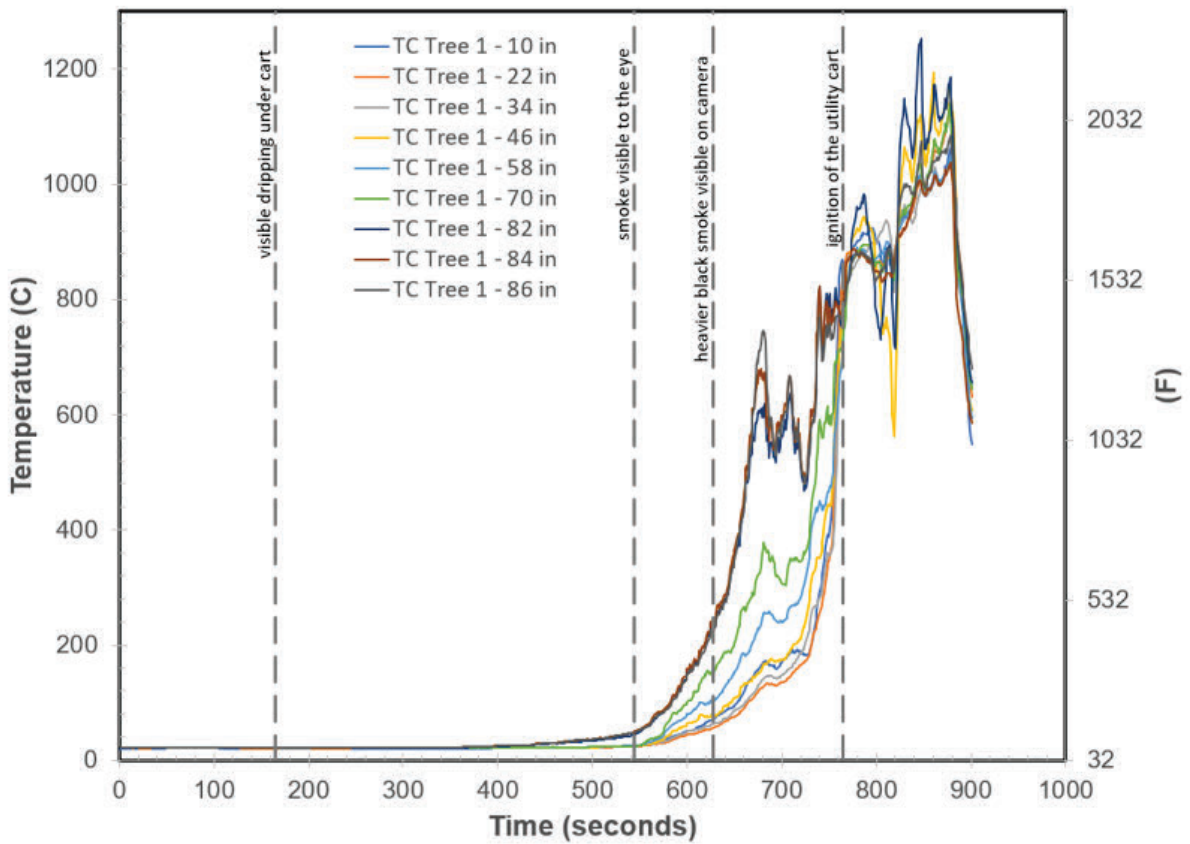
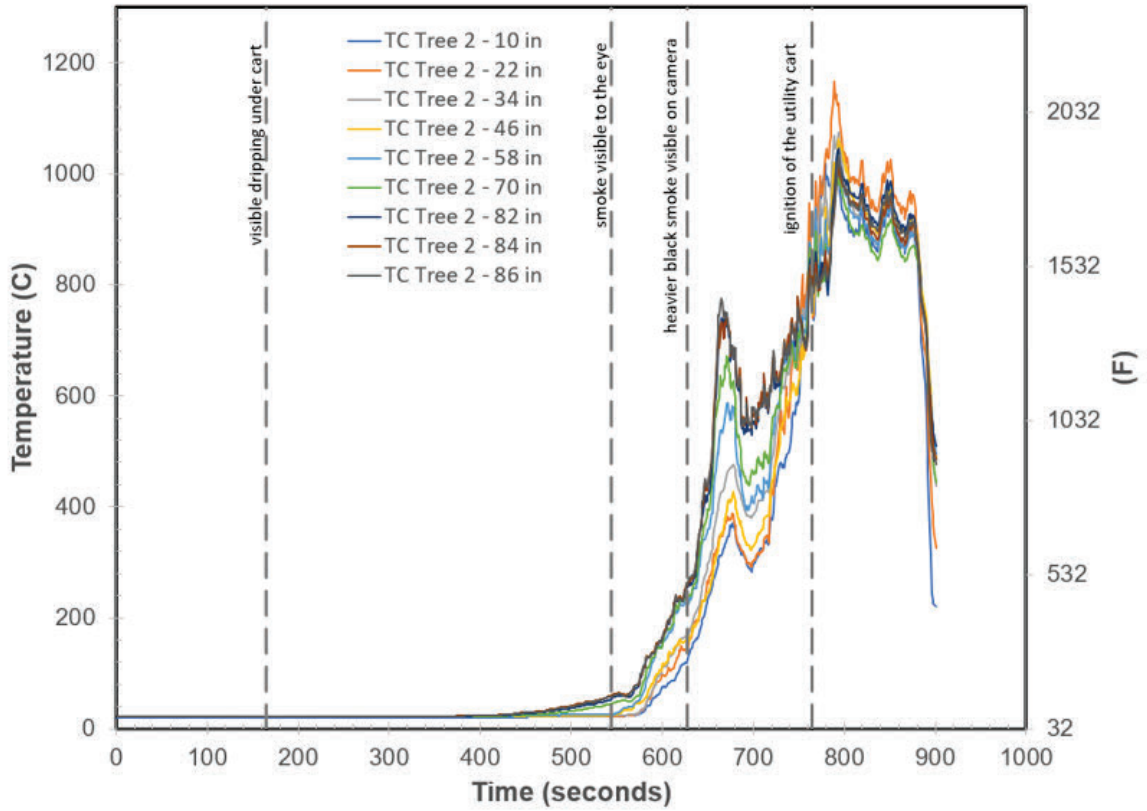
Figure 51: Phase 3, Test 2, Temperature versus time [5]

Figure 52: Phase 3, Test 2, Temperature versus time [5]

Figure 53: Phase 3, Test 7, Temperature versus time [5]

Figure 54: Phase 3, Test 7, Temperature versus time [5]

Figure 51 through Figure 54 shows gas temperatures for Experiment 2 and Experiment 7, respectively. At the time “Heavy” smoke was observed on video compartment, temperatures at the ceiling measured around 100 °C to 150 °C. Approximately one minute after “Heavy” smoke was observed on video the smoke began to turn dark in color and intermittent flames could be seen between the vertical gap in the pony wall and the drop ceiling.

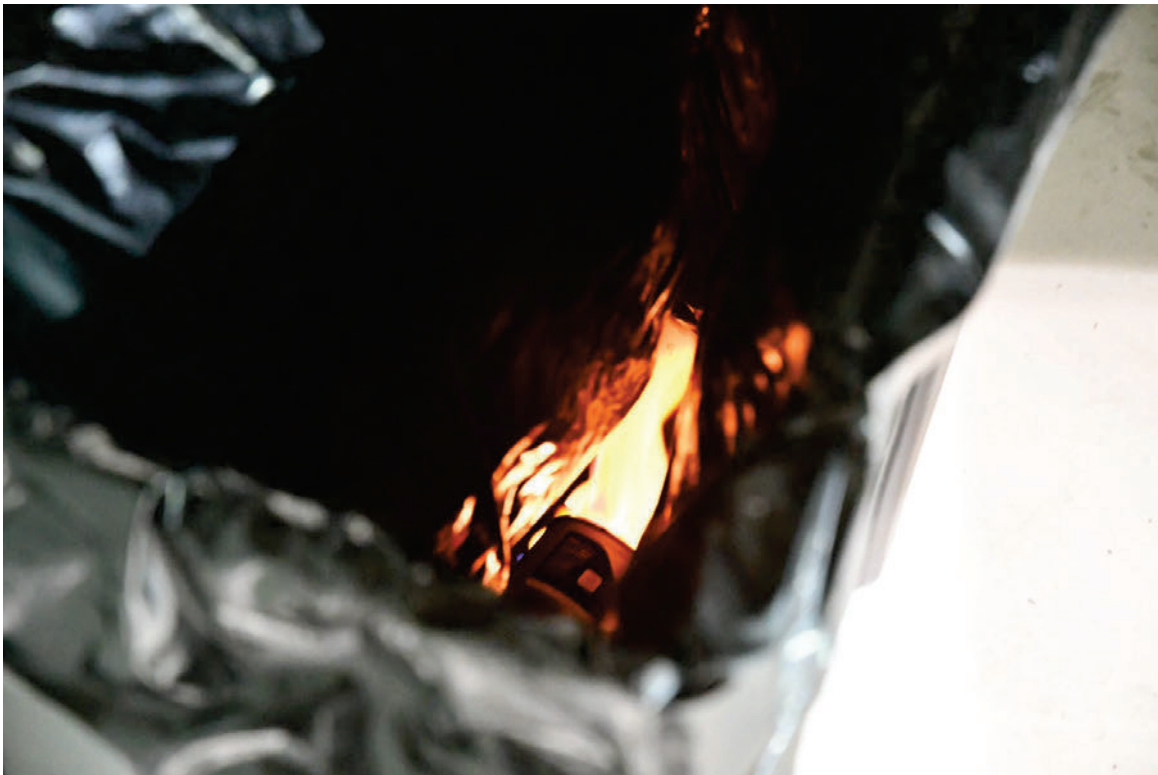
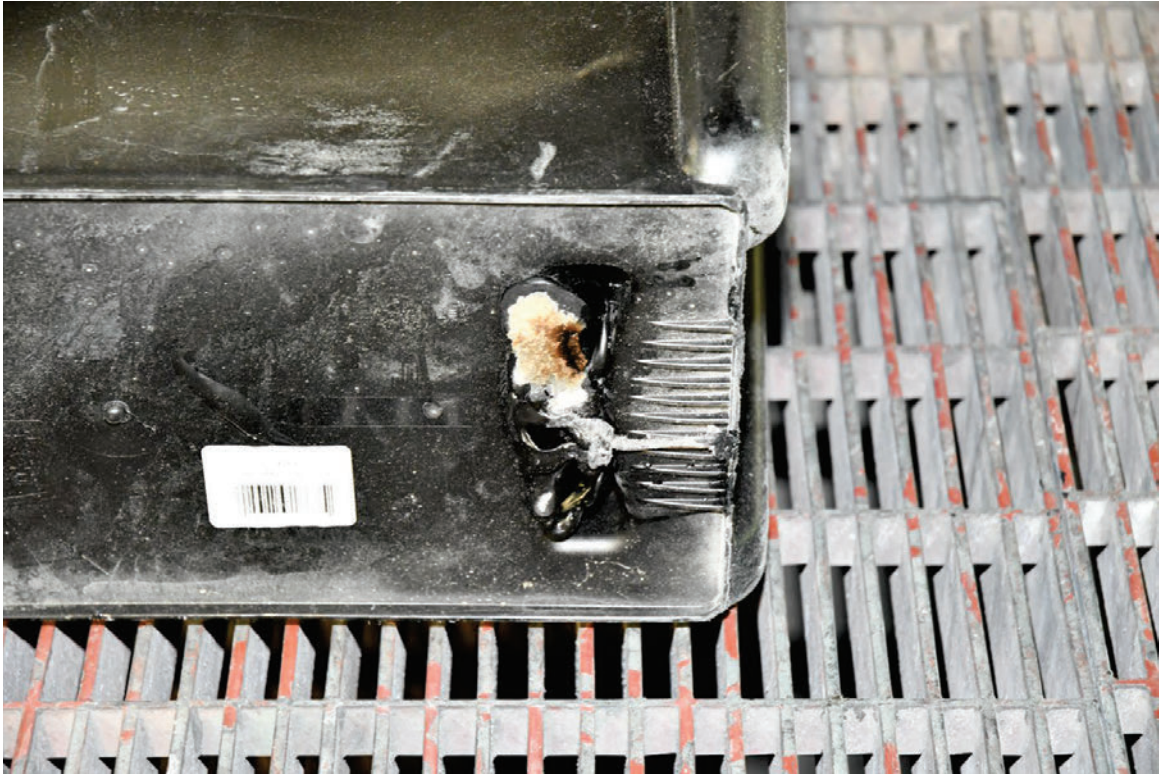
Figure 55: Phase 3, Test 5, (361122_1339878. JPG)

Figure 56: Phase 3, Test 5, post test damage (361122_1339928. JPG)

Figure 55 and Figure 56 show the interior of the trashcan in Experiment 5 and the exterior of the trash can following suppression, respectively. Fire failed to spread from the interior of the trashcan to the exterior.
