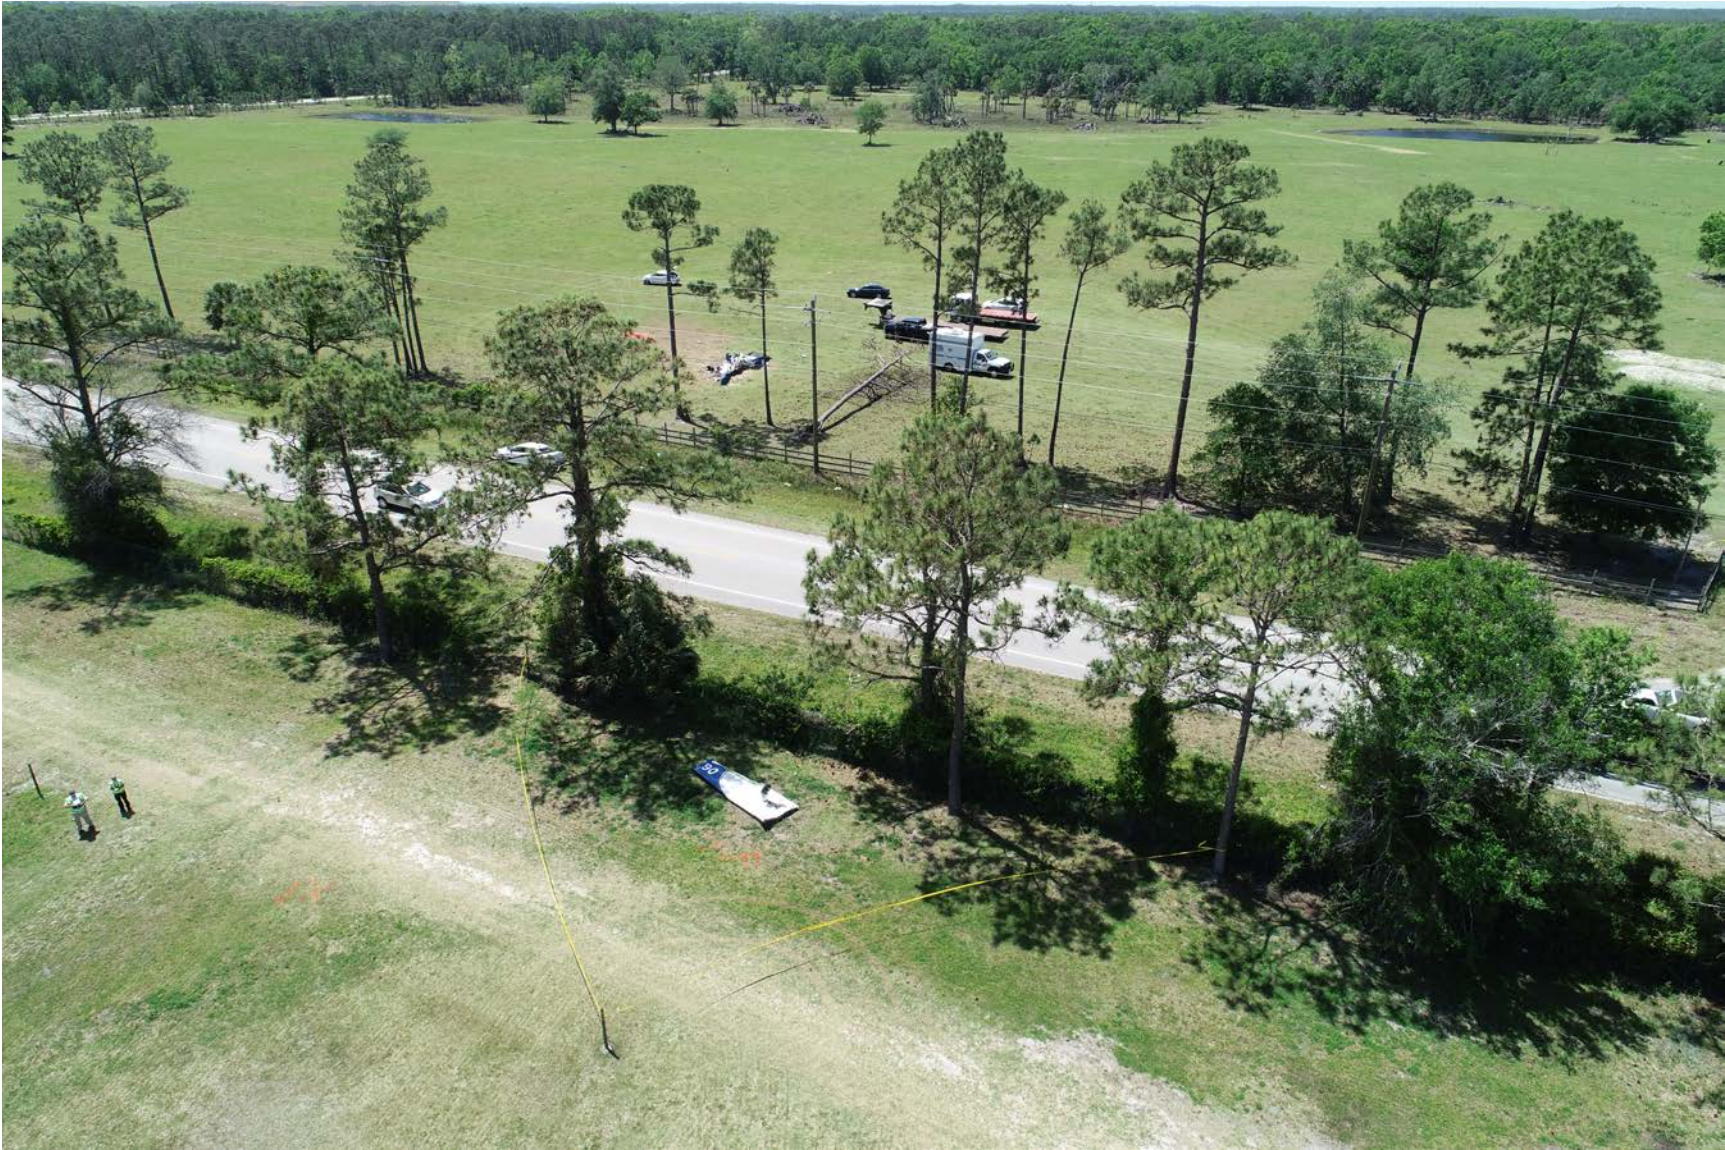
Photo 1 – Overhead view of left wing looking southwest towards main wreckage in background.

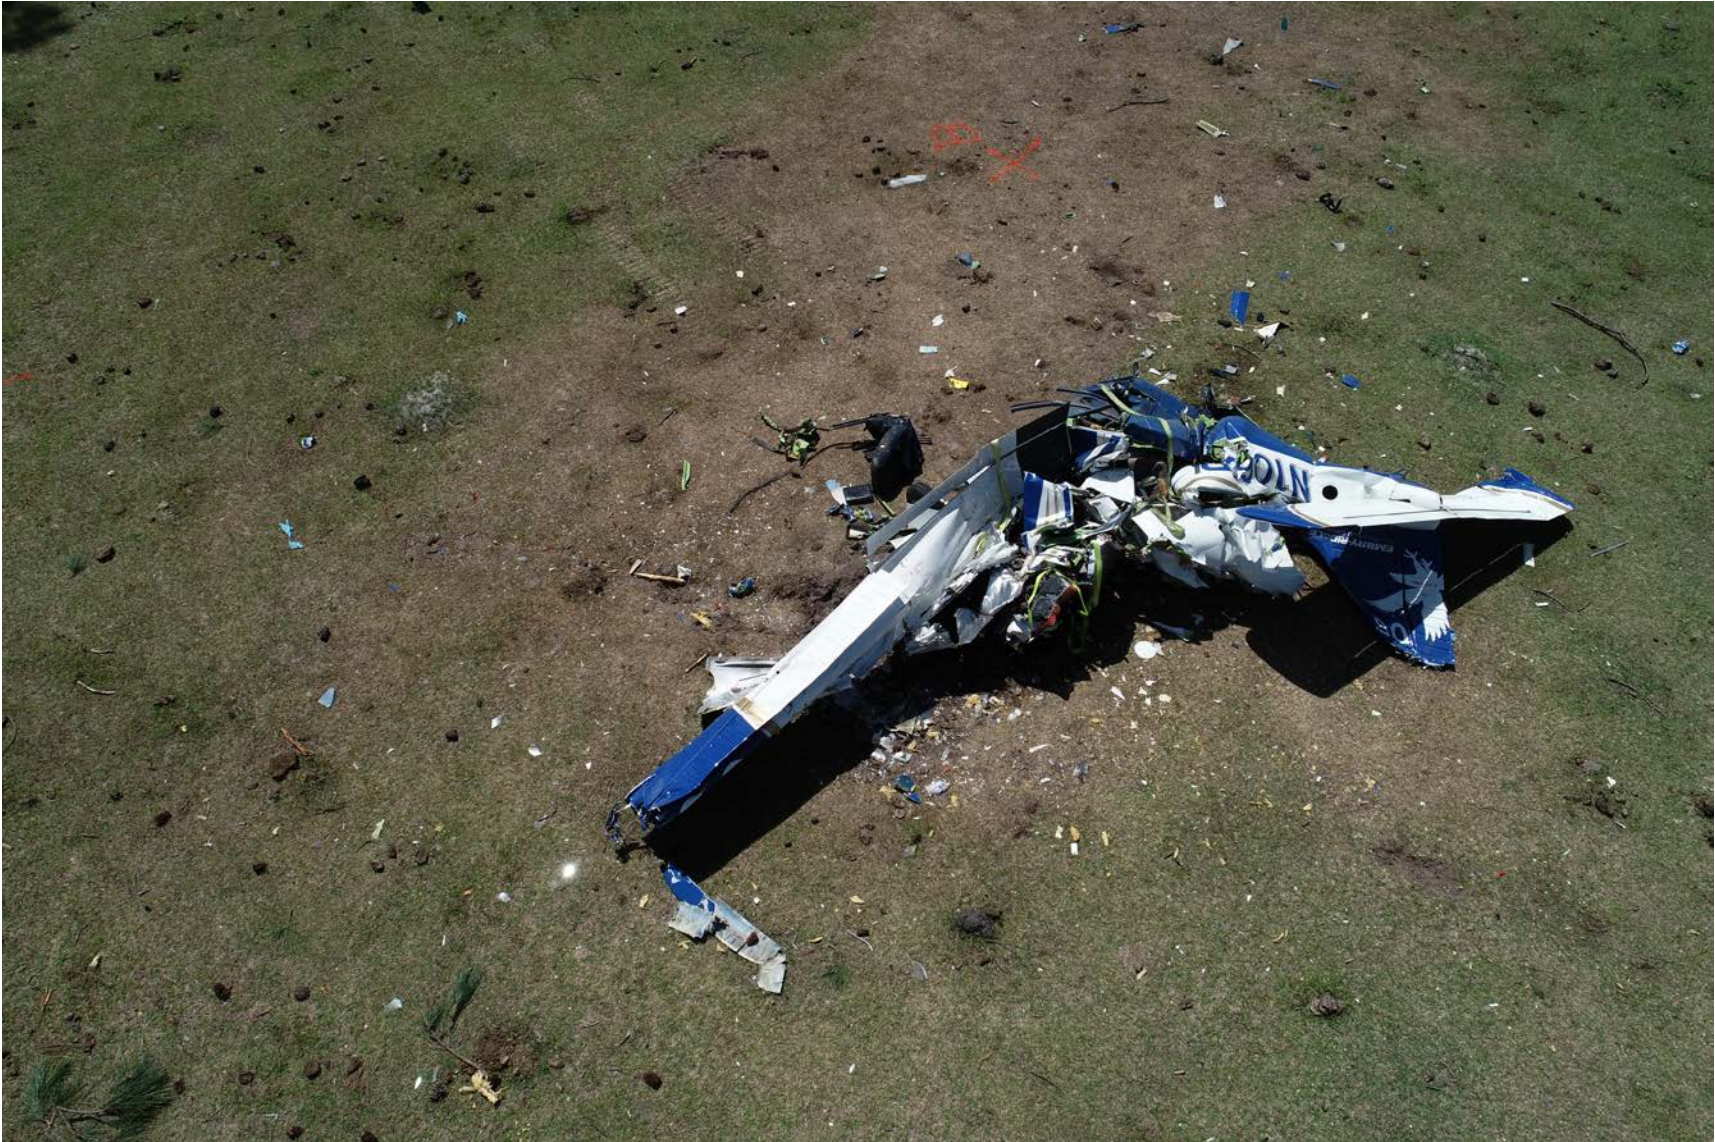
Photo 2 – Overhead view of main wreckage.

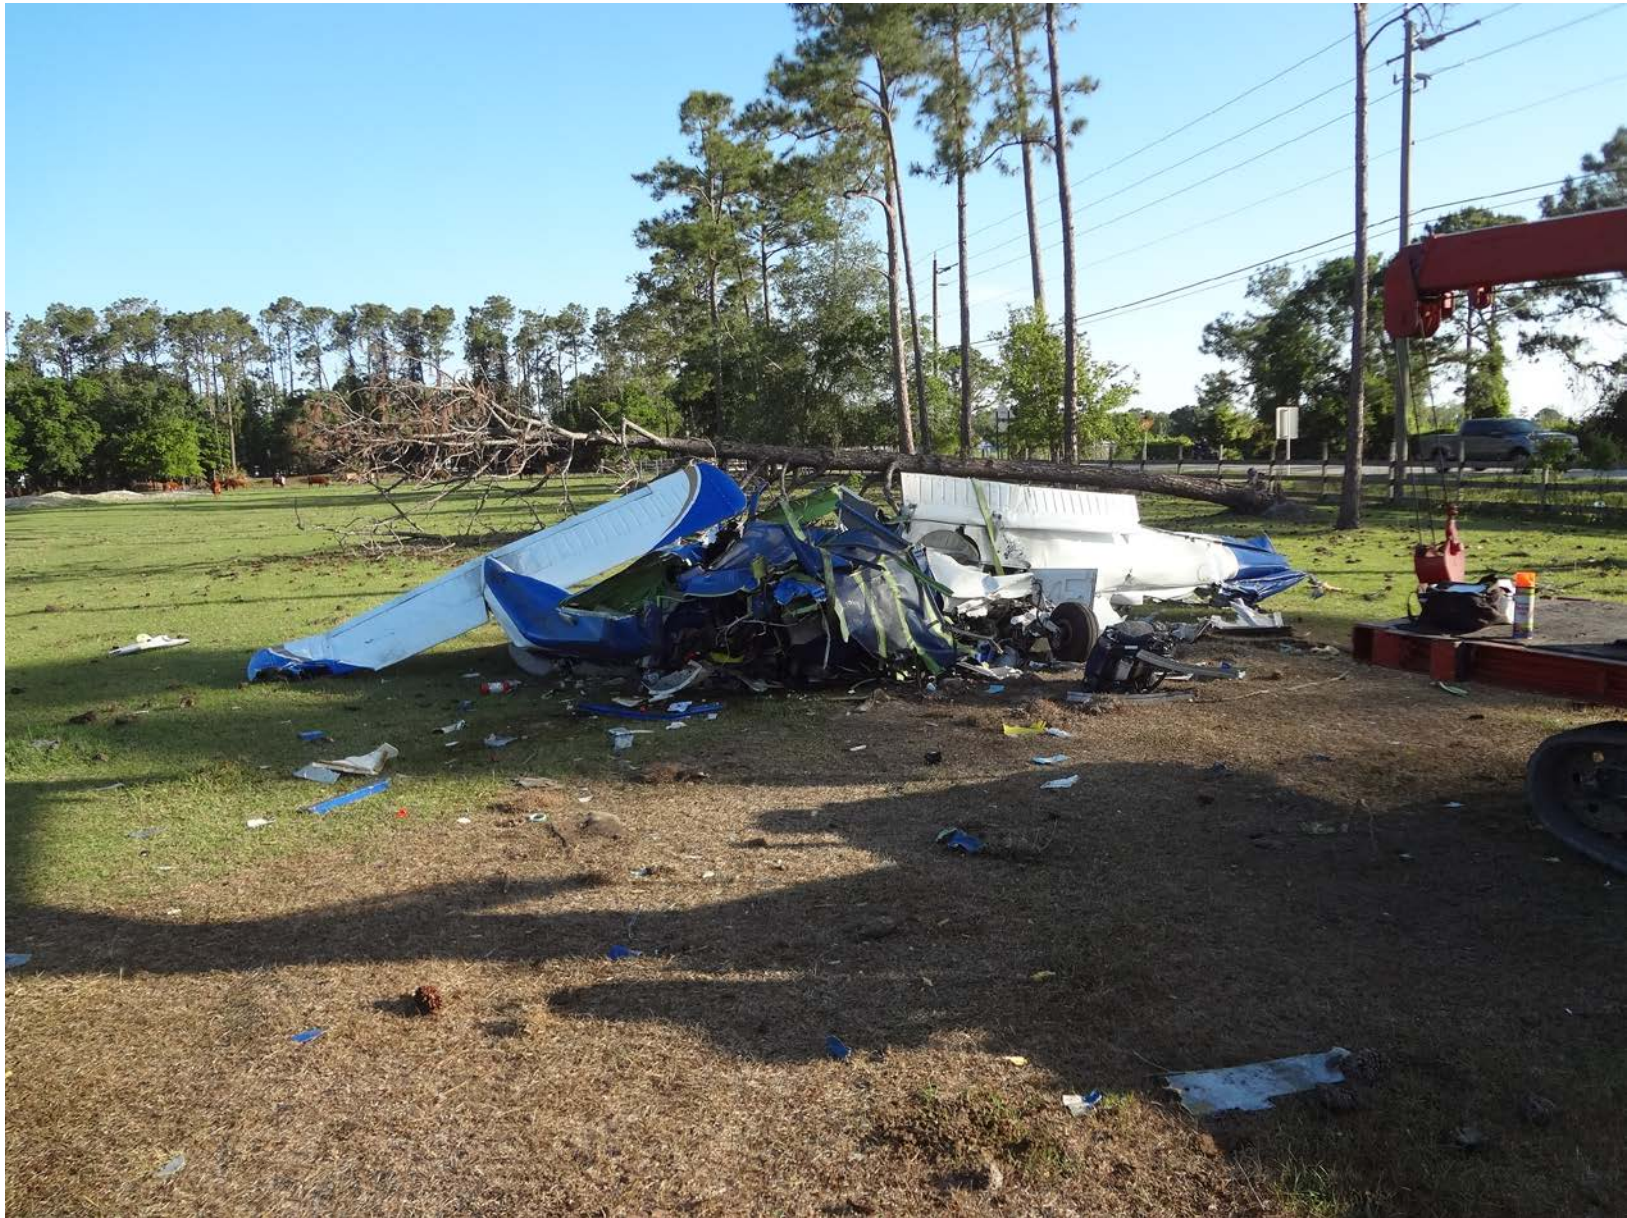
Photo 3 – Ground level view of main wreckage looking north.

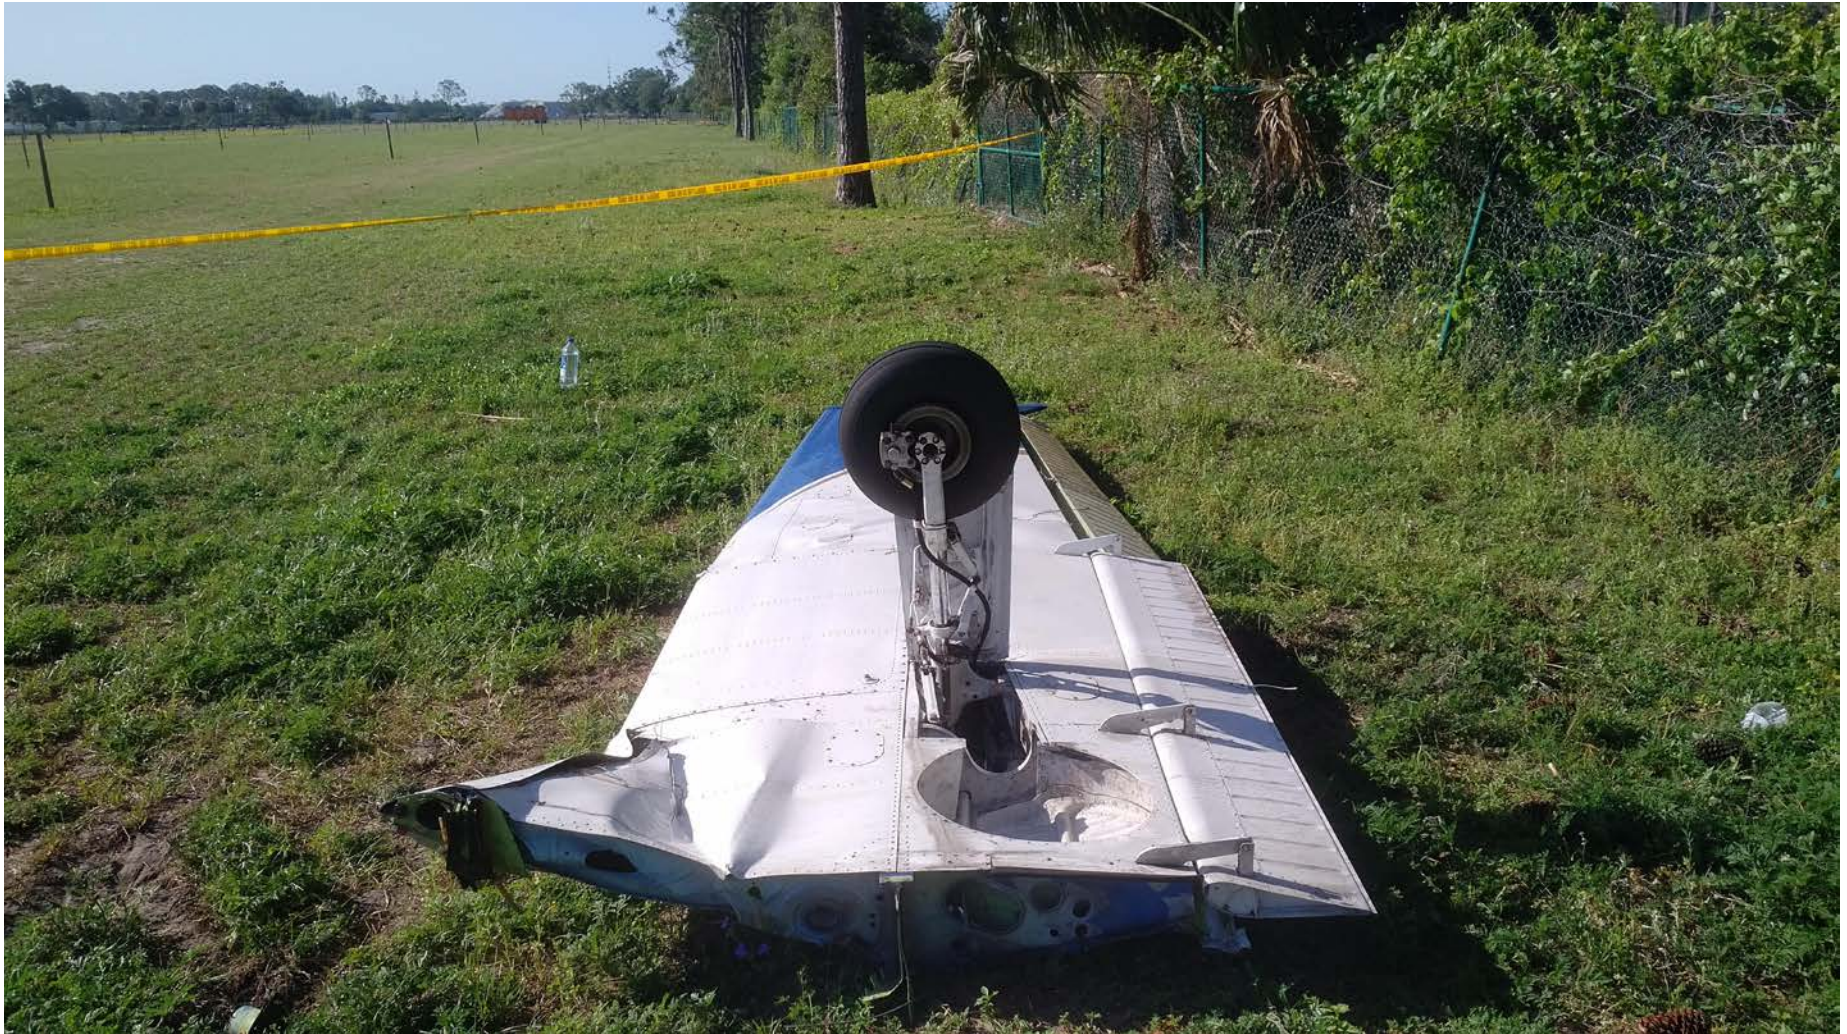
Photo 4 – View of final resting spot of left wing as it was discovered. Wing is upside down with the landing gear extended. Note the fractured wing spar.

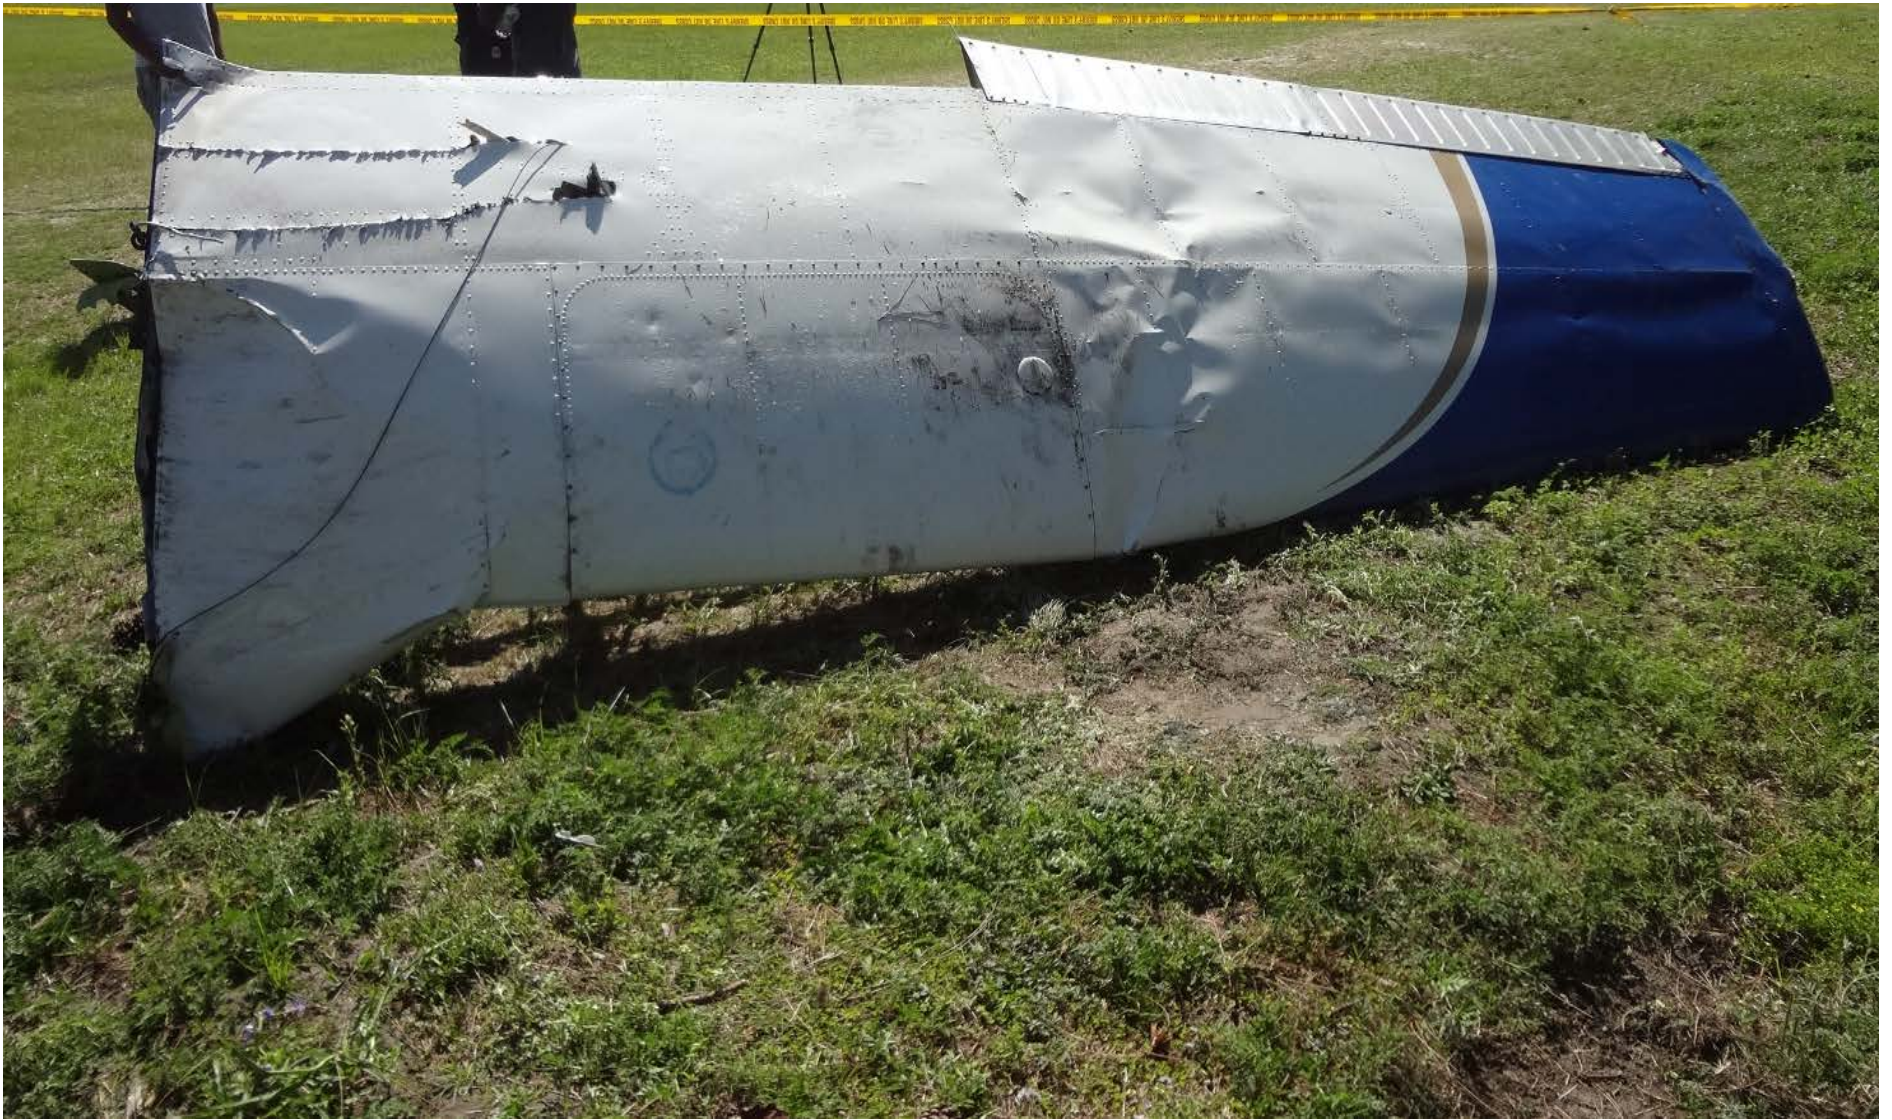
Photo 5 – View of left wing upright showing top of wing and control cable tears and skin buckling.

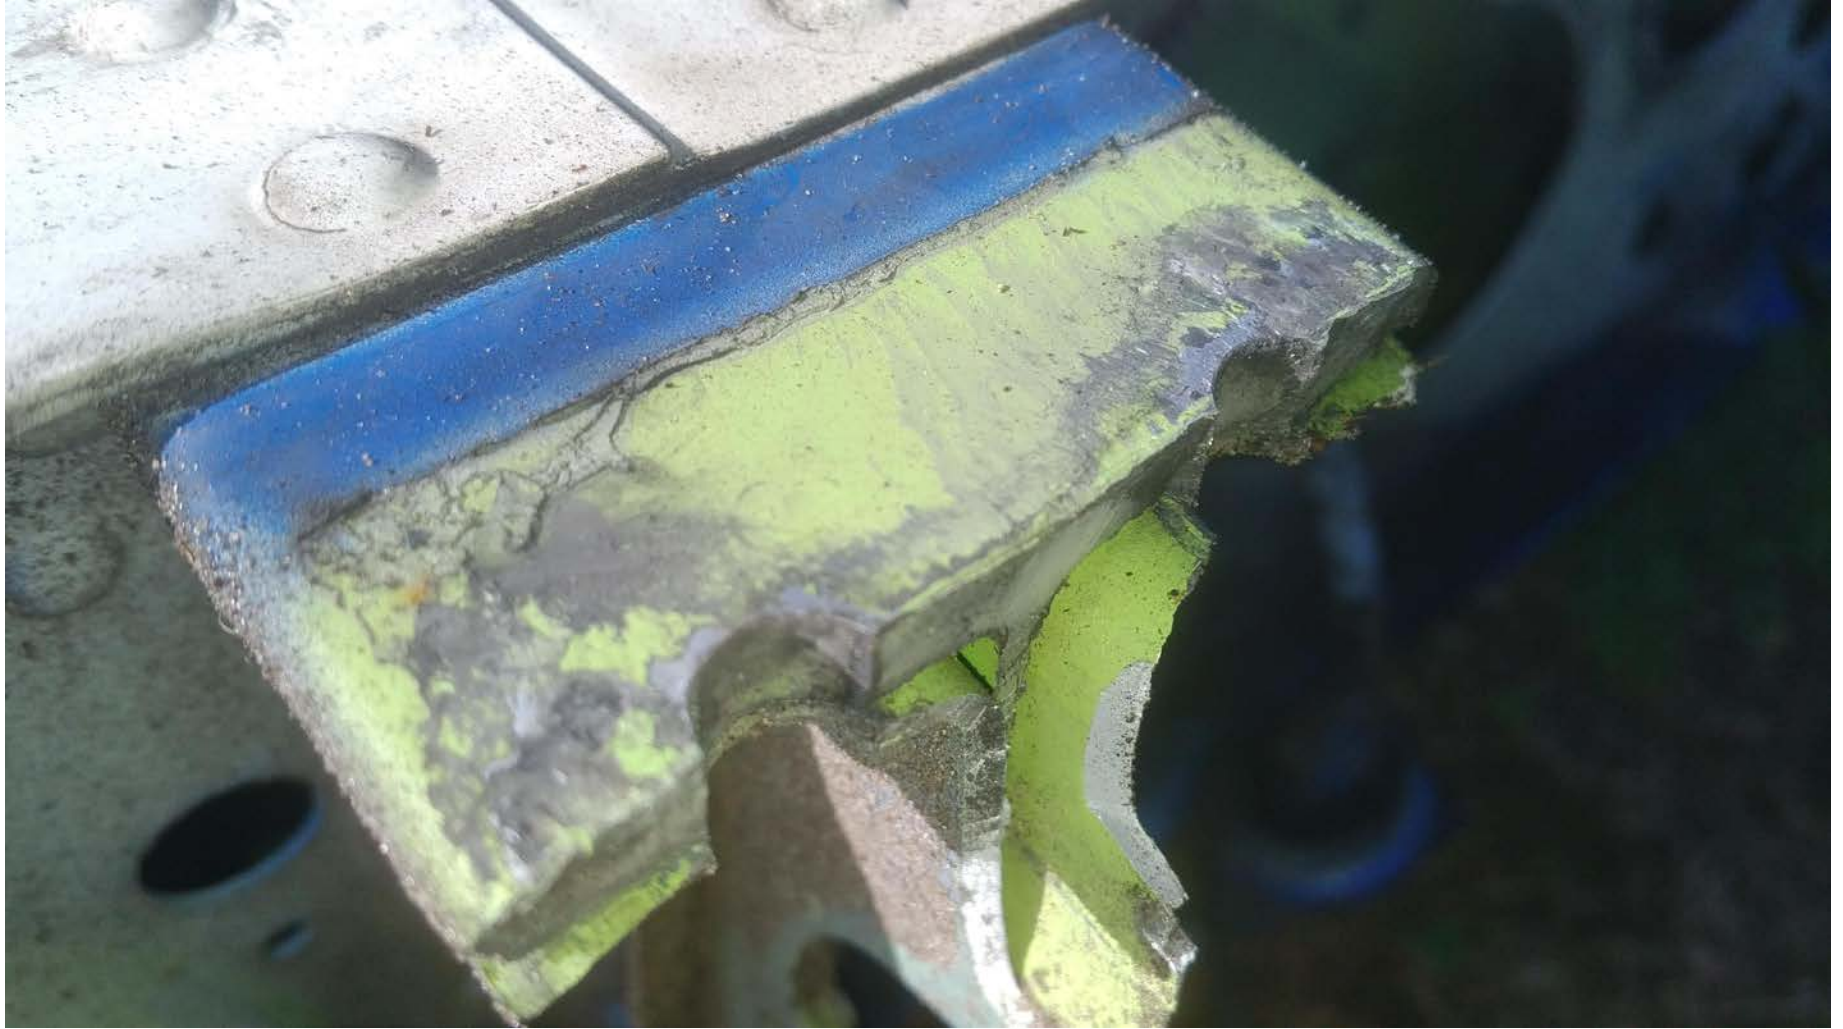
Photo 6 – Close up view of left-wing lower spar cap fracture.

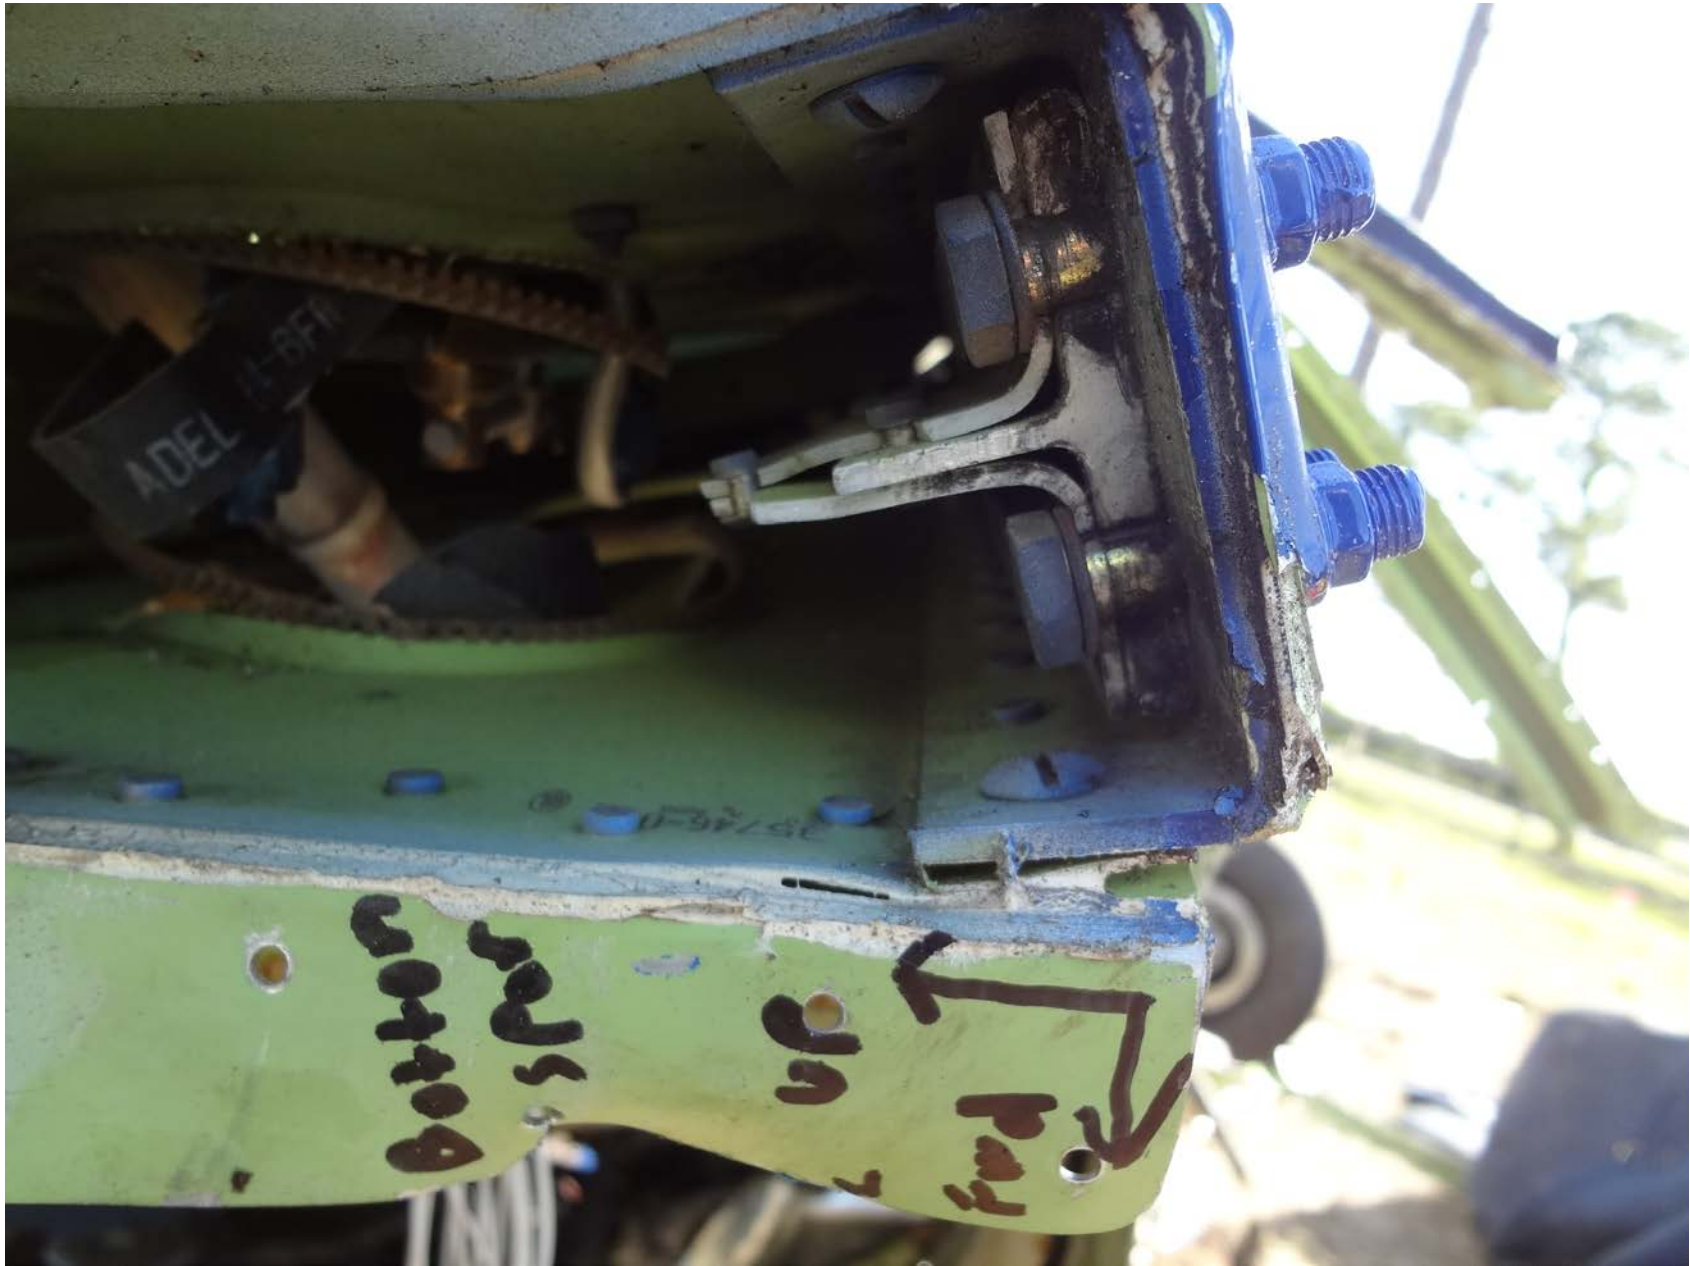
Photo 7 – Close up view of left fuselage wing spar and fracture surface.
