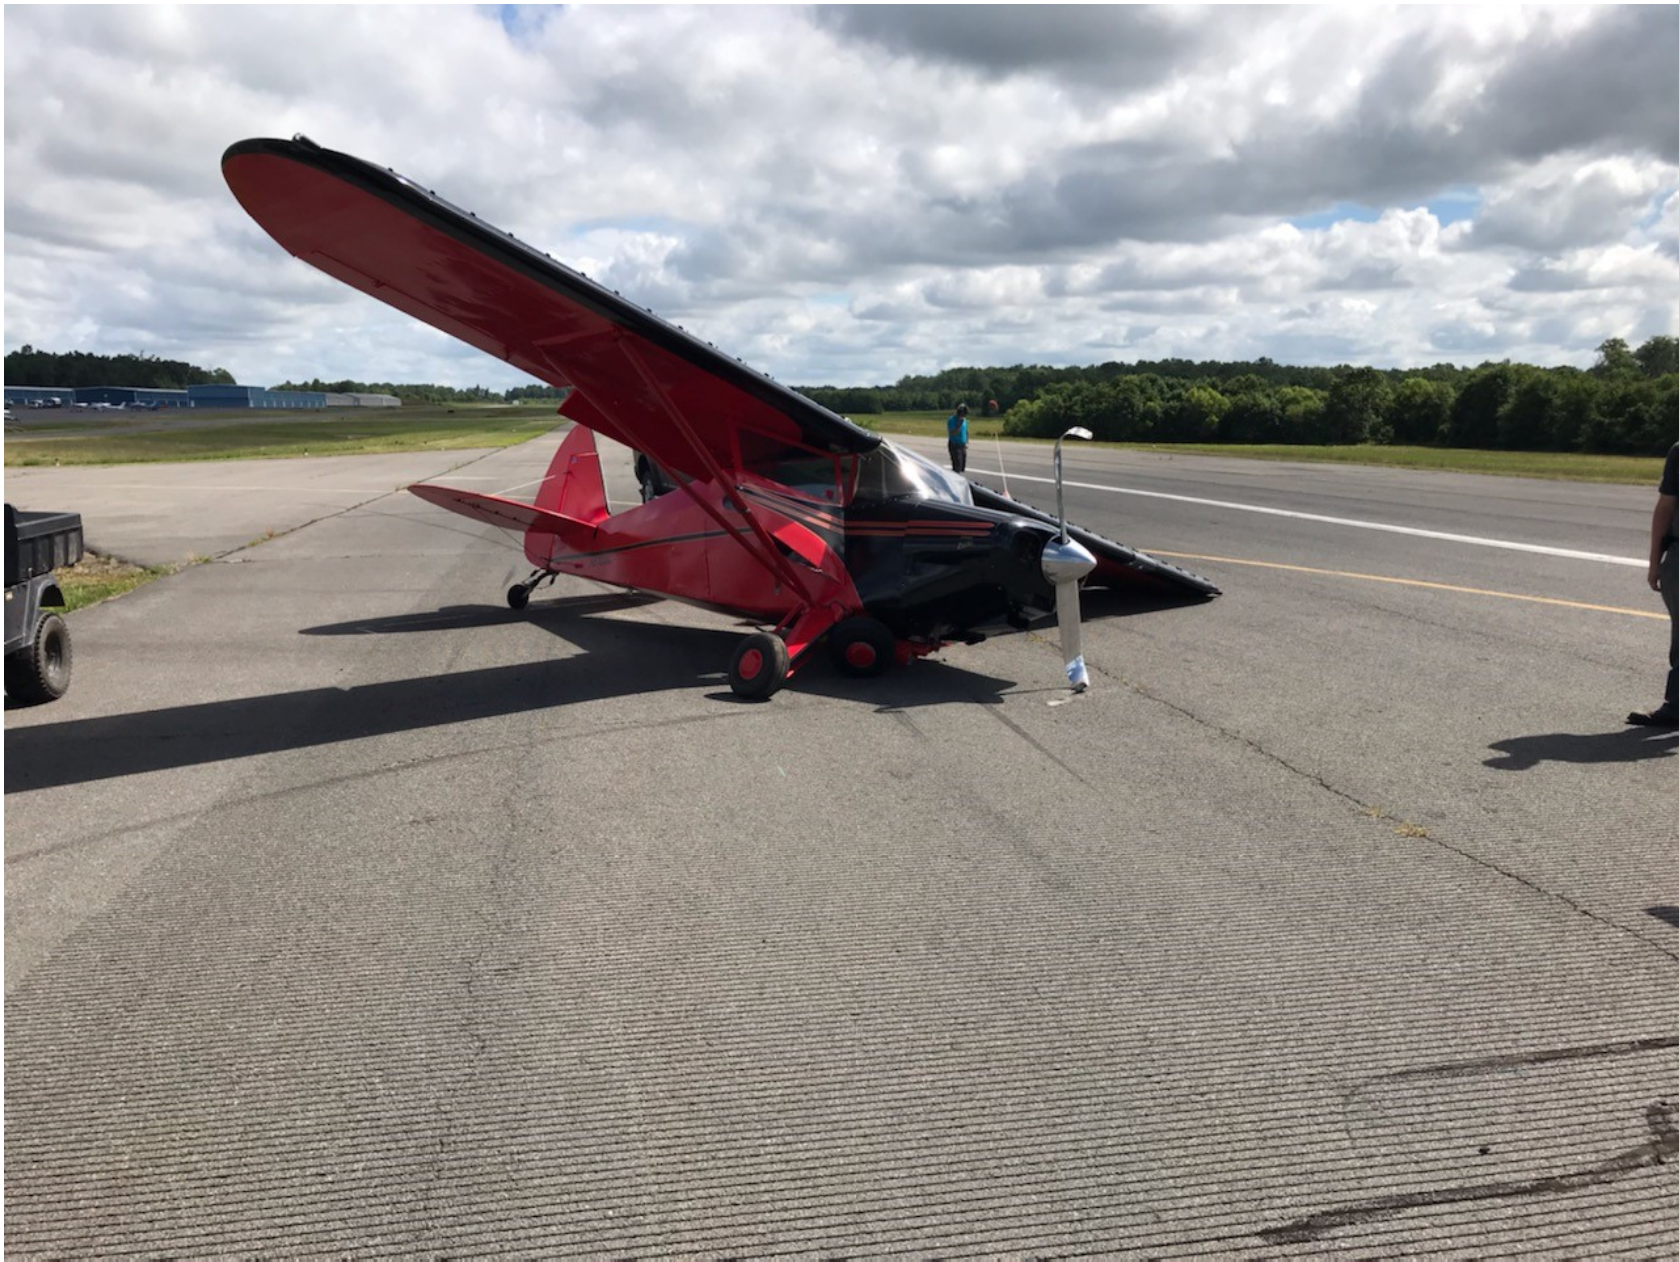
Photo 1 – View of airplane and damage as it sits on the runway. Note the fuselage wrinkles and the left landing gear bent under the fuselage. (Courtesy of CJR Airport)
