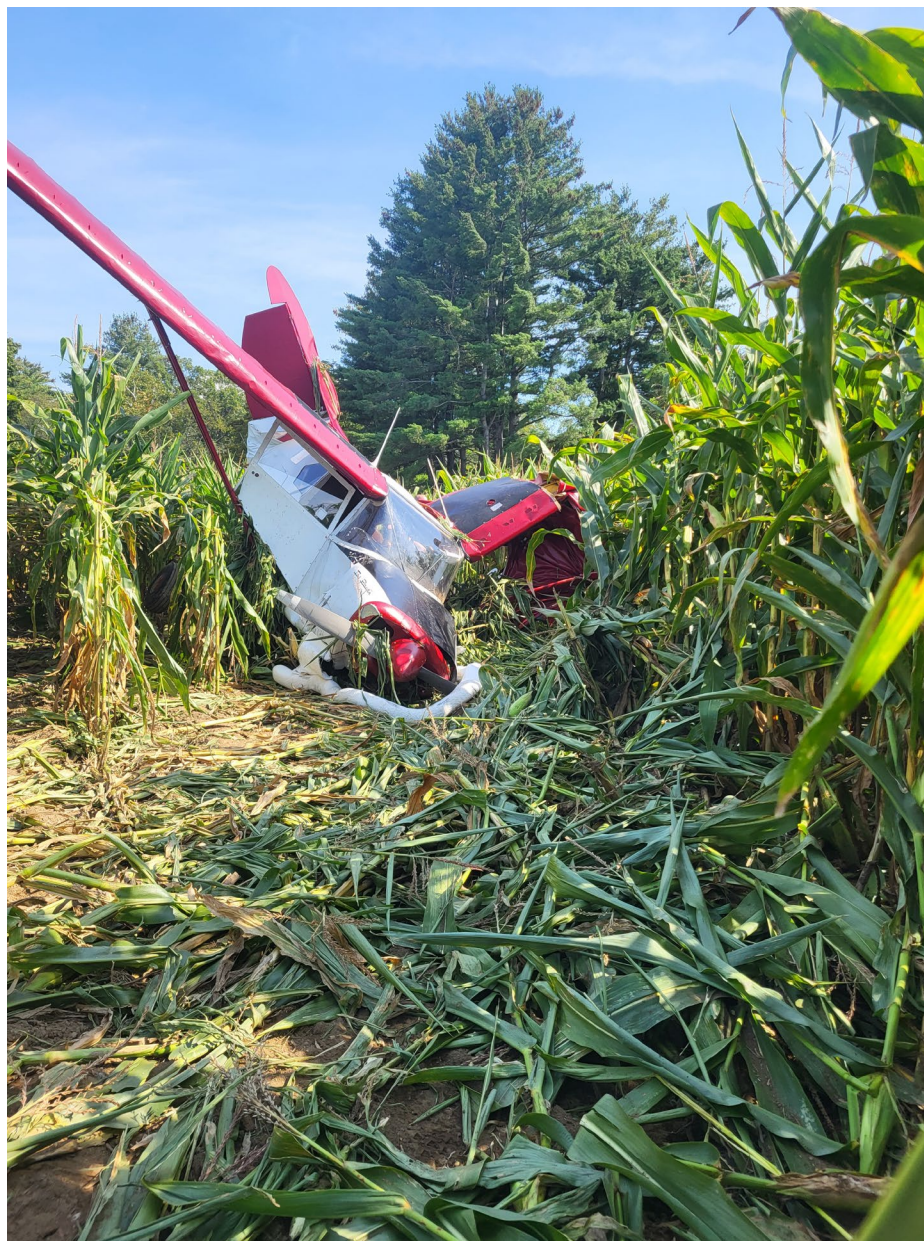
**Photo 1 – Overall view of airplane damage as it rests in the corn field (Courtesy of FAA)**

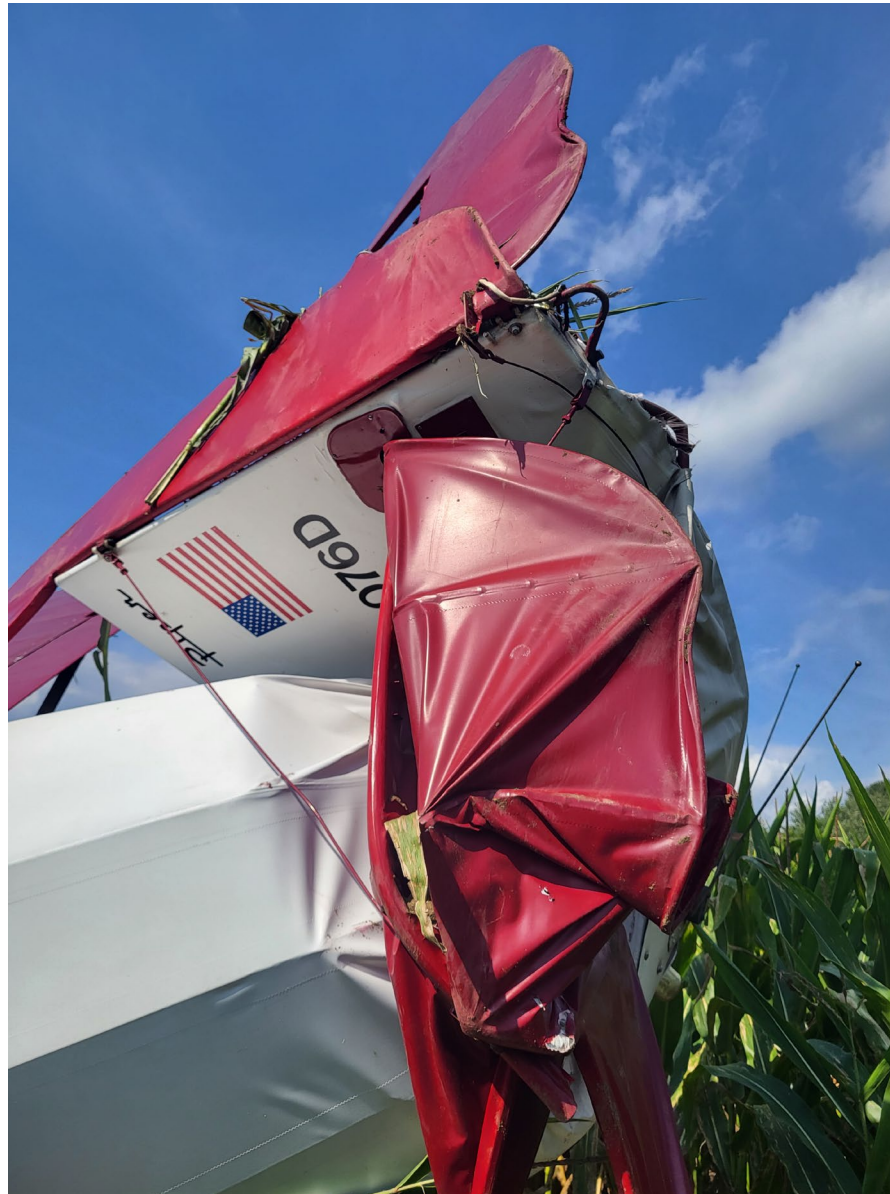
**Photo 2 – View of empennage damage to elevator and rudder. (Courtesy of FAA)**

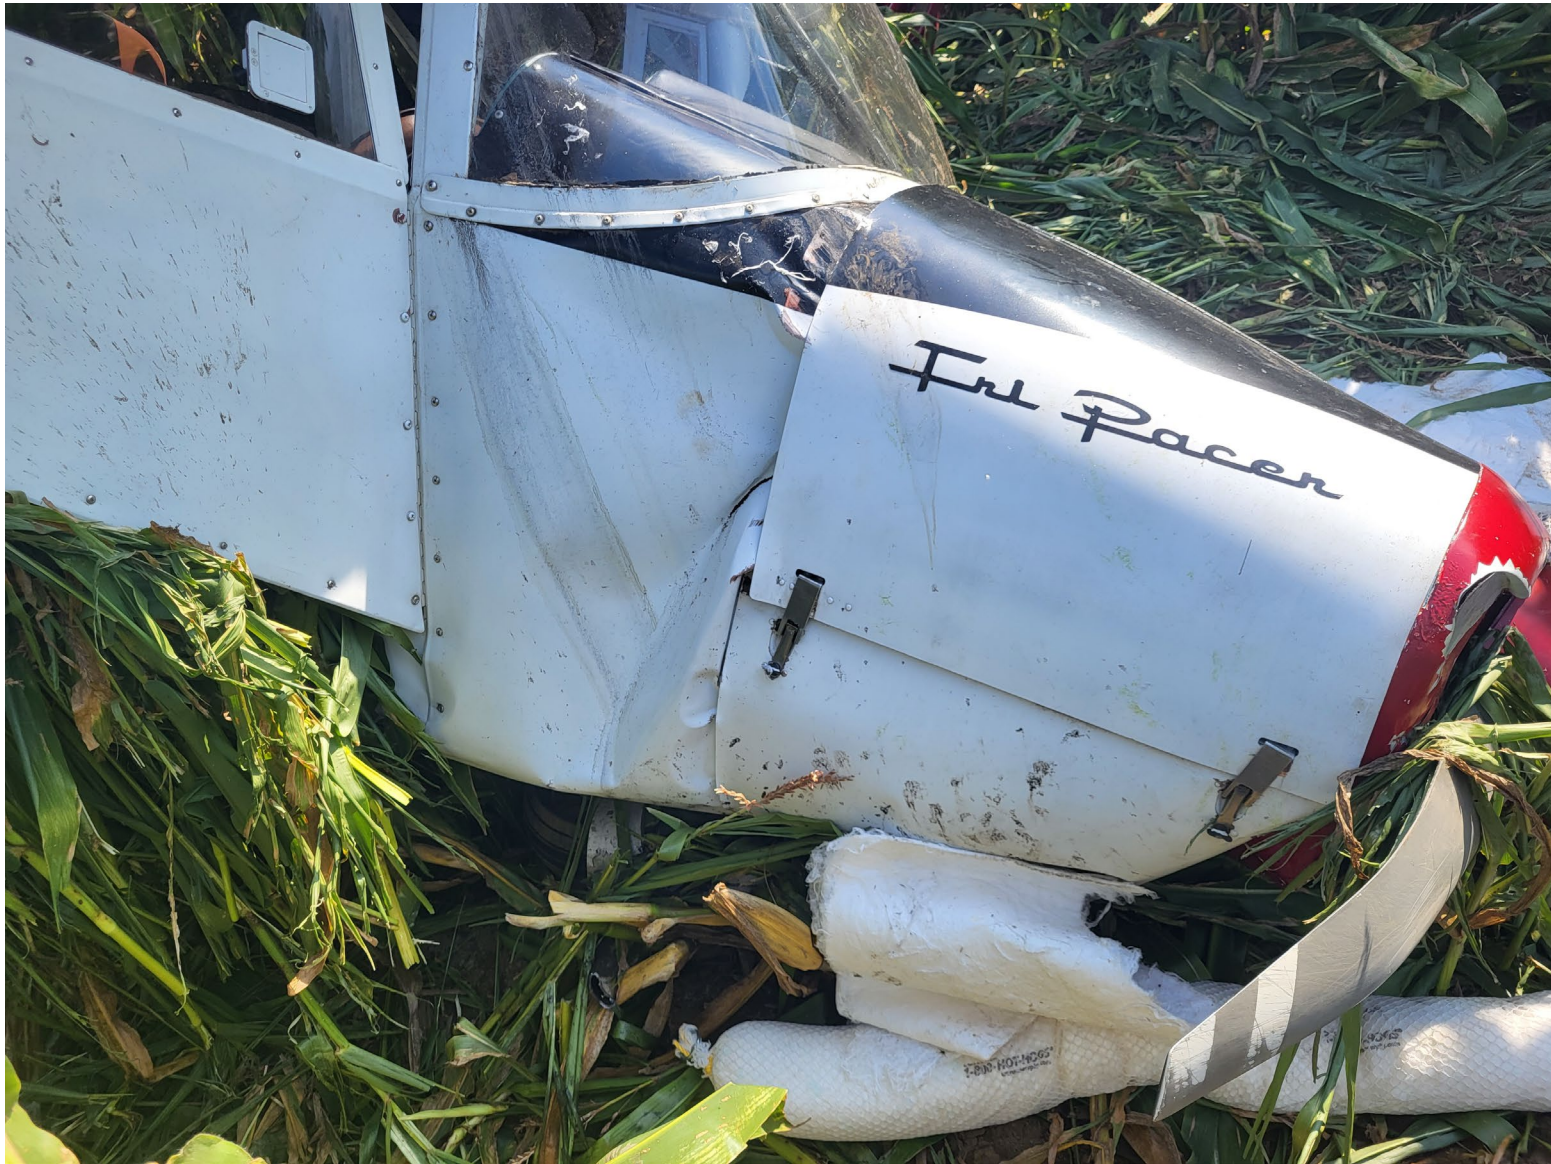
**Photo 3 – Right side view of fuselage damage. (Courtesy of FAA)**

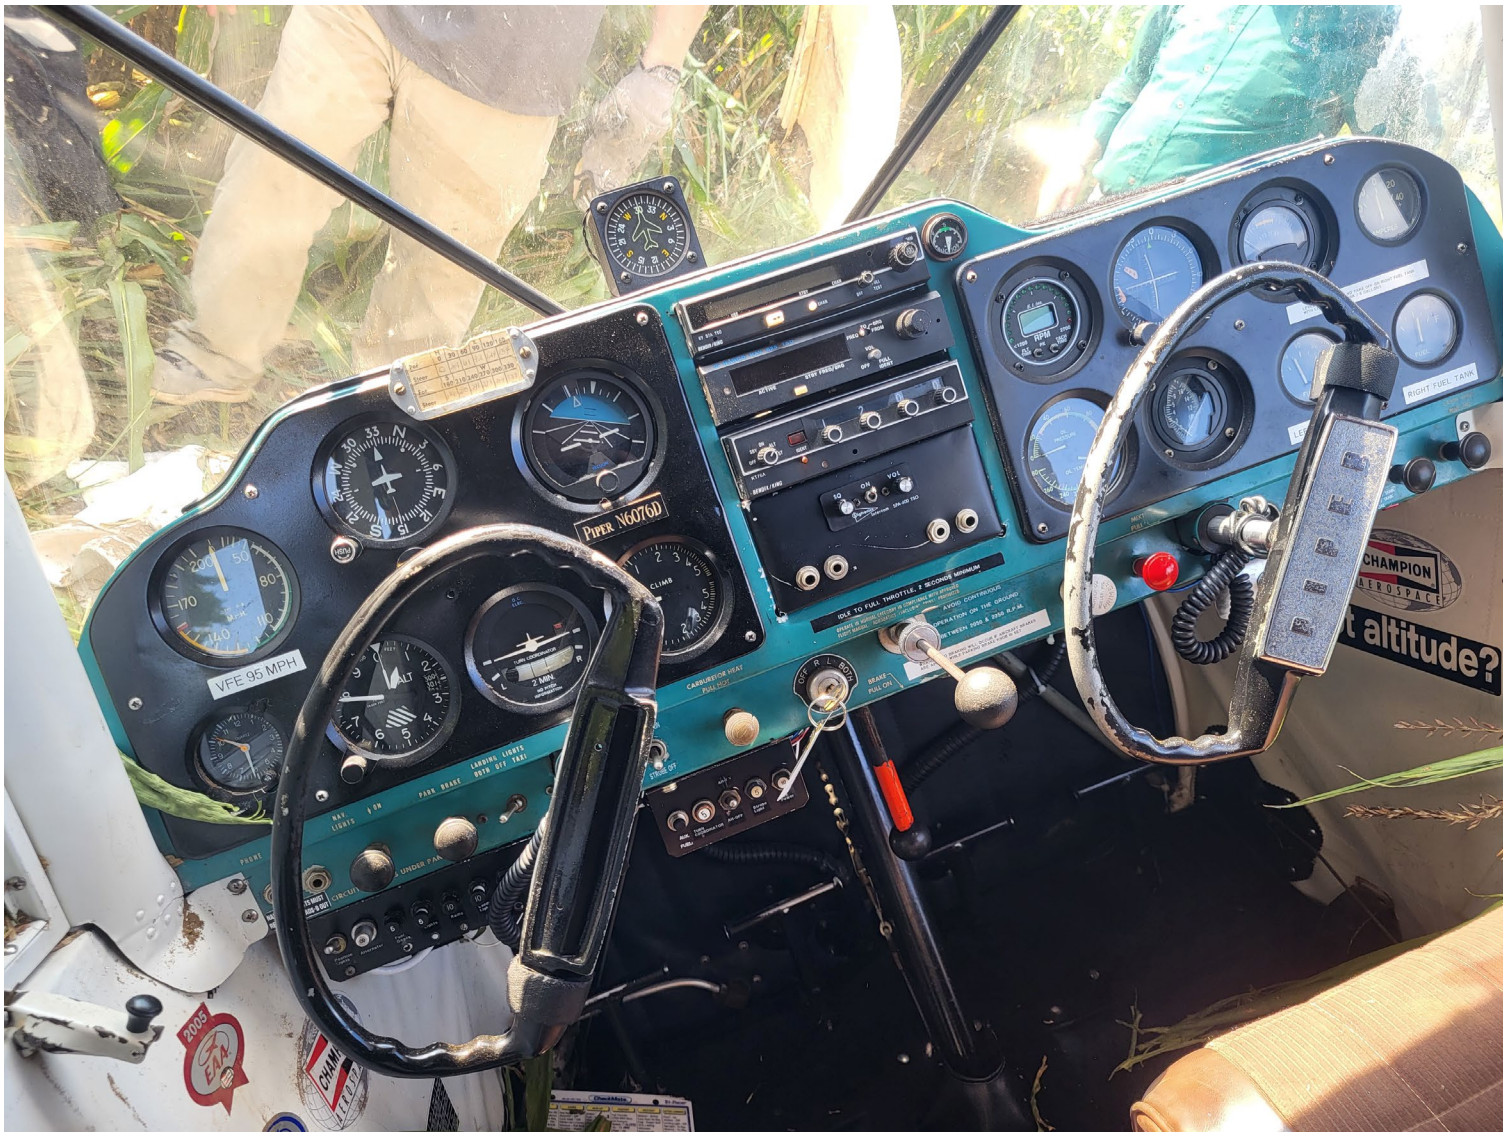
**Photo 4 – Cockpit controls and instrument panel view. (Courtesy of FAA)**

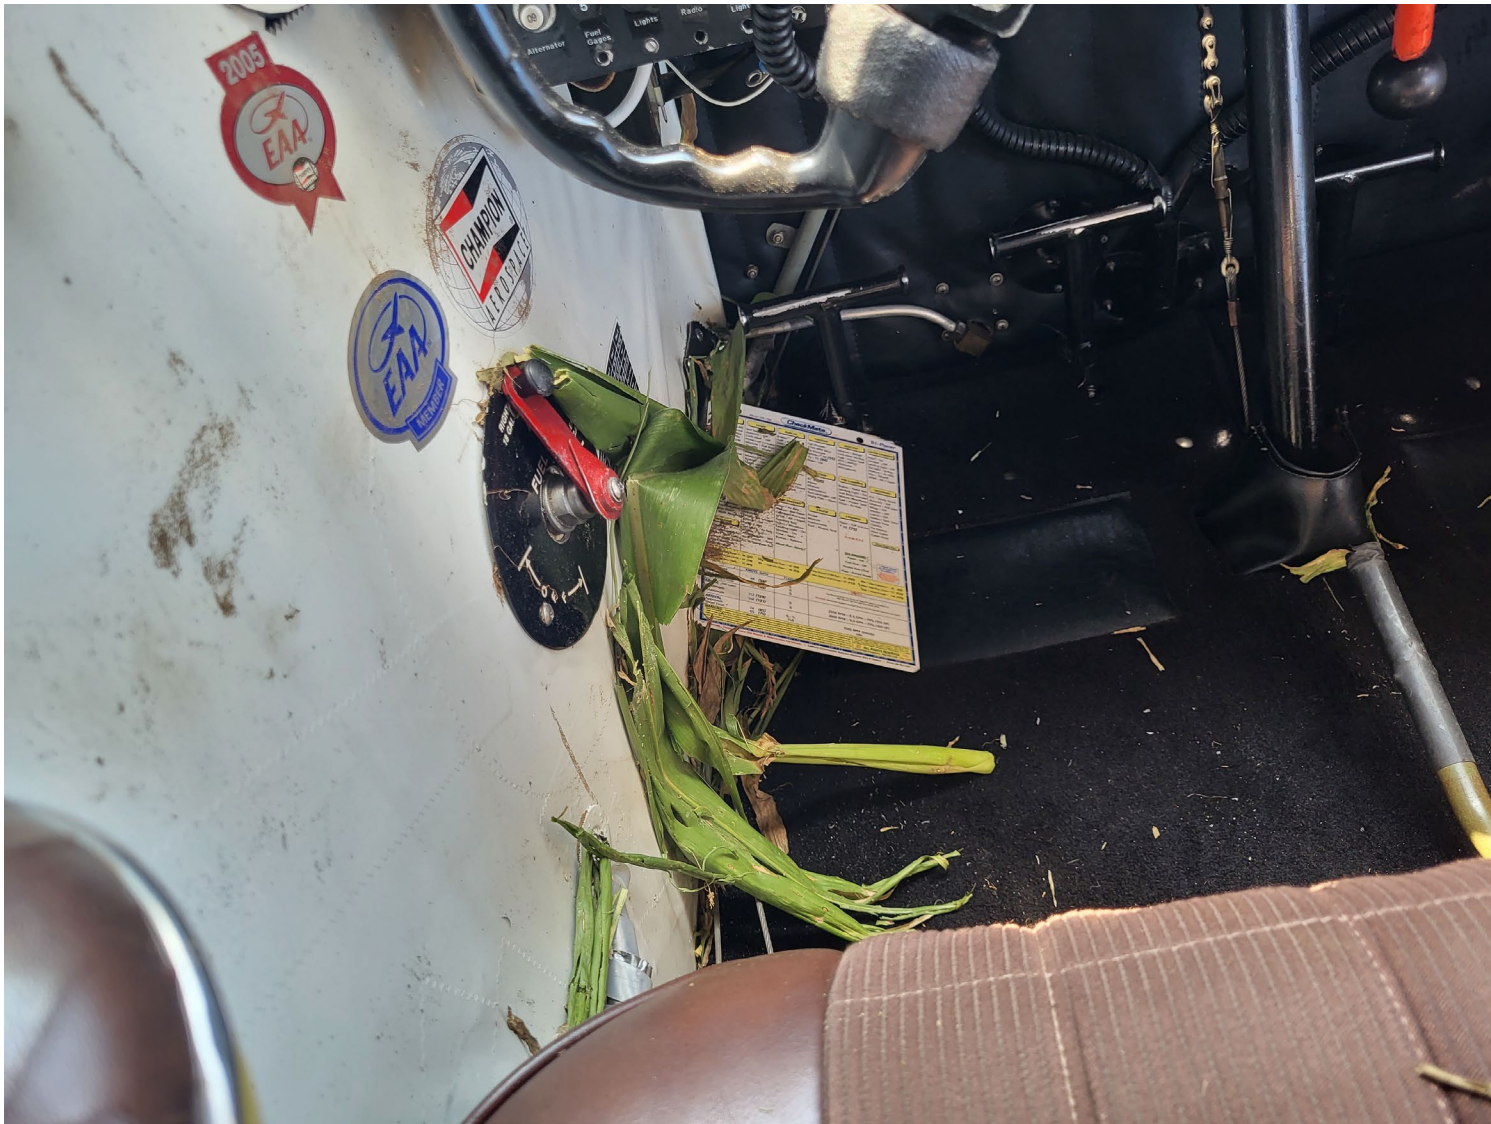
**Photo 5 – Closeup view of fuel selector lever. Note the up position for the right tank. (Courtesy of FAA)**
