**Atmos Energy Corporation's  
Proposed Findings, Probable Cause, and  
Safety Recommendation to  
the National Transportation Safety Board**

**Docket No. PLD21FR002  
Relating to Natural Gas-Fueled Explosion  
During Routine Maintenance  
Farmersville, Texas  
June 28, 2021**

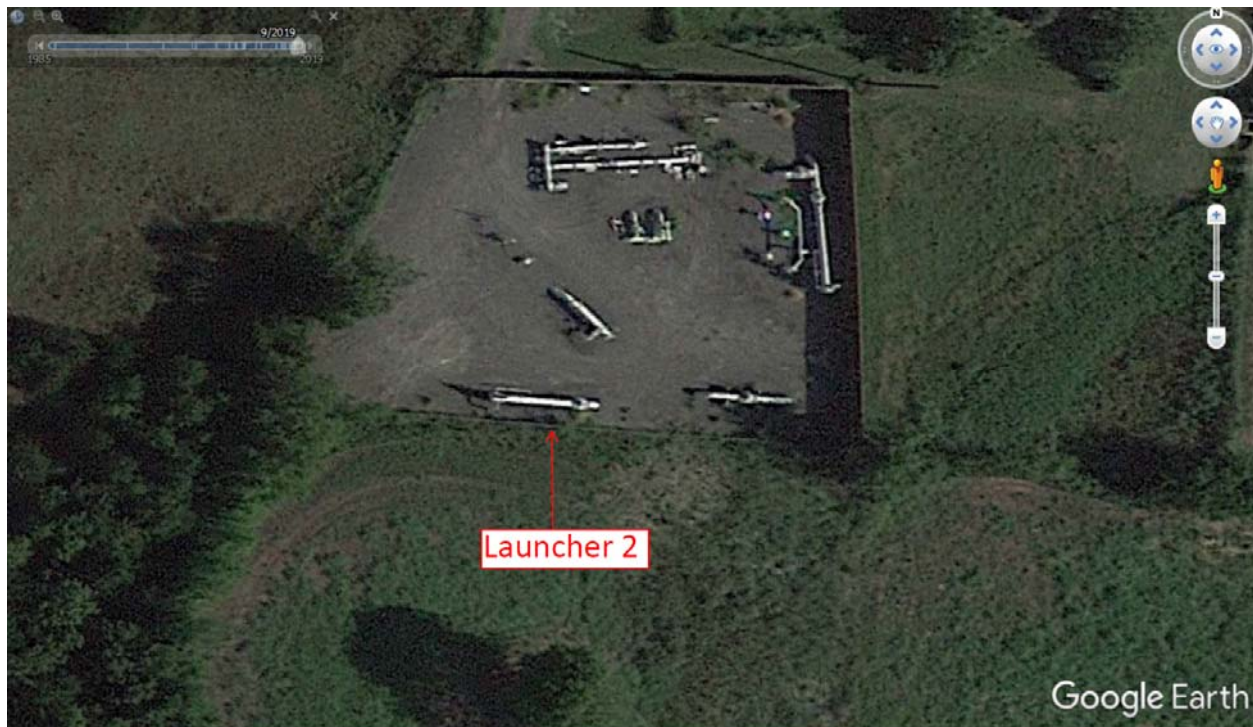
The accident occurred at a station approximately five miles northwest of Farmersville, Texas at which three active Atmos Energy pipelines interconnect: Lines D17, D17-9, and O13-3. The station contained three pig launchers (Launchers 1, 2, and 3) from which in-line inspections are conducted. Launcher 2, which was involved in the accident, was used to launch in-line inspection tools (pigs) south through Line D17. Line D17 has an outside diameter (OD) of 24" and a maximum allowable operating pressure (MAOP) of 800 psig. At the time of the accident Line D17 was operating at 638 psig. An image of the Farmersville site with Launcher 2 identified is shown in *Figure 1* below.

*Figure 1. Image of the Farmersville station showing the location of Launcher 2.*

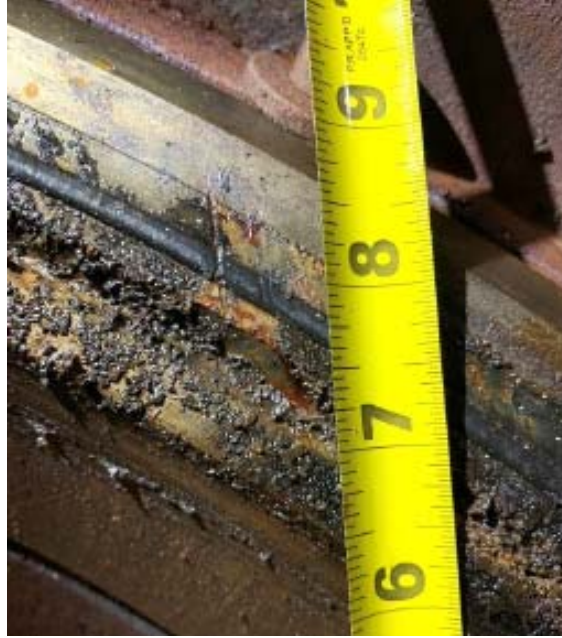
Examination and testing of the 4” kicker valve confirmed it was not leaking.<sup>37</sup> Examination and testing of the 24” mainline valve revealed the inner and outer seat rings (including the soft sealing areas of the O-ring between the inner and outer seat rings) contained multiple scratches on both sides of the valve (*i.e.*, the pipeline side and the launcher side). Metallic debris of an unknown source was found embedded in the O-ring. The ball also contained metallic scratches in areas that corresponded to those found at the seat face sealing surfaces. A disassembly report prepared by the valve manufacturer concluded the scratch damage was consistent with foreign debris entering the valve from an external unidentified source during operation of the valve, and that foreign debris including metallic particles can cause damage to the seat rings and ball sealing surfaces creating a leakage path through the valve.<sup>38</sup>

Figure 6. Photo of scratches in the outer seat ring and O-ring of the 24" mainline valve (from NTSB Materials Laboratory Factual Report No. 21-094).

- 1. There was no indication the 24” mainline valve was damaged or leaking at the time of the accident.**
  - a. The cause of damage to the 24” mainline valve was metallic debris of an unknown origin which caused gouges in the sealing surfaces of the valve.
  - b. A field adjustment to the 24” mainline valve prior to the first pig run on June 21, 2021 identified the correct “closed” position for the valve.
  - c. There were no indications the 24” mainline valve was leaking during any of the four prior pig runs or on the day of the accident.
  - d. The valves at the Farmersville site had received routine maintenance from Atmos' independent contractor leading up to the accident.

The probable cause of the accident was the ignition of natural gas that leaked into the launcher through a closed 24” mainline valve as a result of undetected metal gouges in the sealing surfaces of the valve.

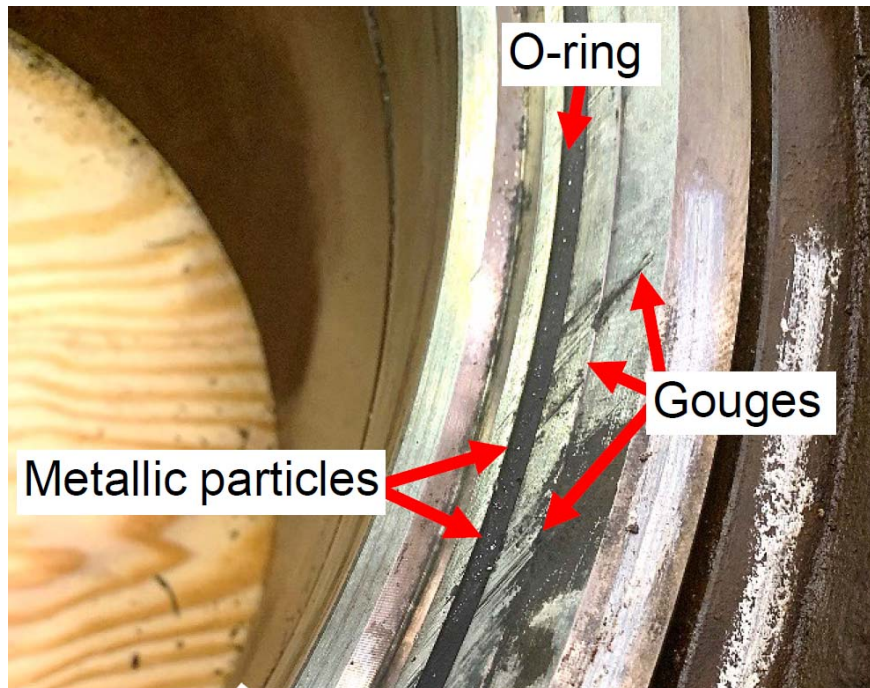
Figure 7. Photo of metallic particles in the O-ring that divides the inner seat ring from the outer seat ring, as well as gouges in the outer seat ring of the 24" mainline valve (from NTSB Materials Laboratory Factual Report No. 21-094).
