**HIGHWAY FACTORS GROUP CHAIRMAN'S
FACTUAL REPORT**

**Highway Attachment – Paved Shoulder Width Measurements Along
Eastbound SR-12 Near Crash Location**

Bryce Canyon City, Utah

HWY19MH012

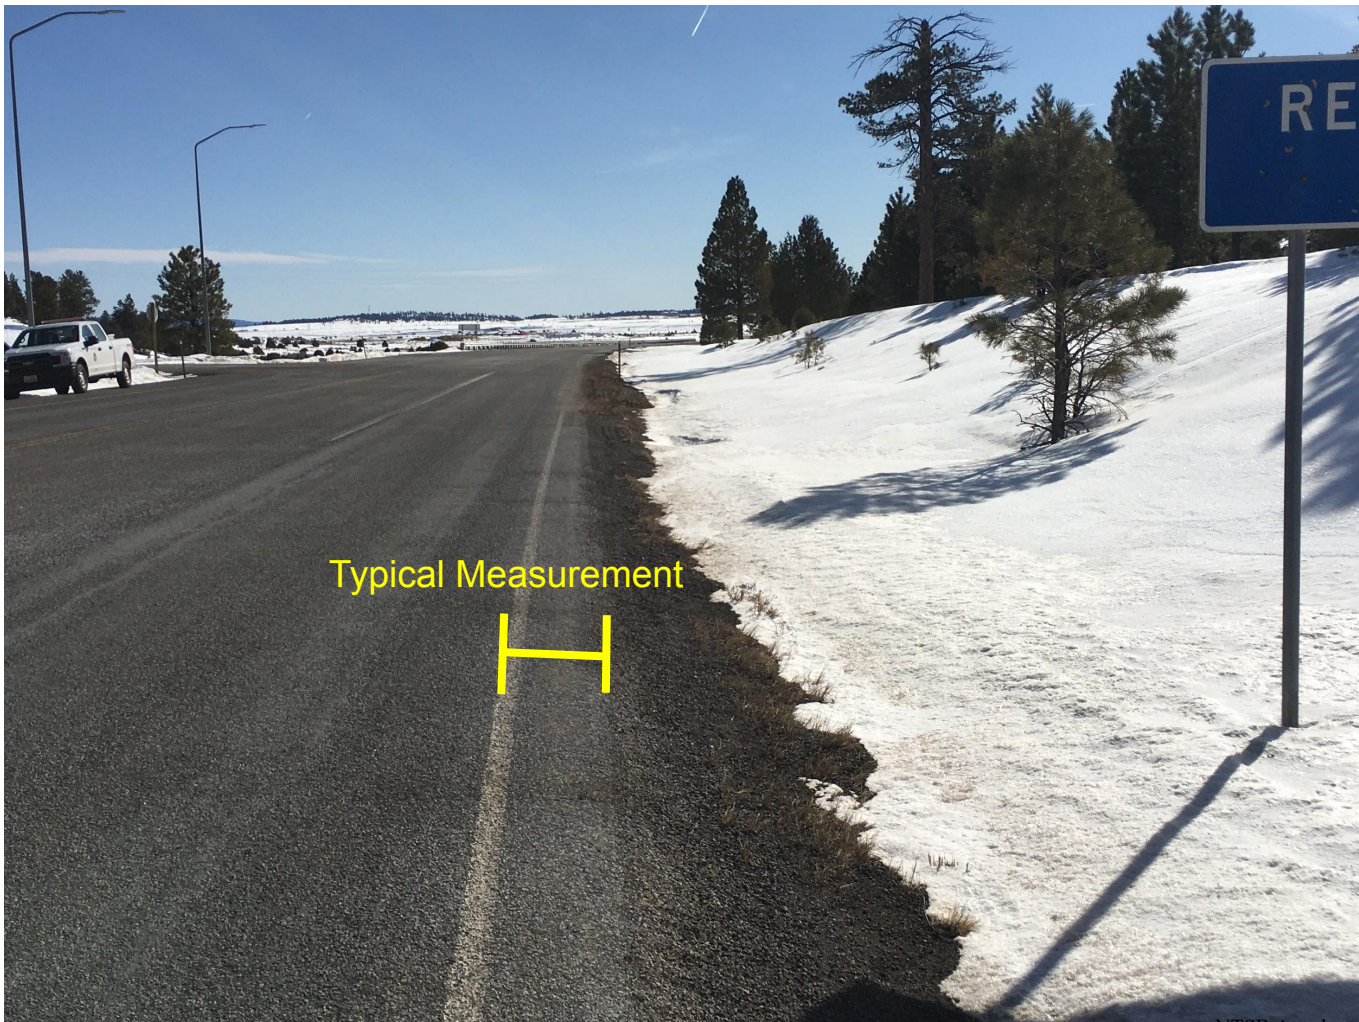
Shoulder Width
Measurement Locations

Physical measurements were taken every 10 steps (approximately 25 feet) through the measured location

Delineator Post

Rest Area Sign
