**Bridge Factors Factual Report Attachment 32 – FIGG 3/15/18 Power Point Presentation**

# FIU - Sweetwater University City Bridge

## Temporary Construction Loading Condition

Additional Review of Pylon Diaphragm Region  
(Type II Deck End Diaphragm)

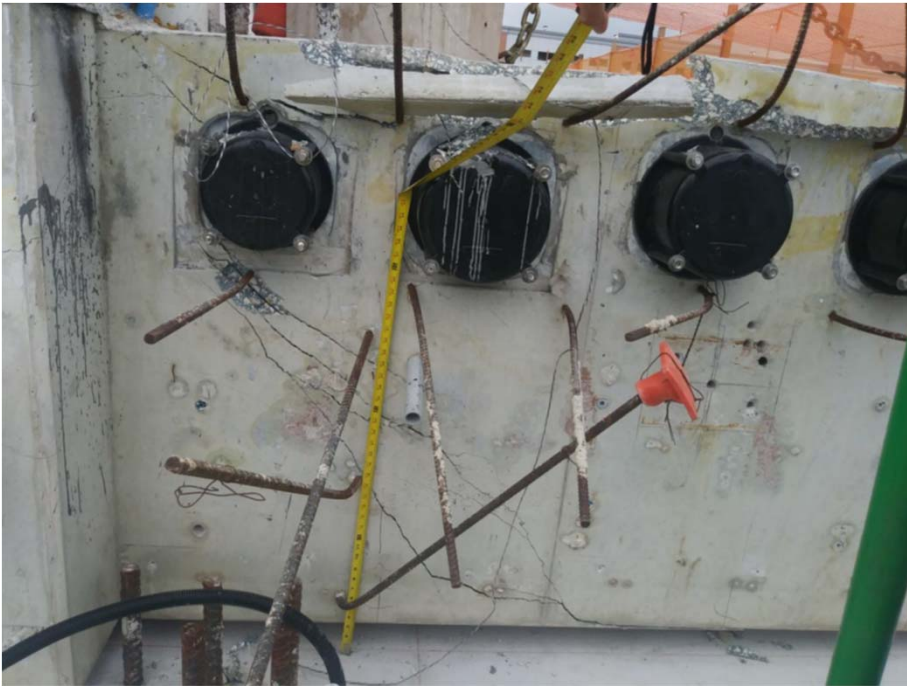
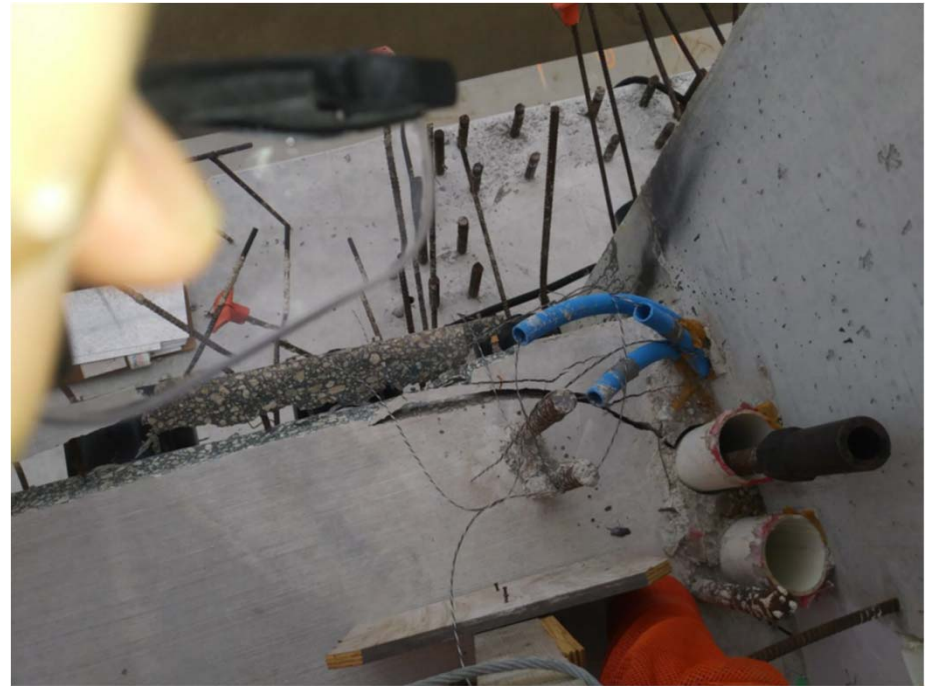
- FIGG was notified by MCM's email of 4:52 pm 3/12/2018 that some cracks and spalls had developed at the pylon diaphragm end of the span. Below are photographs of the West side.

- The diagonal type cracks, in excess of FDOT criteria, should be sealed with approved methods and materials (Epoxy injection, etc.)
- The spalled areas have not been replicated by the engineering analyses. However ...
- The spalled areas are minor and it is recommended that they be prepared using normal procedures and poured back along with the up coming “pylon diaphragm” pour (different from and prior to the back span on falsework pours)

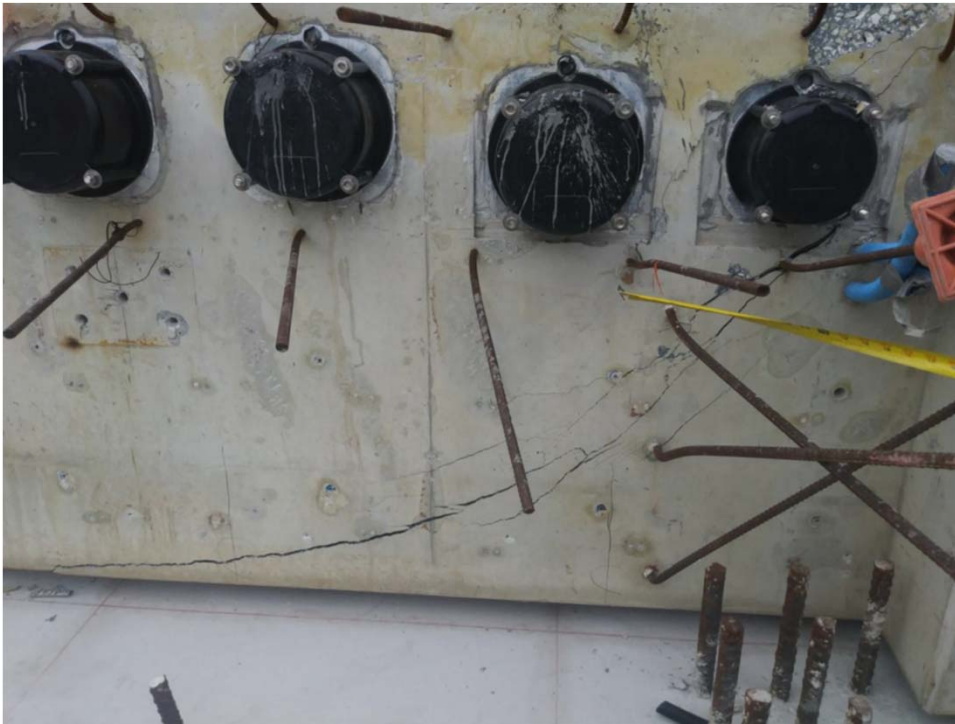
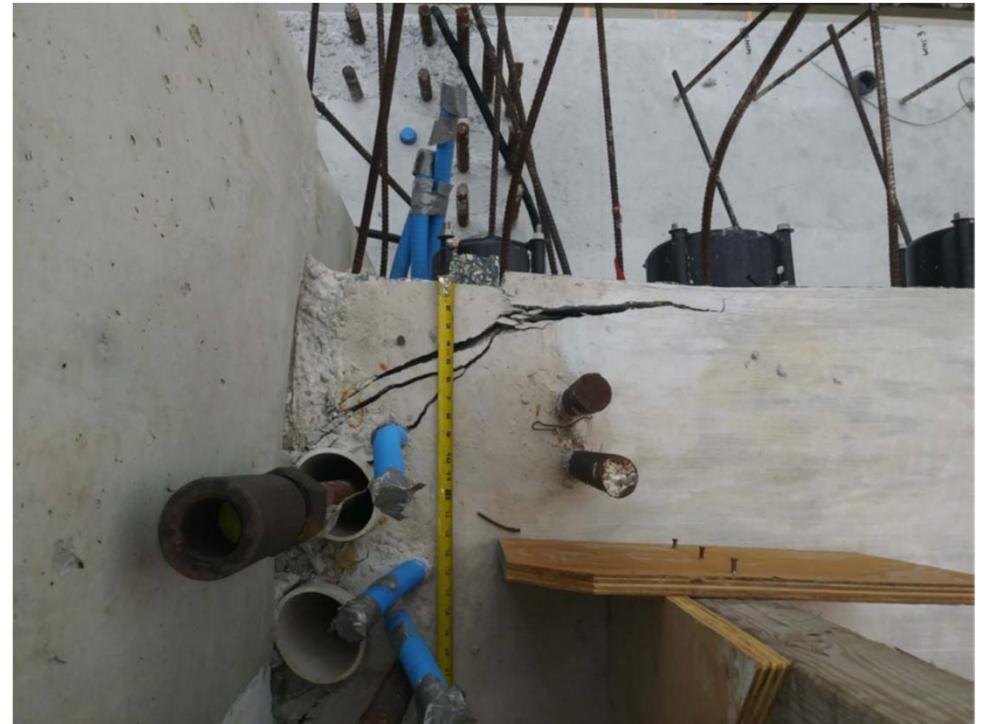
- FIGG was notified by MCM's email of 4:52 pm 3/12/2018 that some cracks and spalls had developed at the pylon diaphragm end of the span. Below are Photographs of the East side

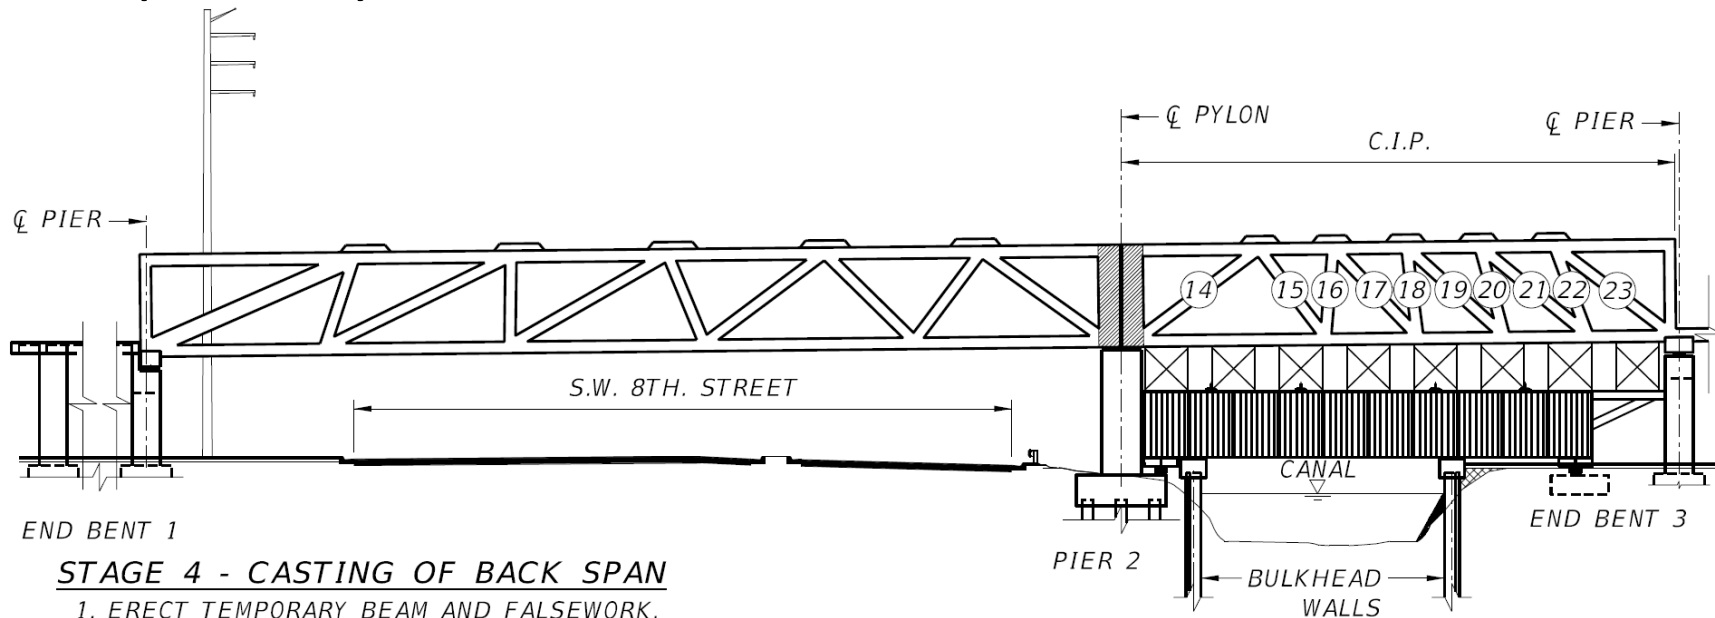
## STAGE 4 - CASTING OF BACK SPAN

1. ERECT TEMPORARY BEAM AND FALSEWORK.
2. INSTALL BEARING PADS AT END BENT 3.
3. CAST INTERMEDIATE SECTION OF THE PYLON
4. CAST DECK, DIAGONAL MEMBER, VERTICAL MEMBERS, CANOPY AND TOP ANCHOR BLOCKS.
5. AFTER CONCRETE COMPRESSIVE STRENGTH HAS REACHED 6000 PSI, STRESS POST-TENSIONING OF THE BACK SPAN IN THE FOLLOWING SEQUENCE:
  - I. STRESS DECK LONGITUDINAL TENDONS D7.
  - II. STRESS CANOPY LONGITUDINAL TENDONS C5.
  - III. STRESS PT BARS IN DIAGONAL MEMBERS 15 AND 23.

- IV. STRESS PT BARS IN DIAGONAL MEMBERS 16 AND 22.
- V. STRESS PT BARS IN DIAGONAL MEMBERS 17 AND 21.
- VI. STRESS PT BARS IN DIAGONAL MEMBERS 18 AND 20.
- VII. STRESS PT BARS IN DIAGONAL MEMBER 19.
- VIII. STRESS DECK LONGITUDINAL TENDONS D8 & D9.
- IX. STRESS BOTTOM SLAB TRANSVERSE POST-TENSIONING. ALTERNATED END STRESSING IS REQUIRED FOR THE TRANSVERSE TENDONS.

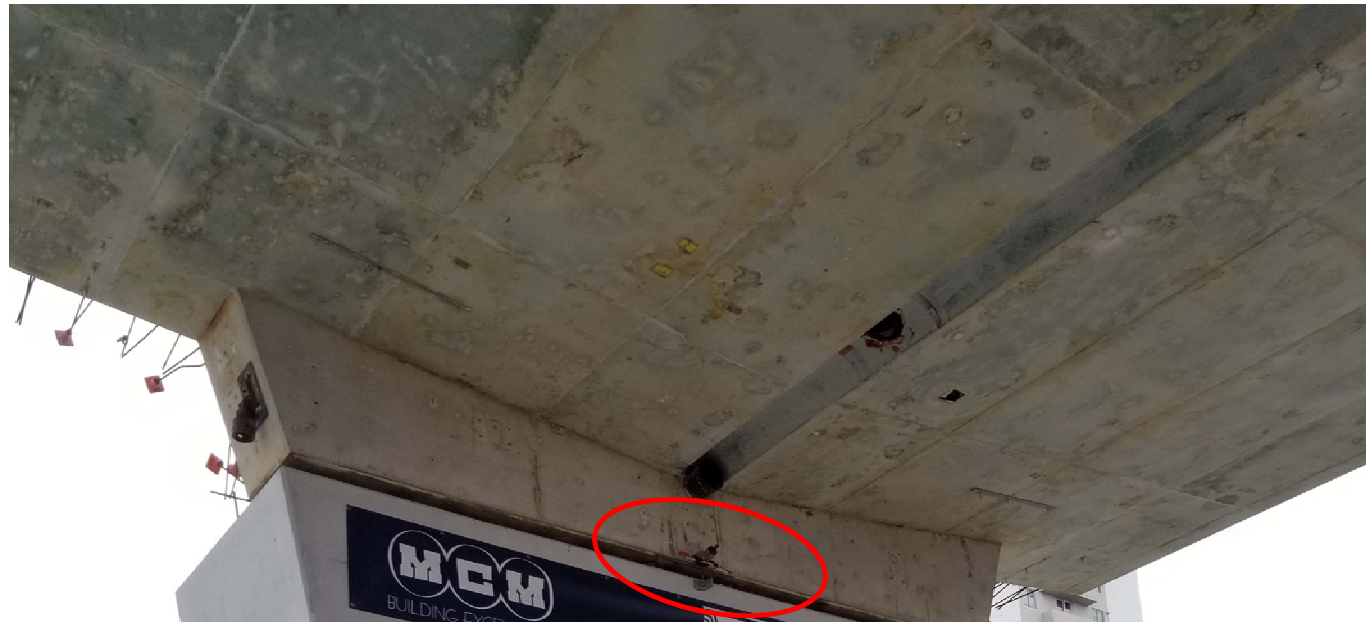
- Tuesday morning, upon seeing MCM's information, FIGG requested that, as a prudent action, MCM immediately install temporary shims directly below the nodal area of members 11/12 and the top of the Pylon/Pier, while further evaluations were on-going by FIGG.

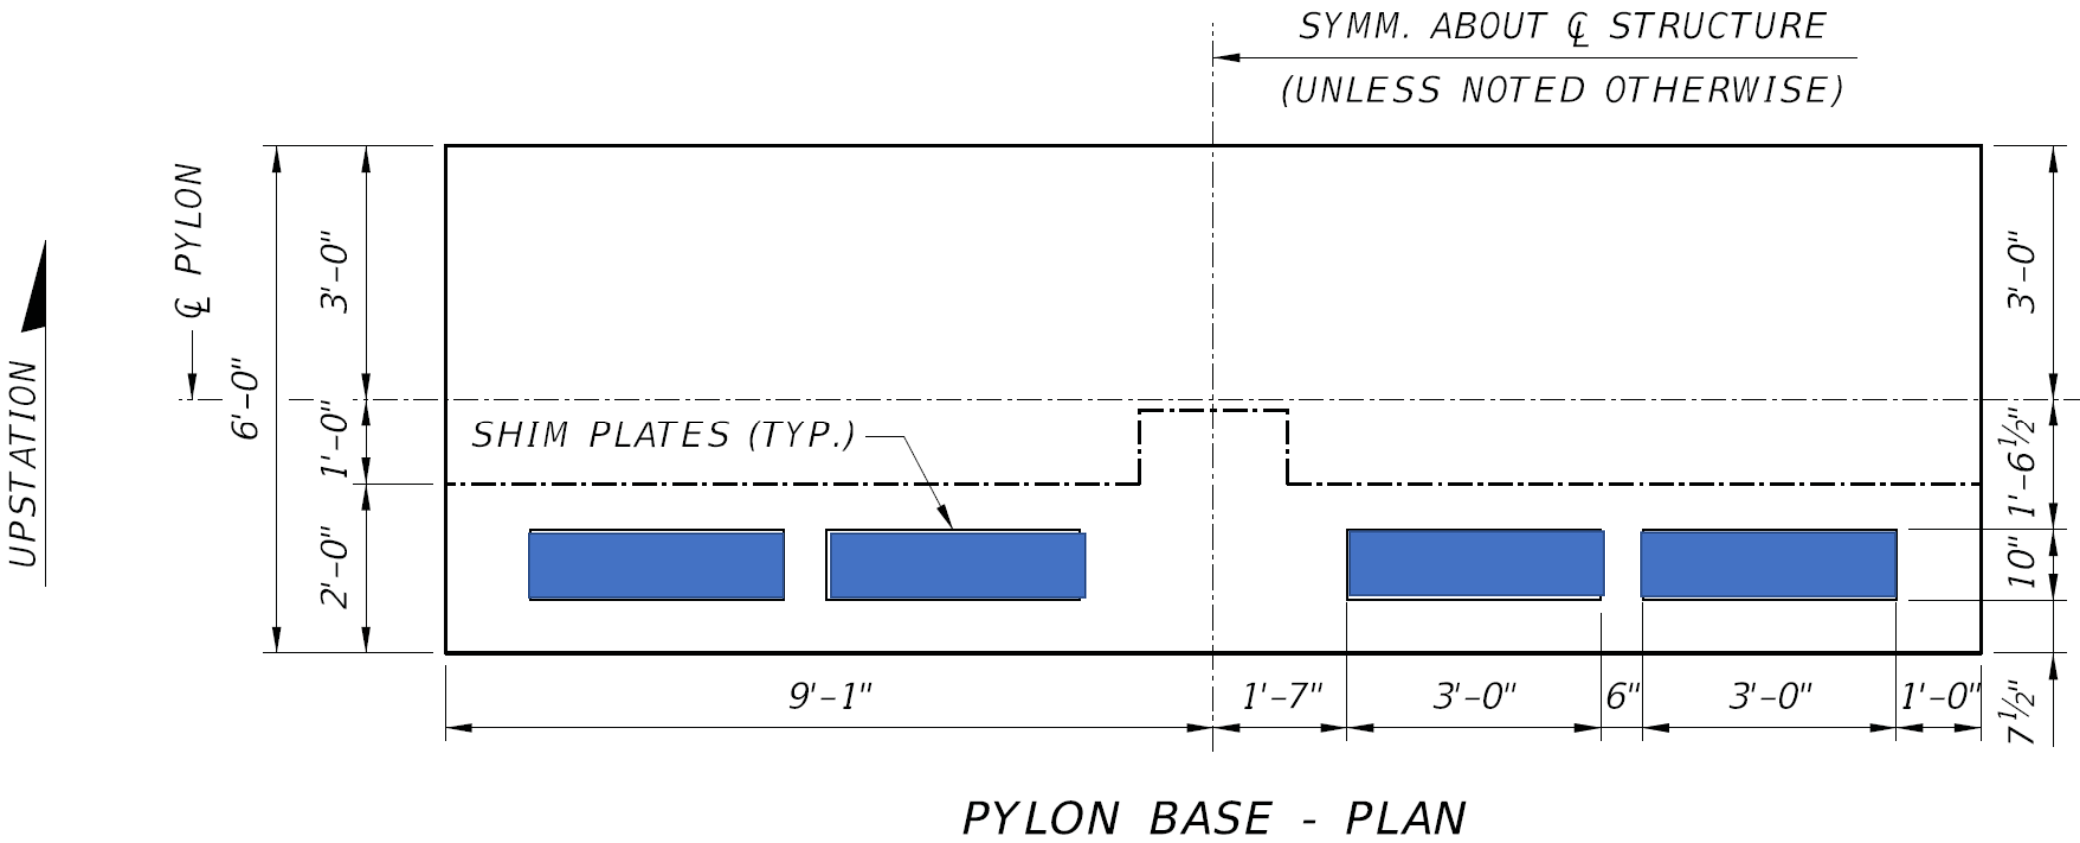
The shims placed during the span move were:

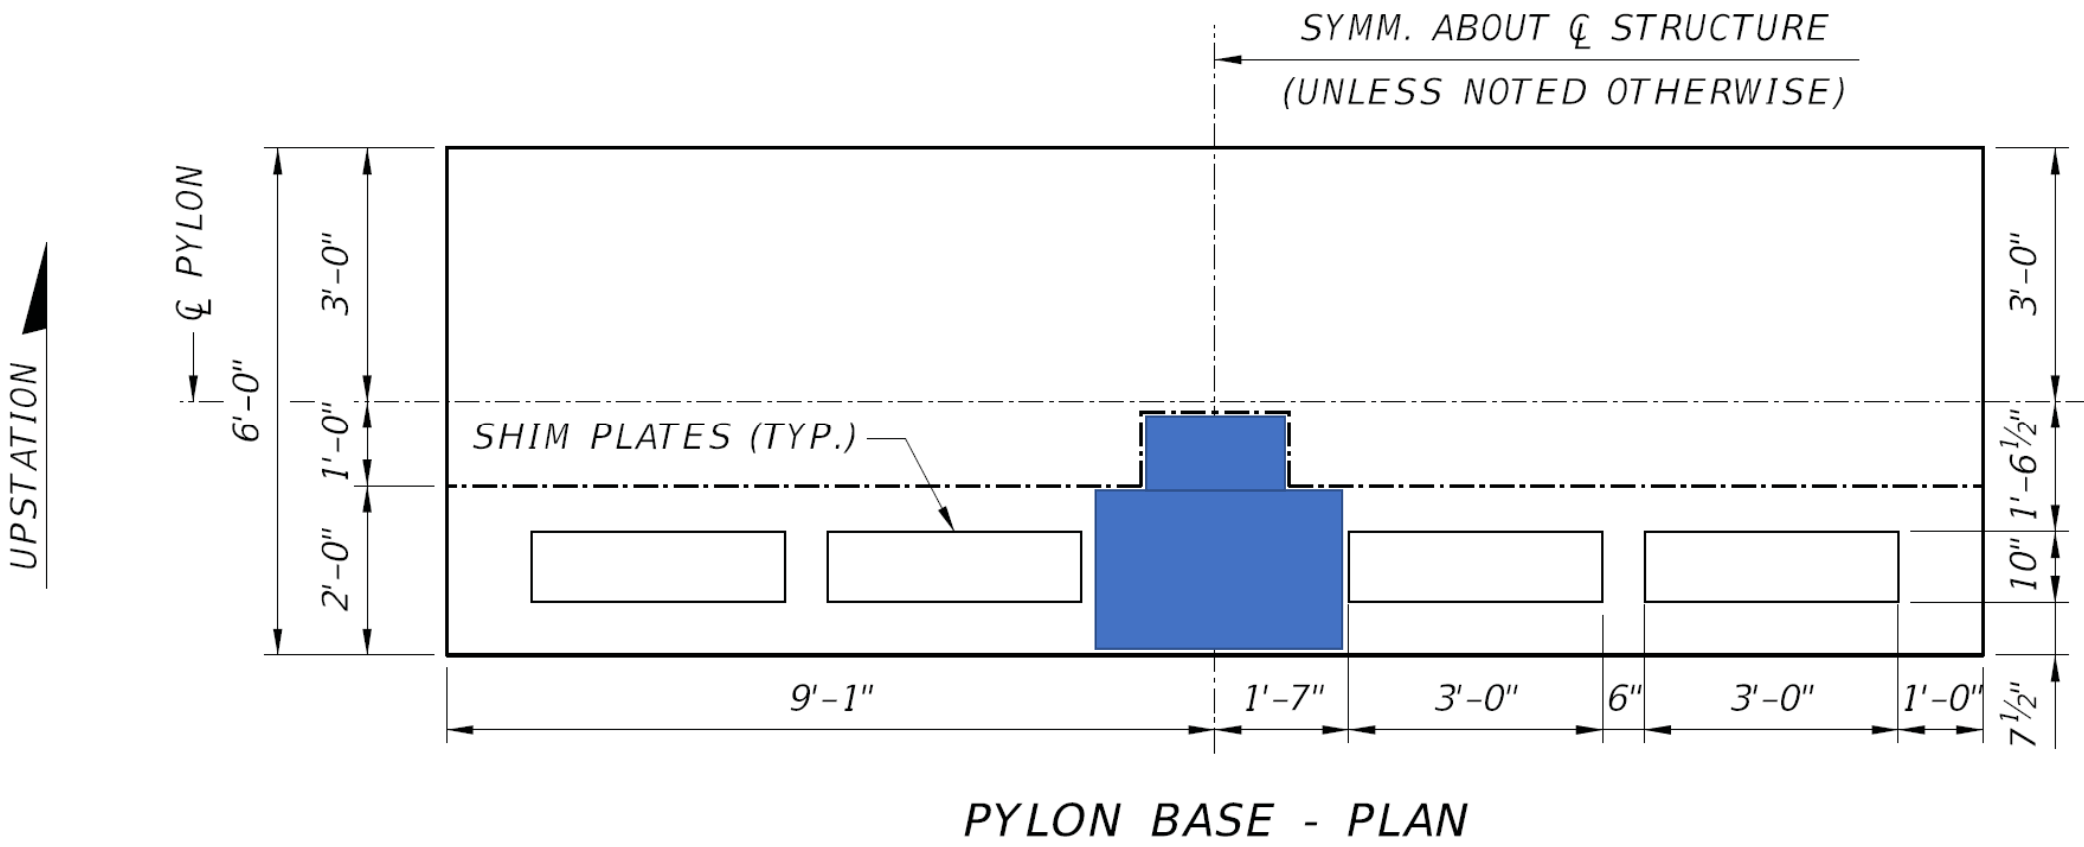
The recommended temporary shimming region is shown below, in blue:

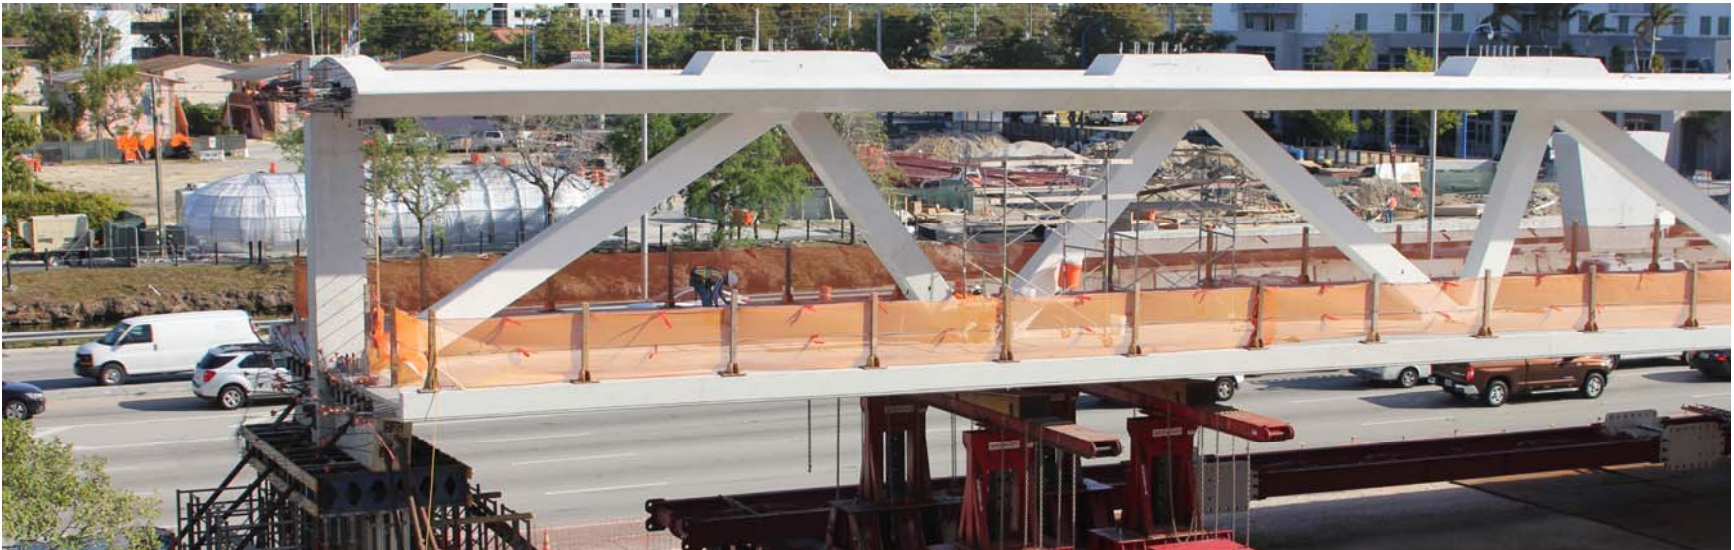
- The span was fully self-supporting on the end diaphragms in the casting area (full PT, etc.) for several weeks prior to the move.
- During this time, the pylon end diaphragm was uniformly supported over its entire surface area on the original soffit used during casting.
- No significant cracks or distress of this region were noted.

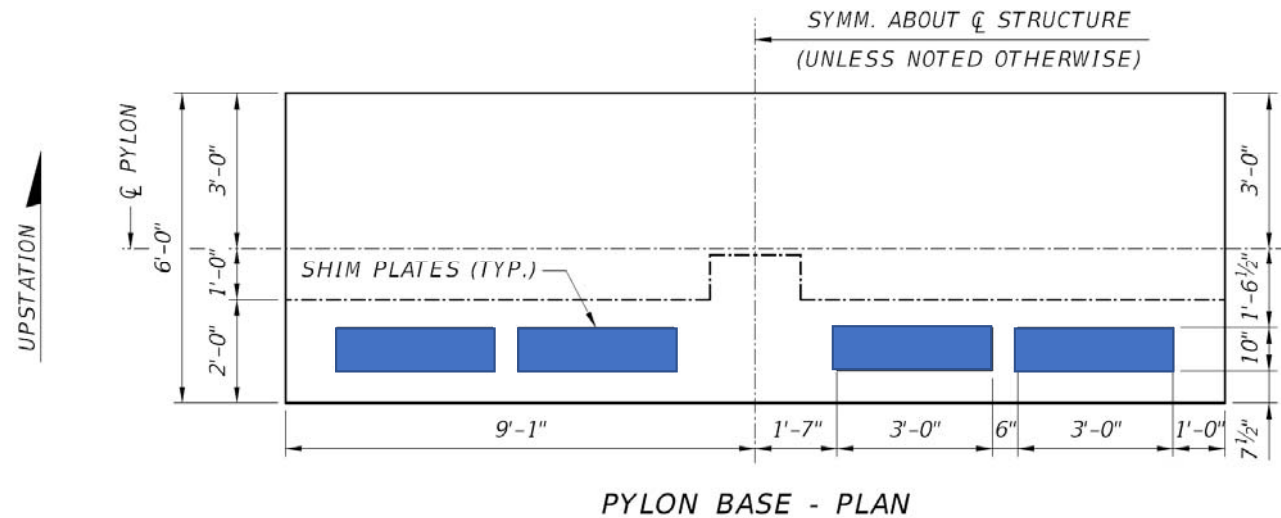
- The span over the road is supported at similar locations as were used in the casting area,
- The difference being that the permanent bearings at the EJ (south) end, and
- The four shims (rather than uniform contact pressure) at the Pylon/north end.

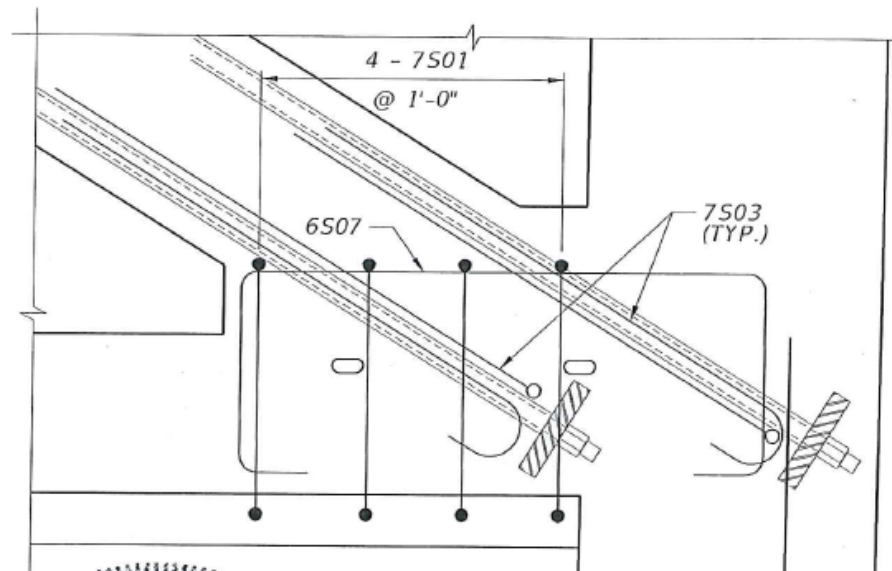
- The only other notable difference from the condition in the casting yard location, is that the temporary PT bars in diagonal members 2 & 11 (needed for the move) were destressed.
- A study of the local effects of this detensioning has been made and will also be discussed later in this presentation.

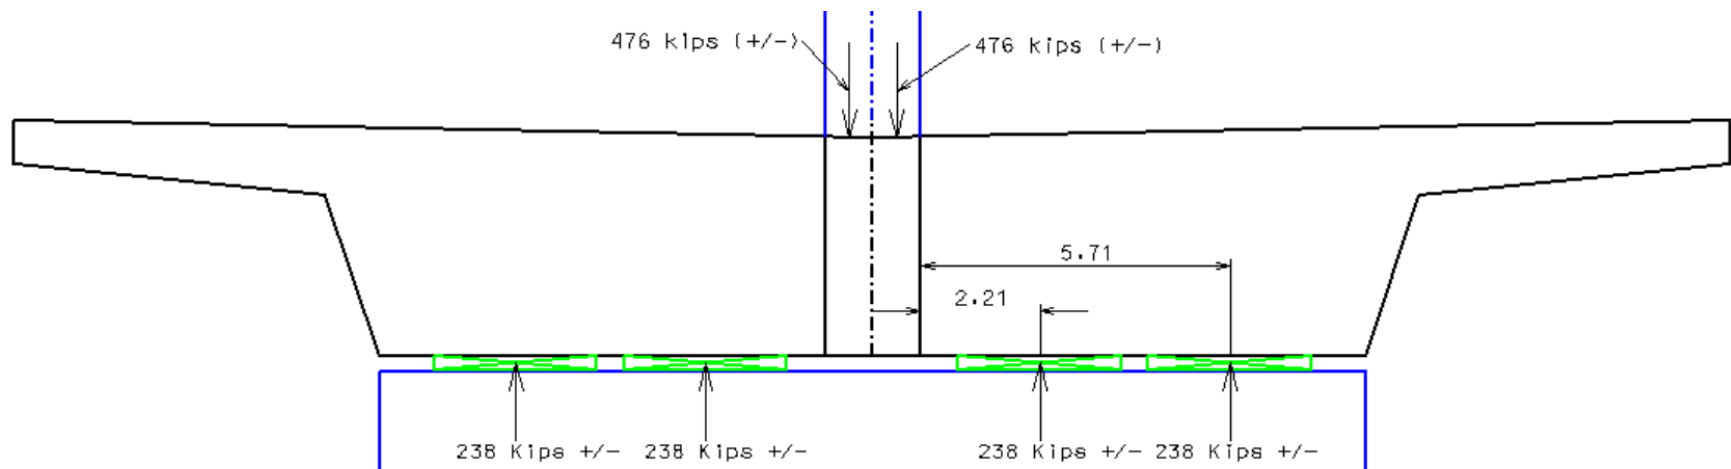
- The field operations were conducted with the intent of achieving reasonably equal loads at the 4 shim locations.
- Assuming that that was achieved, and that the span weighs 950 tons (Barnhart told us that it was somewhat less; we are trying to get the as-weighted value), the following load diagram was developed:

- Bending Moment (M) =  $238 \times (2.12 + 5.71) = 1865 \text{ kip-ft +/-}$
- Beam cross section (4' tall) by (2' wide)
- Bending section modulus (S) =  $(W \times (H^2)) / 6 = 5.33 \text{ ft}^3$
- Bending Stress (M/S) =  $1865 / 5.33 = 350 \text{ ksf}$
- This value is above the concrete ( $f_r$ ) strength, so cracking of the reinforced concrete element would be expected, as allowed by normal reinforced concrete design methods.

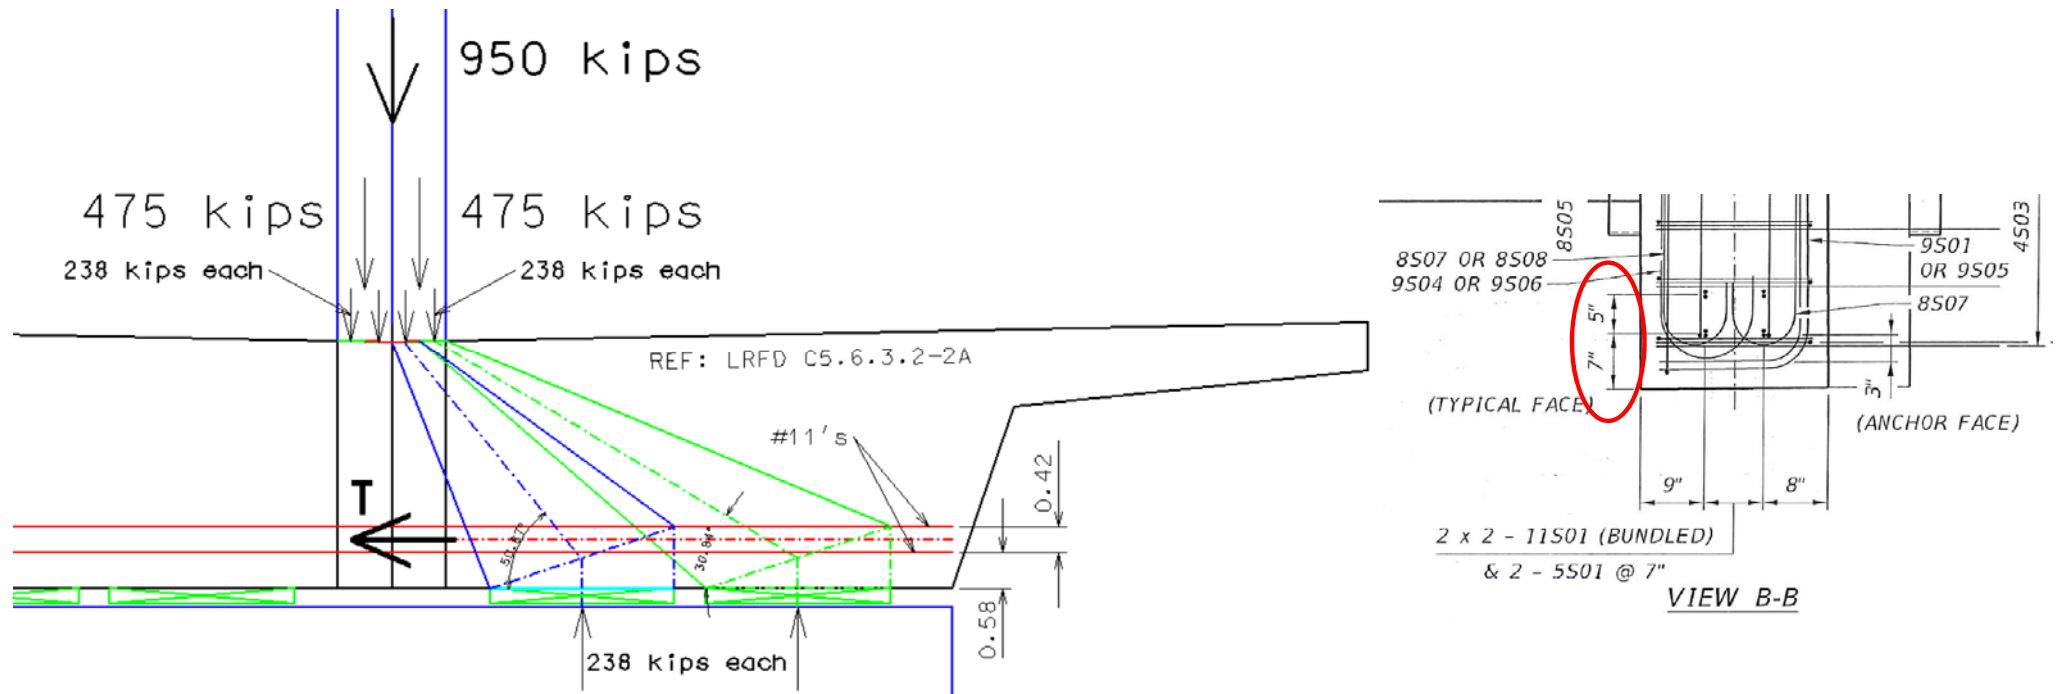
- Given the dimension of this region, the most appropriate design approach is the strut and tie method of LRFD 5.6.3

- $T1 = 238 \text{ kips} / (\tan (50.87 \text{ deg})) = 194 \text{ kips}$
- $T2 = 238 \text{ kips} / (\tan (30.84 \text{ deg})) = 399 \text{ kips}$
- Total Tension (T) = 593 kips (un-factored)

- Area of Steel Tie =  $((8 \times 1.56) + (2 \times 3.1)) = 13.1 \text{ in}^2$
- Nominal strength of tie =  $(A_s)(F_y) = 786 \text{ kips}$
- Phi, per LRFD section 5.5.4.2, since this tie steel is anchoring the shim forces to the nodal region, Phi = 1.0 for “tension in steel in anchor zones” is the appropriate value.
- Thus  $(\Phi)(T_n) = 786 \text{ kips}$  which is larger than  $T_u$  (factored tie force).
- Others might interpret that Phi = 0.9 ( for “tension controlled reinforced concrete”) would be appropriate, in that case,  $(\Phi)(T_n) = 707 \text{ kips}$ , which is still larger than  $T_u = 653 \text{ kips}$  (Ok).

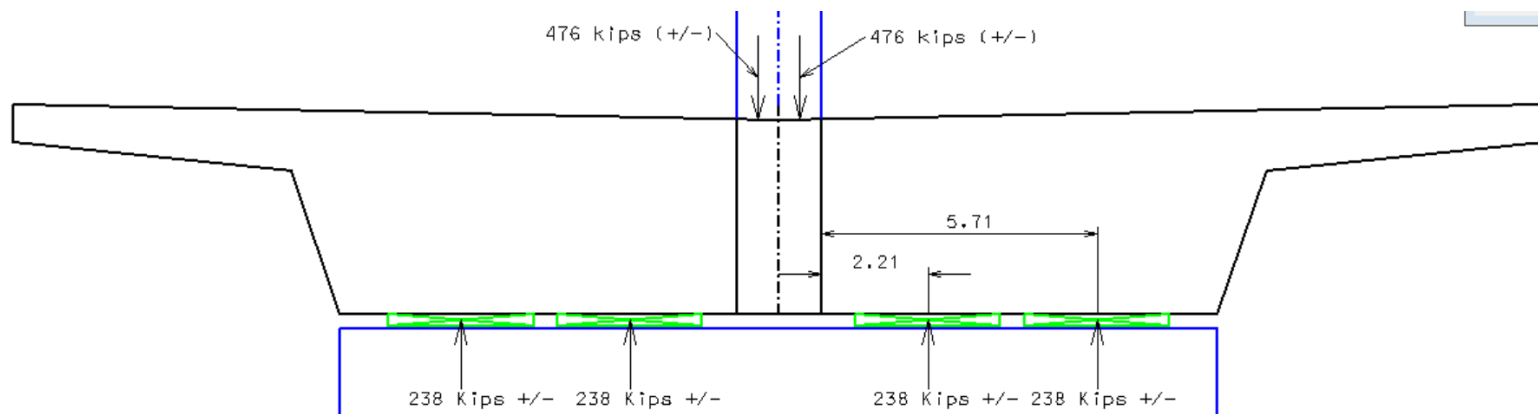
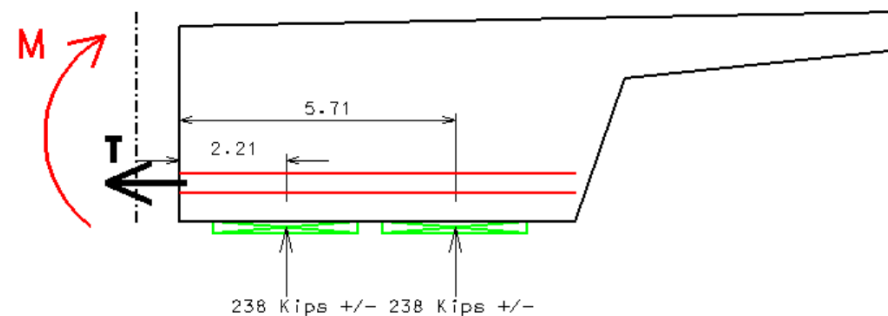
- As previously noted, the strut and tie method is more applicable to this region. However, the conventional beam theory method can serve as a confirmation check to the strut and tie results.

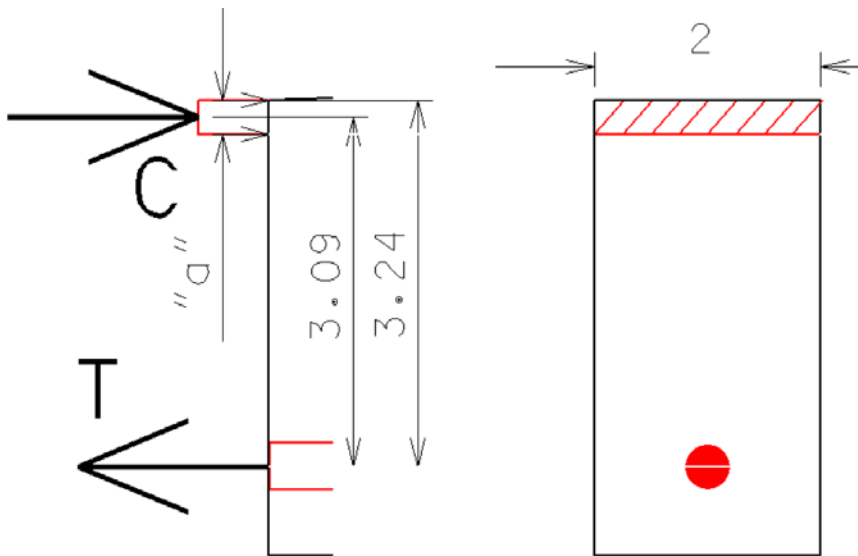
- Steel Area = 13.1 in<sup>2</sup>
- $T = (13.1)(60 \text{ ksi}) = 786 \text{ kips}$
- $f'c = 8.5 \text{ ksi} = 1224 \text{ ksf}$
- $(a)(.85 f'c)(b) = C = 786 \text{ kips}$
- Solving, "a" = 0.38 ft
- $Mn = (T)(d - (a/2)) = 786 \times 3.09'$   
= 2398 kip-ft (nominal capacity)
- $\Phi = 0.9$ , so  $(\Phi)(Mn) = 2158 \text{ kip-ft}$
- Which is larger than  $Mu = 2015 \text{ kip-ft}$
- Check OK

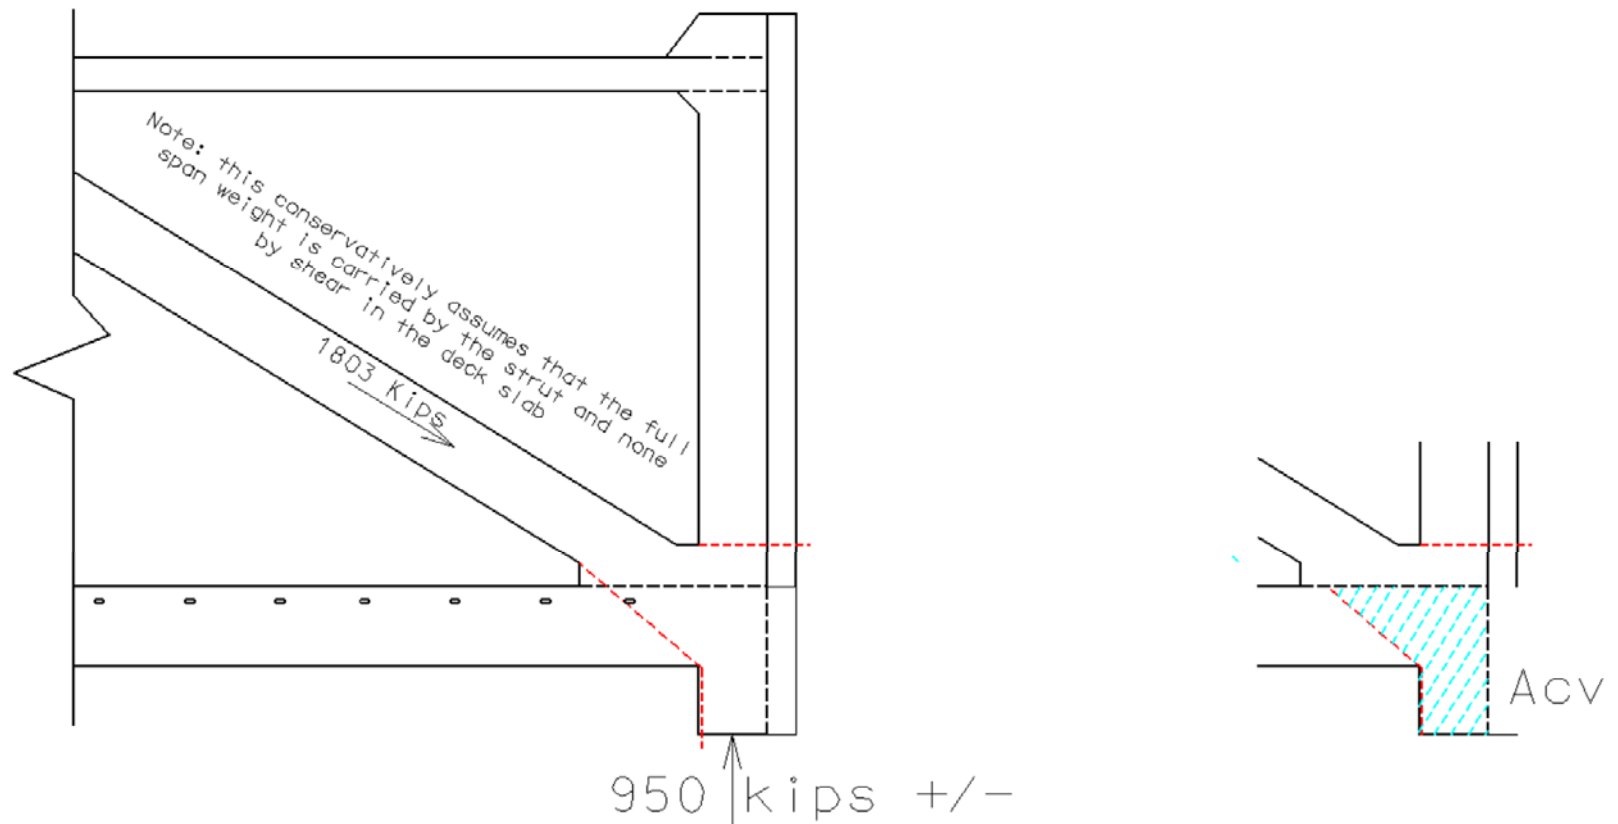
- The total “node” must remain attached to the diaphragm/deck in order for the longitudinal tendons to capture the longitudinal force component of the strut.

Total
	Number	Name	Area	# of sides	Area
	3	4S01	0.2	2	1.2
	1	8S05	0.79	2	1.58
	1	8S06	0.79	2	1.58
	3	5S04	0.31	2	1.86
	3	5S04	0.31	2	1.86
2 legs	2	11S04	1.56	2	6.24
	2	8S04	0.79	2	3.16
	2	9S03	1	2	4
	2	5S02	0.31	2	1.24
					<b>22.72 in<sup>2</sup></b>

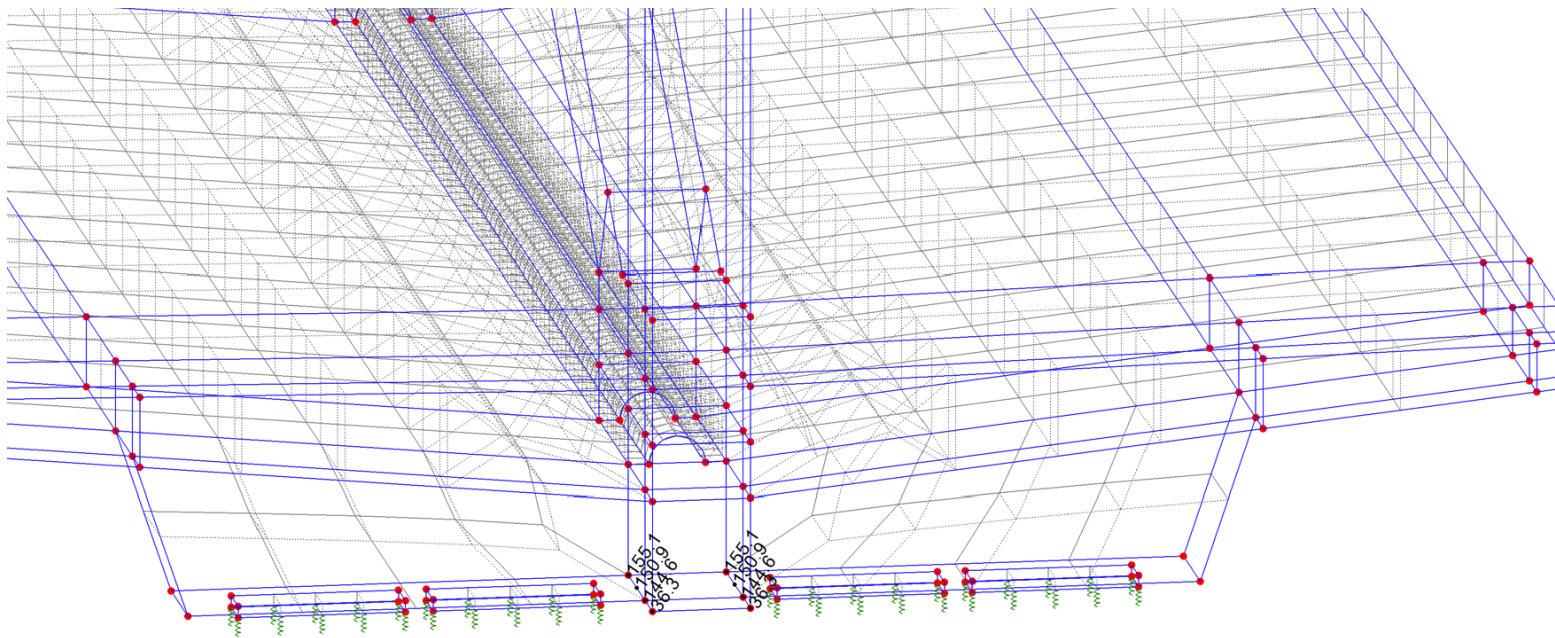
- 3 dimensional (volume element) finite element evaluations were conducted to understand the local distribution of stress adjacent to the nodal area.
- This evaluation included the 4 shim locations placed at the end of the span movement.

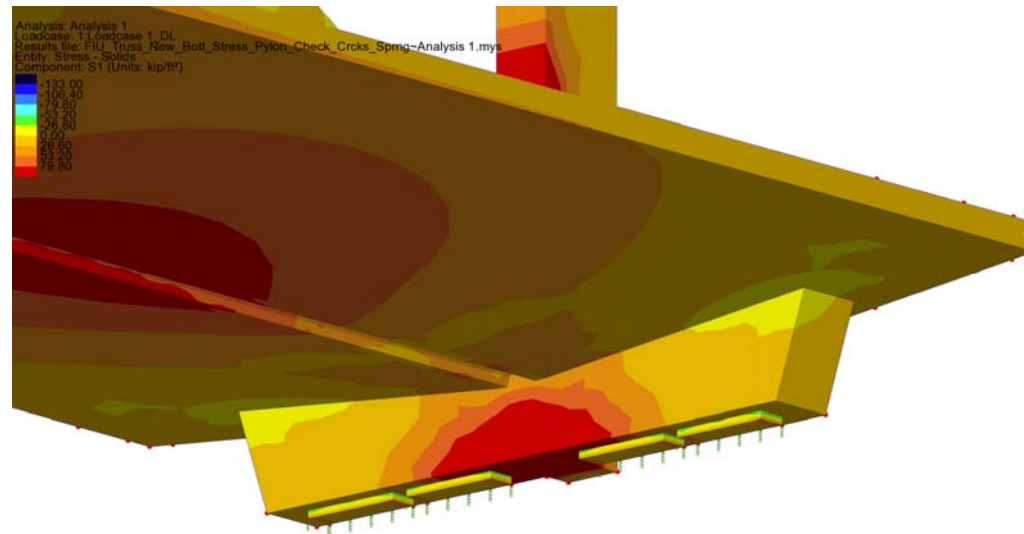
- When the span was placed onto the shims, are the stresses on the diaphragm essentially equal on the North and South Faces, or is one face more highly stressed?

- The results indicate that the stress change on the North and South faces is relatively uniform when the load is transferred to the shims.

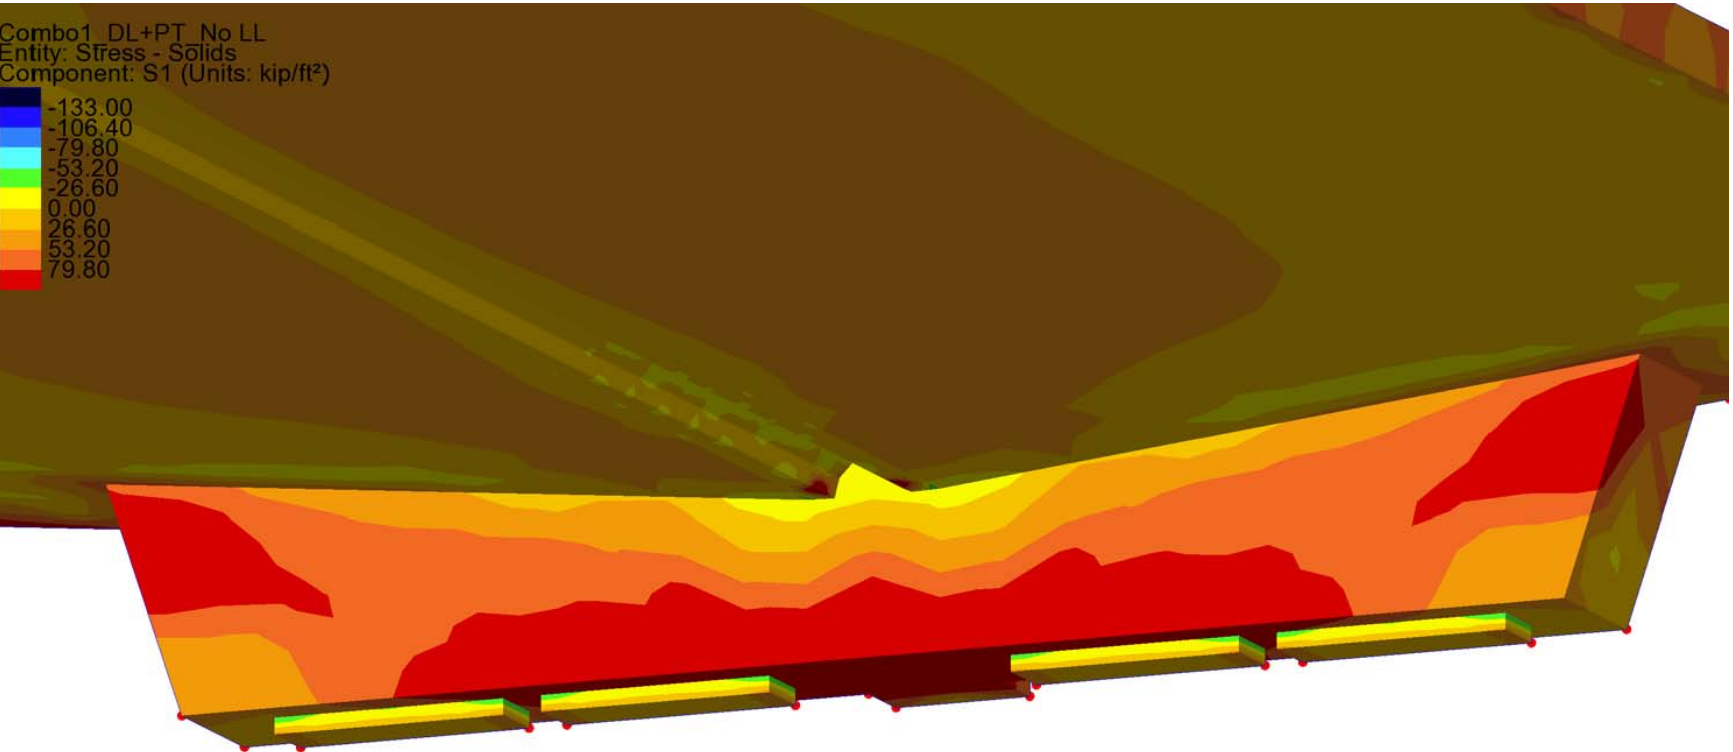
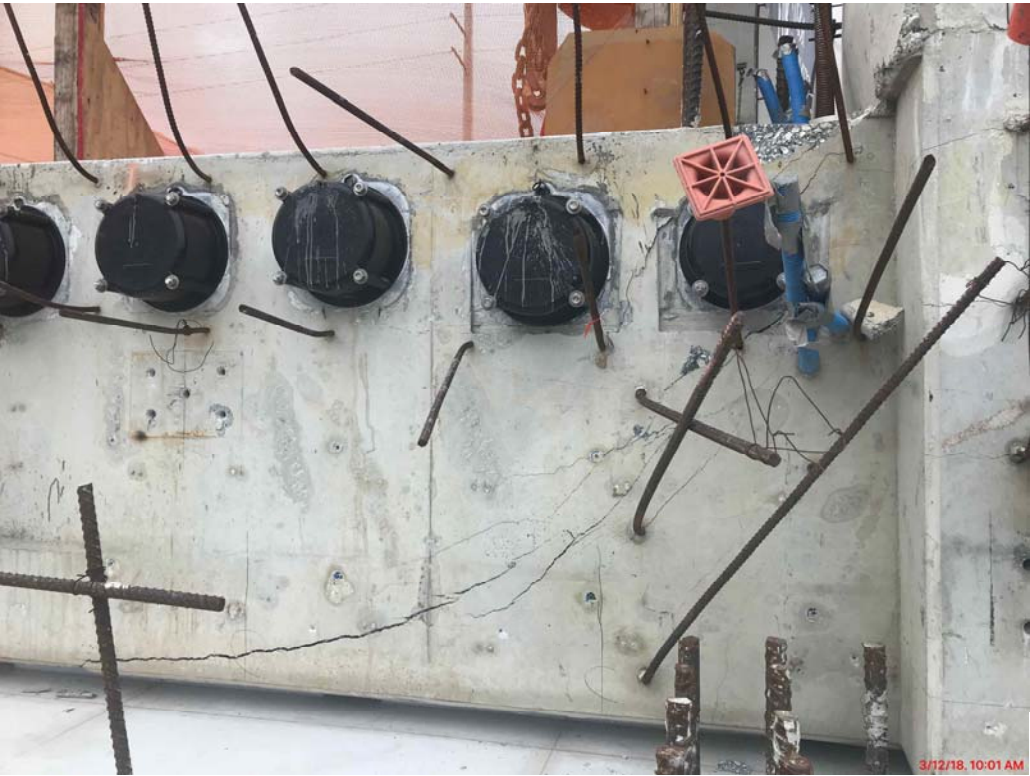
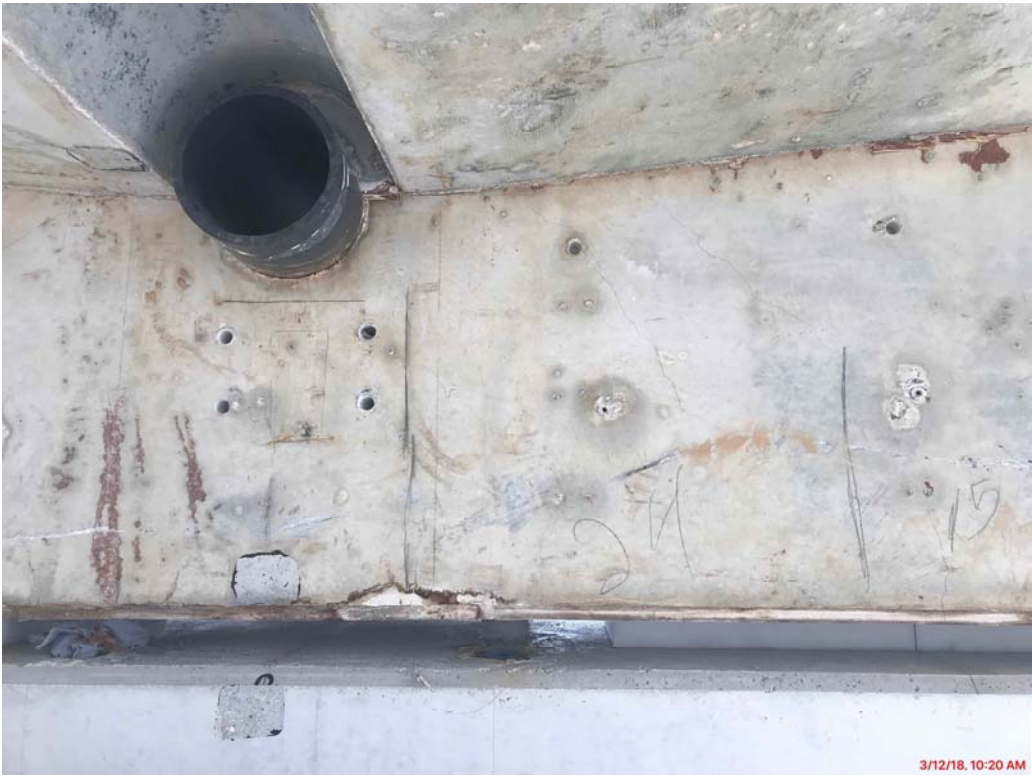
# Total stress when on shims

- Both the hand calculations and the 3D volume element analysis concur that some cracks of the nature photographed are possible
- Why the cracks did not develop in the casting area, is likely related to having a substantial portion of the load carried in the central area
- Having the smaller crack width on the permanently exposed face is preferable, when compared to the other (to be embedded) diaphragm face.

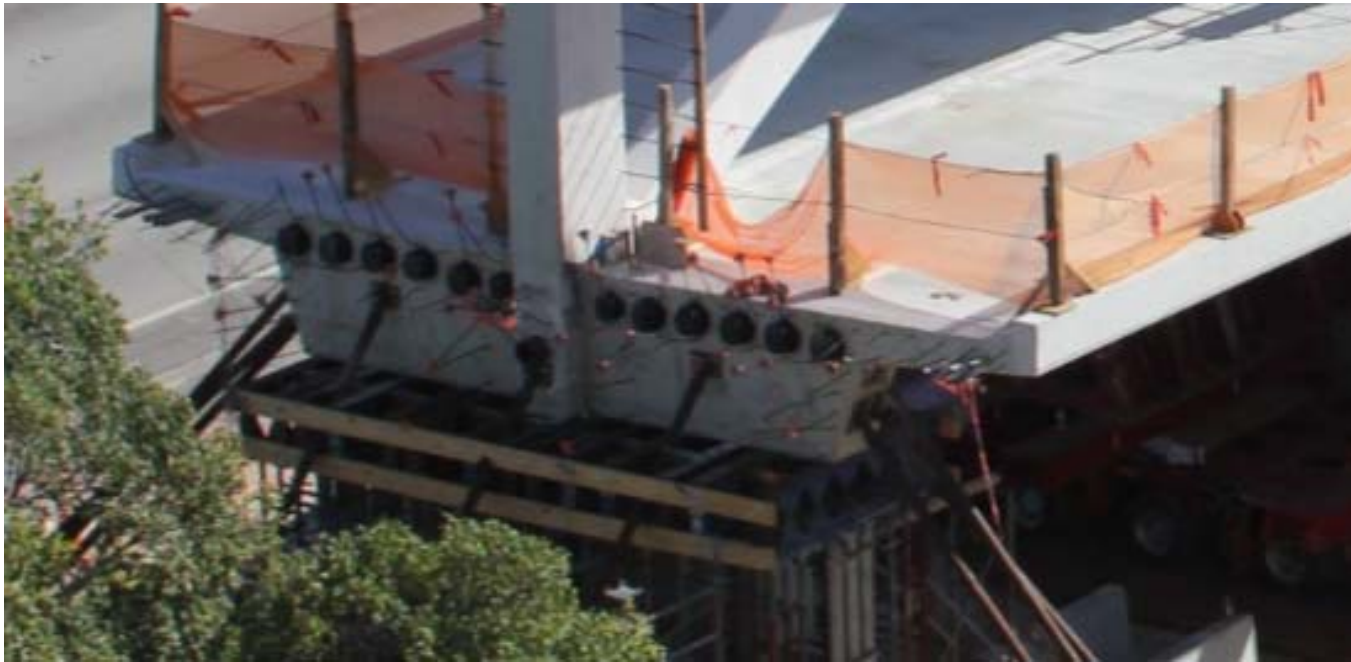
It is unclear how a change in distribution of contact pressure on the bottom surface ...

From Being supported like this for several weeks
