**Bridge Factors Factual Report Attachment 32 – FIGG 3/15/18 Power Point Presentation**

# FIU - Sweetwater University City Bridge

## Temporary Construction Loading Condition

Additional Review of Pylon Diaphragm Region  
(Type II Deck End Diaphragm)

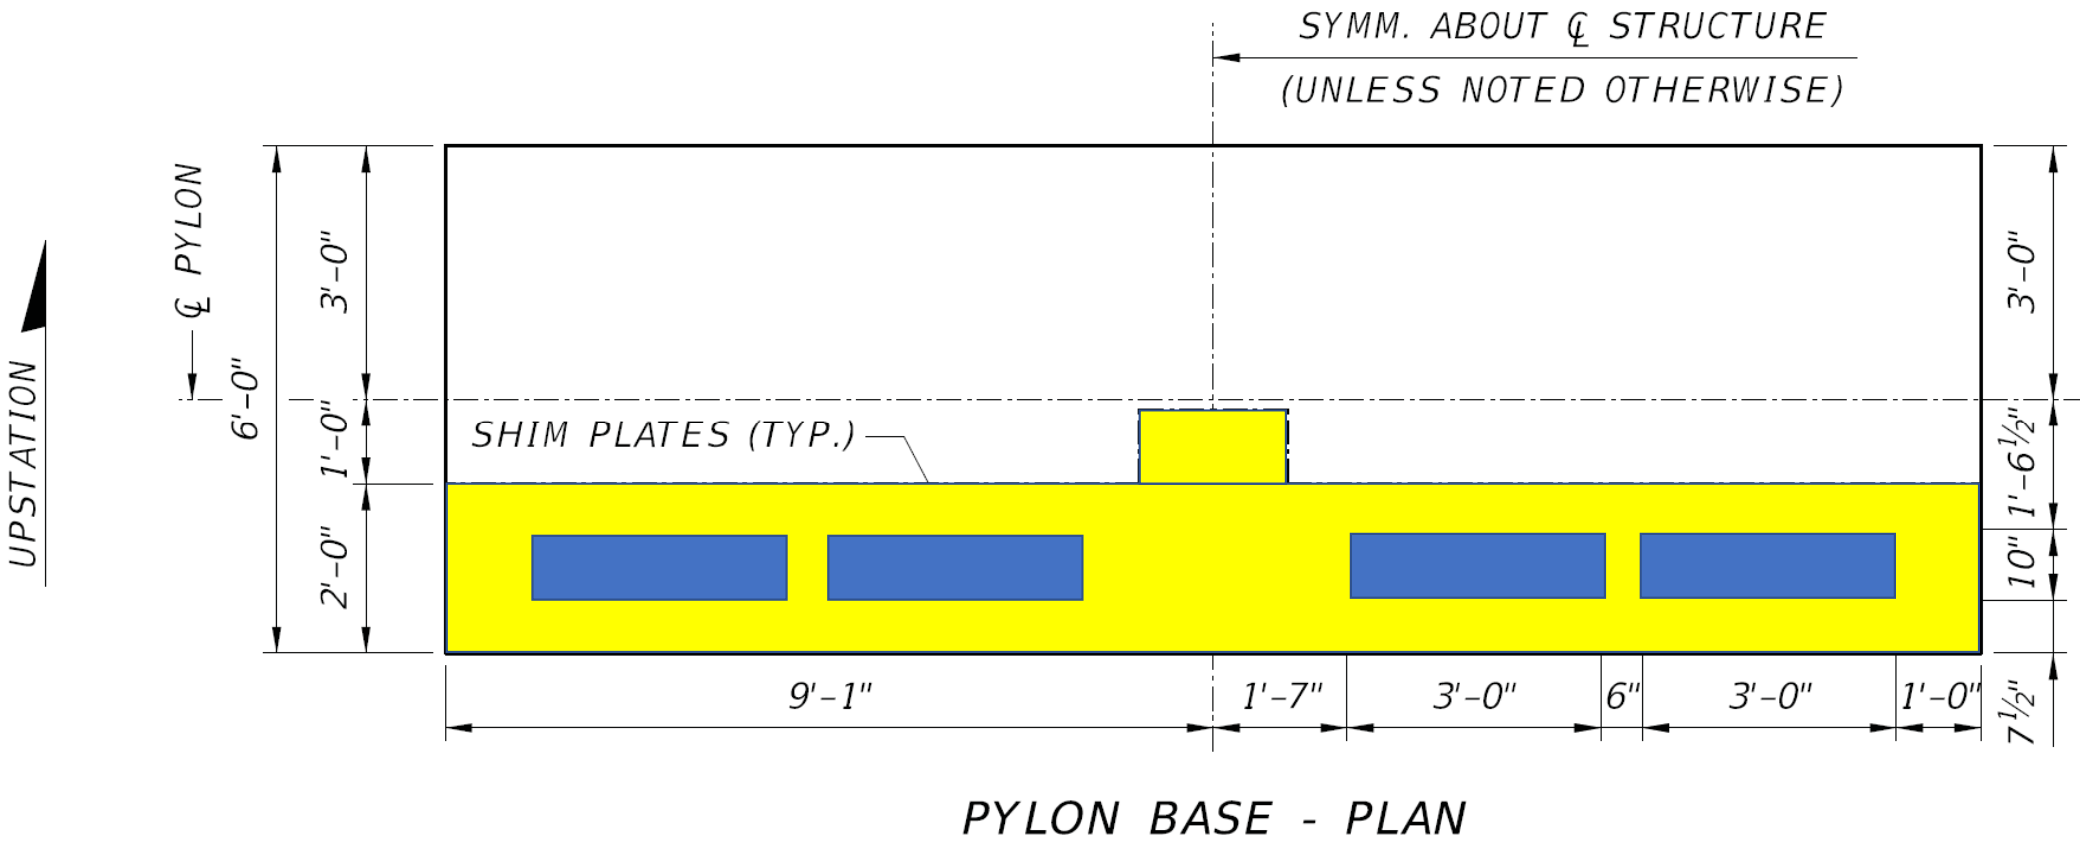
To being supported on the bottom on the four shims ...

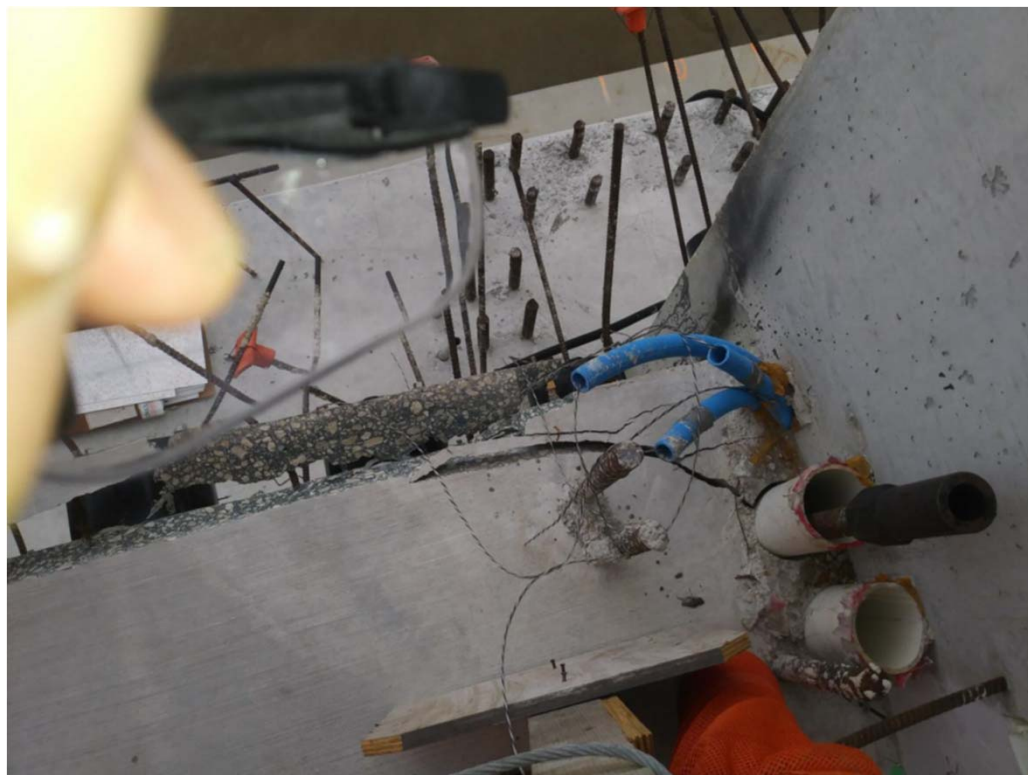
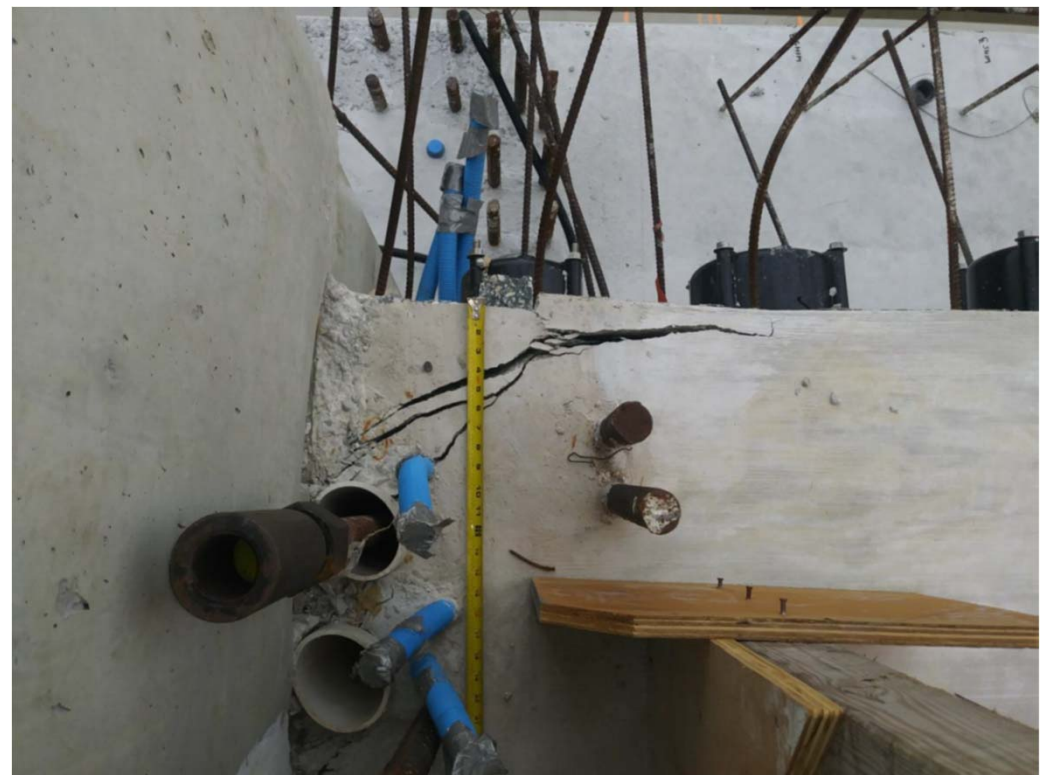
Could possibly create these top spalls ???

- The diagonal type cracks, in excess of FDOT criteria, should be sealed with approved methods and materials (Epoxy injection, etc.)
- The spalled areas have not been replicated by the engineering analyses. However ...
- The spalled areas are minor and it is recommended that they be prepared using normal procedures and poured back along with the up coming “pylon diaphragm” pour (different from and prior to the back span on falsework pours)

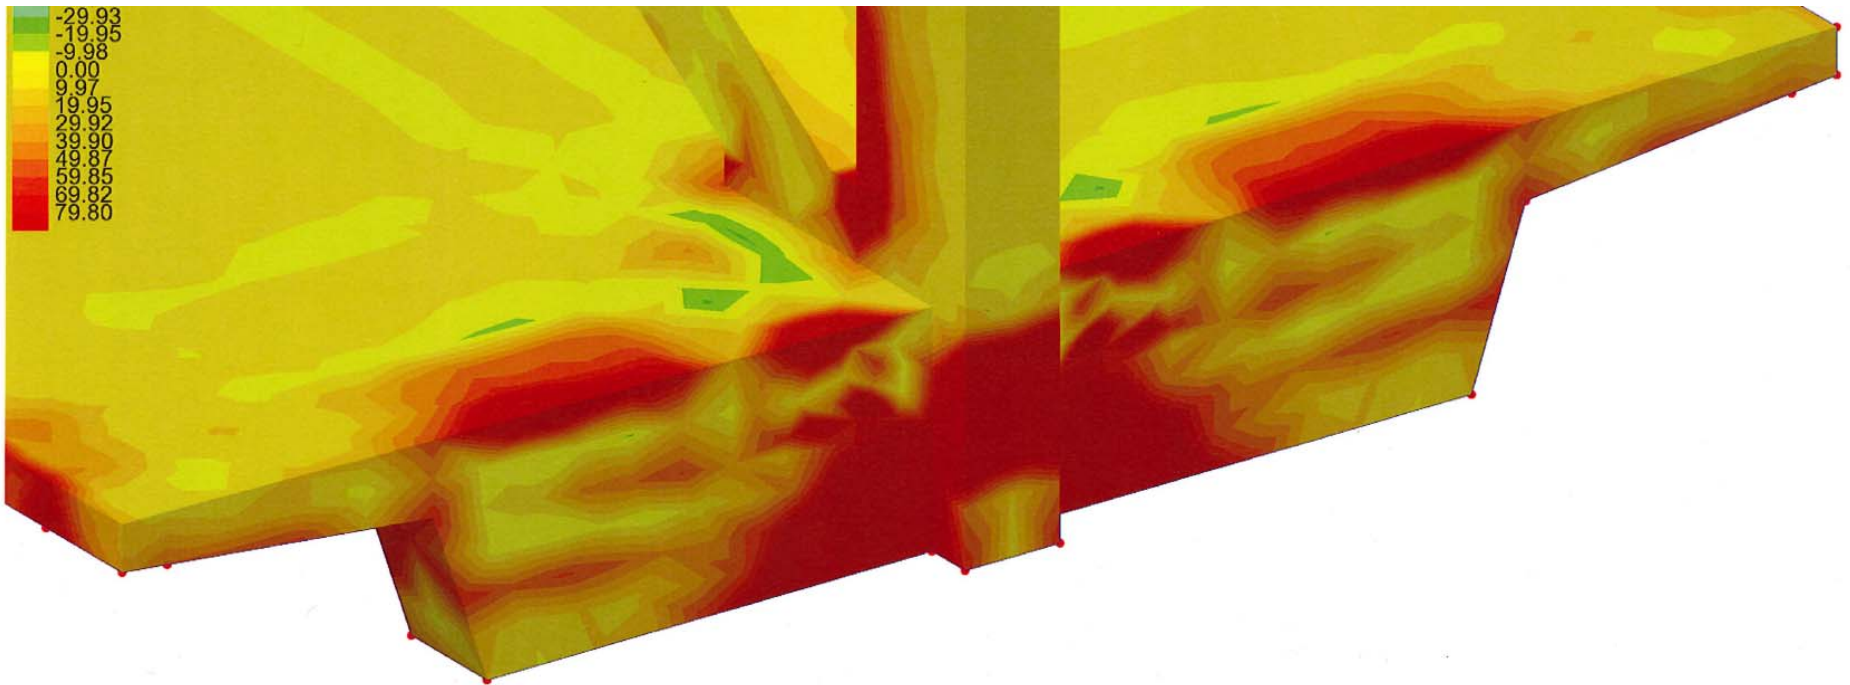
The total (plotted as Principle Tension) stresses from the 3D Model are

- This plot has the diagonal PT bars in Member 11 destressed

- The analyses (neither total stresses, nor PT bar only stresses) shows any spike in tensile stresses at the corner of the deck/diaphragm/member 12.

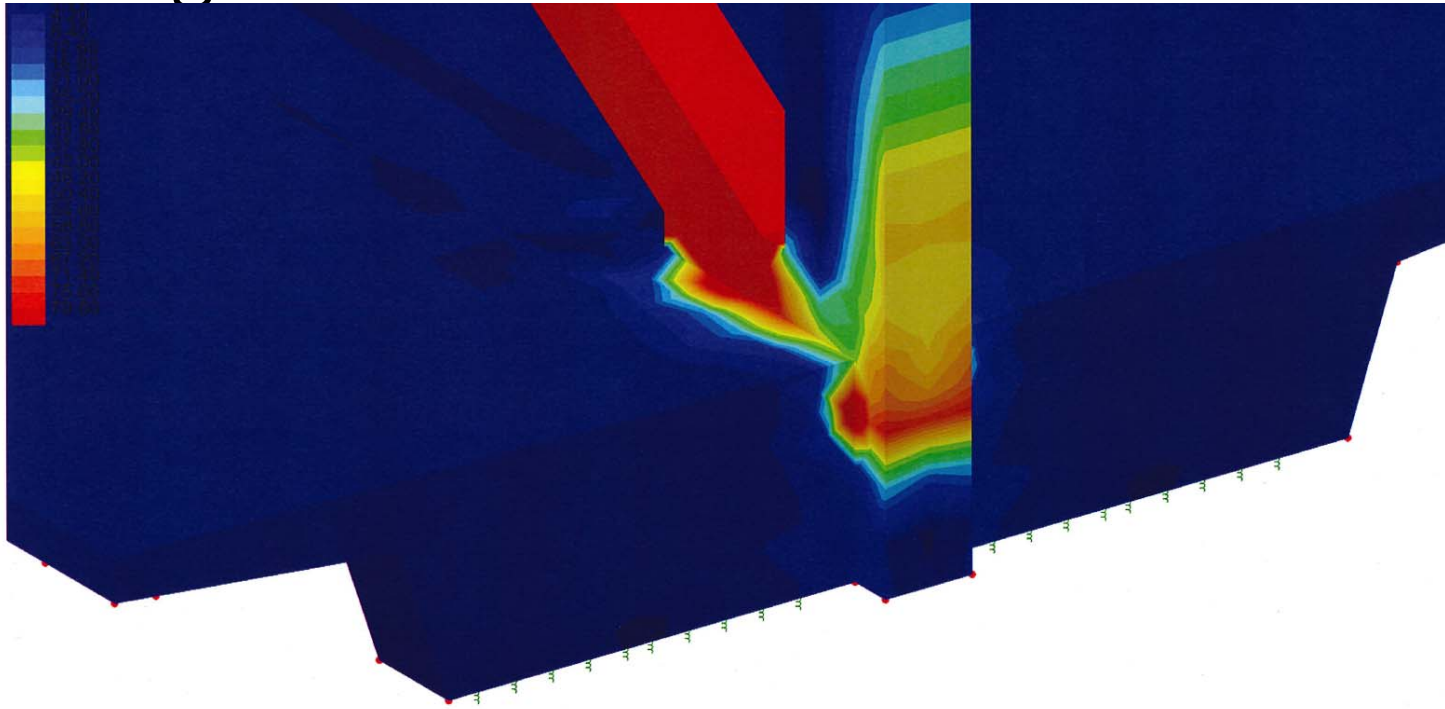
The change (principle stresses) solely from destressing the PT bars in Member 11 are
