**Bridge Factors Factual Report Attachment 41 – Email from Mr. John Engberg of
Barnhart Crane and Rigging to Mr. Dan Walsh of NTSB dated August 20, 2018**

Miami, FL

HWY18MH009

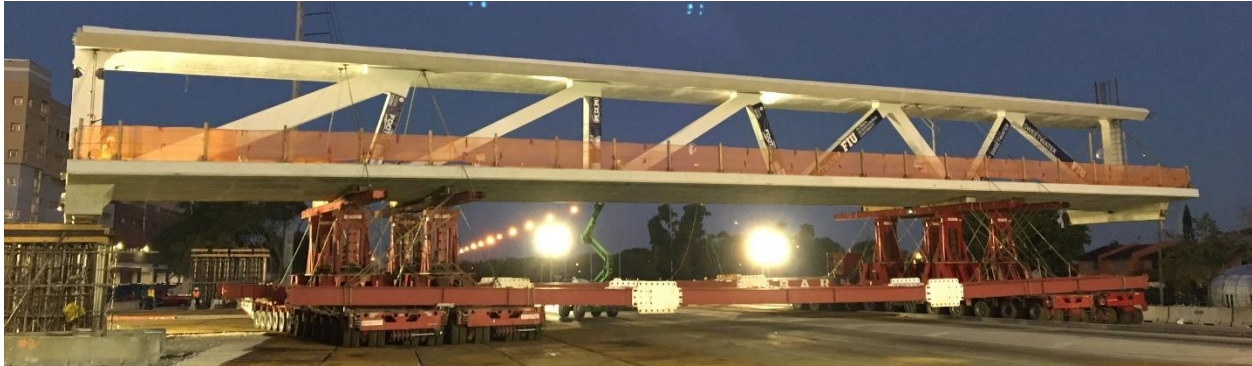
Figure 2 - Main Span During Move

The system utilized to transport the 950 Ton bridge consisted of two SPMTs that were positioned at locations that were specified by FIGG, in a memorandum from Dwight Dempsey dated July 25, 2017, based on their structural evaluation of the bridge for the temporary support condition during transport. Located symmetrically about the longitudinal and transverse centerlines of each SPMT were four shoring stands (eight total), each stand supported a hydraulic jack assembly. The hydraulic jack assemblies were positioned symmetrically about the longitudinal centerline of the bridge, resulting in four pairs of hydraulic jack assemblies located at discrete locations along the length of the bridge. Each pair of hydraulic jack assemblies supported a beam, positioned transversely to the bridge span. Two wedge shaped hardwood mats (the angle of the wedge matched the angle of the tapered bottom flange of the bridge) were installed on top of each beam, symmetrically about the longitudinal centerline of the bridge. Two truss assemblies were installed at both ends of the SPMTs to connect them together to assure the two SPMTs maintained the proper spacing throughout the travel path. Figure 1 shows the transport system during the movement of the bridge on March 10, 2018. Transportation of the bridge began at approximately 4:30 am on March 10, 2018. Final placement of the bridge on the permanent supports concluded eight hours later at approximately 12:30 pm.
