## Certified Test Report

**Material Description:** Sections of Tank Car  
**Identification:** NATX 400688 & UTLX 954193  
**Specification:** AAR CIII, Appendix M, Section 5.0: AAR TC128

### TENSILE TEST –ASTM A370 (NATX 400688)

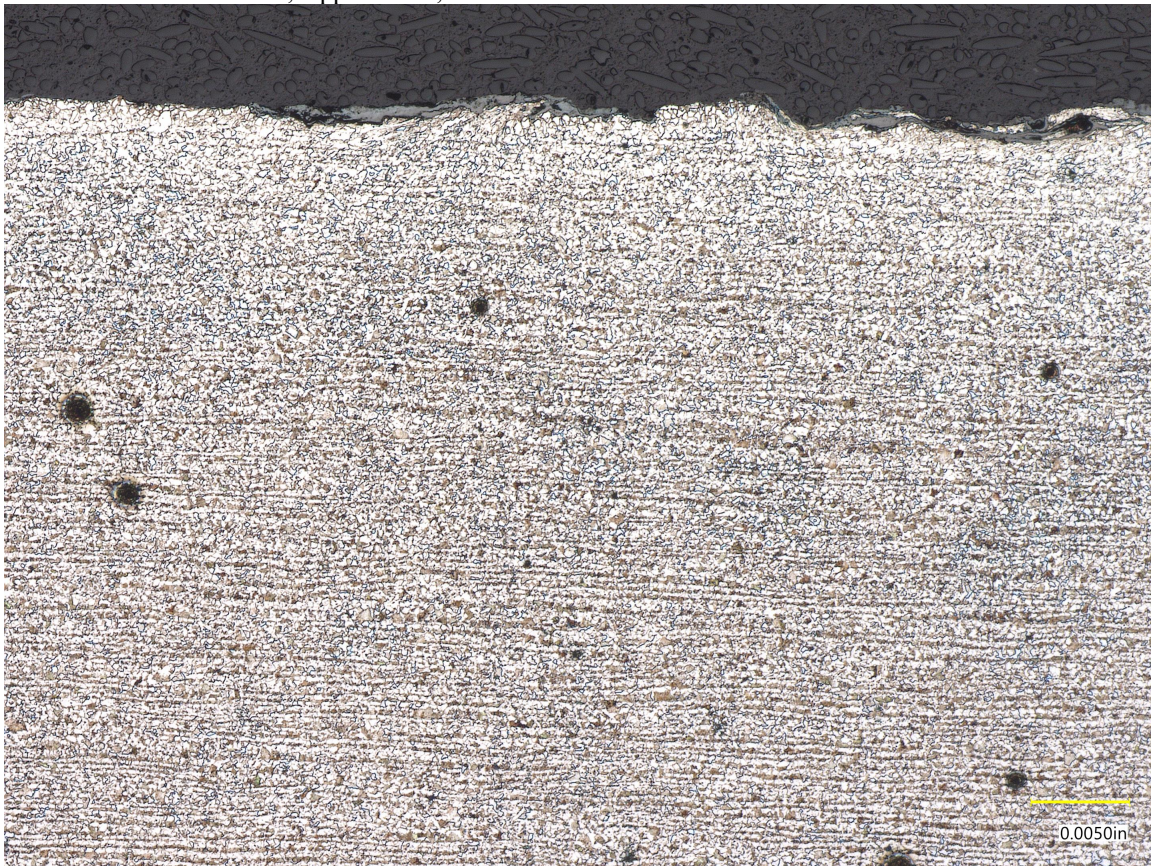
*Figure 1 - NATX 400688 Microstructure, Surface, Longitudinal Direction, 200X Magnification*

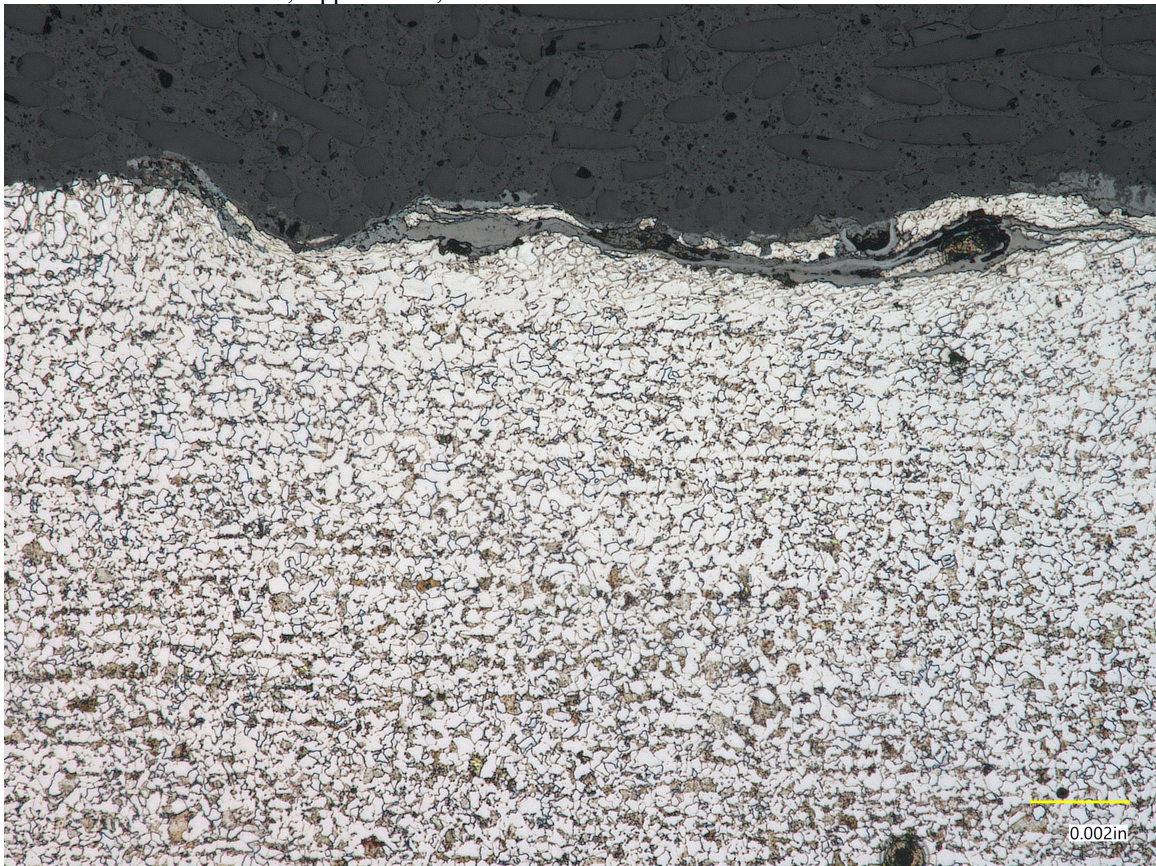
*Figure 2 - NATX 400688 Microstructure, Surface, Longitudinal Direction, 500X Magnification*

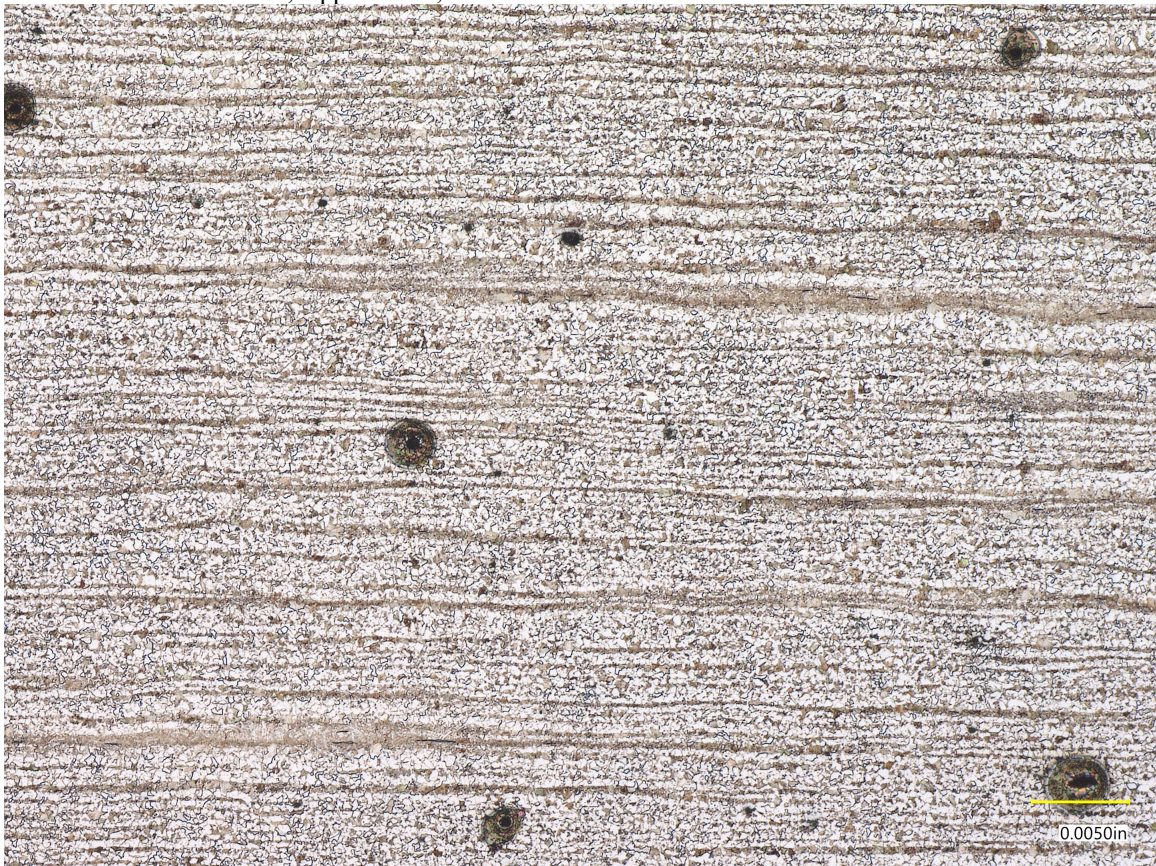
*Figure 3 - NATX 400688 Microstructure, Longitudinal Direction, Centerline, 200X Magnification*

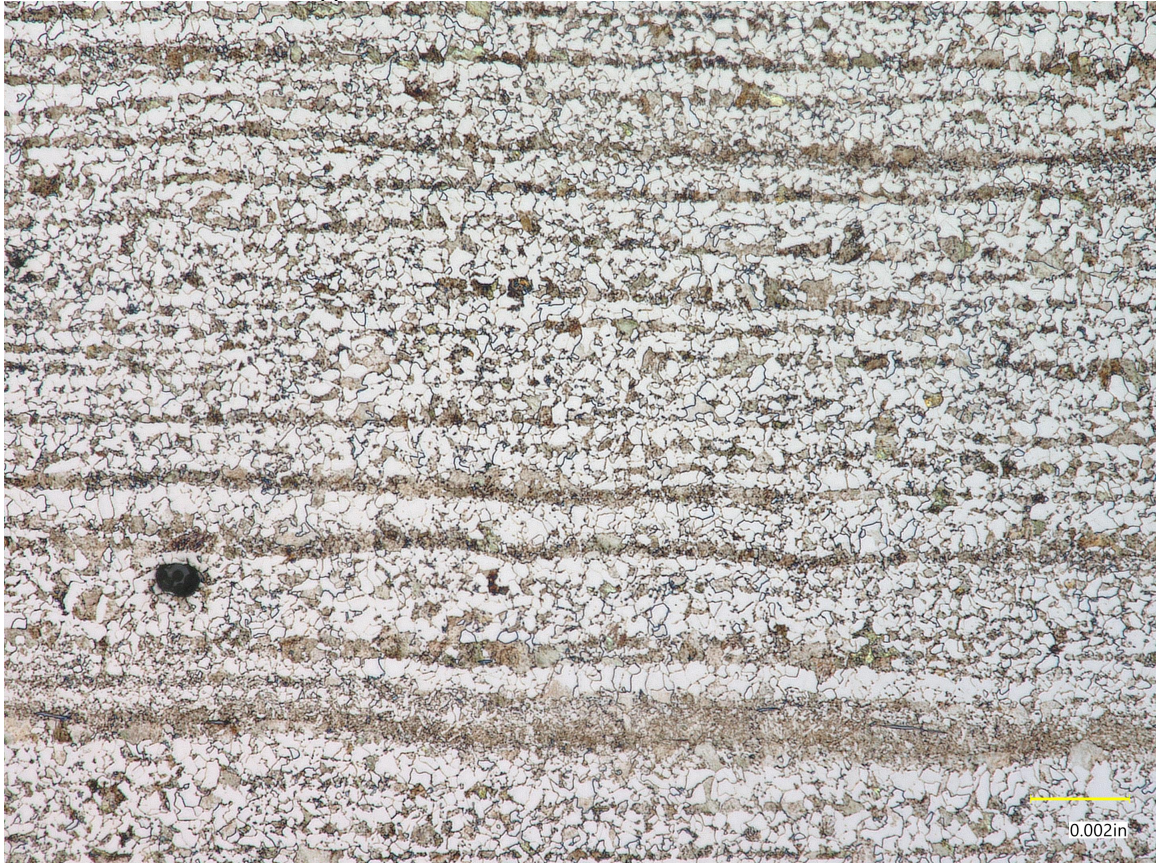
*Figure 4 - NATX 400688 Microstructure, Longitudinal Direction, Centerline, 500X Magnification*

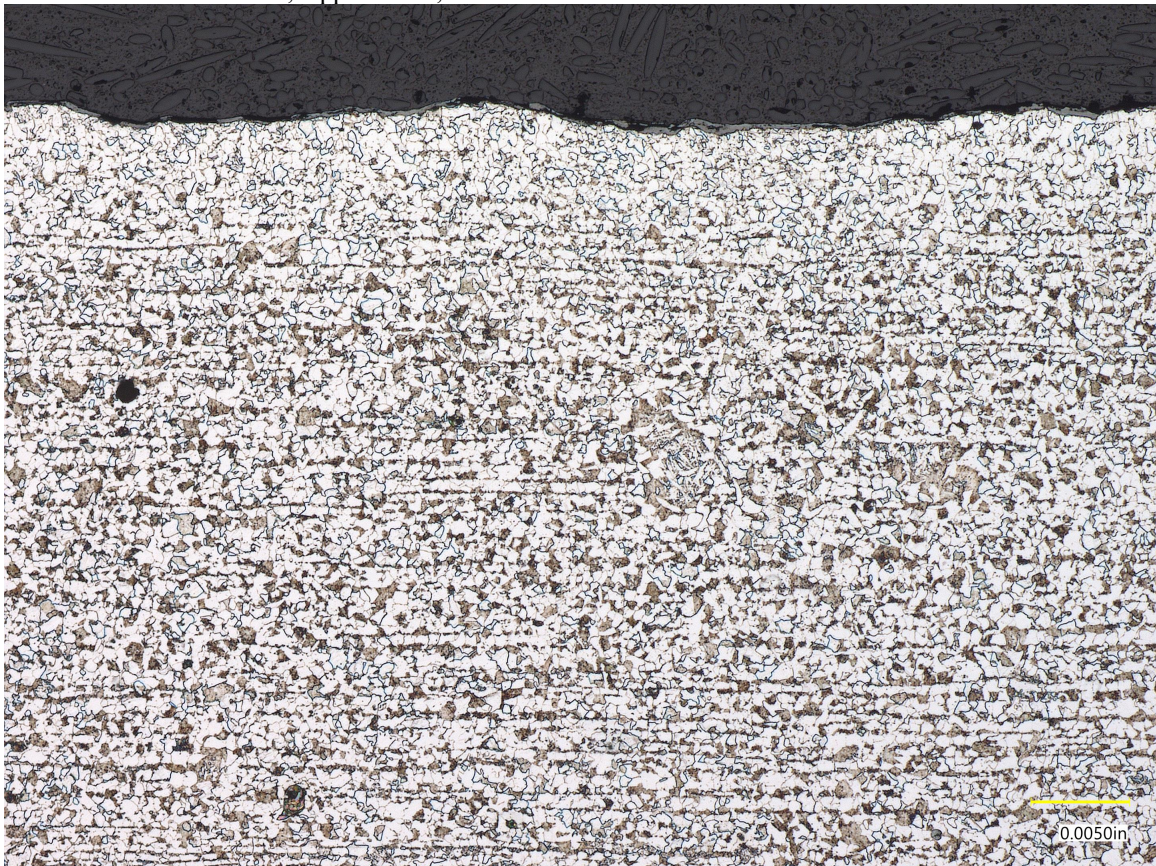
*Figure 5 - UTLX 954193 Microstructure, Longitudinal Direction, Surface, 200X Magnification*

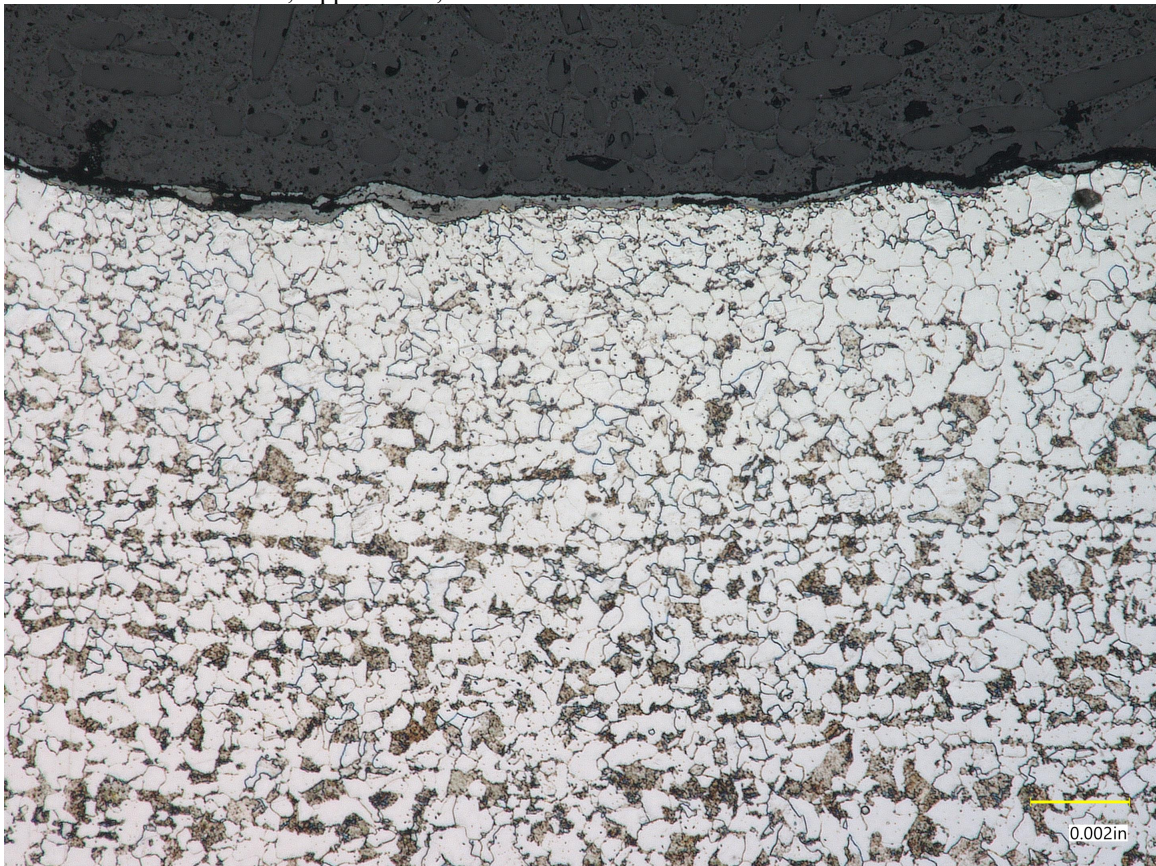
*Figure 6 - UTLX 954193 Microstructure, Longitudinal Direction, Surface, 500X Magnification*

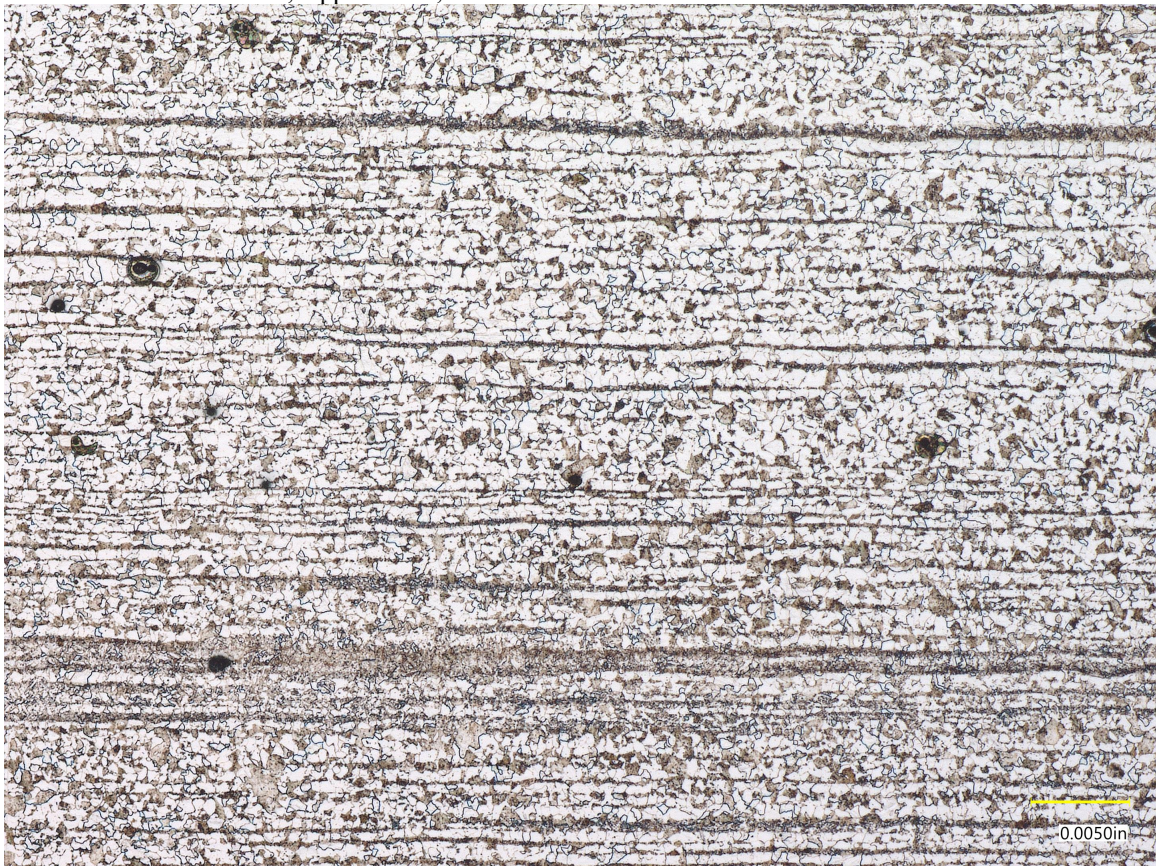
*Figure 7 - UTLX 954193 Microstructure, Longitudinal Direction, Centerline, 200X Magnification*

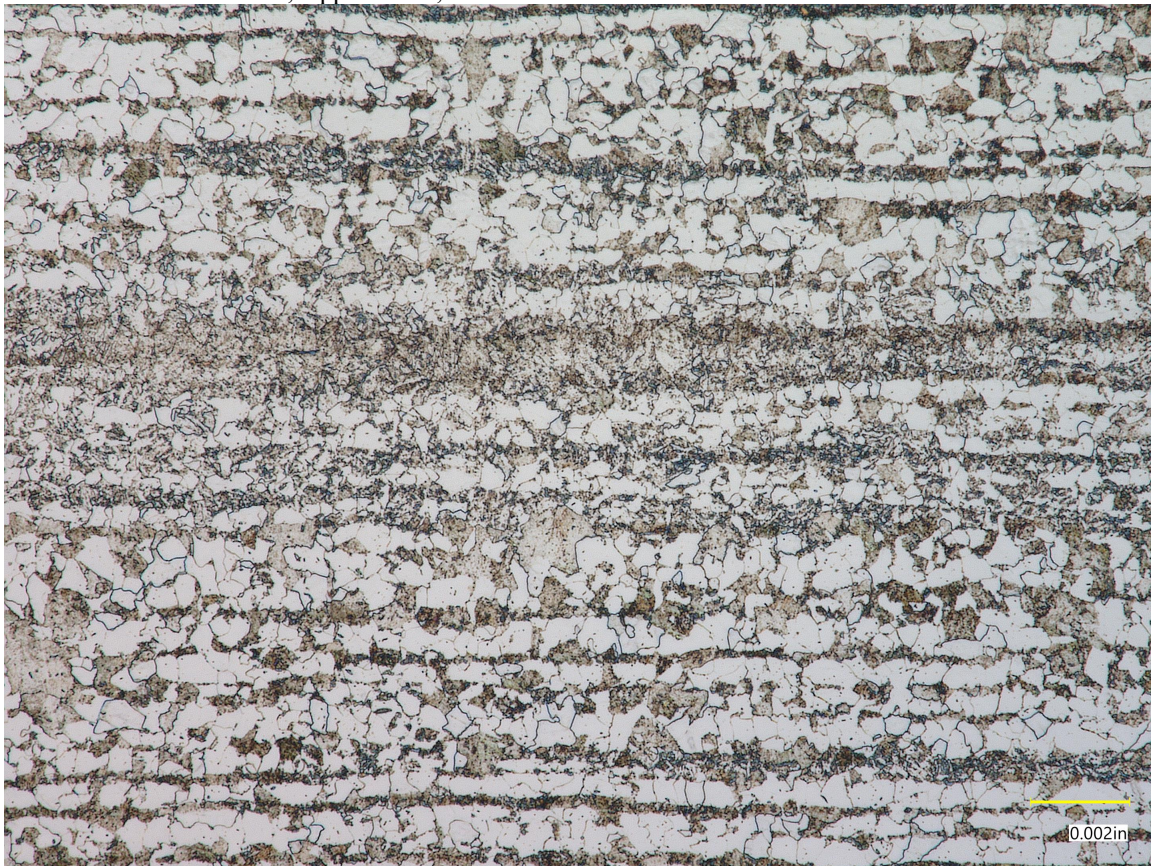
*Figure 8 - UTLX 954193 Microstructure, Longitudinal Direction, Centerline, 500X Magnification*
