**BNSF Oklaunion TX Ethanol Derailment 1-8-2022**

**Report date 4-11-22r1**

**Date:** 3-16-2022  
**Location:** Trinity Saginaw #25  
**Attendees:** Vernon Walker -FRA, Trinity-Ron Lawler, Luis Espinosa & Robert McGinley  
**Subject:** Post Derailment -Valve Inspection/Teardown

**Summary 2**

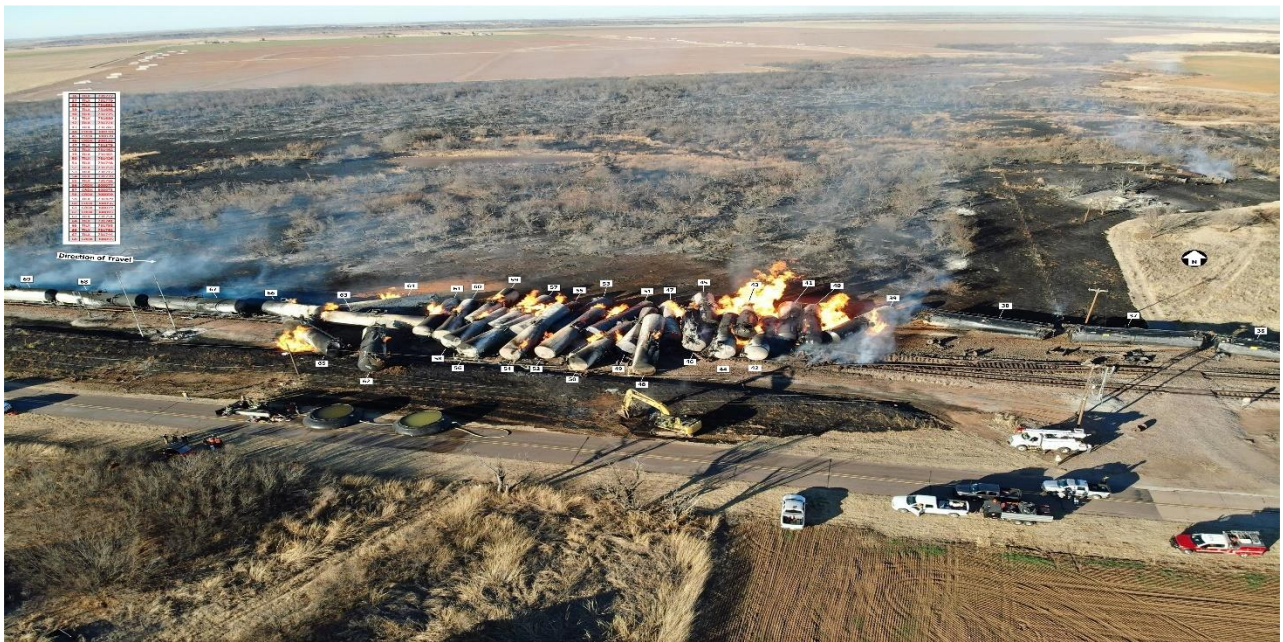
**Car location to fire damage.**

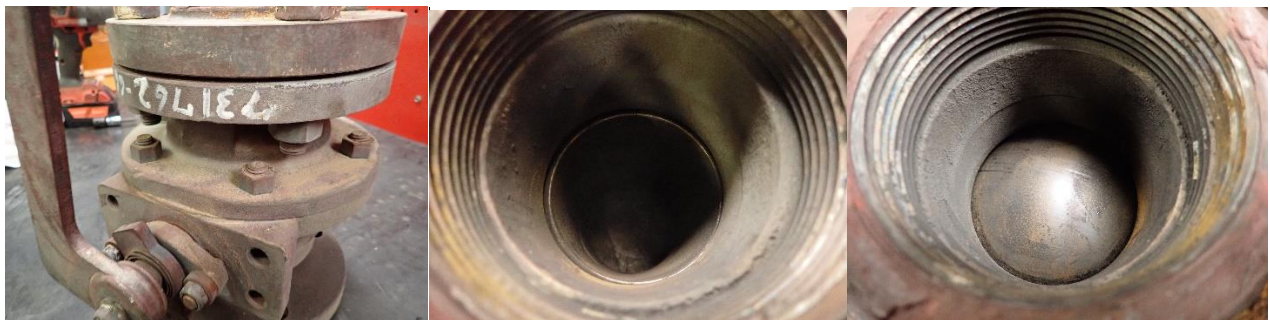
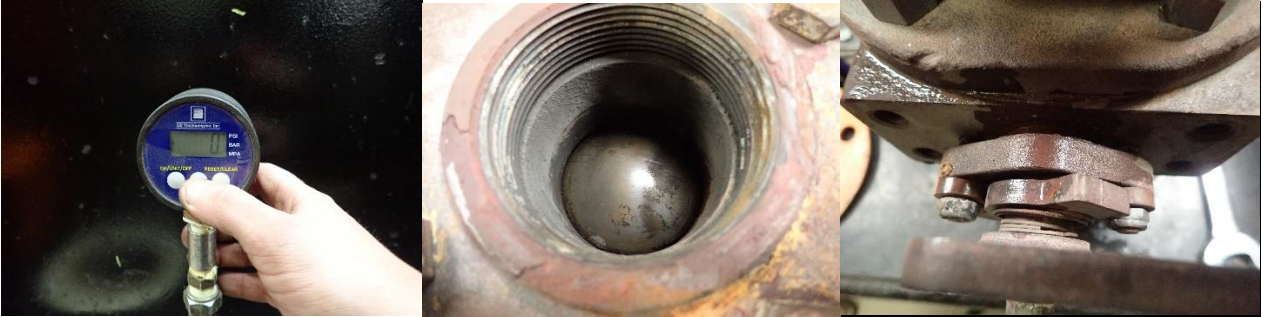
**TILX 731762 (66) Jamesbury 9150 RR 2" Top valve**

**Valve would not hold any pressure or make bubbles due to size of leakage.**

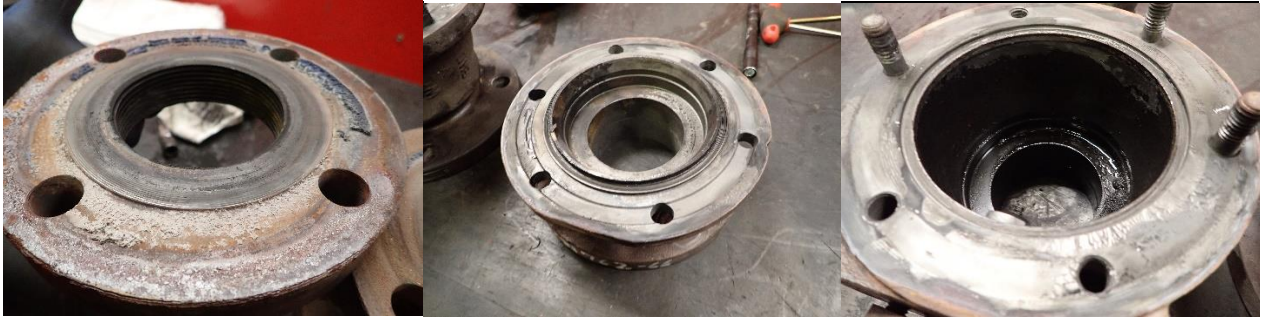
**1570E flange gasket disintegrated. Spiral wound body gasket disintegrated.**

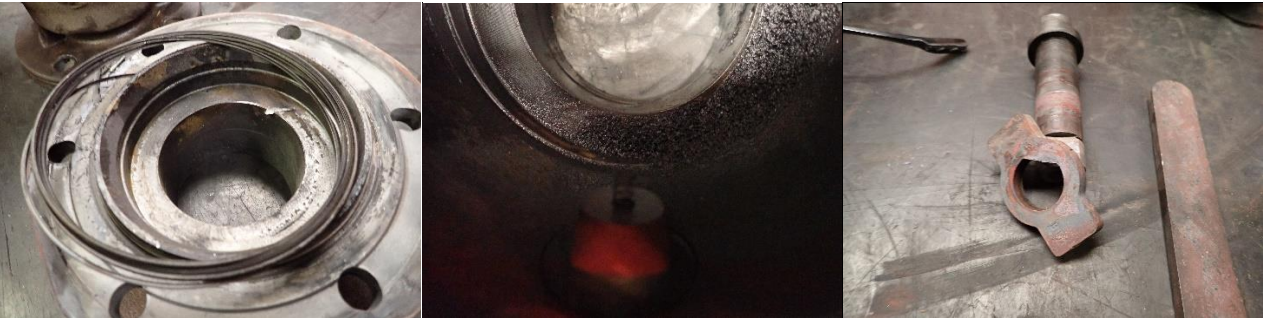
**Top and bottom extreme seats only reside remaining. Stem packing disintegrated.**

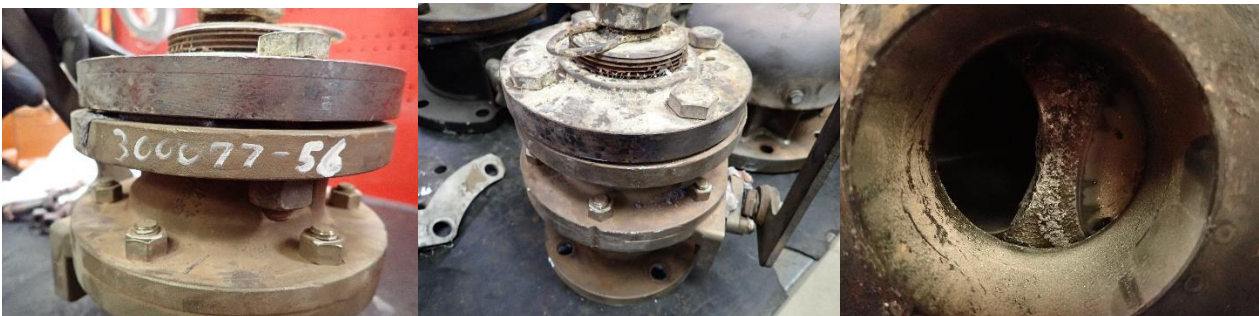
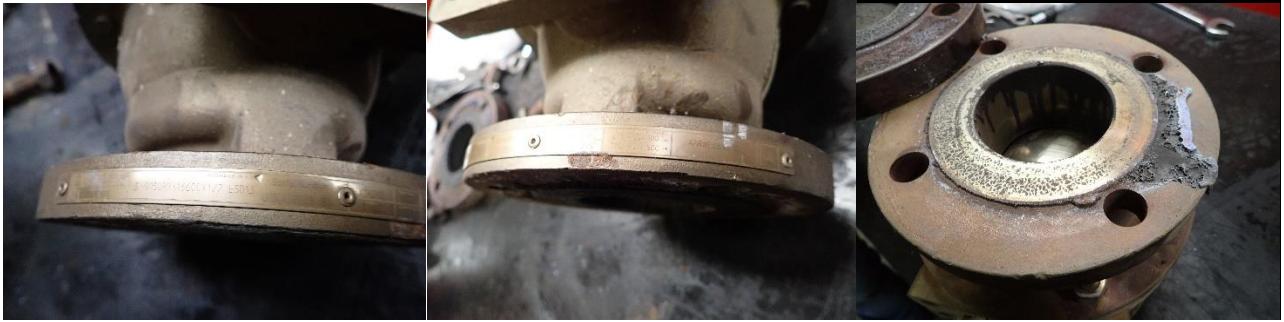
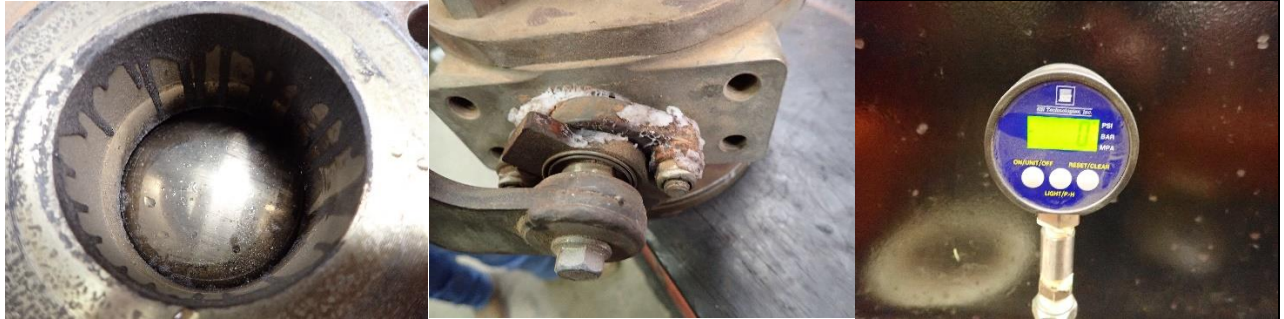
**CRDX 30077 (56) Jamesbury 9150 RR 3" Top valve**

**Valve would not hold pressure to test.**

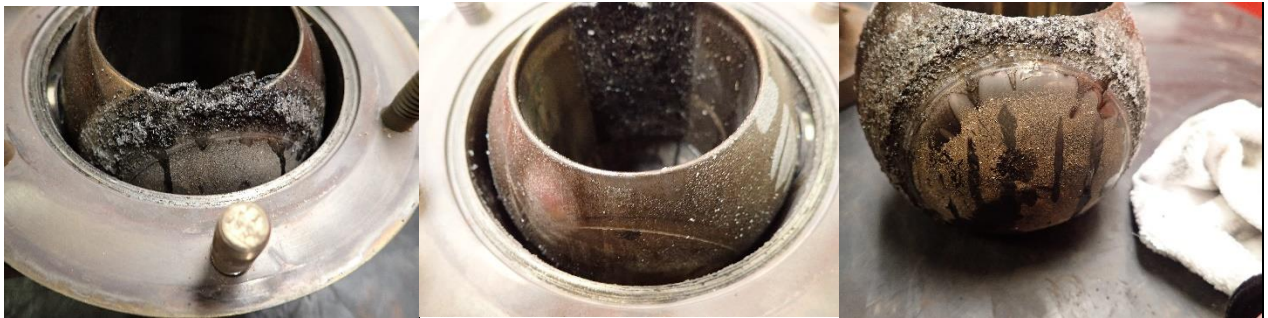
**Seat residue on ball.**

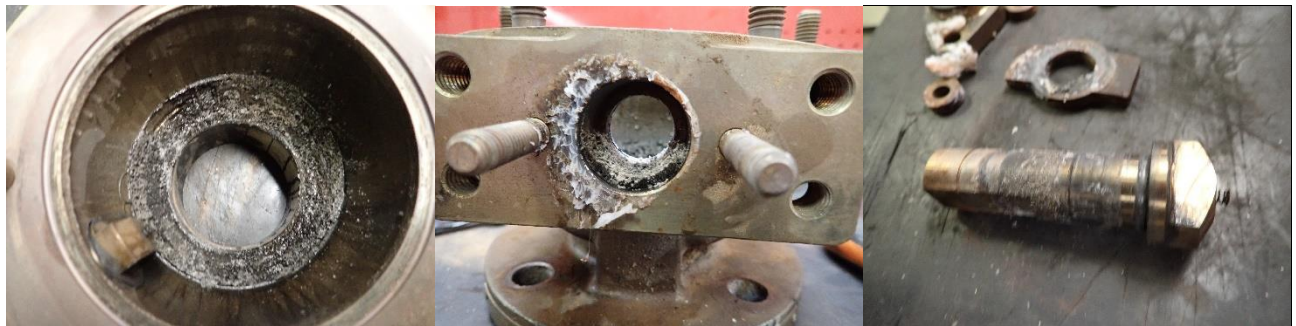
**Seat residue in bottom of body. Stem packing residue in bottom 1/2.**

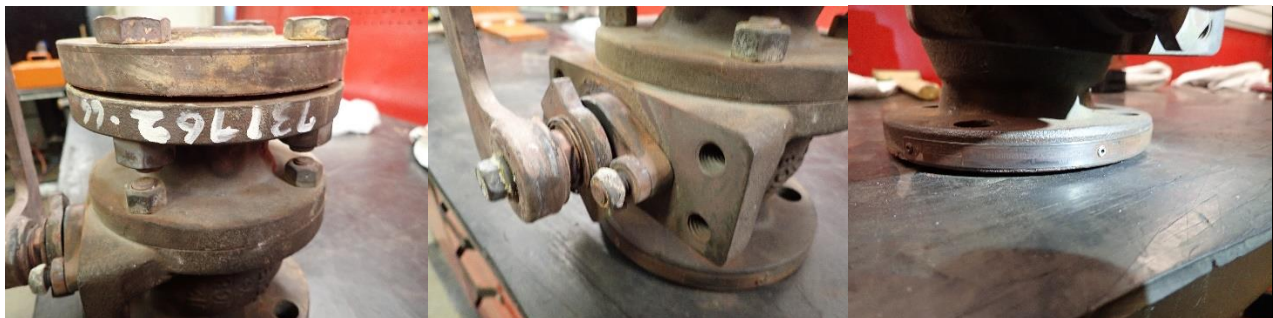
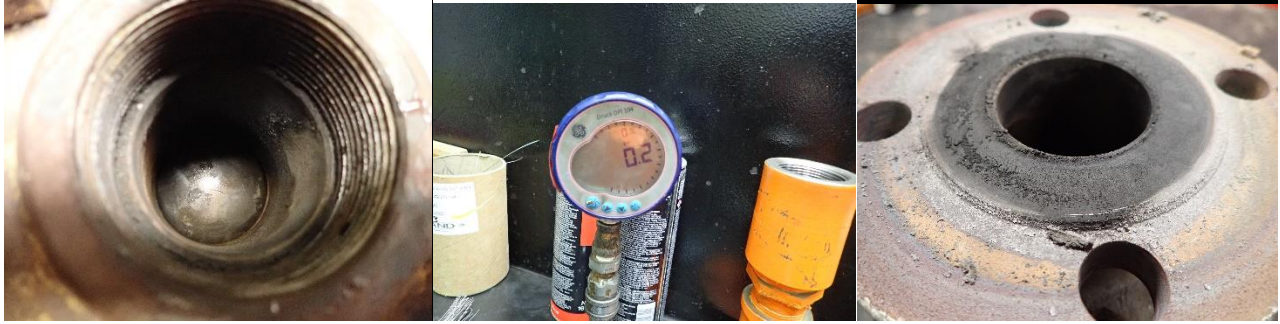
TILX 731762 (66) Jamesbury 9150 RR 3" Top valve

**Valve would not hold pressure to test.**

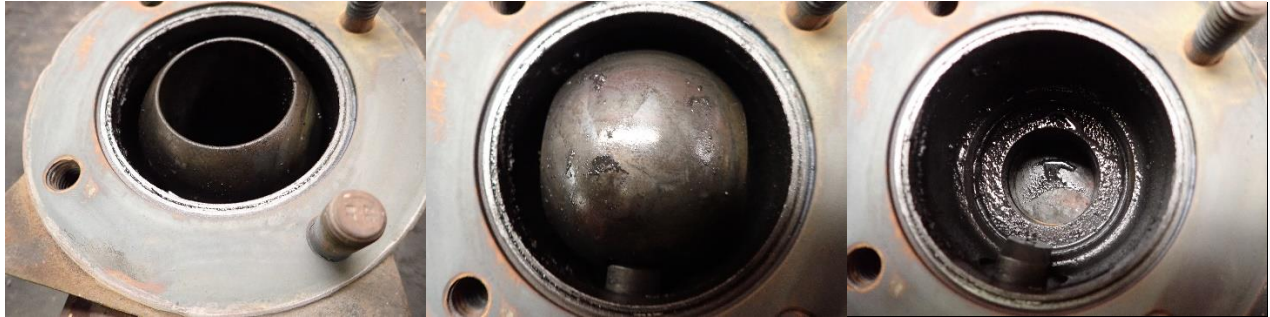
**Only residue of seats remaining**

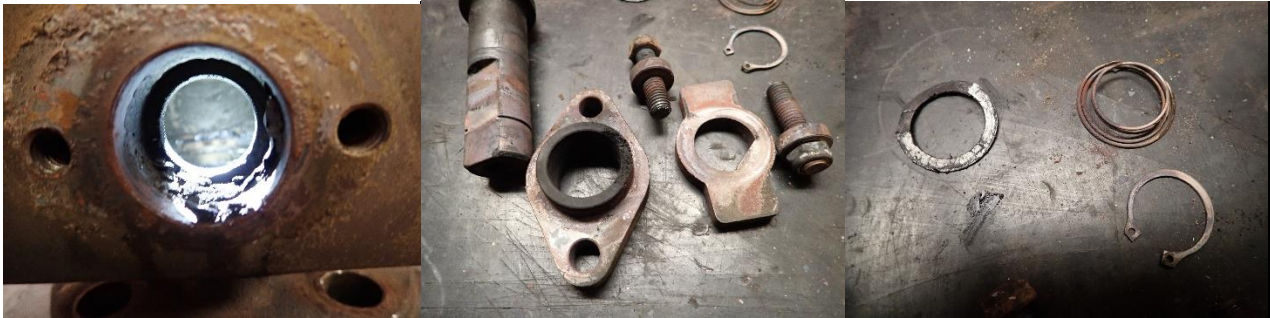
**Stem packing has disintegrated.**

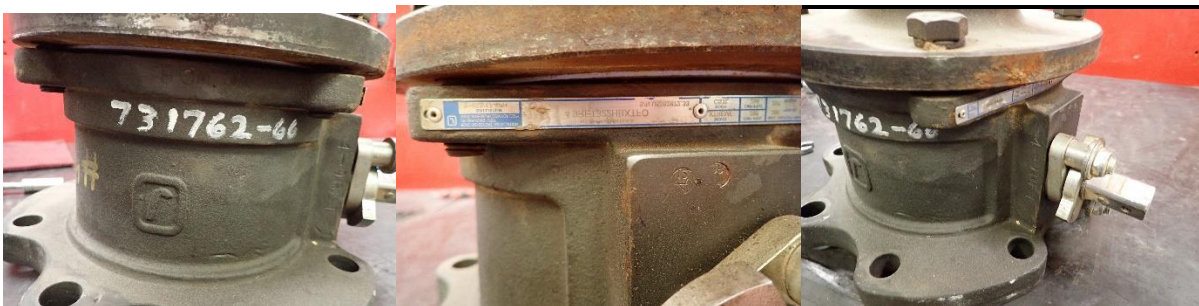
**TILX 731762 (66) BOV Jamesbury 9RET3 22HB XT**

The majority of valves exhibited leaking at very low pressure and could not be pressured up due to the amount of leakage. When torn down the gaskets and o-rings were either disintegrated or had a residue from what was a gasket or O-ring. The BOV from TILX 731762 didn't have fire damage indications as other valves exhibited and temperature it was exposed was considerably less than other valves. However it still started leaking at low pressure around 9 psi.

**Valve doesn't appear to have direct heat damage**

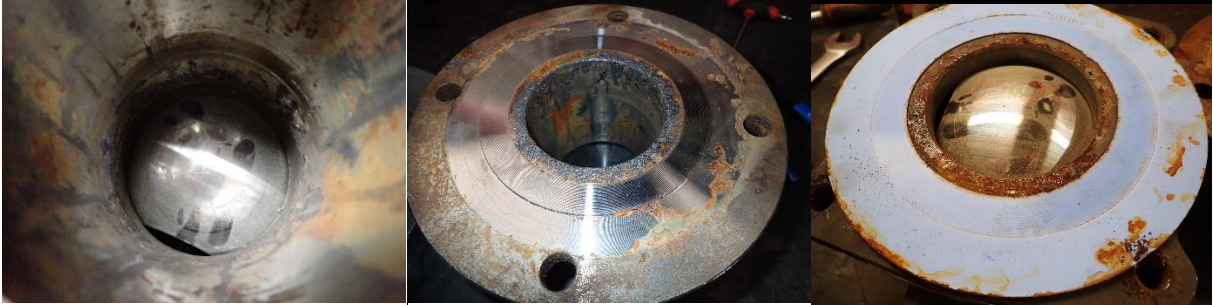
**Ball and gasket were in good condition considering.**

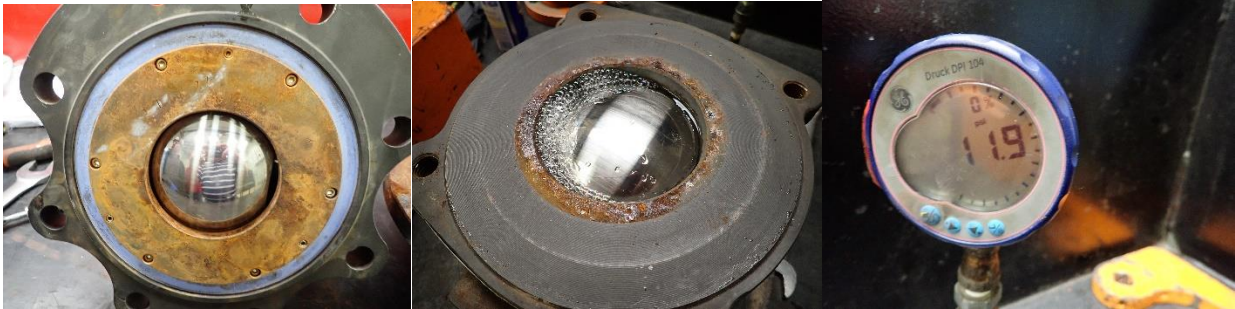
**Gasket to car saddle intact. Valve started leaking at 11.9 psi**

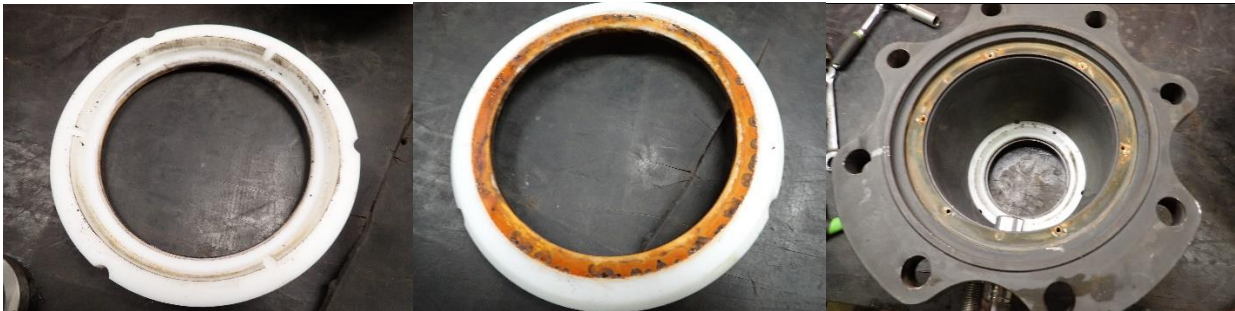
**Seats intact and in original configuration.**

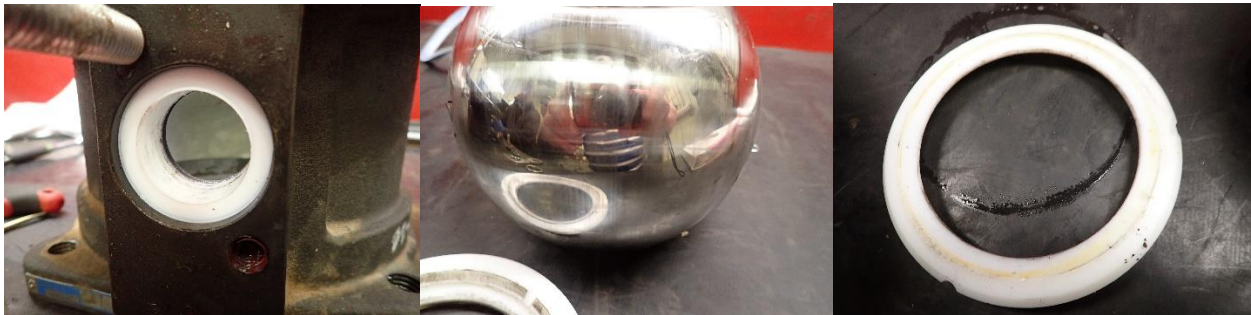
**Stem and seat packing appearance is good.**
