U.S. Department  
of Transportation  
Federal Railroad  
Administration

## Bearing Grease Degradation Related to Water and Roller Bluing

1. AGENCY USE ONLY (Leave blank)		2. REPORT DATE <b>September 2023</b>		3. REPORT TYPE AND DATES COVERED POP: September 2018 – April 2022
4. TITLE AND SUBTITLE Bearing Grease Degradation Related to Water Ingress and Roller Bluing			5. FUNDING NUMBERS DTFR53-11-00008 Task Order 0033

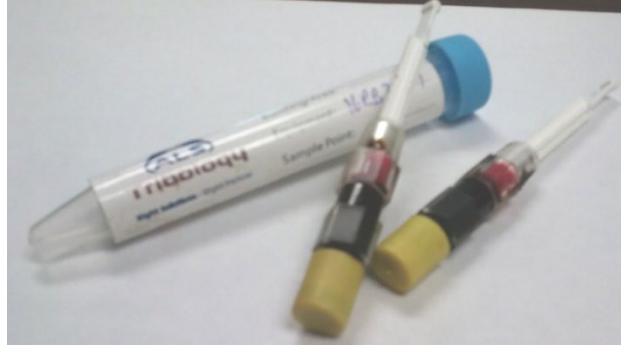
**Figure 1. Collected Grease Thief Samples**

Of the 200 samples collected, 27 were identified with Water-Etch failure mode and 27 were identified with Non-Verified failure mode. These were used to create the two comparison groups. Each sample had 53 data variables from the AAR MD-11 report and the grease analysis. Four different types of greases were identified among these samples. Researchers used Grease Thief<sup>®</sup> sample collection kits to obtain the grease samples, as shown in [Figure 1](#).

The kit allows for complete analysis with a very small sample size of approximately 1 gram. The grease was sampled as the bearings were opened for the first time and the samples were taken from the center of the bearing, near the spacer. As the bearings' failure modes were determined throughout the year, the grease samples were sent to the laboratory for testing.

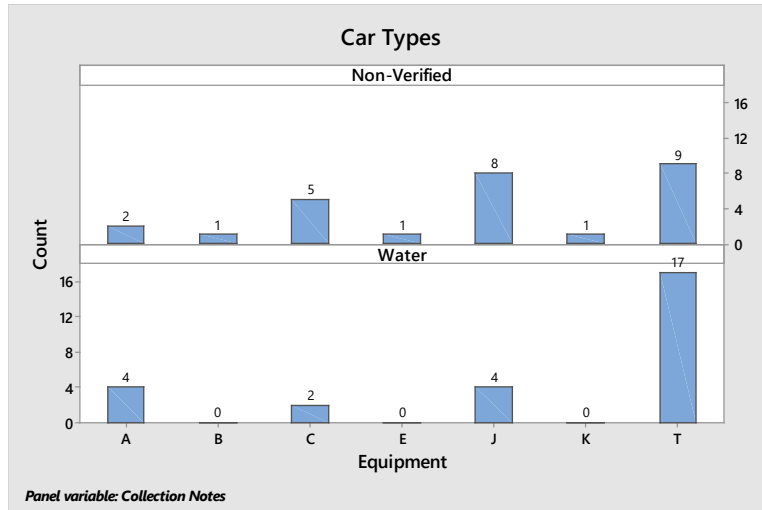
**Figure 2. Chart of Car Types**

Data analysis of the water-related grease degradation began with a breakdown of the attributes of the sample sets. [Figure 2](#) shows that most of the bearings sampled from both sets were Car Type A – Equipped Box Cars, Type C – Covered Hopper Cars, Type J – Rotary Gondala Cars, and Type T – Tank Cars. Most of the Water-Etch set and a plurality of the Non-Verified set came from Tank Cars.

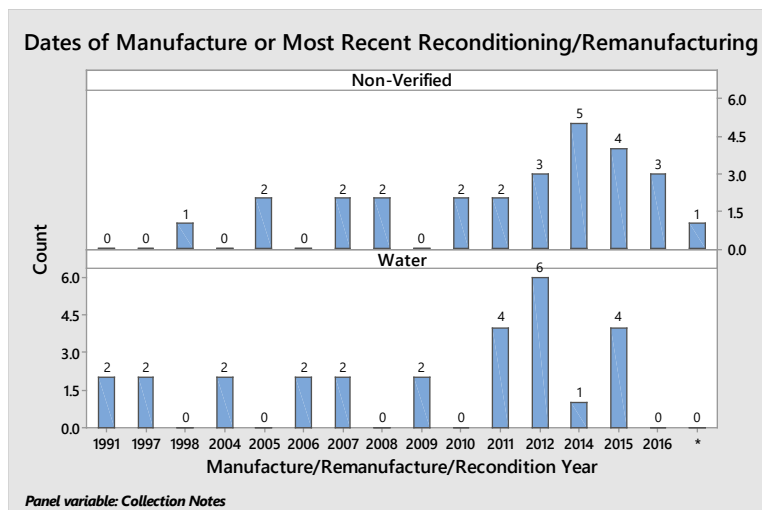
**Figure 3. Chart of Dates of Manufacture**

The number of years since installation for each bearing gave an indication of the service life of the bearing. Most of the bearings sampled in each group were from within the last decade, with some bearings installed as long ago as 1991. The chart in [Figure 3](#) shows the dates of manufacture or most recent reconditioning/remanufacturing.

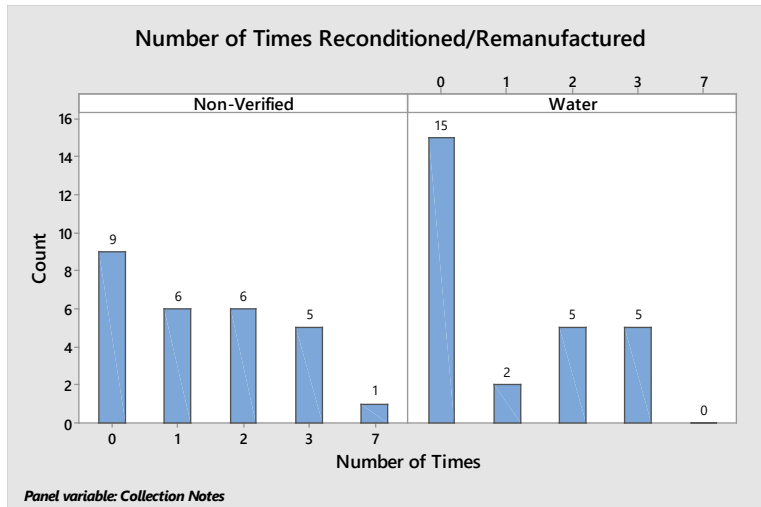
**Figure 4. Chart of Number of Times Reconditioned/Remanufactured**

[Figure 4](#) shows the number of times each bearing sampled had been reconditioned or remanufactured. The majority of Water-Etch bearings and a plurality of Non-Verified bearings were in use for the first time, and had not been reconditioned or remanufactured.

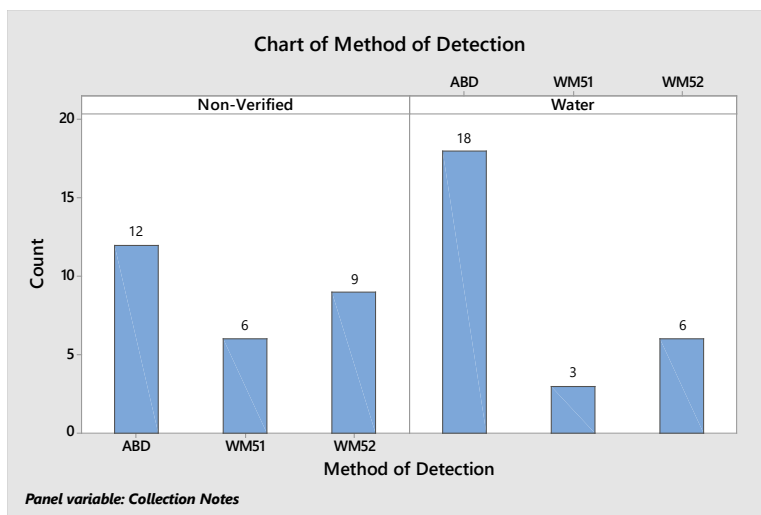
**Figure 5. Chart of Method of Detection**

Researchers also determined the method of detection by which the bearings were removed from service. Figure 5 shows the most common method of removal for Water-Etch defect bearings was from ABD. The Why Made (WM) codes 51 (WM51) and 52 (WM52) are used when the alerting wayside detection device is an HBD [4].

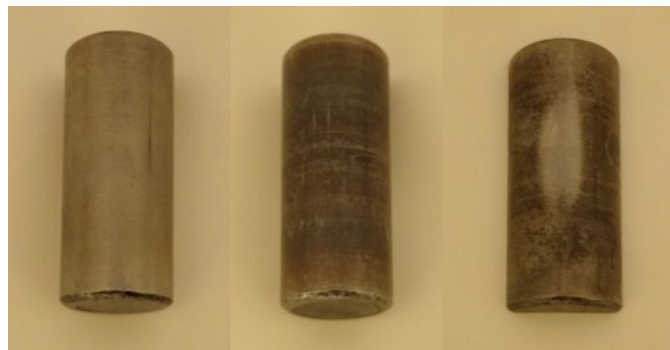
**Figure 8. Control Set Roller, Lube Stain Roller, Rub Test**

The team first identified bearings with lube stain, which was most noticeable on the rollers. When discolored rollers are discovered and there are no other signs of heat, a rub test can be performed. The rub test, an industry standard process, is passed when a 180-grit or finer abrasive cloth can remove the discolorations from the surface [8]. Once the rub test has been confirmed, the bearing is said to contain lube stain. The rub test is completed by a representative from the railroad or a representative from the bearing manufacturer.

The metallurgical samples were collected by the bearing manufacturer, Timken. Forty defect-free rollers were sampled, as well as 20 lube stain rollers. [Figure 8](#) shows the visual differences between the control set and the lube stain set of rollers. Also shown is an example of the rub test that demonstrates how the discoloration is removable from the surface of the bearing.

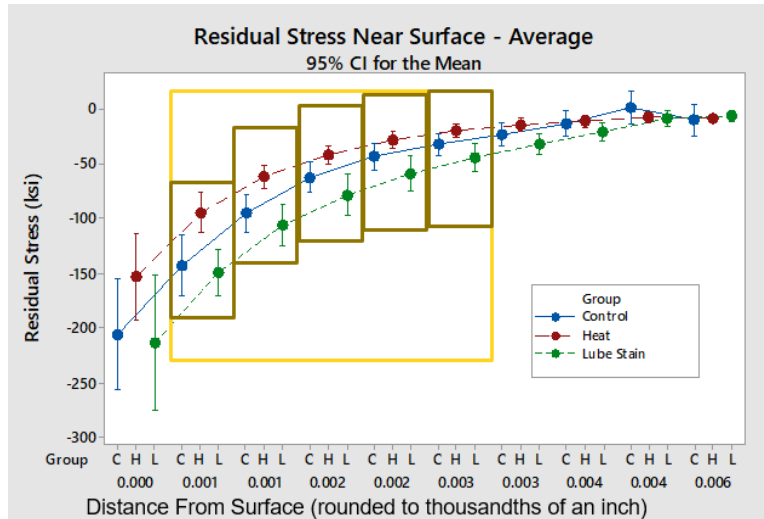
**Figure 10. Near Surface Average Residual Stress**

The residual stress was measured to 2 millimeters in depth across all 60 rollers. Figure 10 shows the average measurements for each set of rollers for the near surface measurements.

The team observed no significant difference between rollers with lube stain and the control set of rollers. There is significantly less compressive stress in the near surface measurements of the heat-blued rollers, probably due to heat relieving stress in the material. Losing compressive residual stress can result in earlier failure of the material in the form of spalling.

The research team observed no metallurgical differences between the lube-stained rollers and the defect-free rollers. Lube stain does not appear to have affected any tested material properties other than surface discoloration. The heat-blued set of rollers lost near-surface compressive stress, but this effect did not occur in the rollers with lube stain.

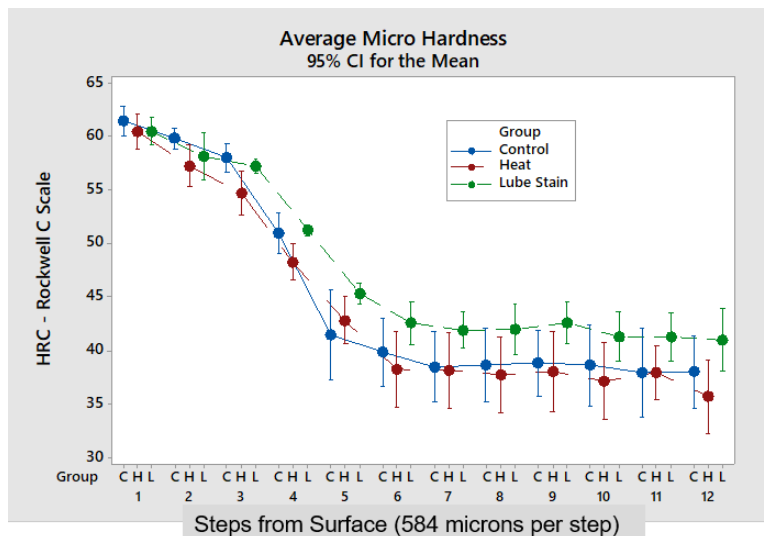
**Figure 11. Average Micro-hardness**

Figure 11 shows the average micro-hardness measurements of the three sample sets from the surface of the roller toward the center.

No practical differences in hardness were found between the sets; any differences in hardness found were less than the variation of the testing machine. The maximum difference between the average near-surface readings was approximately 3 on the Rockwell C Hardness Scale (HRC).
