NTSB/HAR-21/02

# Collision between Sport Utility Vehicle and Medium-Size Bus Transporting Adult Passengers with Disabilities and Special Needs

Belton, South Carolina

December 17, 2019

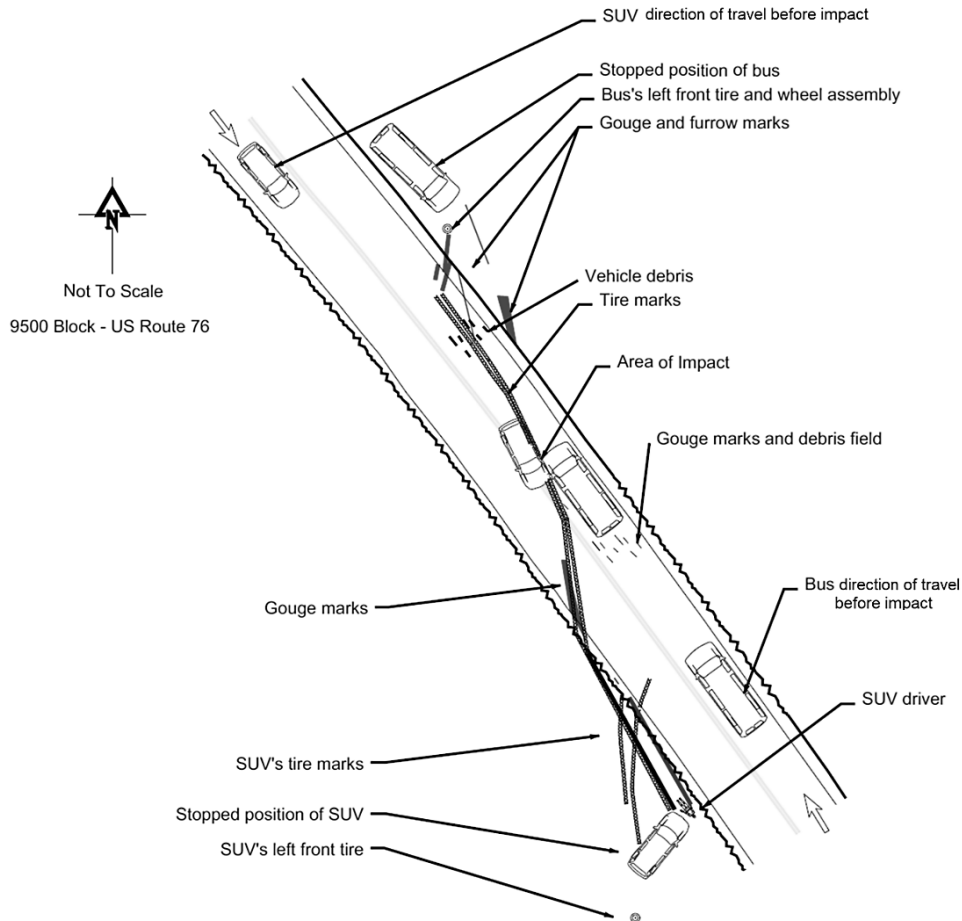
The left front of the SUV struck the front left side of the bus at an angle with maximum intrusion just behind the bus driver's seat and into the passenger compartment. Gouge and tire marks were found in the westbound lane at the crash site (see figure 1). Both the bus and the SUV rotated counterclockwise, with the bus coming to rest off the paved roadway on the side of the westbound lane and the SUV coming to rest off the paved roadway along the eastbound lane.

**Figure 1.** Crash scene diagram. (Source: Original diagram provided by the South Carolina Highway Patrol. Enhanced by the NTSB)

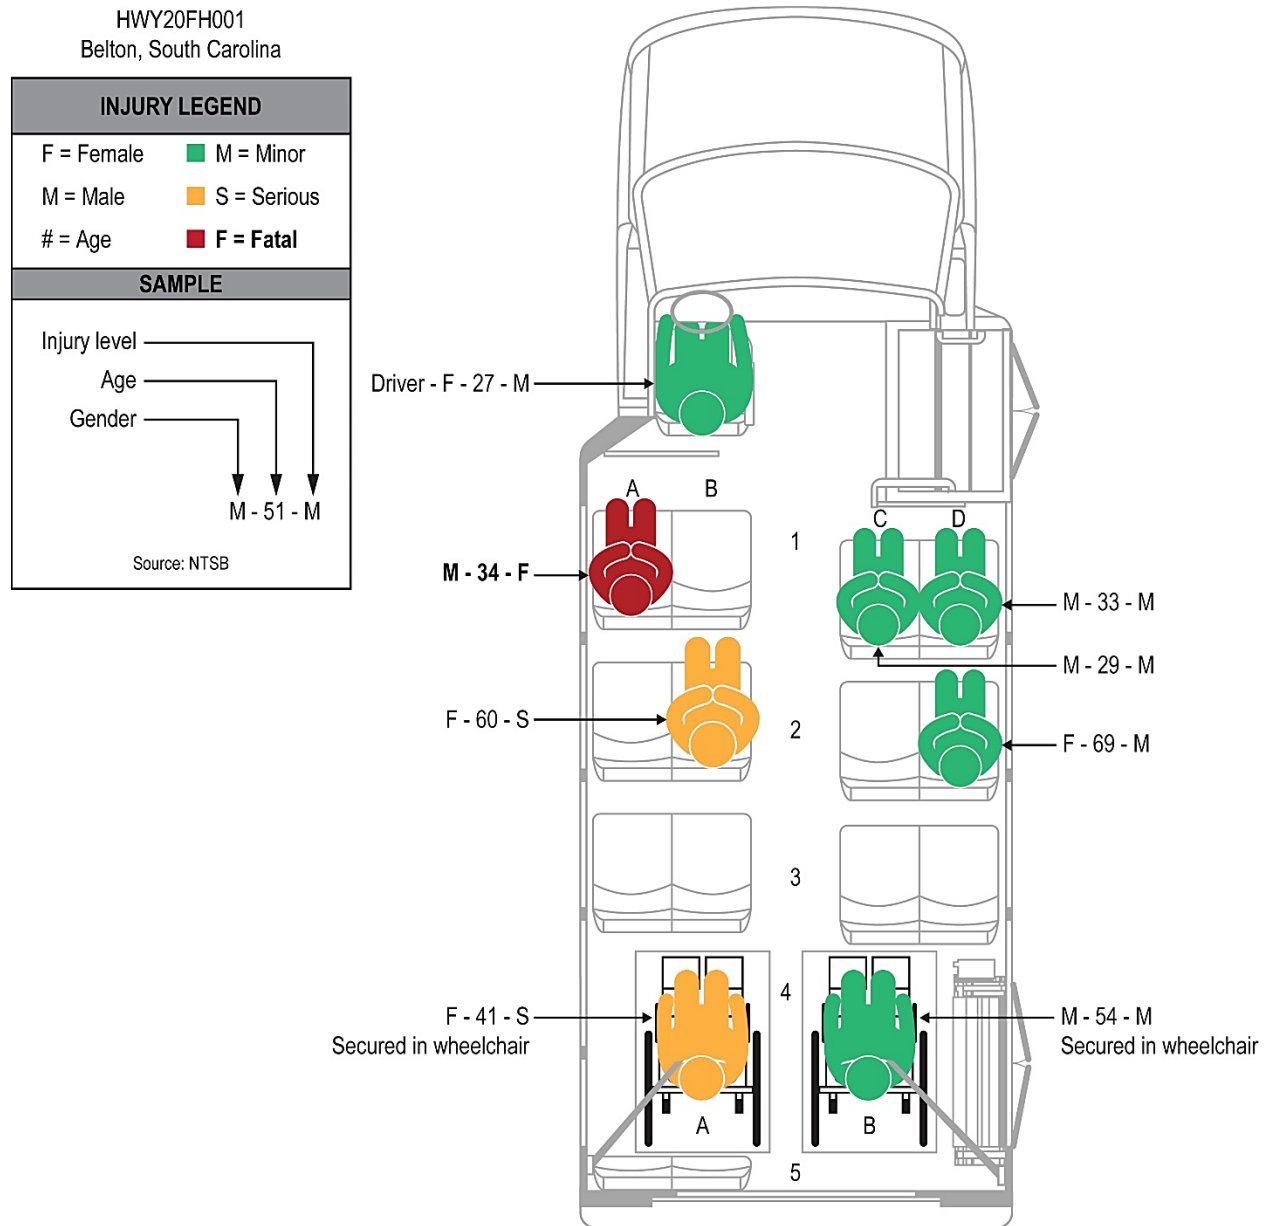
The bus driver sustained minor injuries. The passenger seated behind the bus driver in the window seat was partially ejected and sustained fatal injuries; he was declared deceased on-scene. Another passenger seated on the left (driver) side of the bus was seriously injured, sustaining a fractured left arm, fractured right thumb, and forehead laceration. Three passengers seated on the right (passenger boarding side) side of the bus sustained minor injuries, including bruises, abrasions, and lacerations. The passenger in a wheelchair seated on the left side of the bus was seriously injured, including a fracture to the right leg, cervical and lumbar spinal fractures, and fractures to the right ribs and a pneumothorax. The passenger in a wheelchair seated on the right side of the bus sustained minor injuries, including a laceration to his scalp. Injury information is shown in table 1 and figure 2.

**Figure 2.** Bus seating chart.

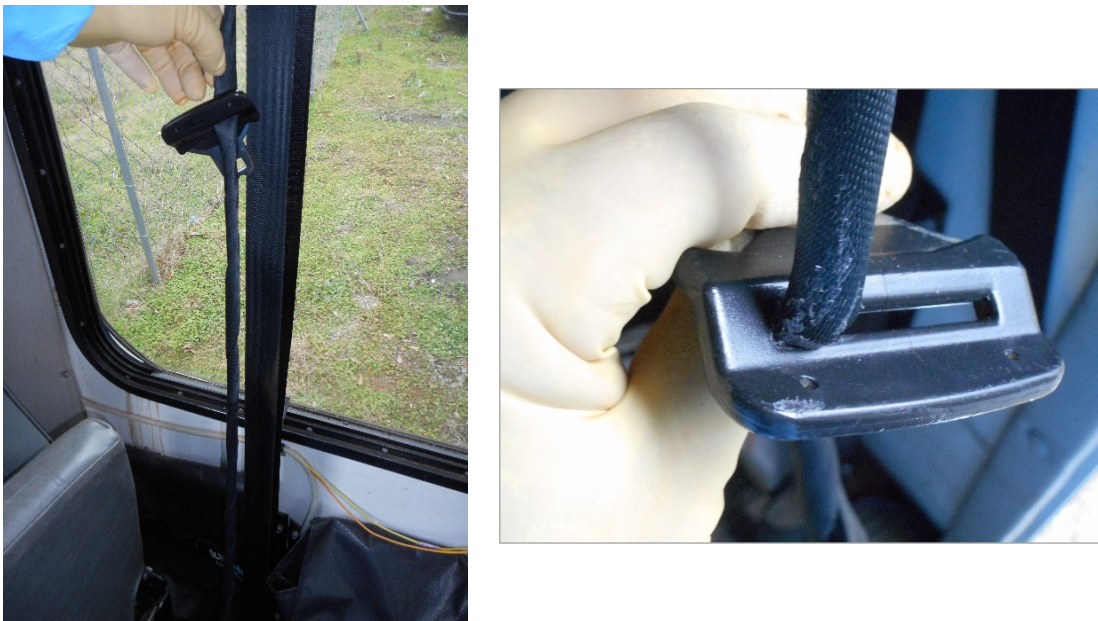
According to a witness, following the crash, the wheelchairs were found strapped to the bus with the occupants strapped to the wheelchairs. The witness said the wheelchairs had flipped forward and their occupants were upside down with the wheelchairs on top of them. The webbing for both of the lap/shoulder belts at the wheelchairs positions was found severely twisted during the postcrash examination of the bus (see figure 3).

**Figure 3.** Lap/shoulder belts used to restrain the wheelchair occupants. Left, the twisted shoulder restraint for the wheelchair occupant on the left side of the bus. Right, close-up view of the shoulder restraint for the wheelchair occupant on the right side of the bus.

Although the wheelchairs had been secured to the bus with ADA-compliant securement systems, witnesses at the crash scene indicated that both wheelchairs and their occupants were found flipped forward. The wheelchairs and their occupants were restrained. Postcrash examination revealed improper anchoring of the wheelchair front and rear securement straps/retractors for both wheelchairs. Further, the occupant lap/shoulder belts for both wheelchair positions were found severely twisted, reducing the belts' ability to perform properly in a crash.

Manufacturers of the wheelchair restraint systems highlight in their instruction and training that any twisted or damaged wheelchair occupant restraints or wheelchair securement straps can compromise the entire securement system. The NTSB concludes that improper positioning of the wheelchair securement straps and the twisting of the webbing on the lap/shoulder belts used by the wheelchair occupants increased their risk of injury.

11. Improper positioning of the wheelchair securement straps and the twisting of the webbing on the lap/shoulder belts used by the wheelchair occupants increased their risk of injury.

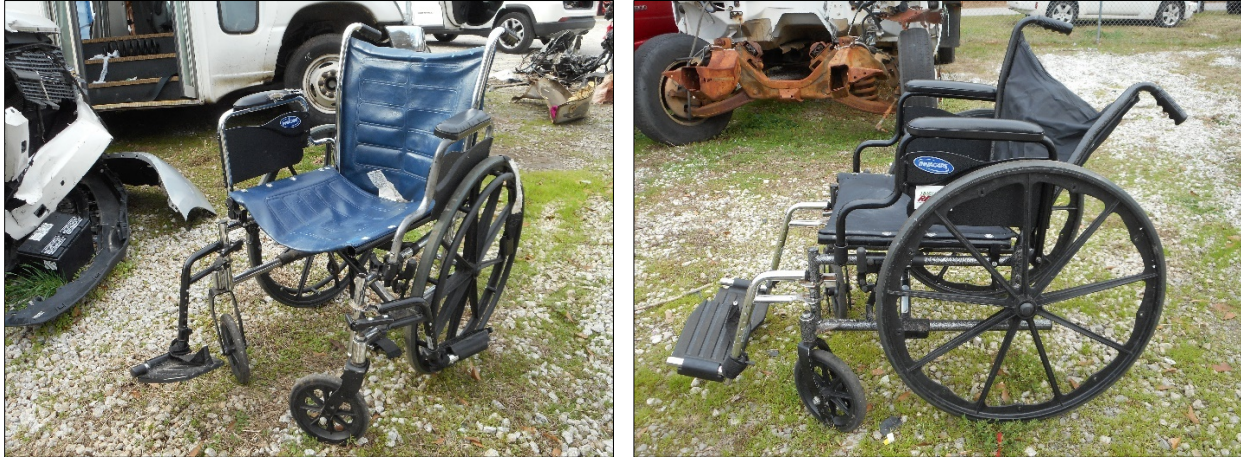
Both wheelchairs sustained crash damage and displayed visible signs of loading. The wheelchair that had been secured on the left side of the bus sustained damage to the left side of the seat frame. The weld at the vertical frame member and the horizontal frame member was separated. The hinge plates of the footrest were found partially unhinged. The left-hand pusher of the wheelchair secured on the right side was bent aft almost 45° (see figure 4).

**Figure 4.** Wheelchairs damaged in the collision. Left, the wheelchair that was positioned on the bus's left side. Right, the wheelchair positioned on the bus's right side.

During the postcrash examination of the bus, the NTSB placed the wheelchairs back on the bus to approximate the layout of the WTORS. The examination of the bus's WTORS showed that the wheelchair positioned on the left side of the bus likely had one strap/retractor anchored inside one of the rear wheels, with the other rear strap/retractor anchored on the outside of the other wheel. The front strap/retractors were likely anchored improperly, with one front tie-down strap anchored outside the left front wheel and the other front tie-down strap anchored between the two front wheels. The rear retractors/straps for the wheelchair on the right side of the bus were anchored about 10 inches apart and were close to being centered between the wheels. As for the front tie-down straps, one would likely have been anchored between the wheelchair wheels and the other outside the other wheel. As previously mentioned, the lap/shoulder portions of the occupant restraint system were found severely twisted. The track on the floor of the bus that anchors the securement system was filled with debris and dirt.

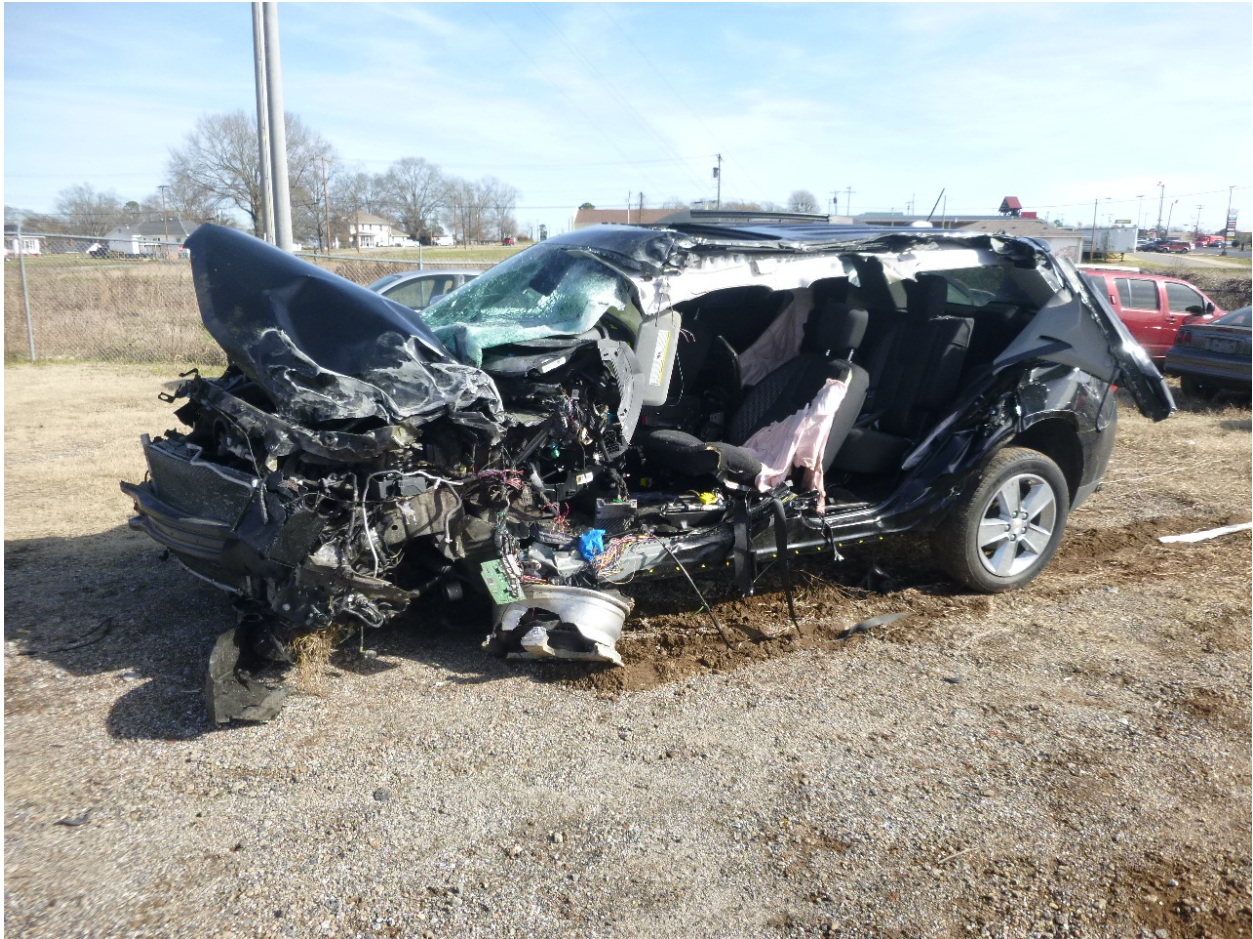
The SUV sustained significant contact damage to the left front axle area and the entire left side (see figure 5). The front left fender, driver door, and rear left passenger door (including the roof siderail, the A, B, and C pillars, and windows) were torn off during the collision event. The damage to the driver door destroyed the left side curtain airbags. The hood was pushed rearward, and the windshield was destroyed by impact forces. The vehicle's retractable sunroof was found in the open position (see figure 6). Investigators found no damage to the right front and rear passenger doors, nor to the right side and rear windows.

**Figure 5.** Crash-damaged SUV.

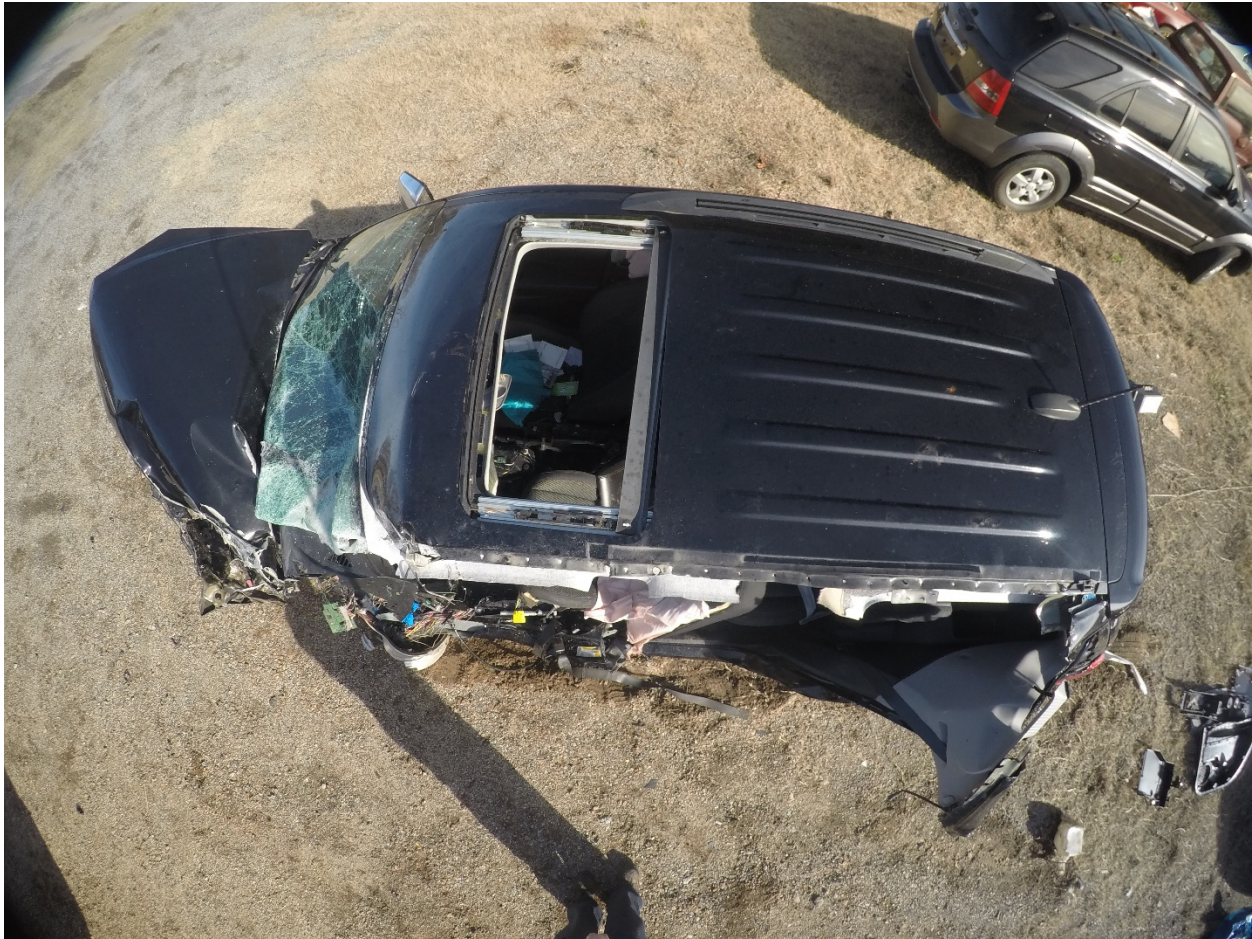
**Figure 6.** Top view of damaged SUV with open sunroof.

<sup>17</sup> The NTSB noted that the sunroof of the SUV was open at the time of the crash. It was not determined if wind noise from the open sunroof would have interfered with voice commands.

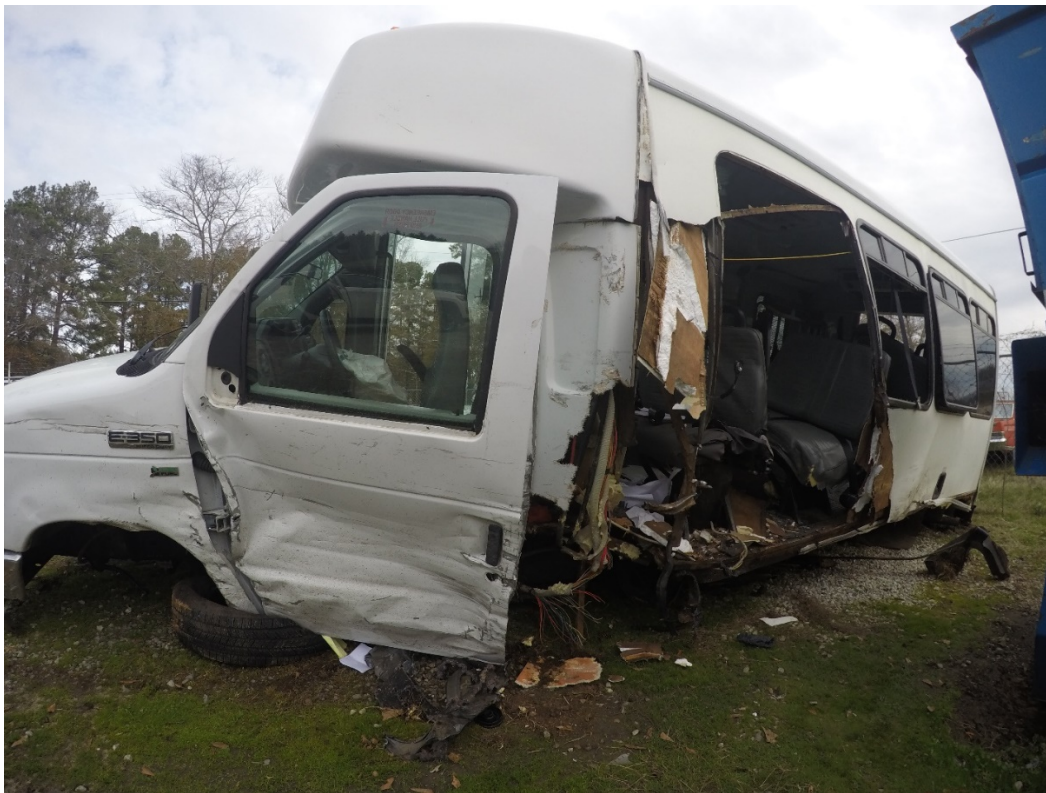
The bus sustained contact damage to the left side, including damage to the steering, brake, and electrical systems. The initial point of contact was in the area of the left front fender and wheel. The contact damage continued down the left fender and driver's door. Intrusion into the rear passenger compartment occurred directly behind the driver seat at the B-pillar extending to the forward edge of the second window (see figure 7). The window frames and glazing on the left side of the bus at the first and second rows of passenger seating were missing, exposing both rows of passenger seating. Damage to the left side of the bus ended just before the rear bumper.

**Figure 7.** Wide-angle-lens photo of the crash-involved bus, with damage visible to the left side beginning at the front wheel.

Due to the collision, the left front axle assembly fractured and the left rear axle, including the rear dual wheel, detached from the rear-end housing. The collision damage precluded functional checks to the steering, brake, and electrical systems, but there was no indication of any malfunction leading up to the crash.

When the SUV left its lane and collided with the left side of the bus in an angular, sideswipe motion, it resulted in the loss of two left-side bus body sidewall panels, exposing a 5-foot by 6-foot opening with as much as 11 inches of intrusion into the first two passenger rows. The bus was traveling at a recorded speed of 45 mph at impact, resulting in a closing speed with the 75-mph SUV of 120 mph. In a side-impact crash, near-side occupant injuries are often caused by a reduction of occupant space, direct contact with the struck portion of the vehicle, and inertial movement by the passenger (Arndt and Grzebieta 2003, Rouhana and Foster 1985, Howard et al. 2004, Acierno et al. 2004). The passenger seated in the left window seat of the first row was exposed to the loss of sidewall integrity and suffered injuries from either contact with the SUV or contact with sections of the sidewall that were damaged during the intrusion. Therefore, the NTSB concludes that the SUV struck the medium-size bus at a speed of about 75 mph, causing catastrophic intrusion damage and compromising the survival space of the bus passenger seated in the primary impact and intrusion path of the SUV.

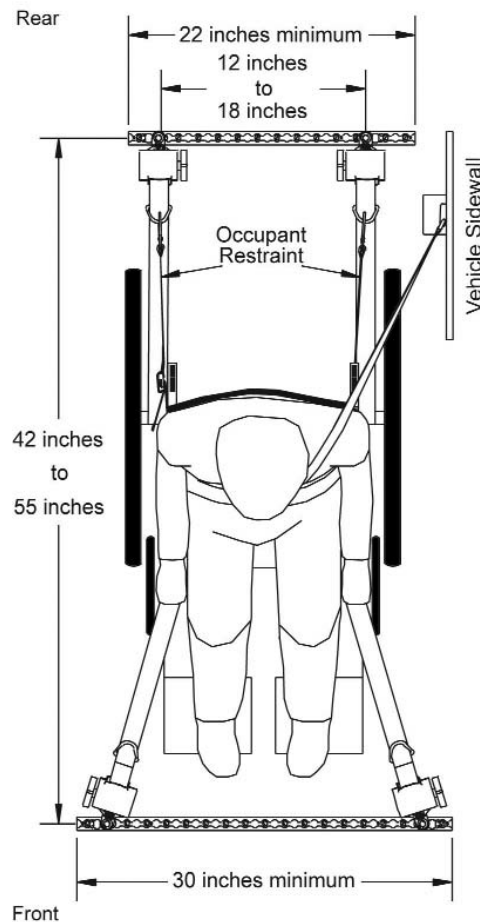
The wheelchair tie-down system and the occupant restraint system work in conjunction to protect the wheelchair passenger during vehicle operation, such as sharp turns or hard braking, and in the event of a crash. Misuse and improper positioning of the wheelchair securement systems and the lap/shoulder belts places wheelchair passengers at higher risk of injury in a crash (NHTSA 1997).

**Figure 8.** Illustrations showing proper positioning of WTORS with straps at all four corners of the wheelchair and a lap/shoulder belt for the occupant restraint (Source: Sure-Lok)
