Investigative Photographs

**Boise, Idaho
HWY18FH015**

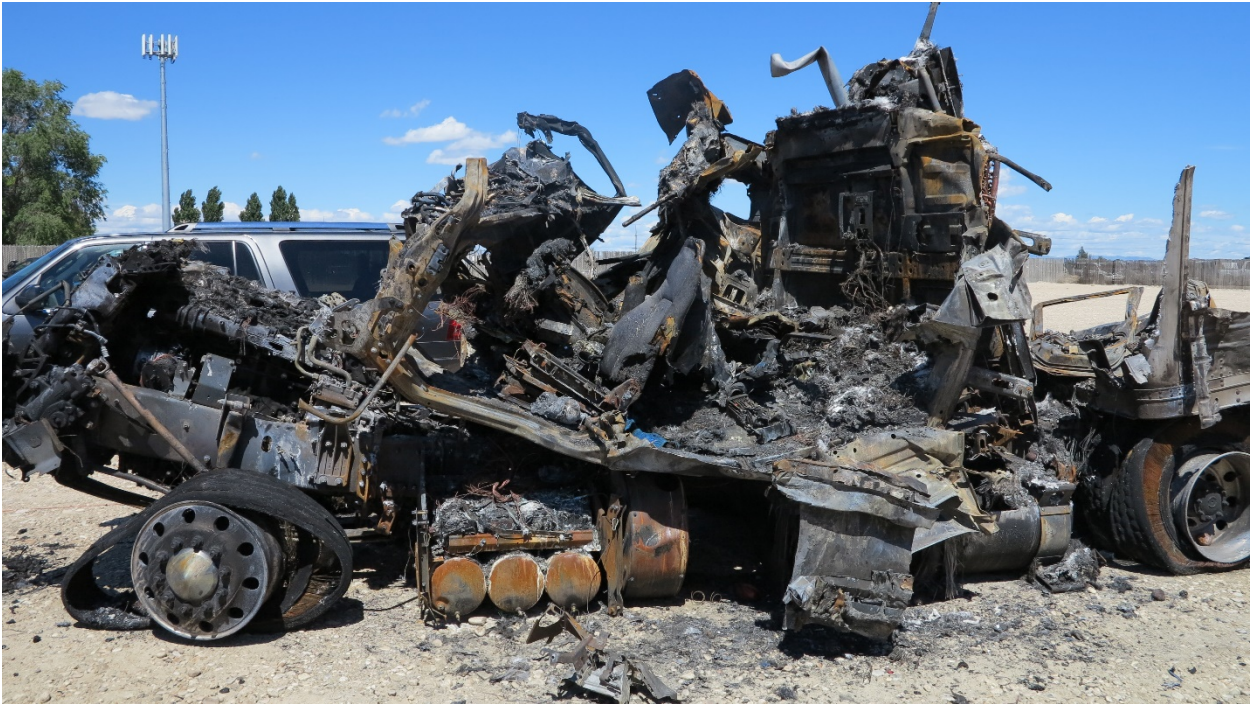
Photograph 2. The right front of the 2019 Volvo truck tractor
