Highway Factors Photographs

Boise, Idaho

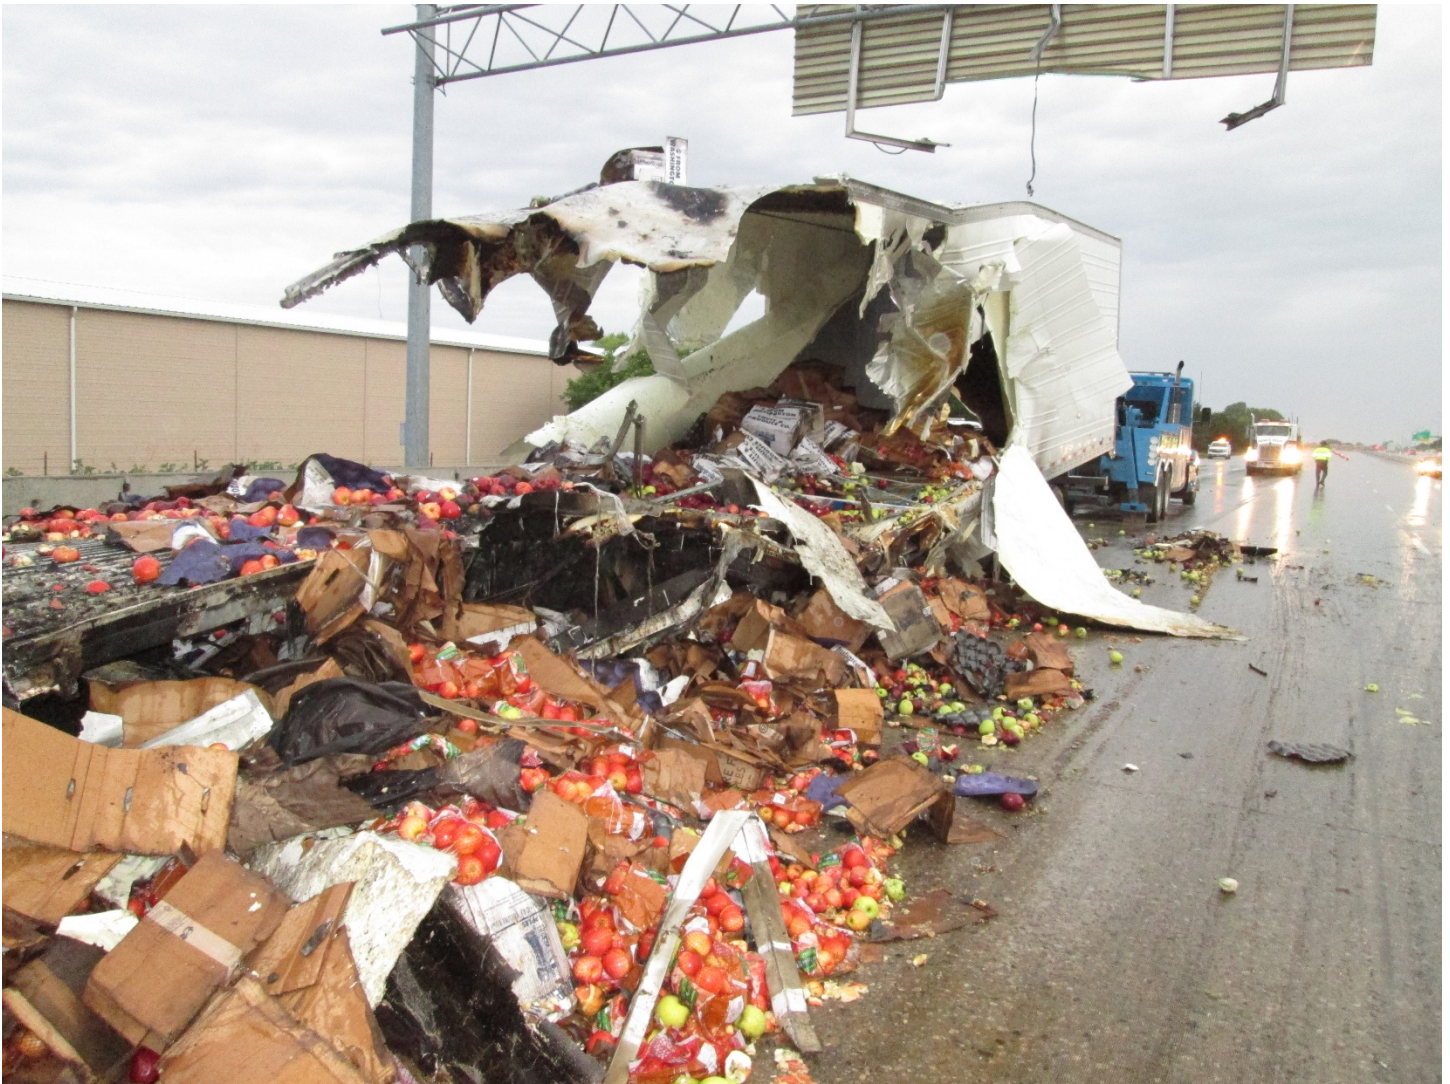
Highway Photo 3 – Additional view of cargo spilled in the impact lane with a view of the damage to the striking semi-trailer.

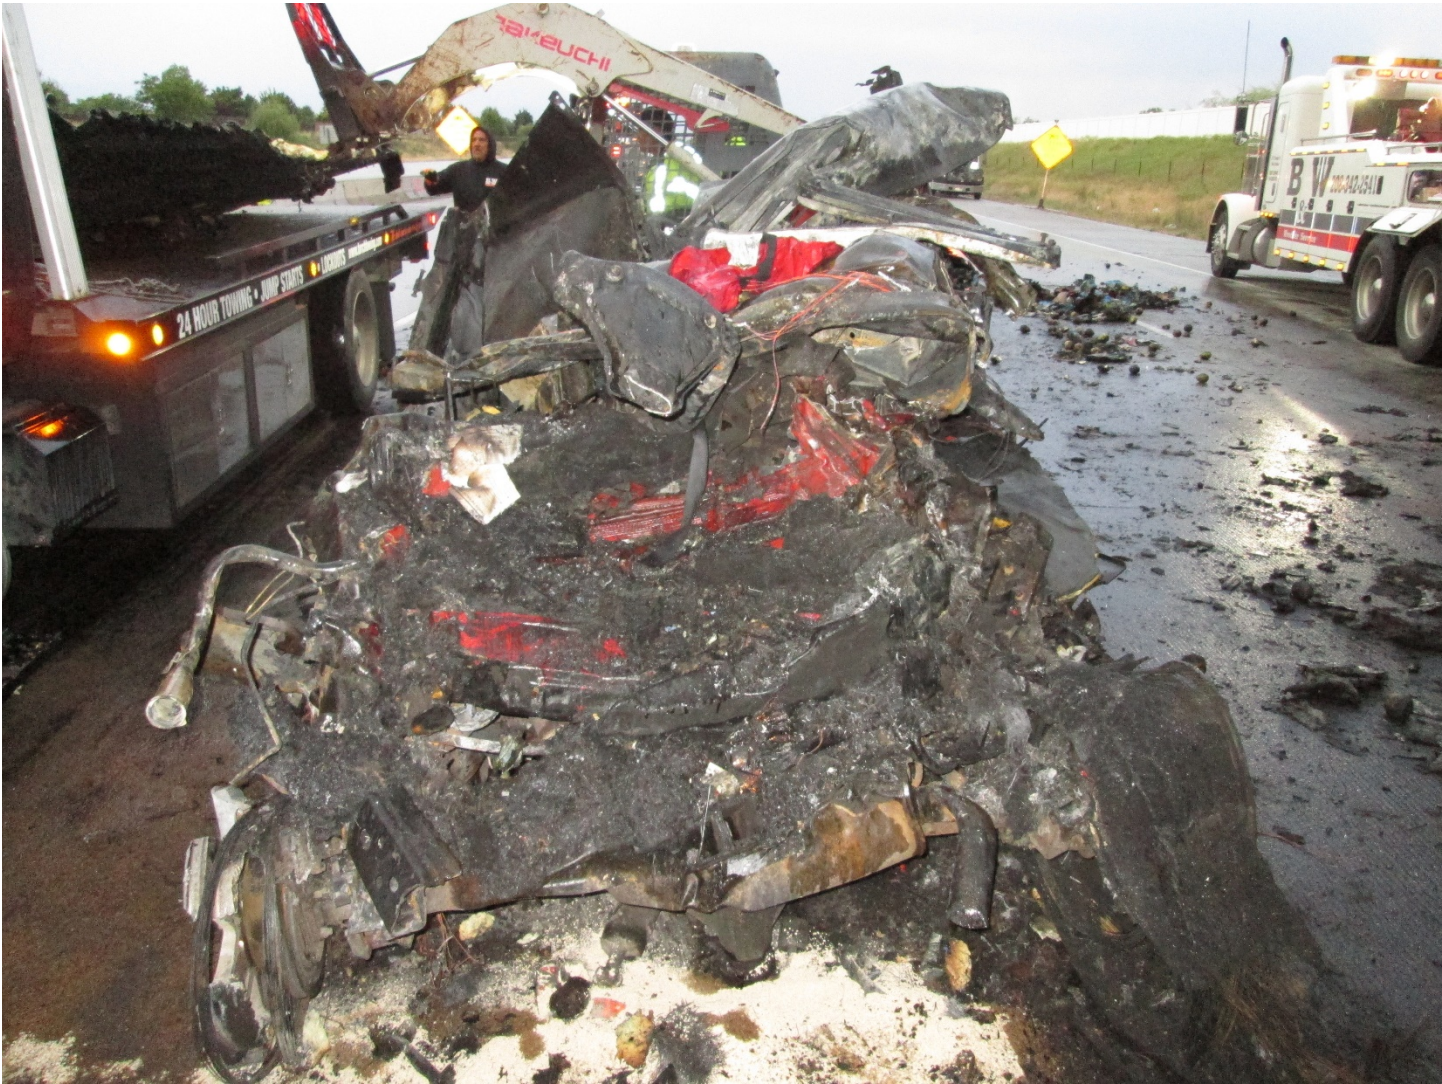
Highway Photo 4 – View of extensive crushing damage to the red Jeep Wrangler

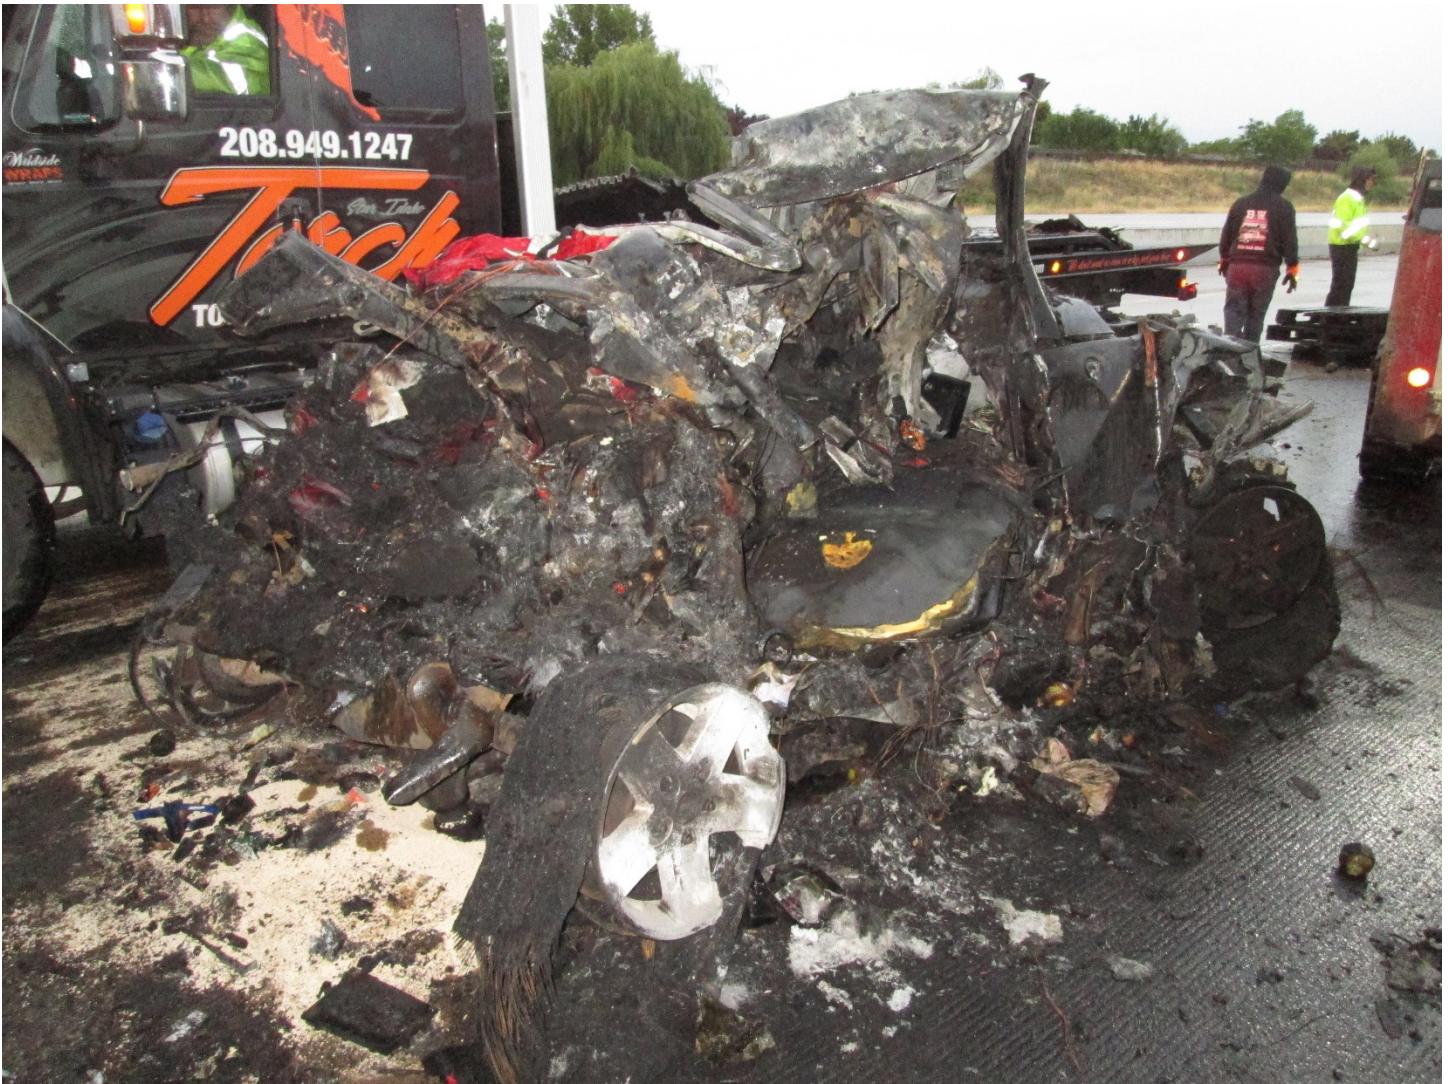
Highway Photo 5 – Right side view showing the extensive rear and front crushing damage to the Jeep.

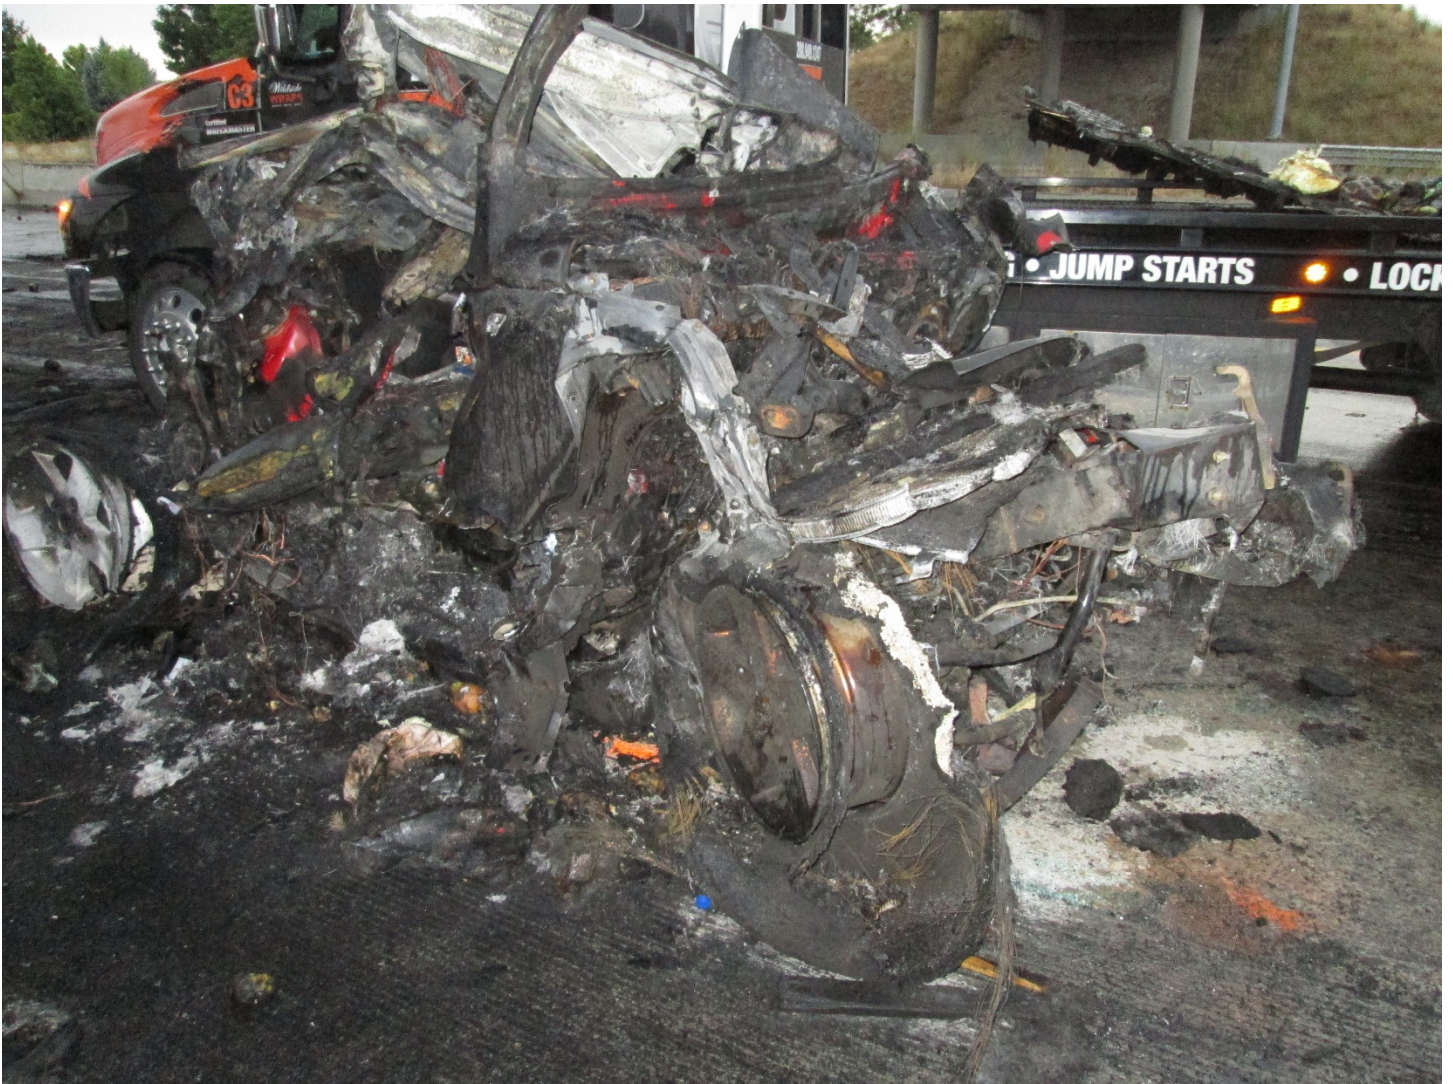
Highway Photo 6 – Closer view of the frontal damage to the Jeep

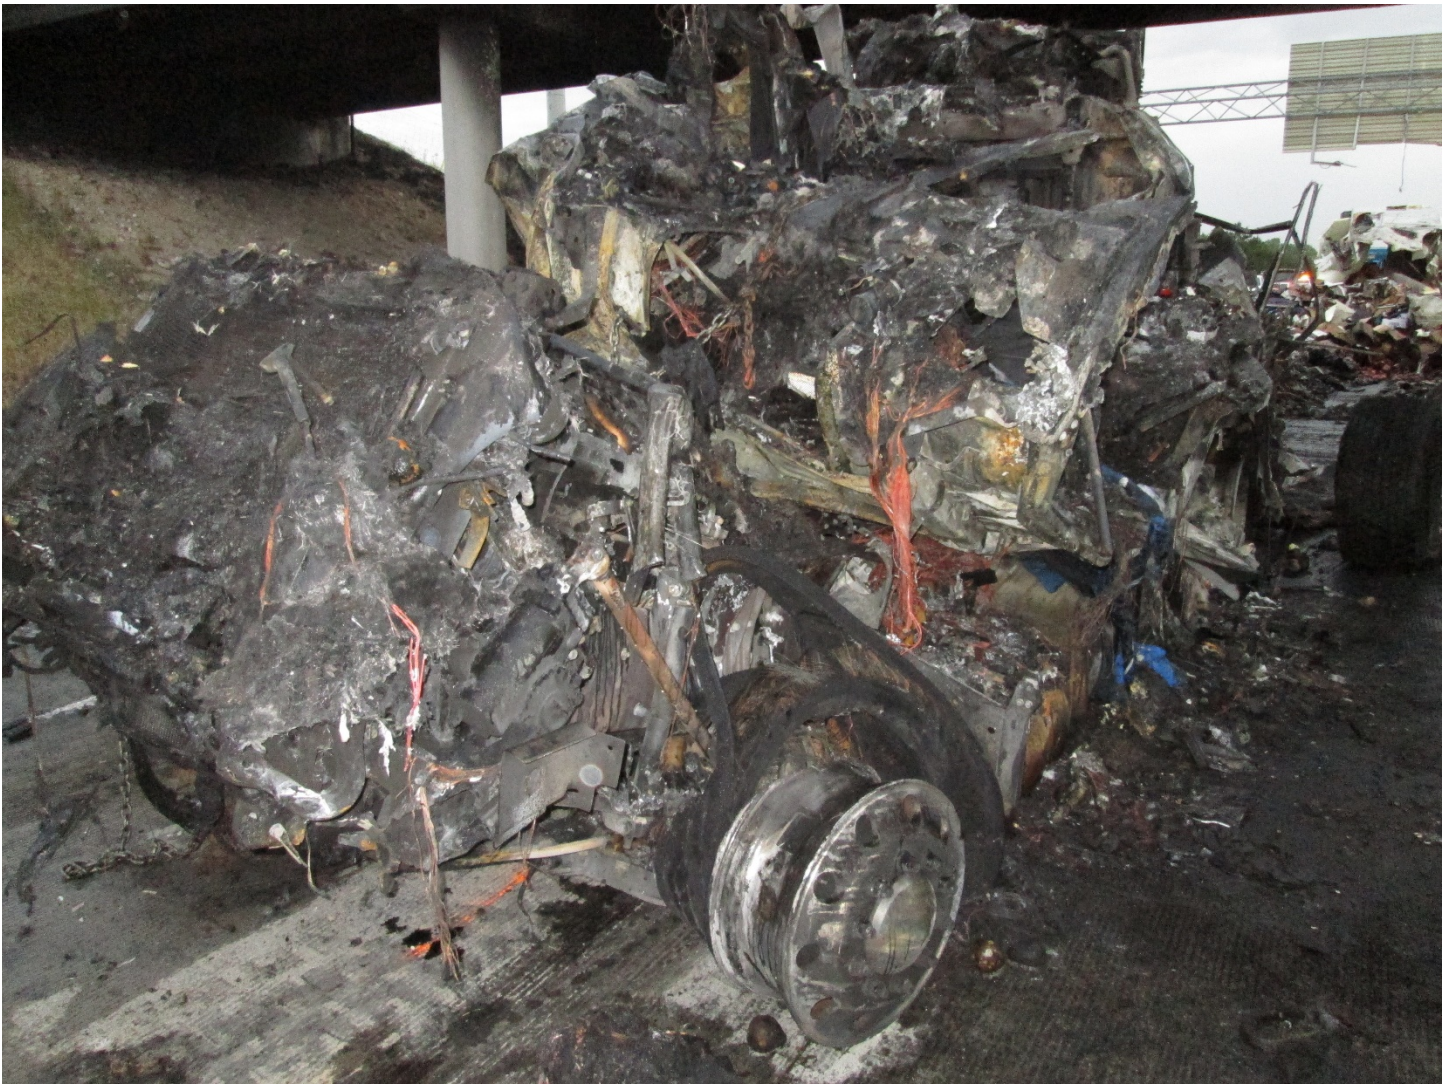
Highway Photo 7 – View of extensive frontal crush to the 2019 Volvo truck tractor

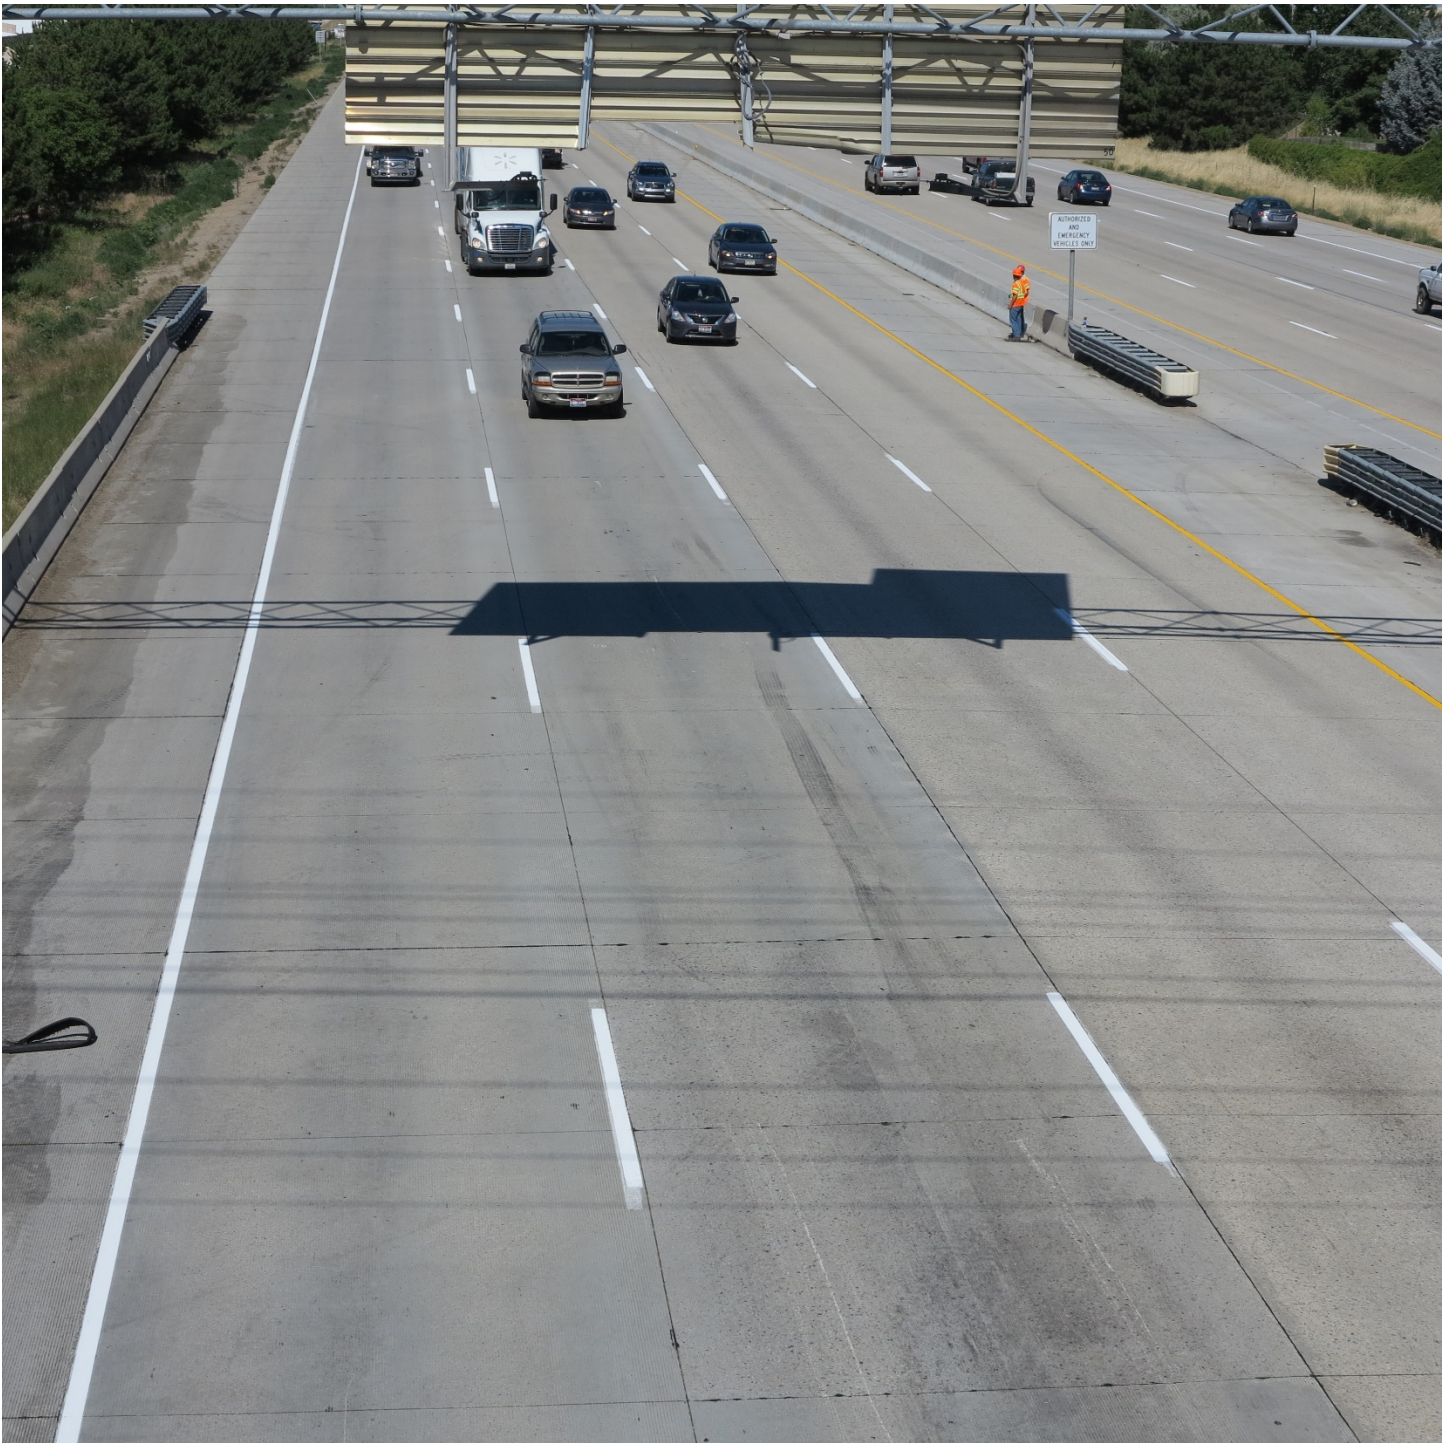
Highway Photo 9 – View of tire friction marks and scrape marks in the number 2 lane. Also note the damage to the bottom of the overhead sign. Photos were taken from the Cloverdale Road overpass.

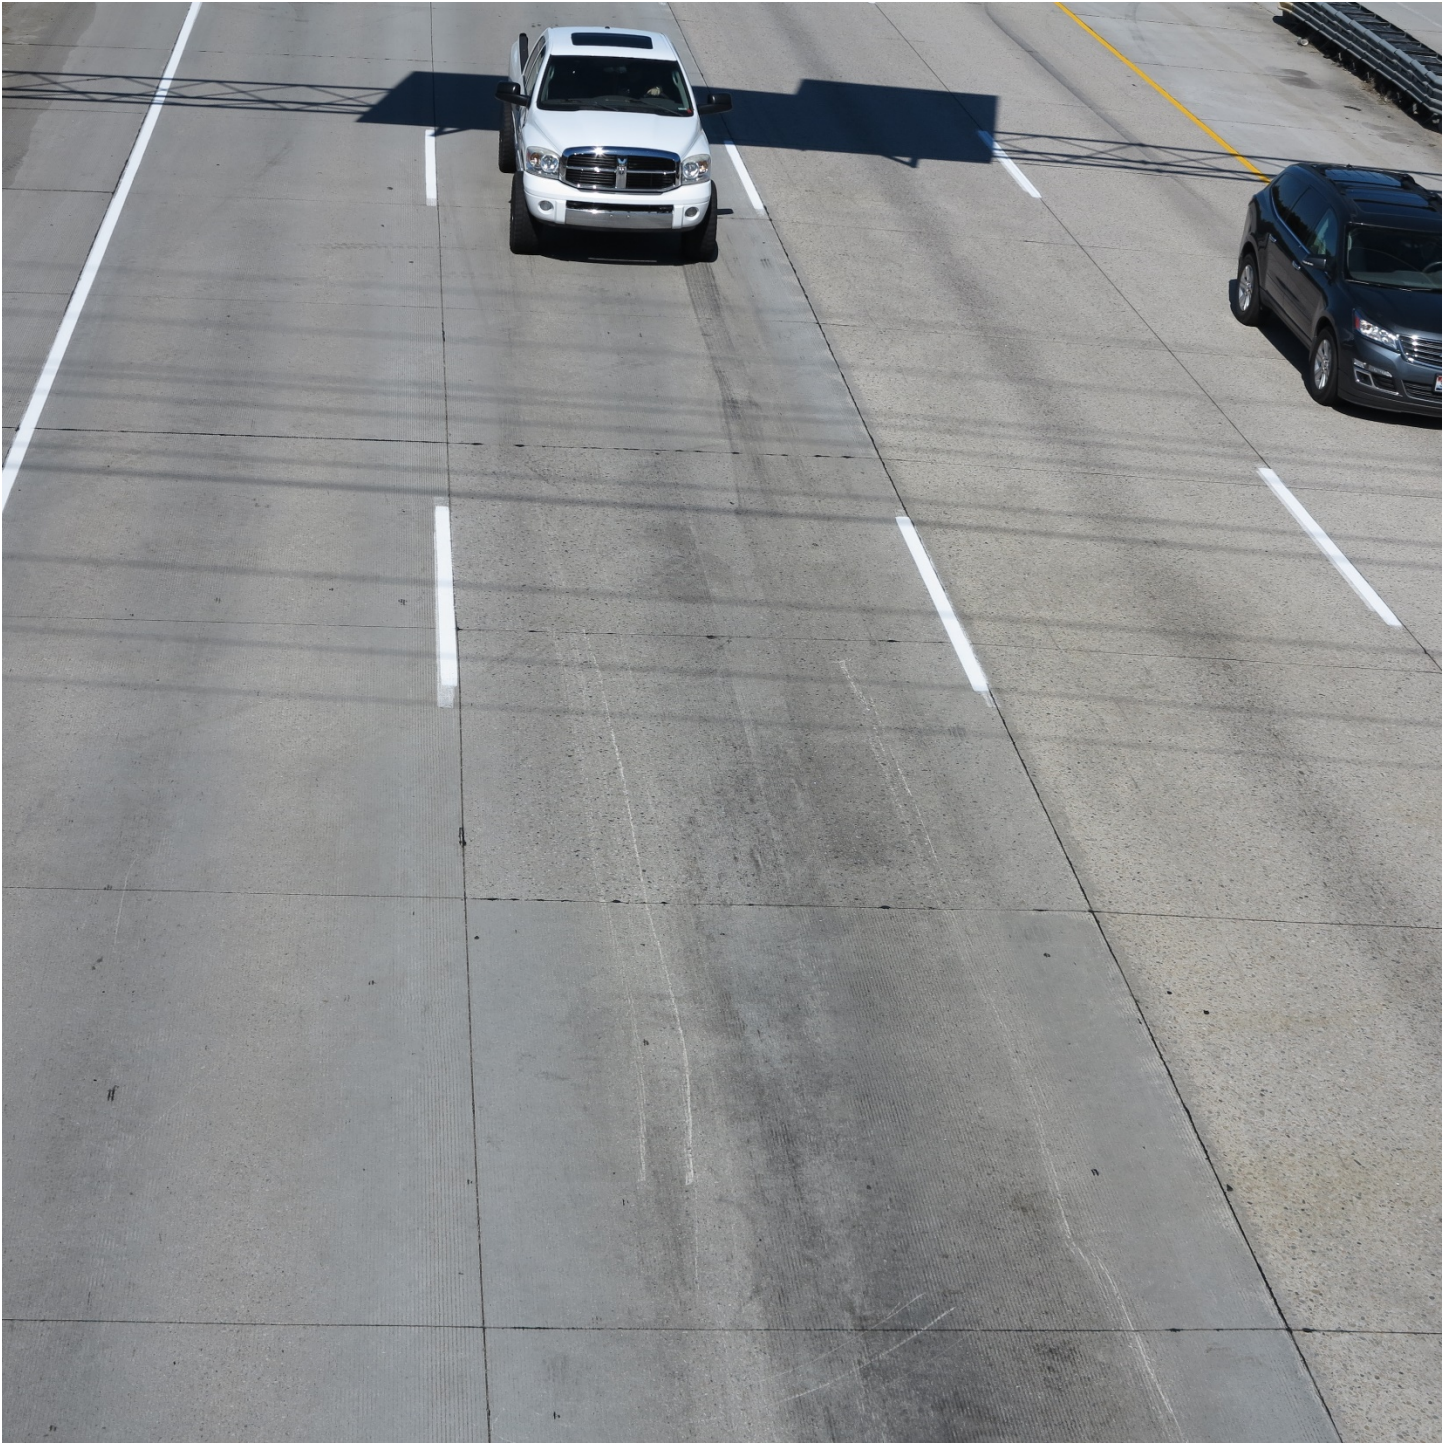
Highway Photo 10 – Additional view of tire marks and scrapes in the impact lane.

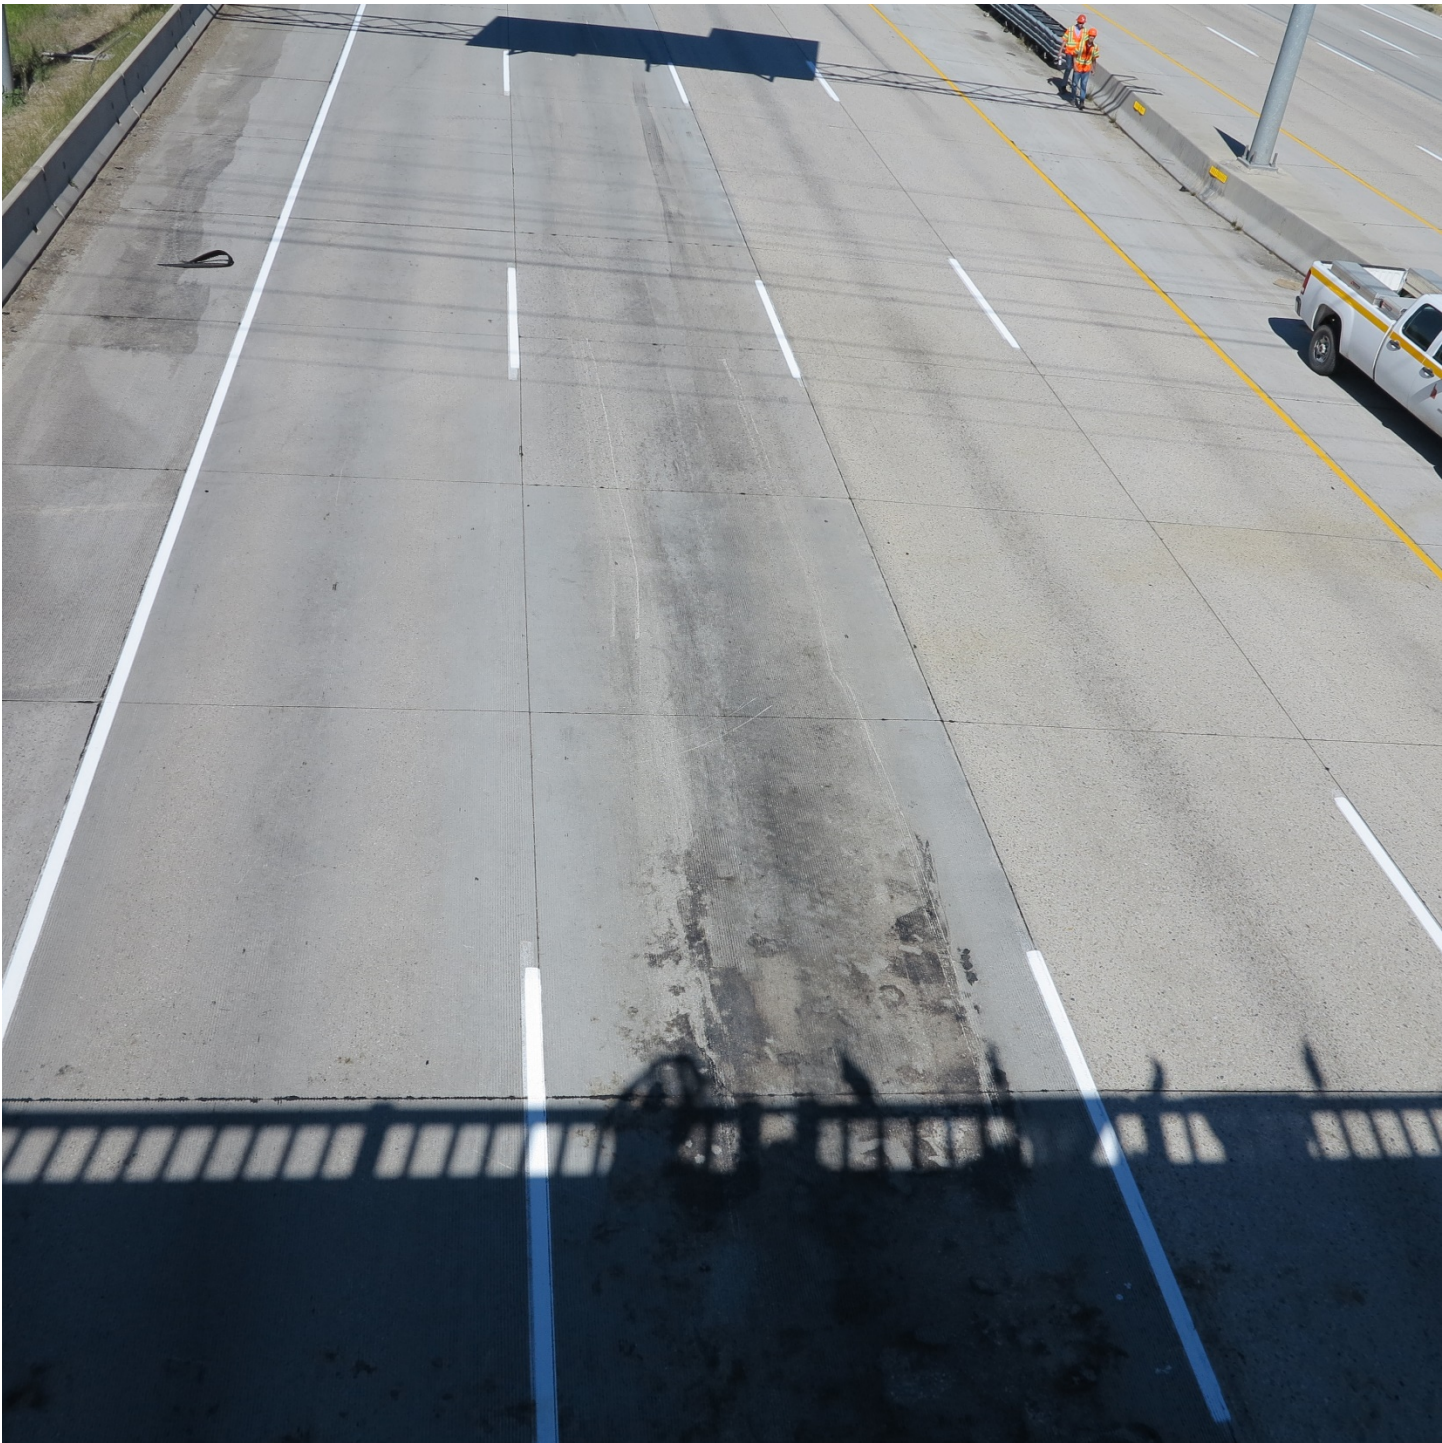
Highway Photo 11 – View of tire marks and pavement scrapes leading to a burned area on the concrete impact lane.

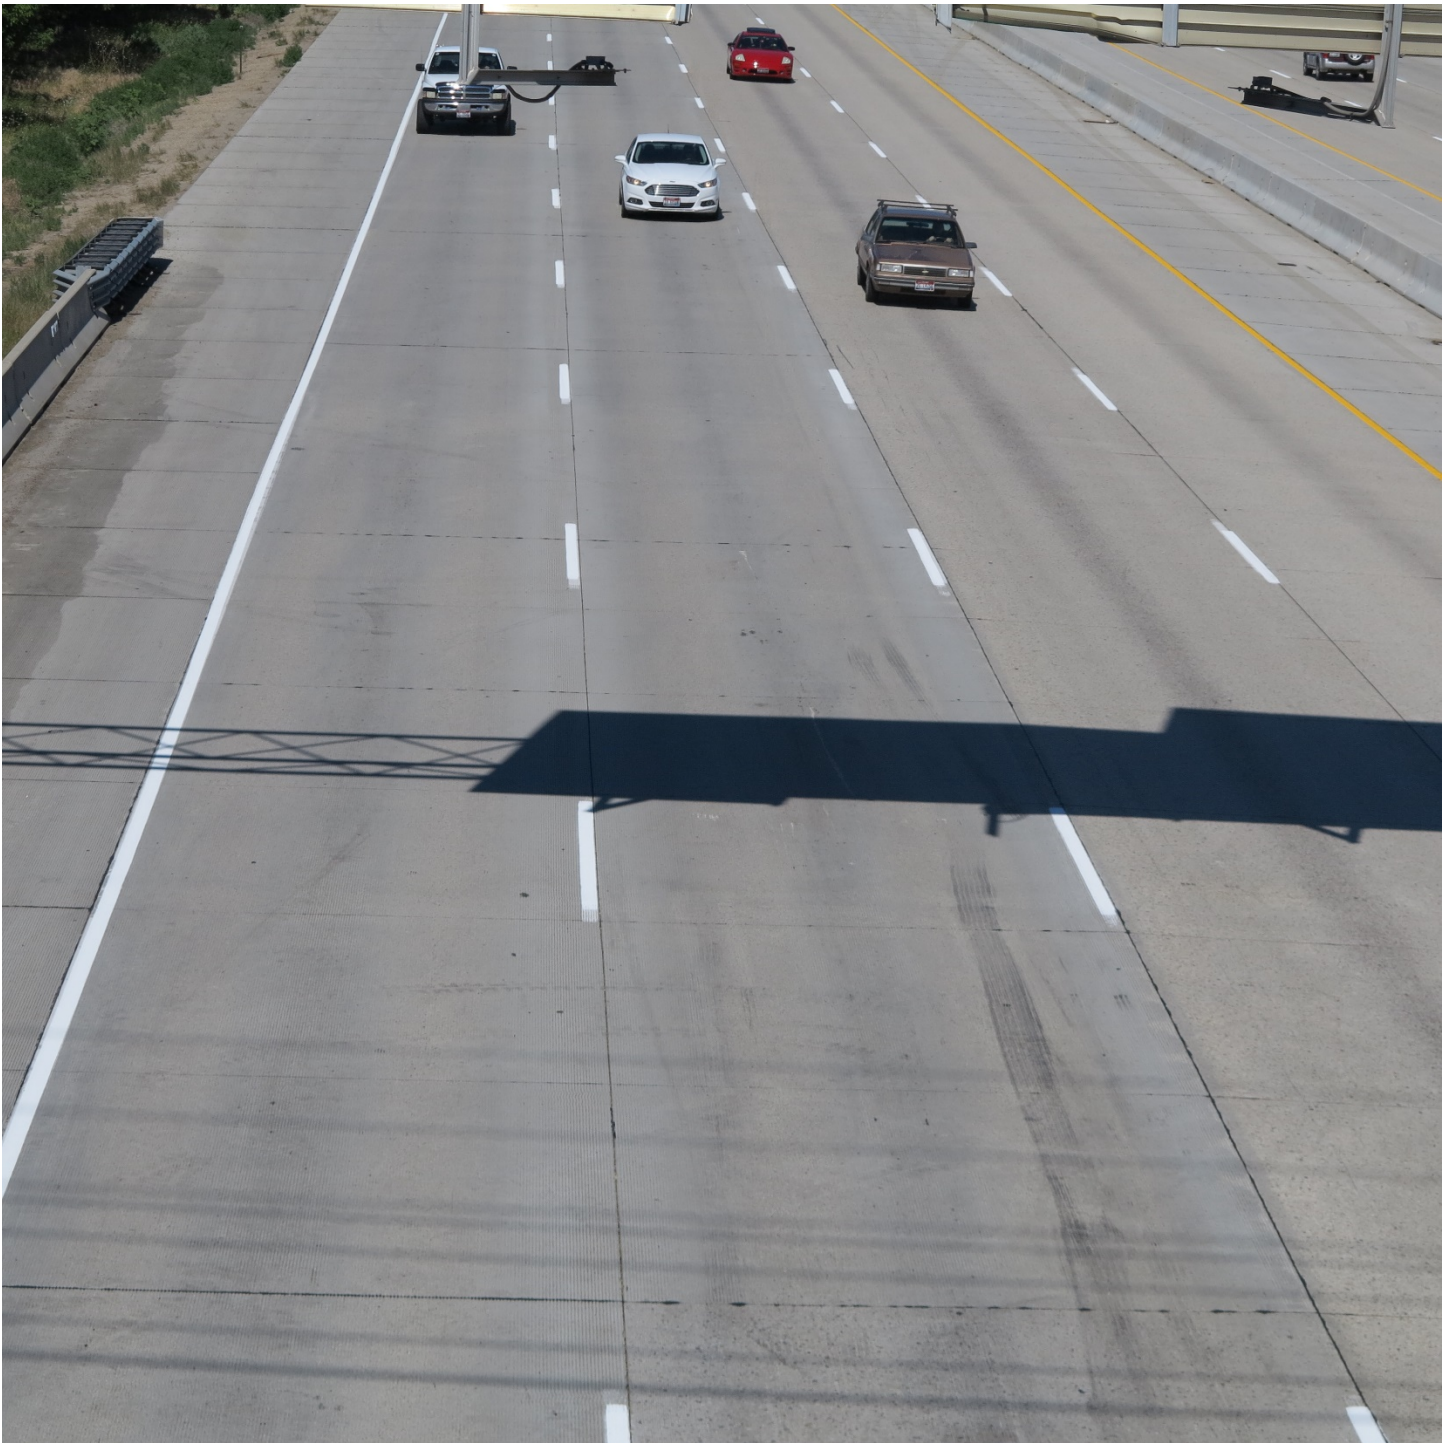
Highway Photo 12 – Additional view looking west in the I-84 eastbound lanes from the Cloverdale overpass. Tire marks and scrapes begin west of the shadow on the pavement formed by the sunlight on the overhead highway sign.
