**Motor Carrier Factors
Group Chairman's
Factual Report
Boise, Idaho**

HWY18FH015
(21 pages)

**MOTOR CARRIER FACTORS GROUP CHAIRMAN'S
FACTUAL REPORT**

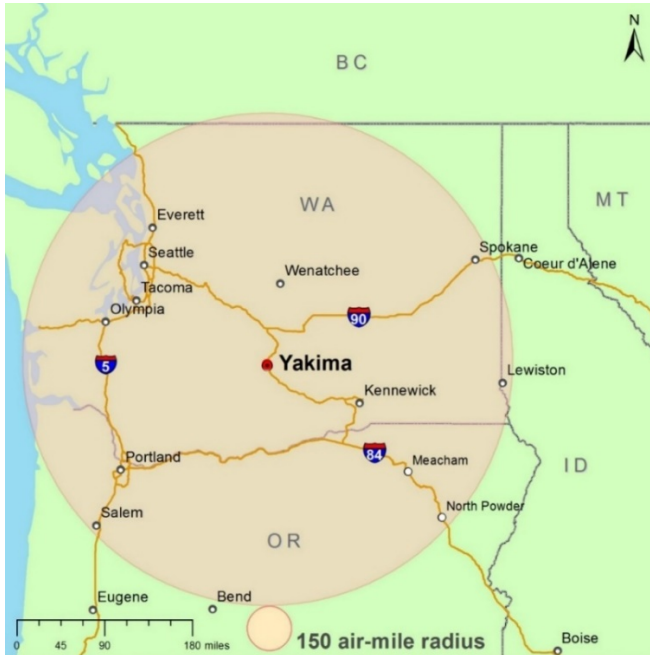
Figure 1 150 Air-Mile radius from Yakima, Washington

Krujex was transporting a load of apples from Yakima, Washington to Methuen, Massachusetts. Apples are classified as an agricultural commodity¹⁶. By hauling an agricultural commodity, Krujex and its driver were allowed the 150 air-mile exemption¹⁷ to the hours of service requirements described above. Basically, the driver was able to drive from Portland, Oregon to Yakima, Washington, load his vehicle and driver 150 air-miles from Yakima east without having to log his hours. **Figure 1** depicts the area covered by the 150 air-mile exemption. While operating within the 150 air-mile radius, time that would normally be recorded as on-duty or driving it is to

be listed as off-duty as per FMCSA's guidance. This time not only does not count against the driver's hours of service but allows the driver to utilize this time as off-duty and extend the driver's hours of service beyond the normal property carrying hours allowed under §395.8. The 2019 Volvo driver's hours of service will be further discussed further in the Driver's Hours of Service section later in this report.

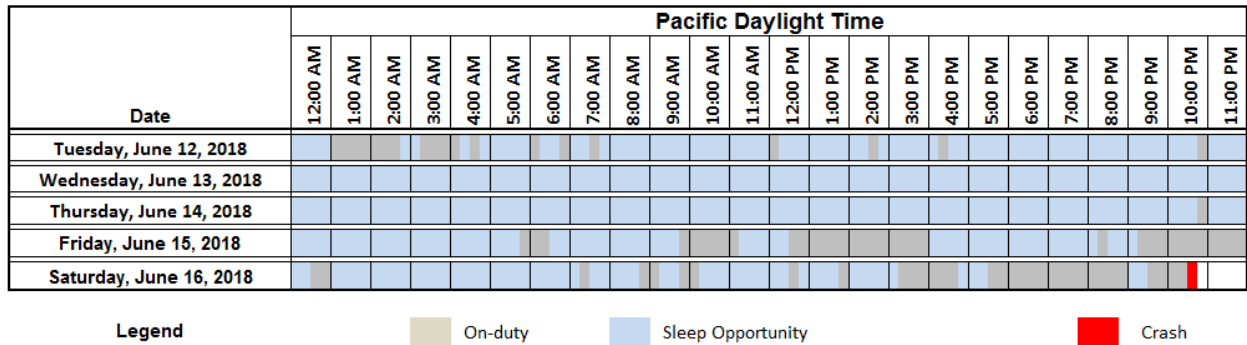
Table 3 2019 Volvo driver’s opportunity for rest

The cumulative information shows that the driver’s opportunity for rest was sporadic in the 48 hours leading up to the crash. The 2019 Volvo driver’s work/rest activity is displayed graphically below in **Table 3**.

The day prior to the crash, the driver began work around 5:45 a.m. after driving for 45 minutes, the truck was then stopped for approximately 3.25 hours. The driver continued this fractured pattern of driving and stopping with the longest time stopped being 6.25 hours from 1:00 a.m. on June 16th to 7:15 a.m. The driver had been on-duty approximately 15.25 hours at the time of the crash. Due to a lack of additional information as to the driver’s activities, there was no way for investigators to narrow down the driver’s activities and actual rest time during the hours the 2019 Volvo was not in motion.

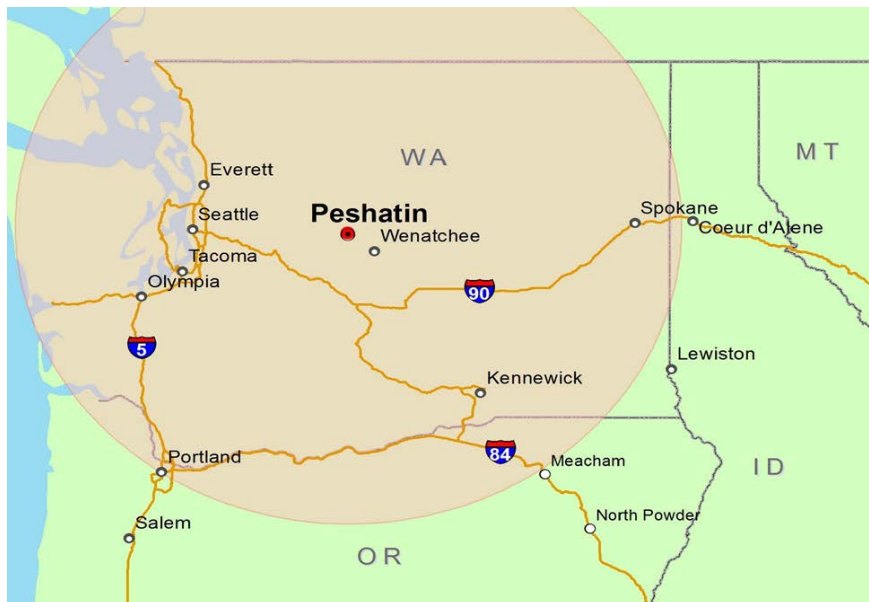
Figure 2. 150 air-mile radius from Peshatin, WA

The image below shows the 150-air mile exemption as it applies to the pick-up location of the pears that Zhuk was transporting. The pears were loaded in Peshatin, WA²⁶

As the image shows the entire trip that Zhuk made from the start at 6:00am until approximately Meacham, OR was in the 150-air mile exemption. The distance from Meacham OR to the crash site is 187 miles and takes approximately 3.30 hours to drive. When interviewed the Zhuk driver was unaware of the agricultural exemption.
