BRIDGE FACTORS GROUP CHAIRMAN'S FACTUAL REPORT

Miami, FL

HWY18MH009

**BRIDGE FACTORS GROUP CHAIRMAN'S
FACTUAL REPORT**

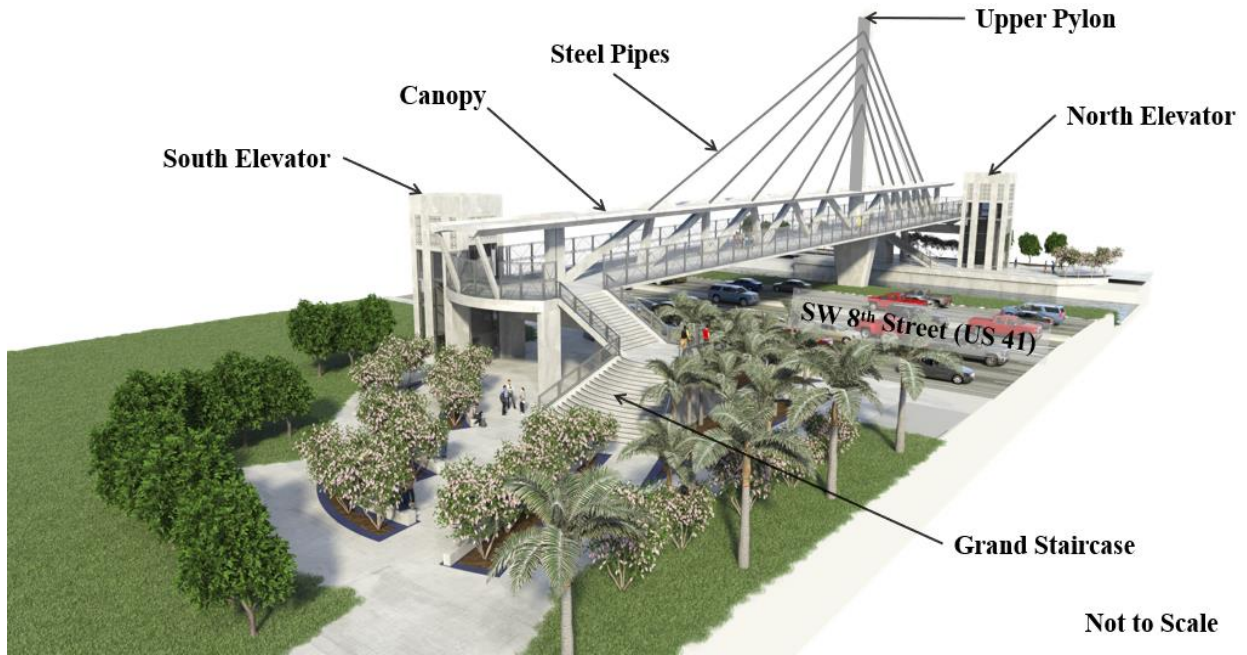
Figure 6 – Rendering of what the signature pedestrian bridge would look like when completed looking to the northwest (Source: FIU modified)

Figures 6 through 8 illustrate other renderings of what the signature pedestrian bridge would look like when completed.

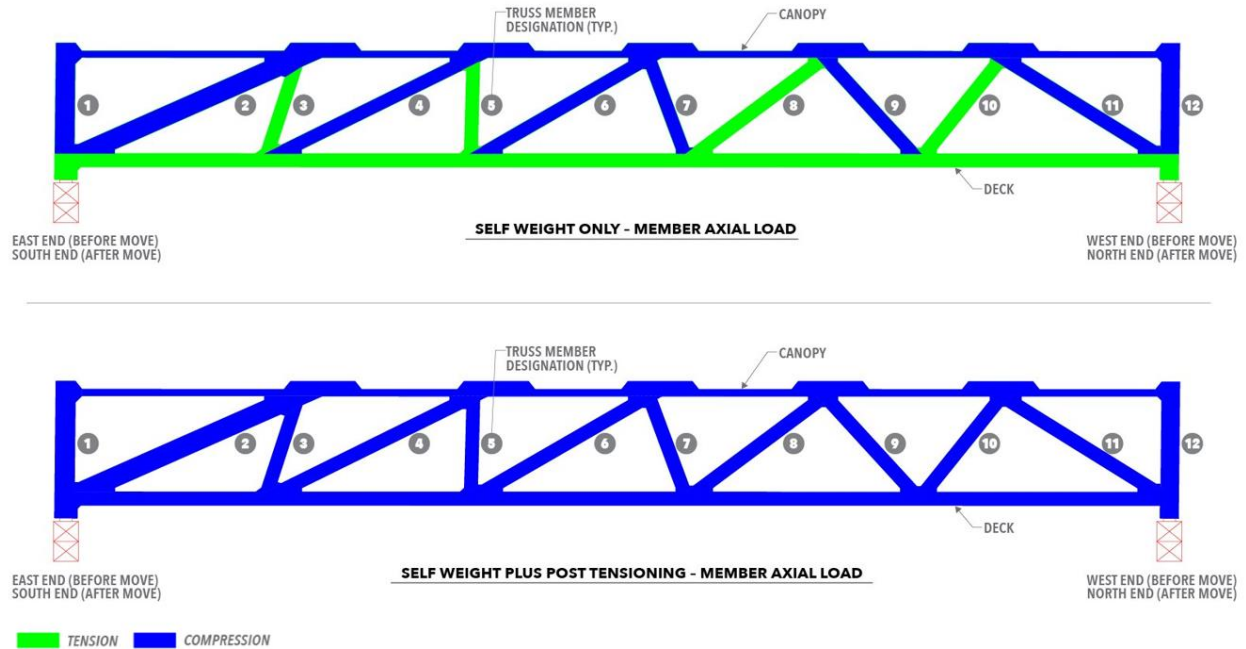
Note: The top diagram is shown without post-tensioning for illustration purposes only. The bottom diagram is shown with actual loads.

Figure 12 – Map illustrating the tension and compression members of the main span simply supported at each end before the move and on the permanent piers after the move (Source: FIGG Bridge Engineers, Inc. modified)²⁷

²⁷Top diagram illustrates self-weight axial forces only, which are combined with post-tensioning forces concurrently acting on the span to produce the net axial forces shown in the bottom diagram.

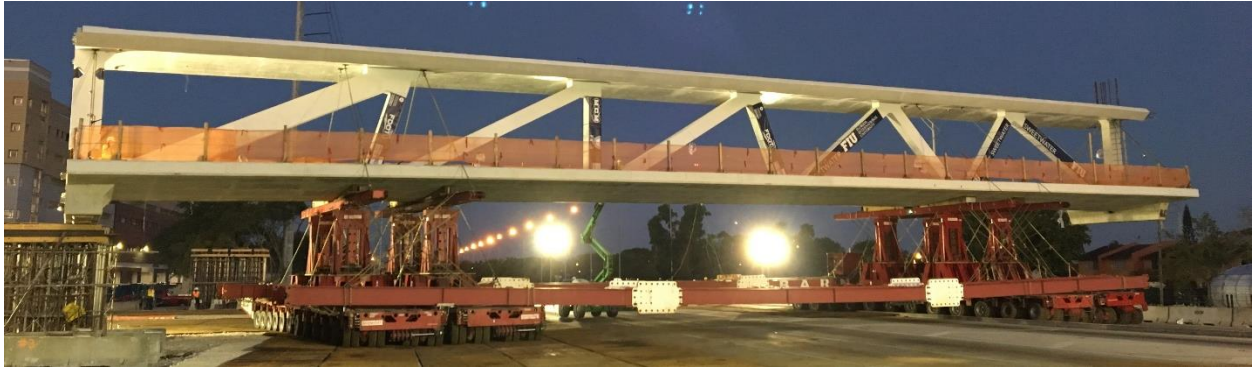
Figure 15 – Main span during move (Source: Barnhart Crane and Rigging)

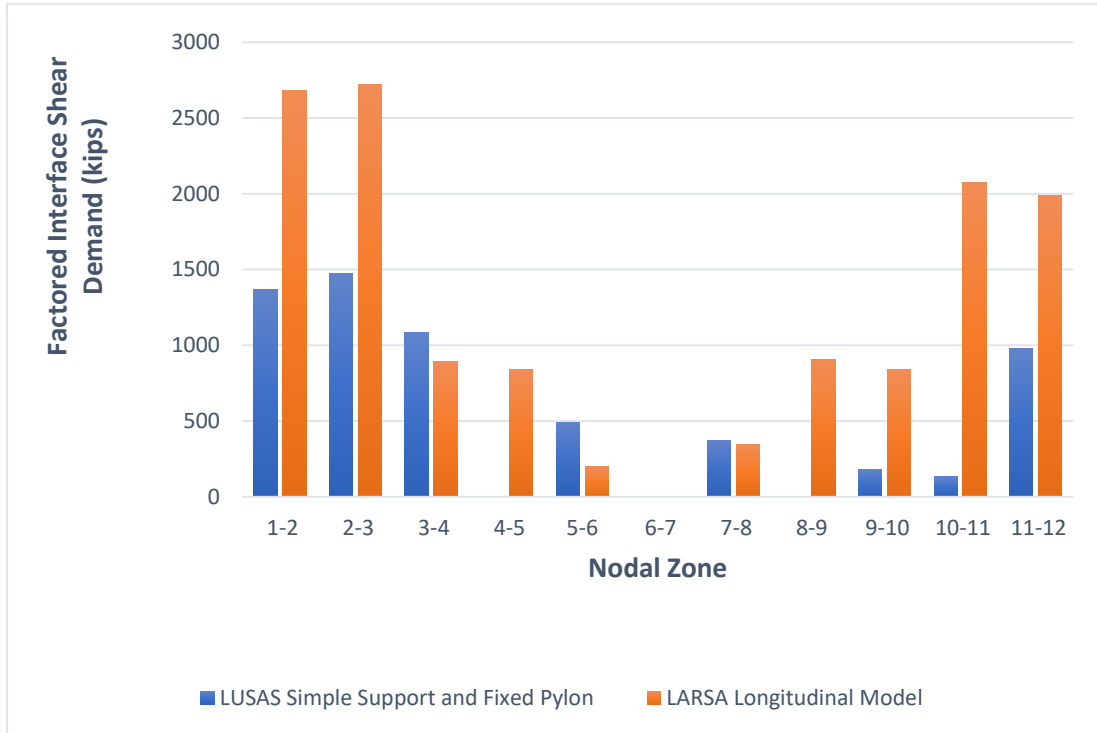
Figure 17 illustrates the factored interface shear demands on the nodal zones.

Figure 17 – Factored interface shear demand on nodal zones

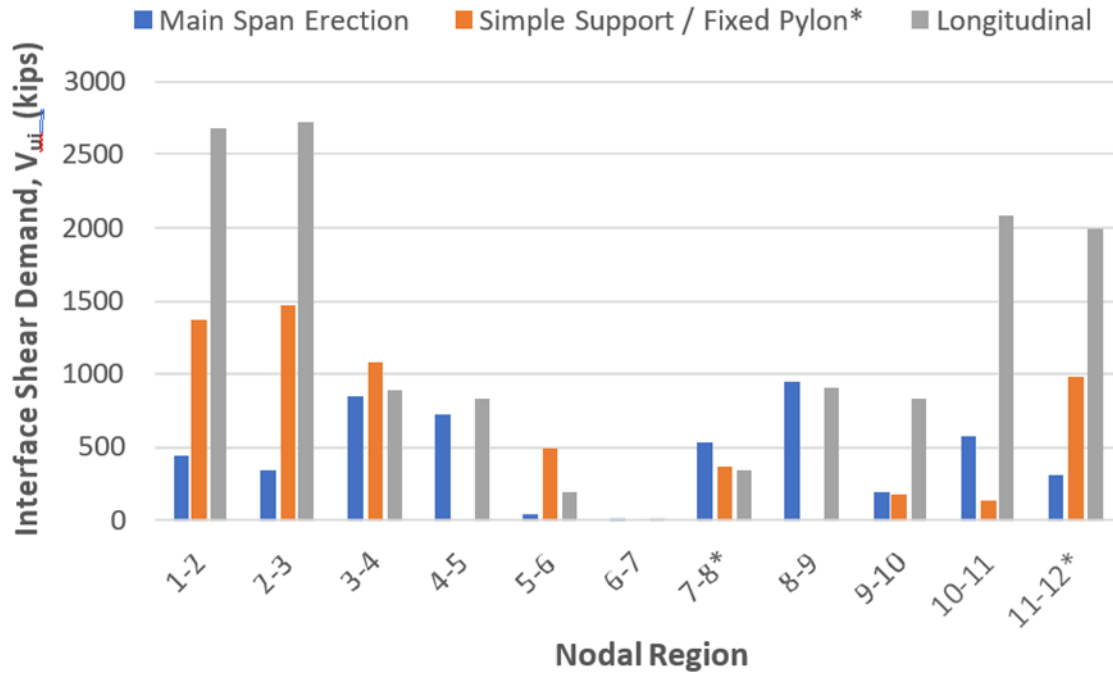
Figure 18 shows that the interface shear demand generated for each nodal region can vary significantly. The forces generated from the LARSA Longitudinal Model (for the completed bridge structure) generated the largest forces for the nodal regions at the north and south ends of the main span. The FIGG Design exclusively used the results from the LUSAS Simple Support / LUSAS Fixed Pylon modeling combination for the design of every main span nodal region.

Figure 18 – Nodal zone interface shear demand results generated for FIGG bridge design, with horizontal axis showing two truss member identification numbers that connect into each nodal region
