HIGHWAY FACTORS GROUP

Photographs

Bryce Canyon City, Utah

HWY19MH012

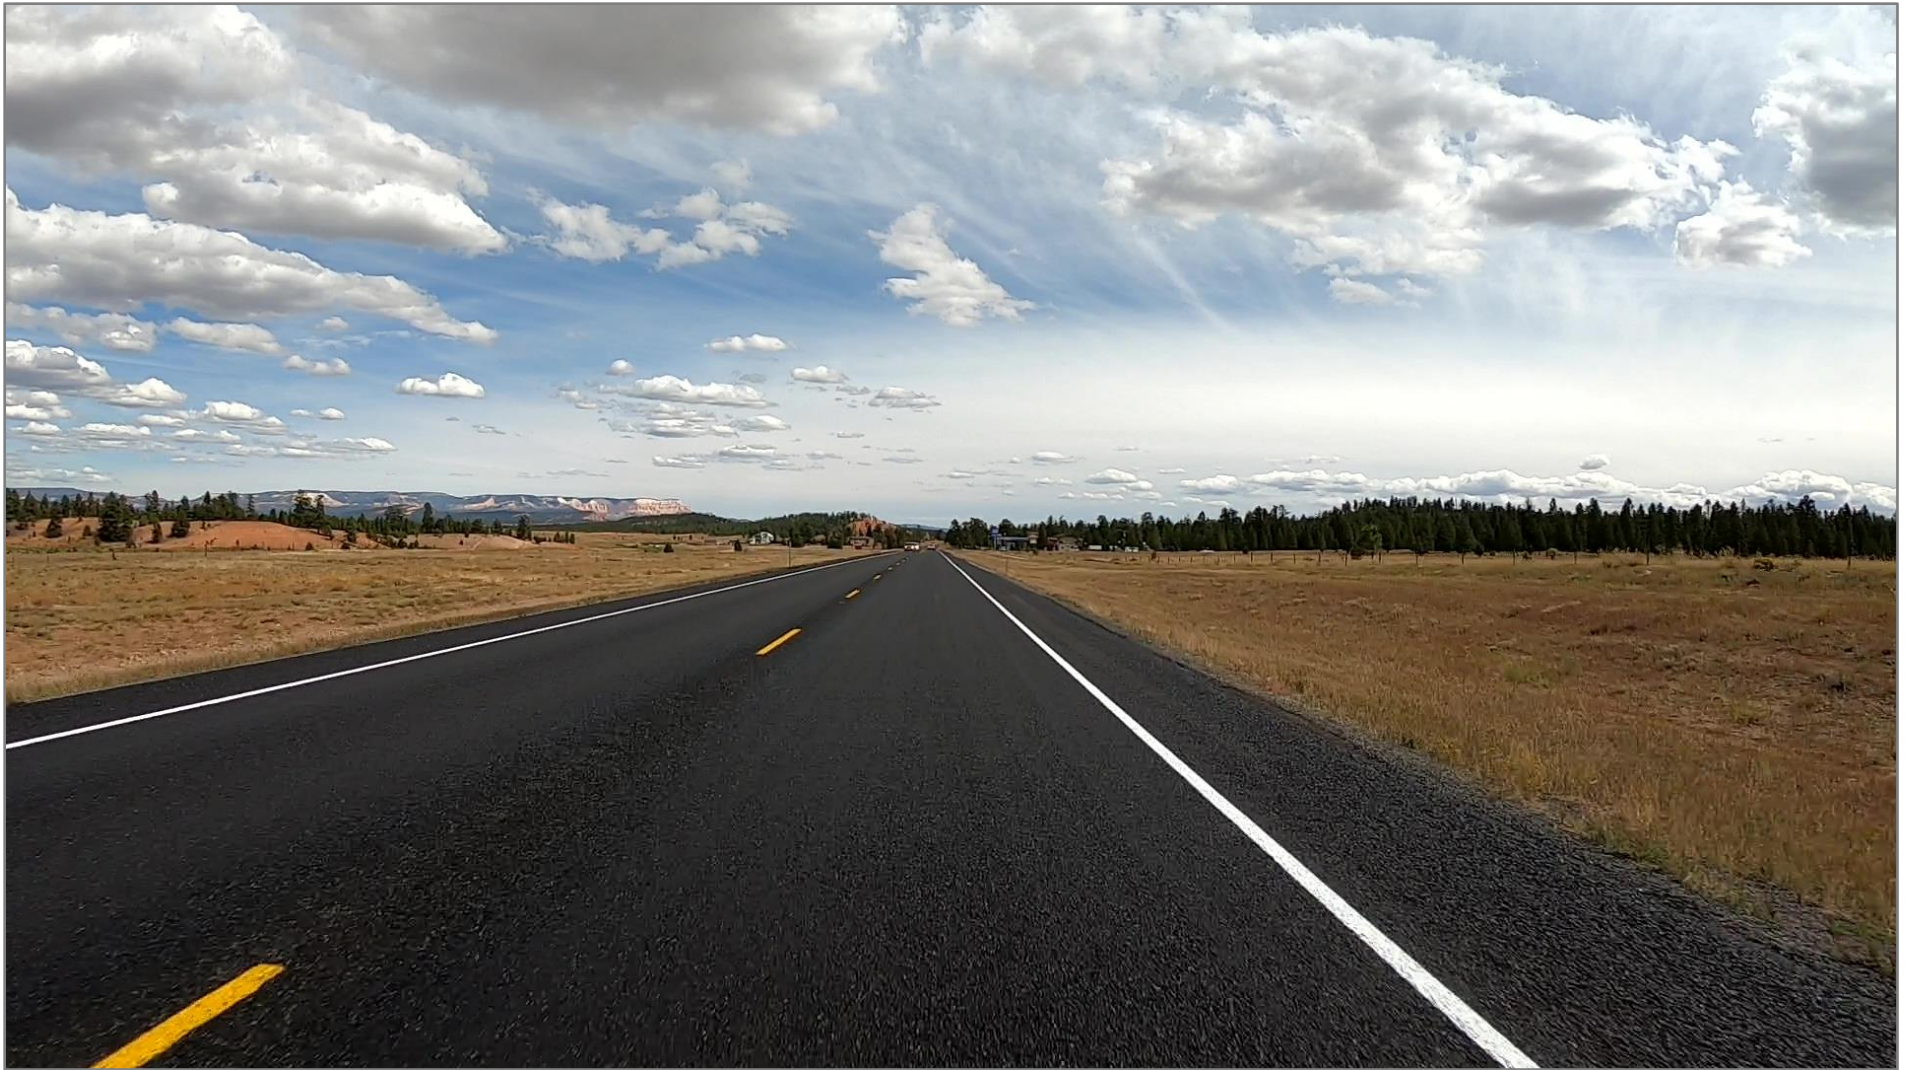
Highway Photograph 2 – SR-12 Eastbound Travel Lane Prior to Crash Location – Facing East

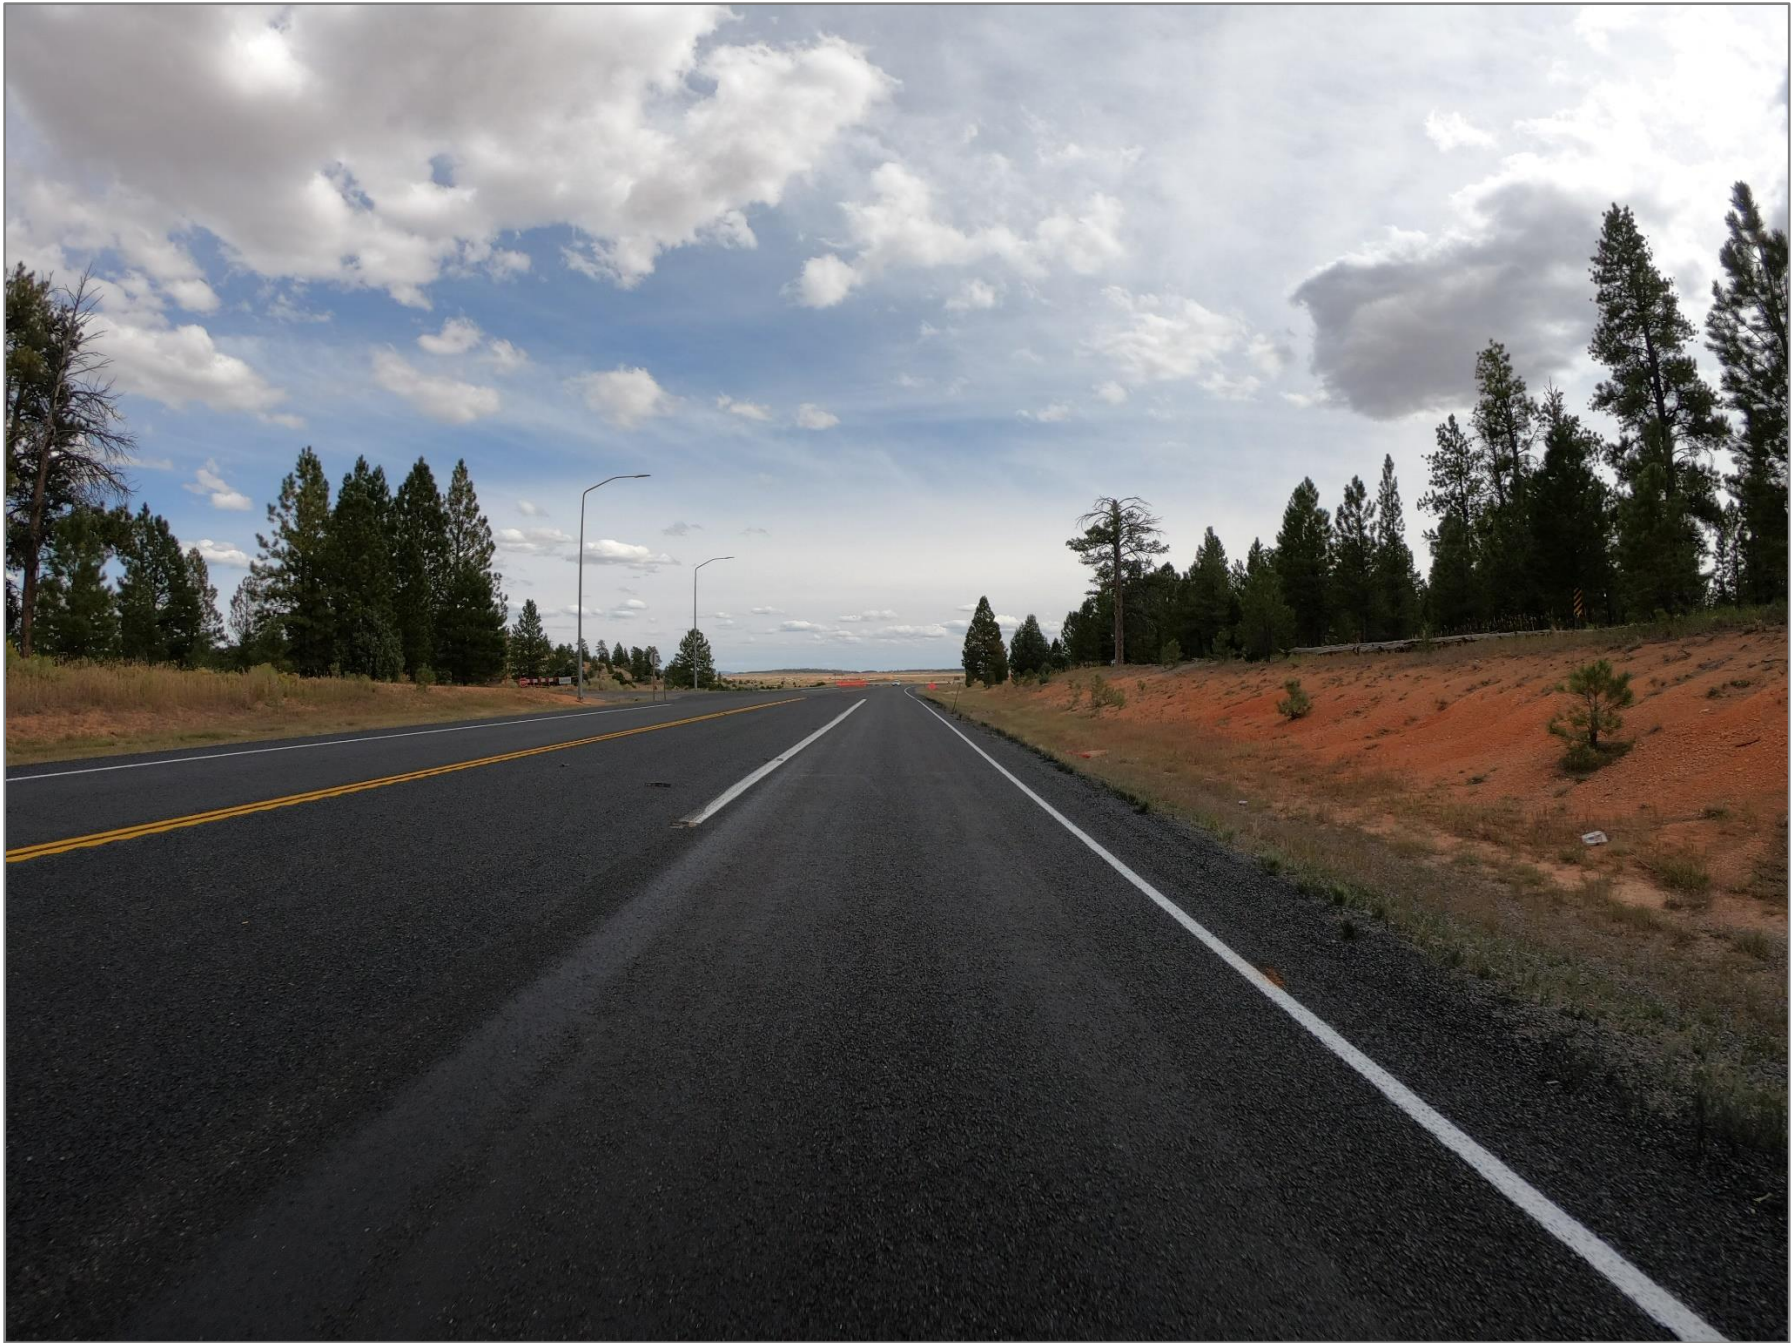
Highway Photograph 3 – SR-12 Eastbound Travel and Dedicated Left Turn Lanes Near Crash Location – Facing East

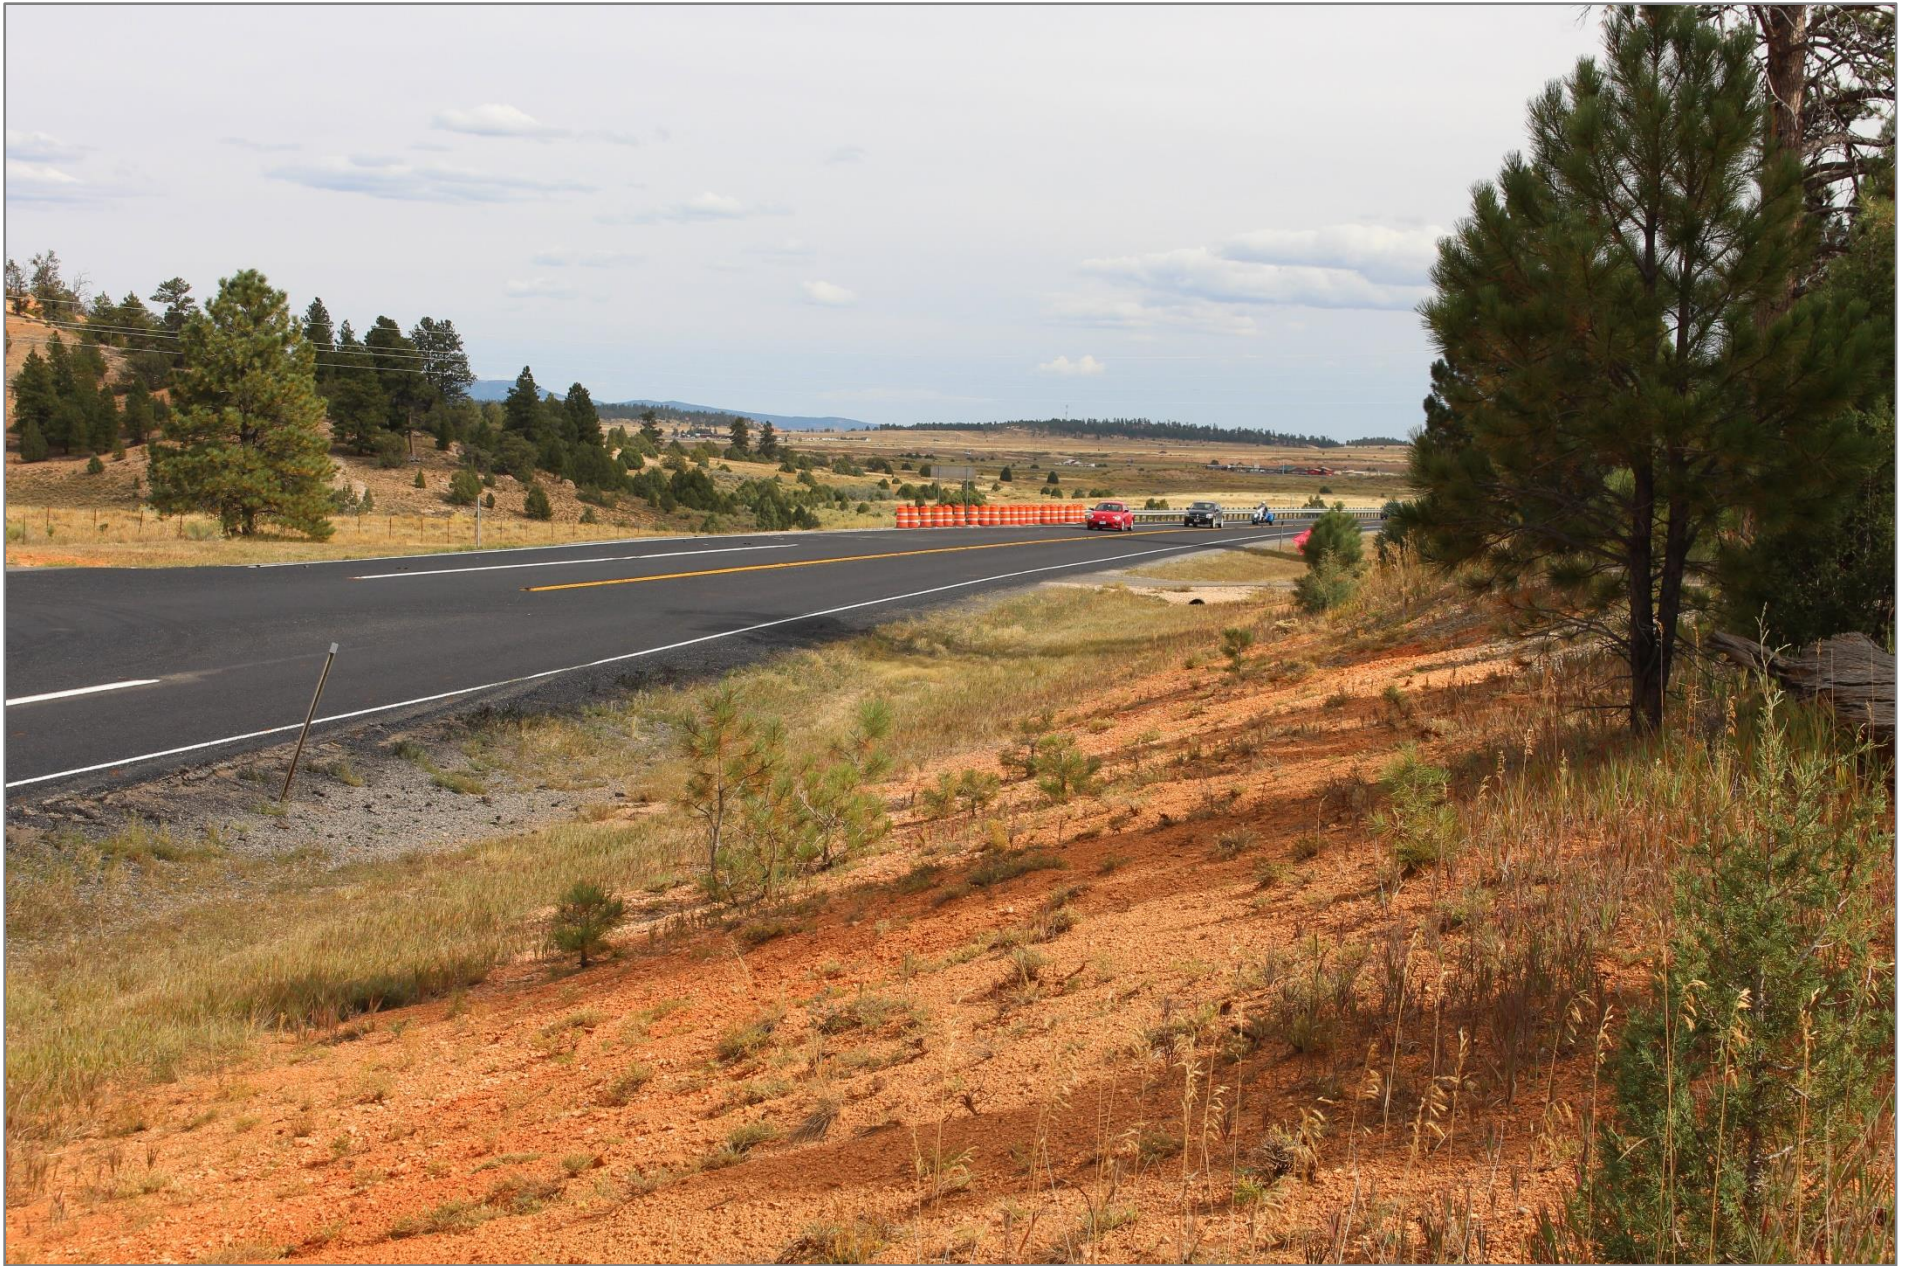
Highway Photograph 4 – Eastbound Clear Zone Along South Side of SR-12 in the Area of the Collision – Facing East

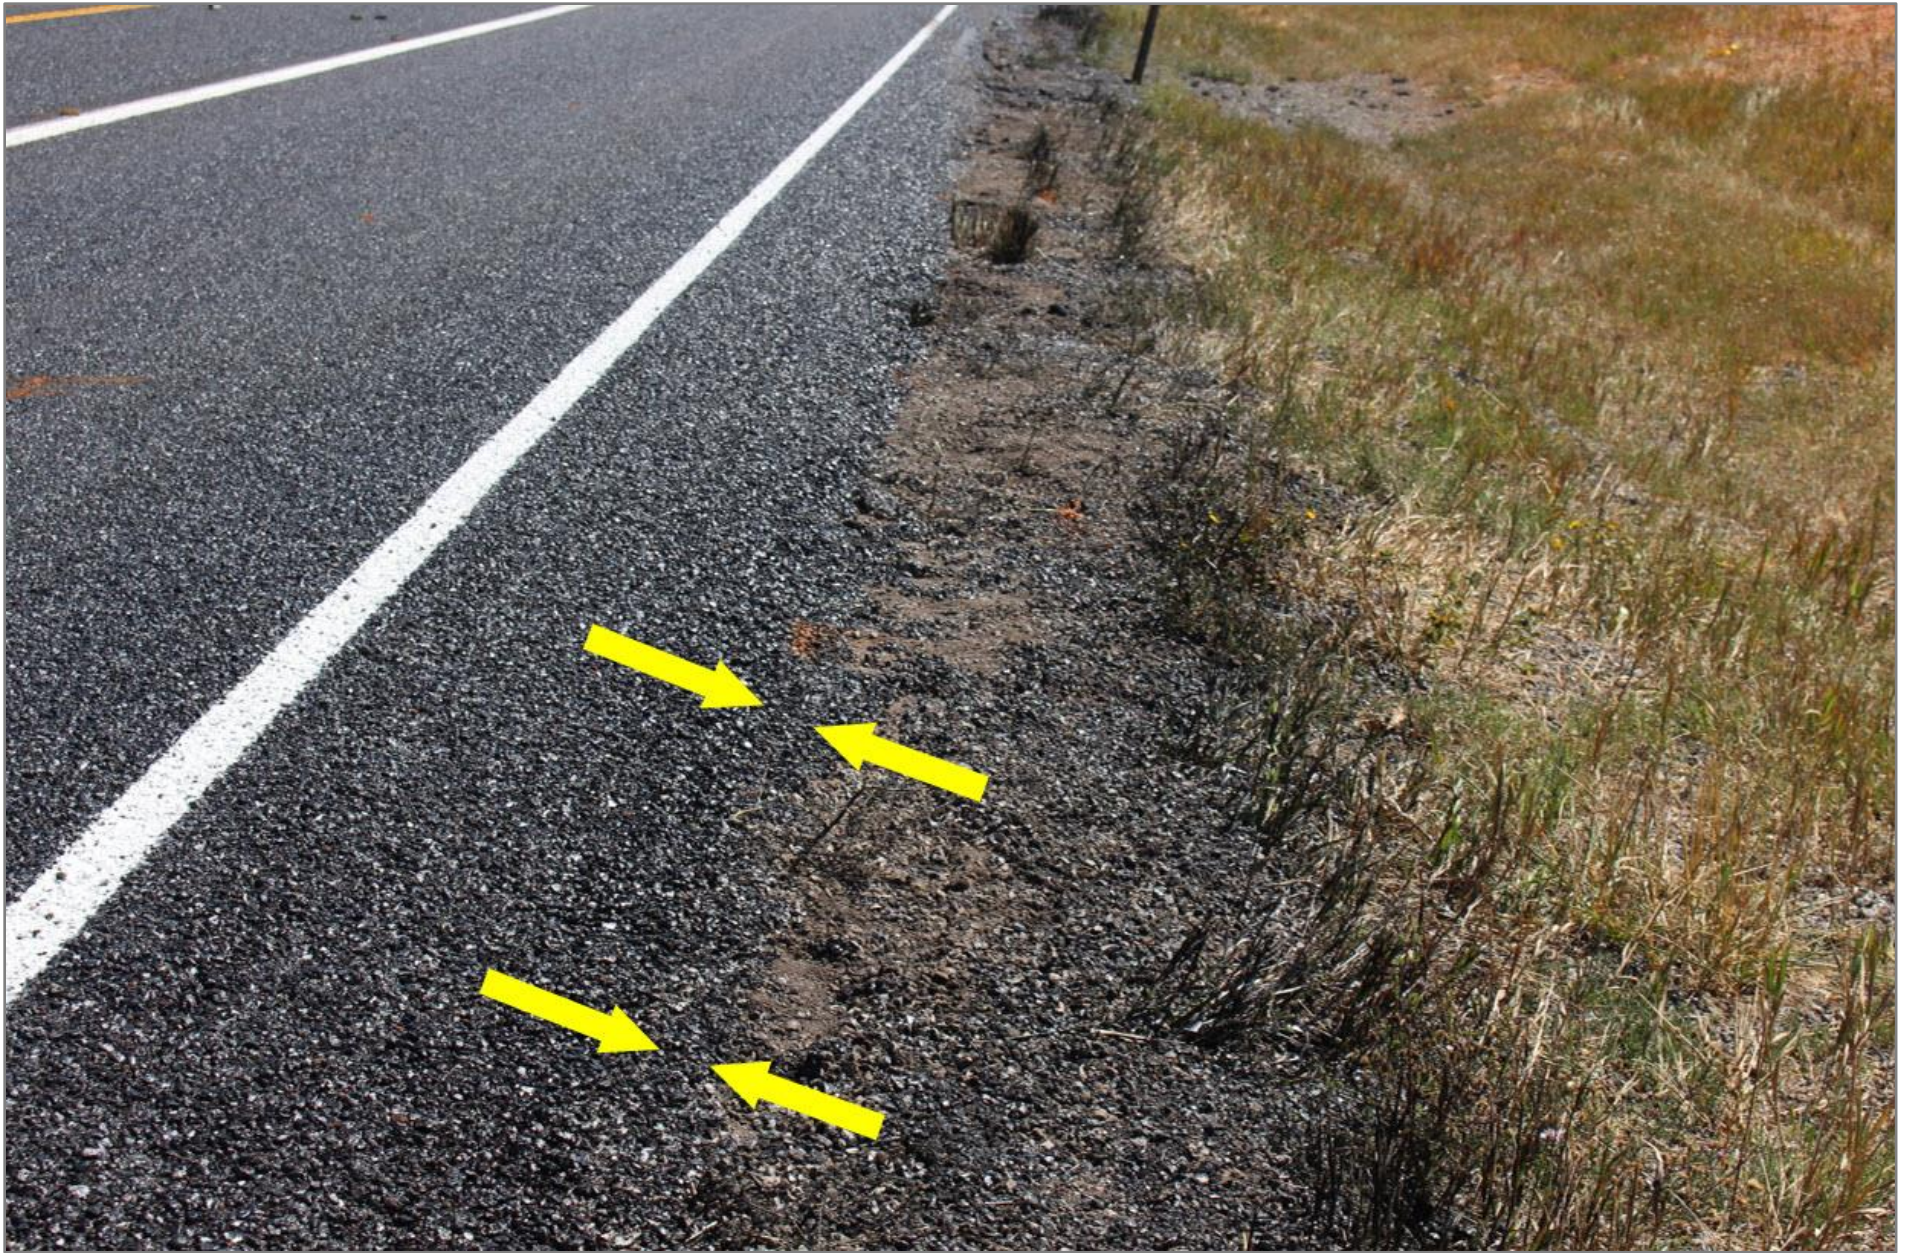
Highway Photograph 5 – Eastbound Pavement Edge Drop-off in Area of Collision – Facing East-Southeast

(The edge drop-off is indicated between the sets of yellow arrows.)

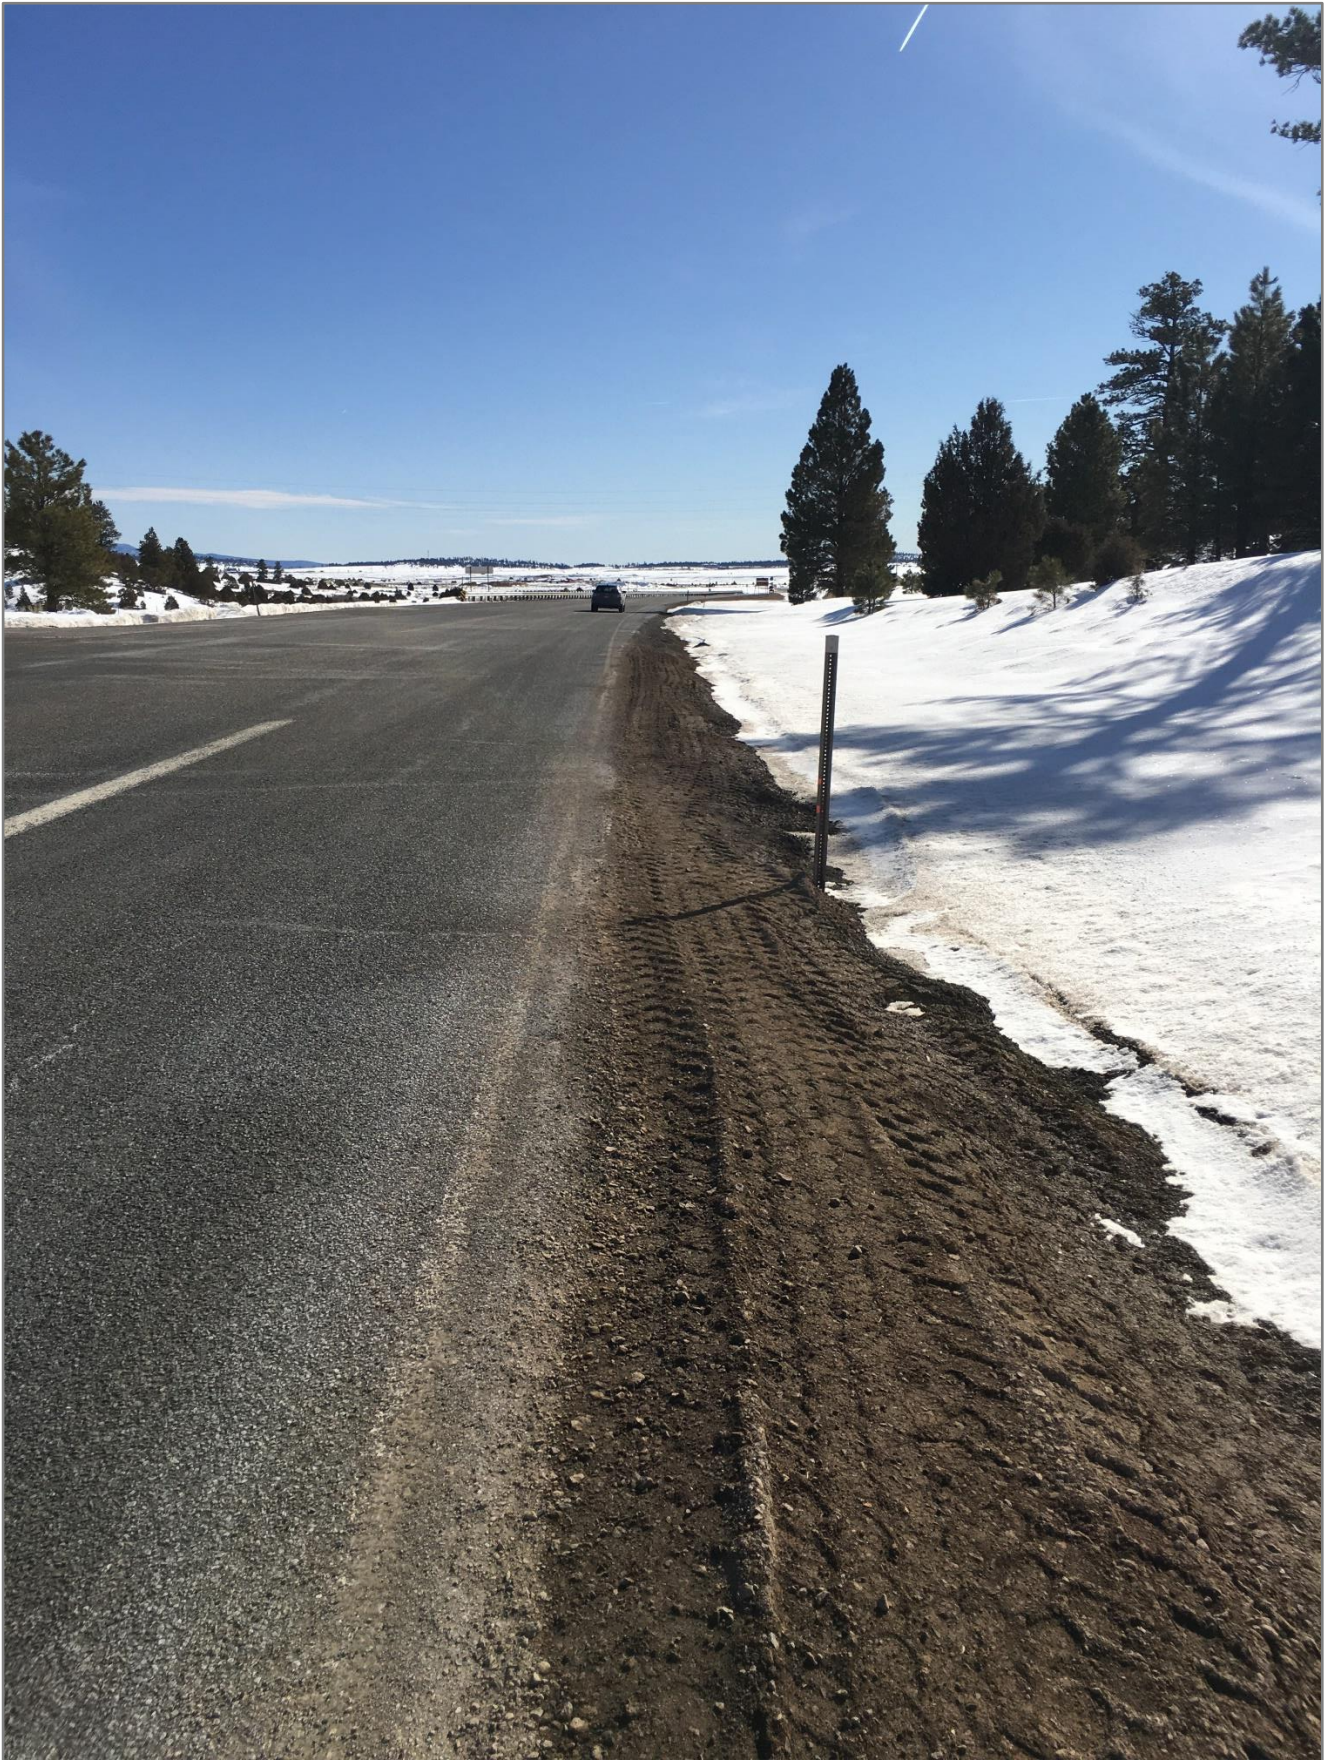
Highway Photograph 6 – Repaired and Re-graded Eastbound Shoulder in Area of Collision – Facing East-Southeast
(source: Utah Department of Transportation)

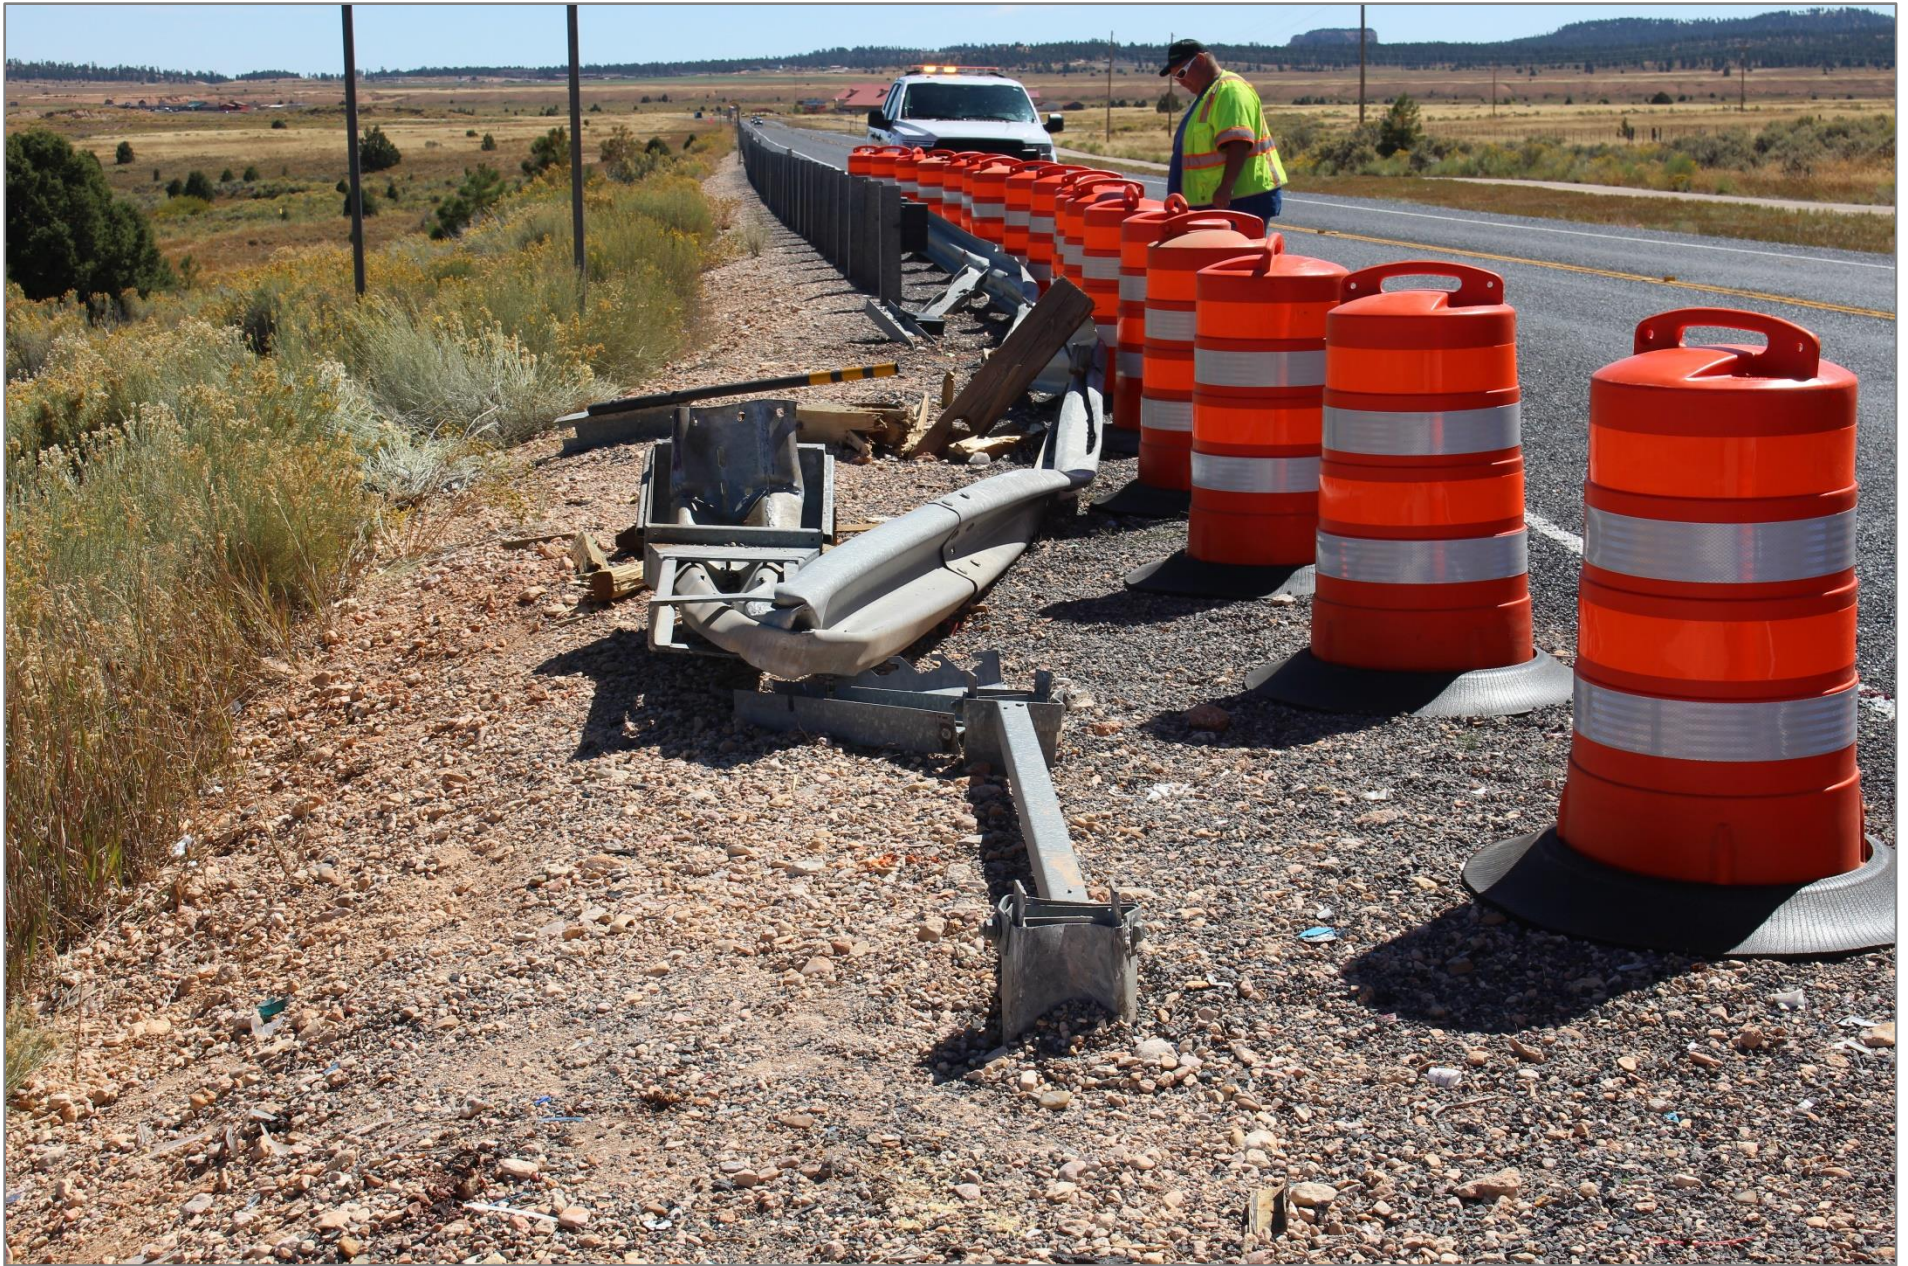
Highway Photograph 7 – West End of Guardrail and End Terminal Showing Collision Damage

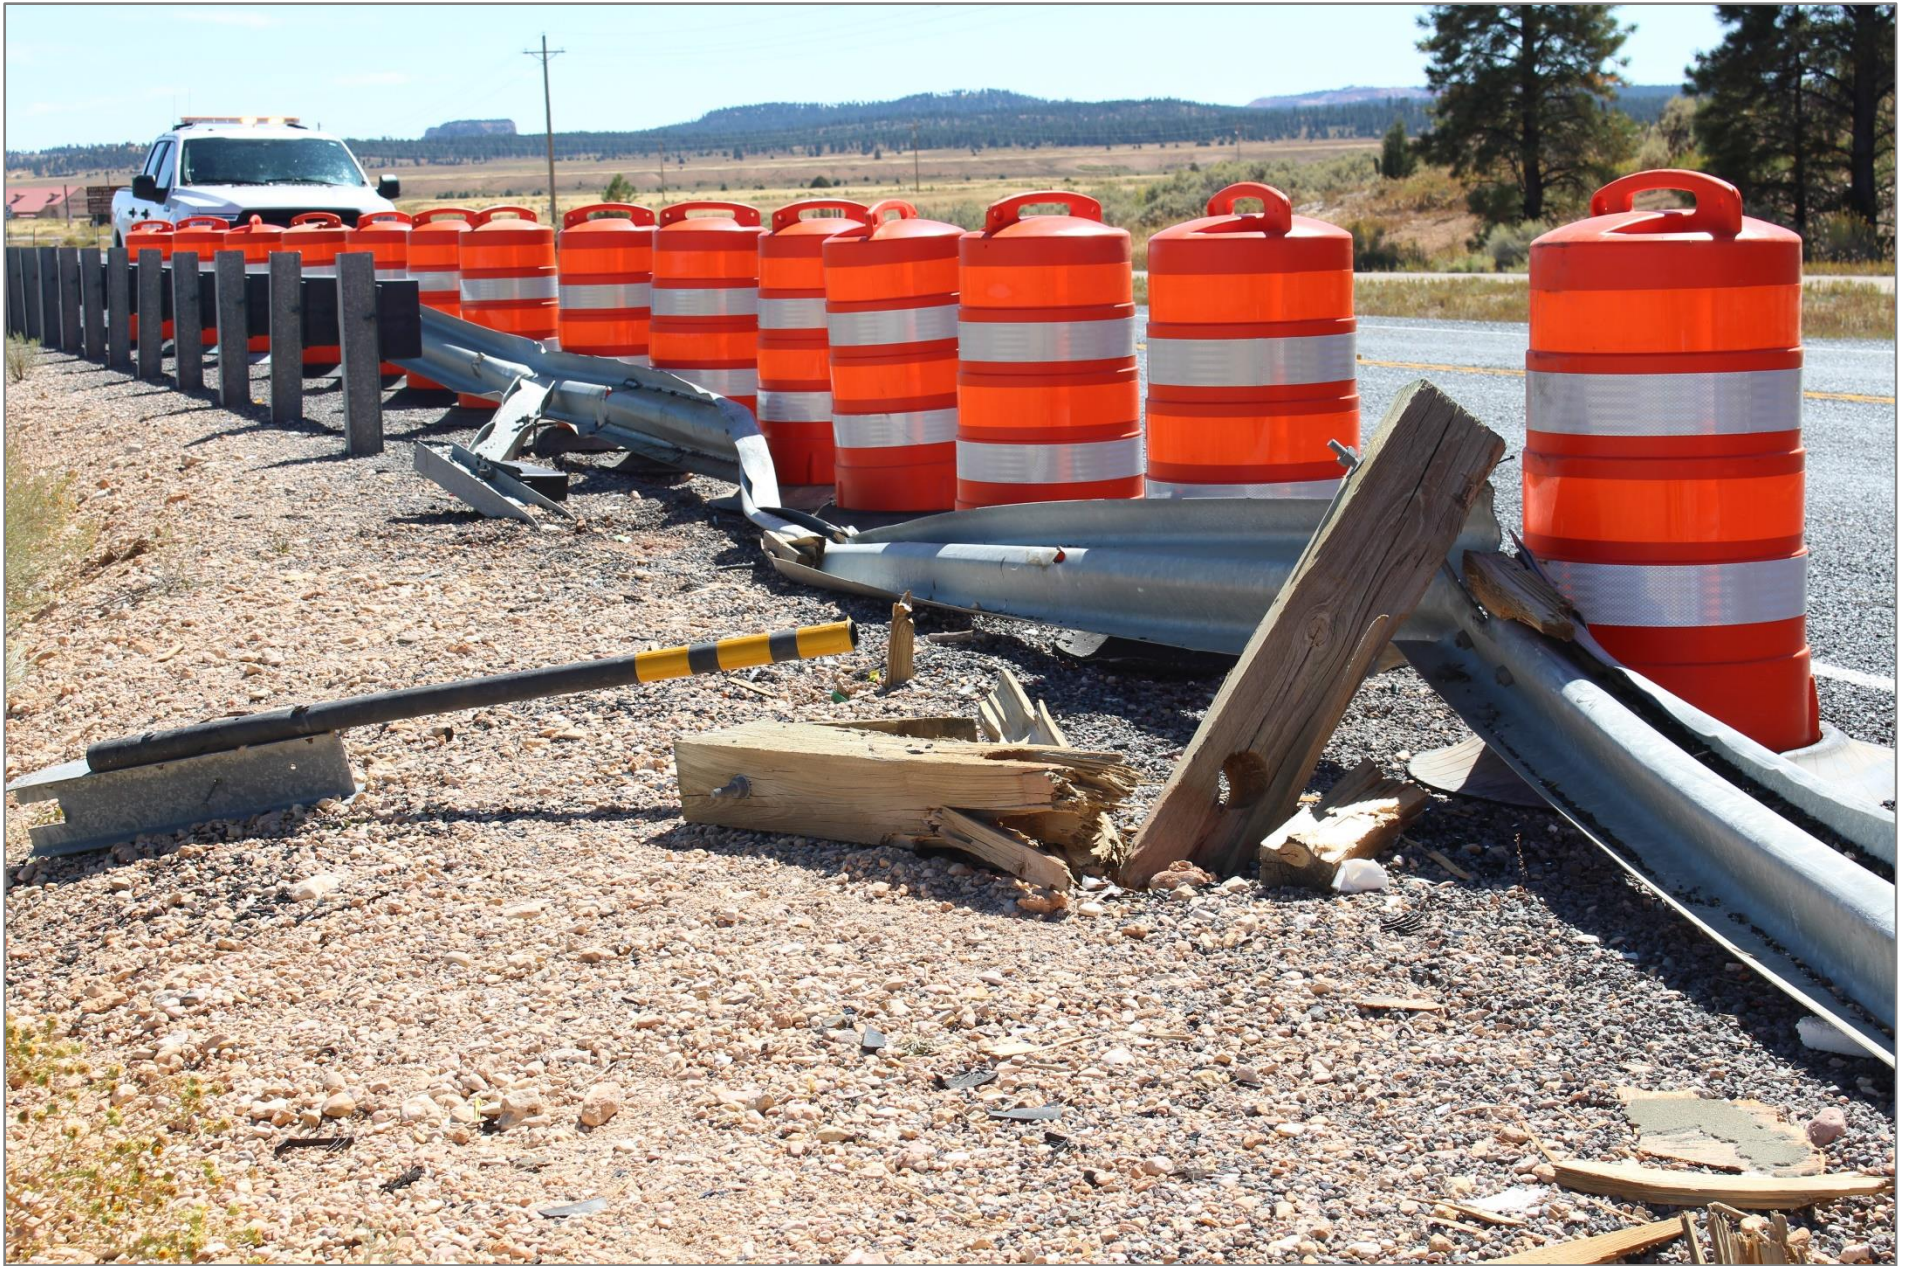
Highway Photograph 8 – Collision Damage to West End of Blocked-Out Strong-Post W-Beam Guardrail
