NATIONAL TRANSPORTATION SAFETY BOARD

Group Chairman's Factual Report

METEOROLOGY

CEN16FA286

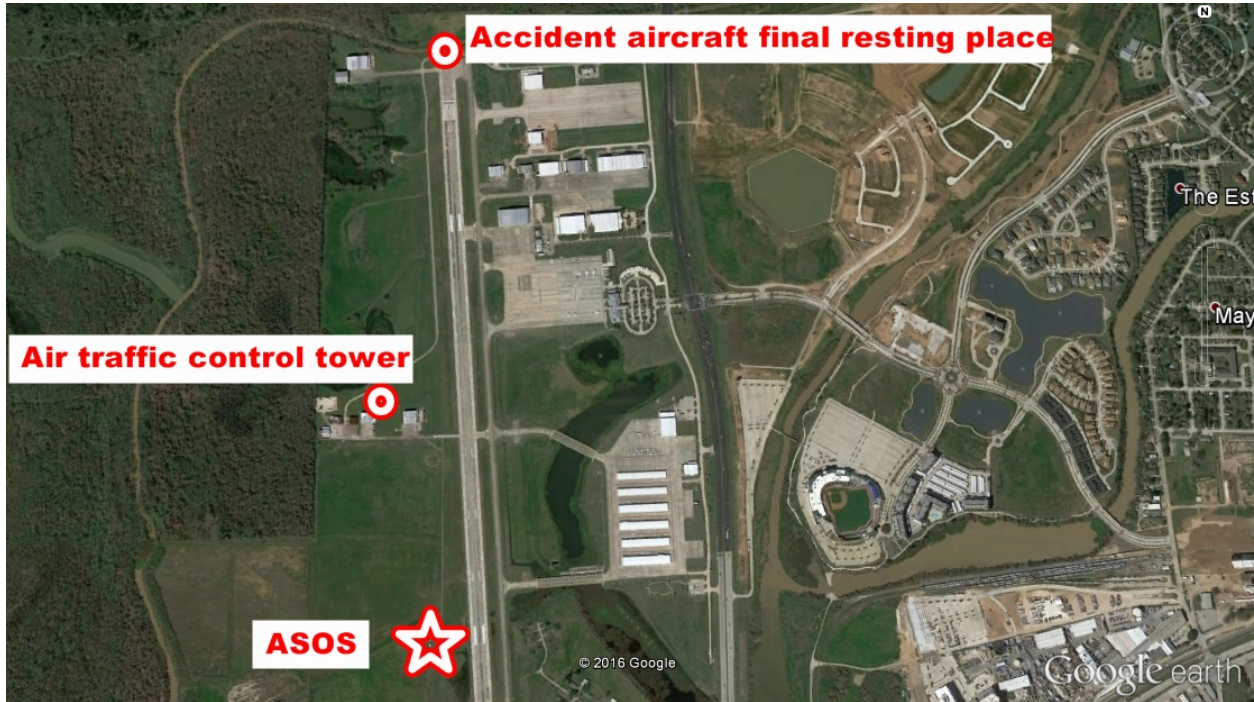
Figure 8 – SGR airport overview diagram

The ASOS equipment was located three-eighths of a mile south-southeast of the SGR air traffic control tower (figure 8). Figure 9 shows a view from the ASOS equipment looking north-northwestward toward the air traffic control tower. The ASOS equipment including the visibility sensor was operating during normal parameters around the time of the accident. A NWS technician from the Houston/Galveston, Texas office had serviced the SGR ASOS equipment on July 18, 2016, including cleaning off the visibility (figure 10) sensor lenses and other equipment.

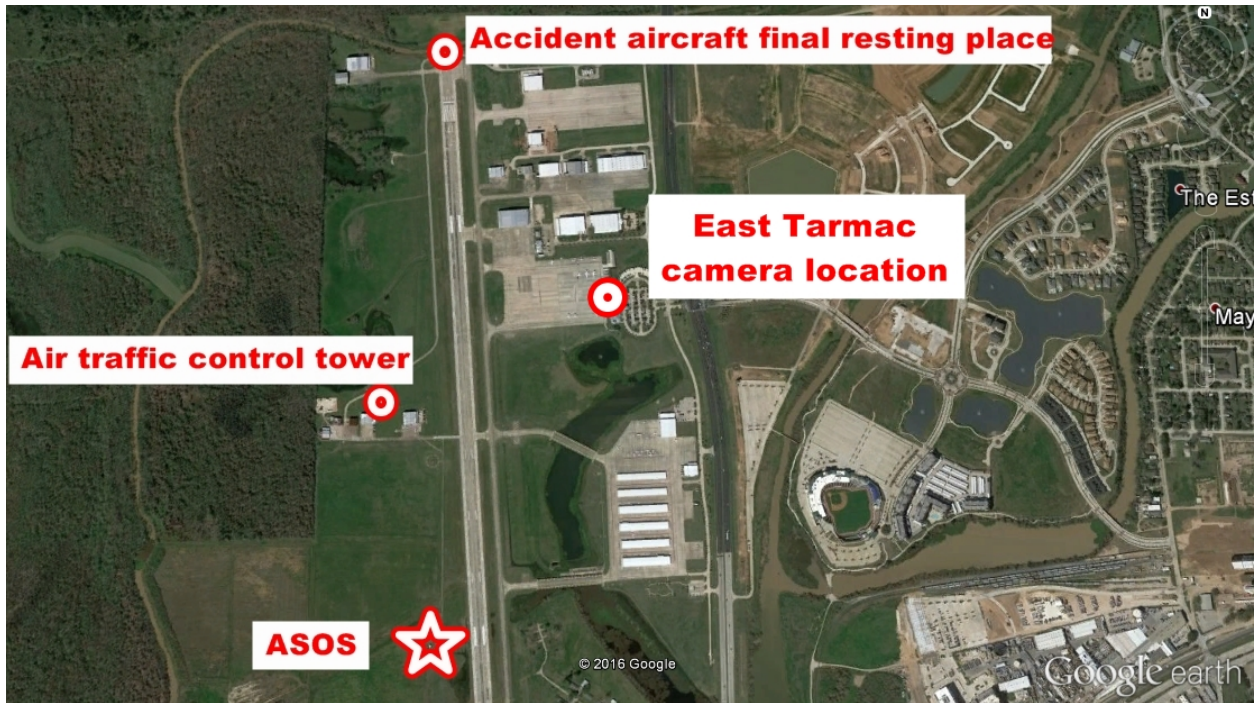
Figure 42 – SGR airport overview diagram with the location of KSGR, the air traffic control tower, the East Tarmac camera location, and accident aircraft final resting place

SGR camera imagery was obtained from 1403 to 1527 CDT (attachment 23, figures 43 to 55). The East Tarmac camera was located five-eighths of a mile north-northeast of the KSGR ASOS equipment (with the ASOS located near the tree line behind the concrete bridge over the pond, figure 43) and three-eighths of a mile east-northeast of the air traffic control tower (figure 42). Figure 43 showed the south-southwest facing SGR security camera imagery from 1450:16 CDT with visibility towards the south-southwest greater than five-eighths of a mile. Between 1500 and 1505 CDT the visibility towards the south-southwest dropped below five-eighths of a mile (figures 45 and 46), and the visibility (based on the SGR camera imagery) remained below five-eighths of a mile through the accident time (figures 47 through 49). The west-southwest facing camera (figures 50 through 55) indicated a similar drop in visibility (as the south-southwest facing camera) between 1459 and 1505 CDT (figures 52 and 53), with a further reduction in visibility by 1509 CDT (figure 54). The accident airplane can be seen at 1510:09 CDT (figure 55, red circle) with visibilities to the west-southwest at or below three-eighths of a mile.

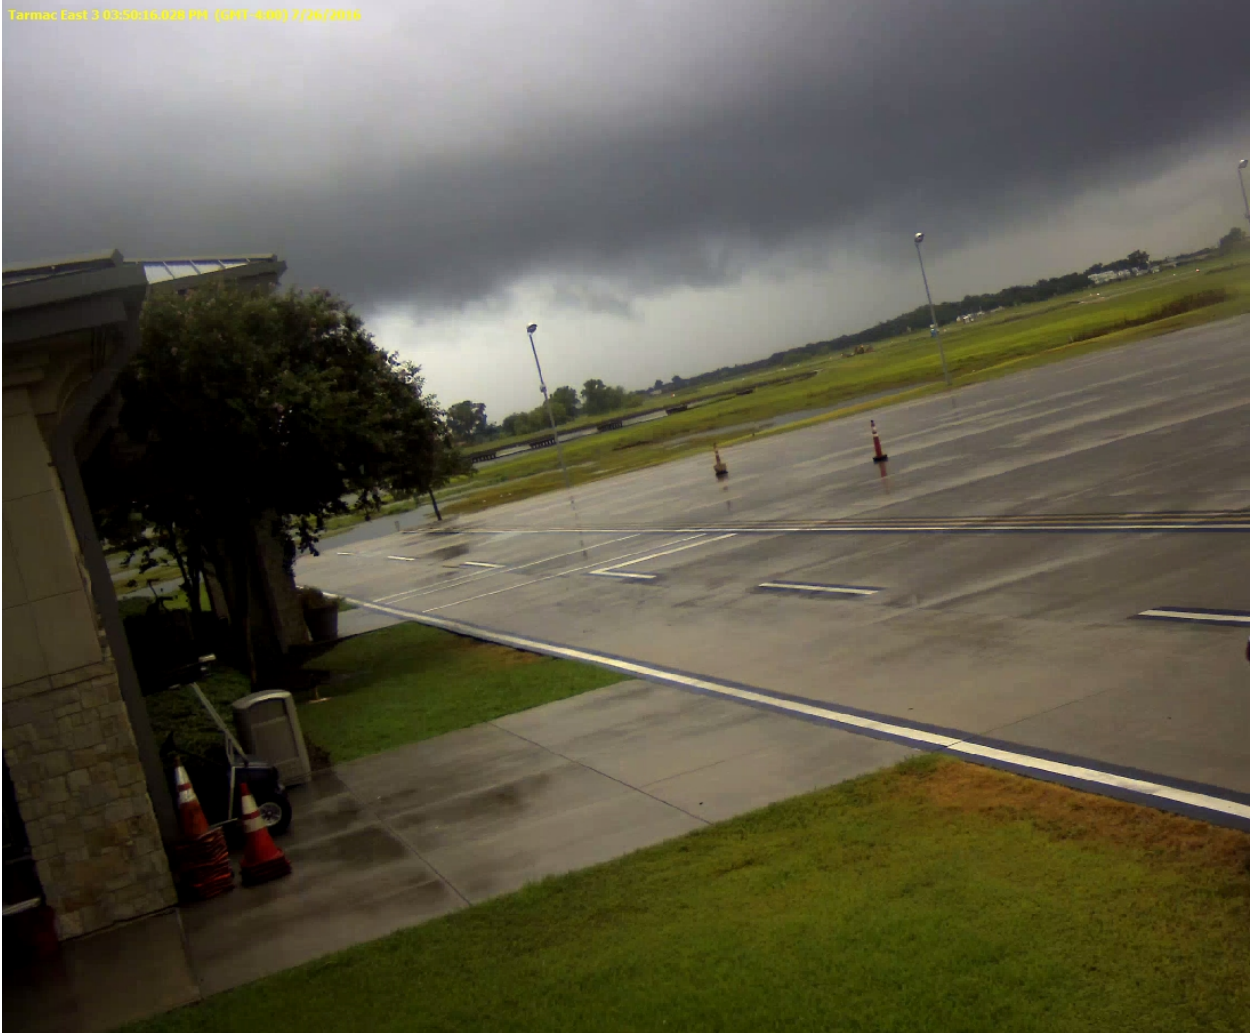
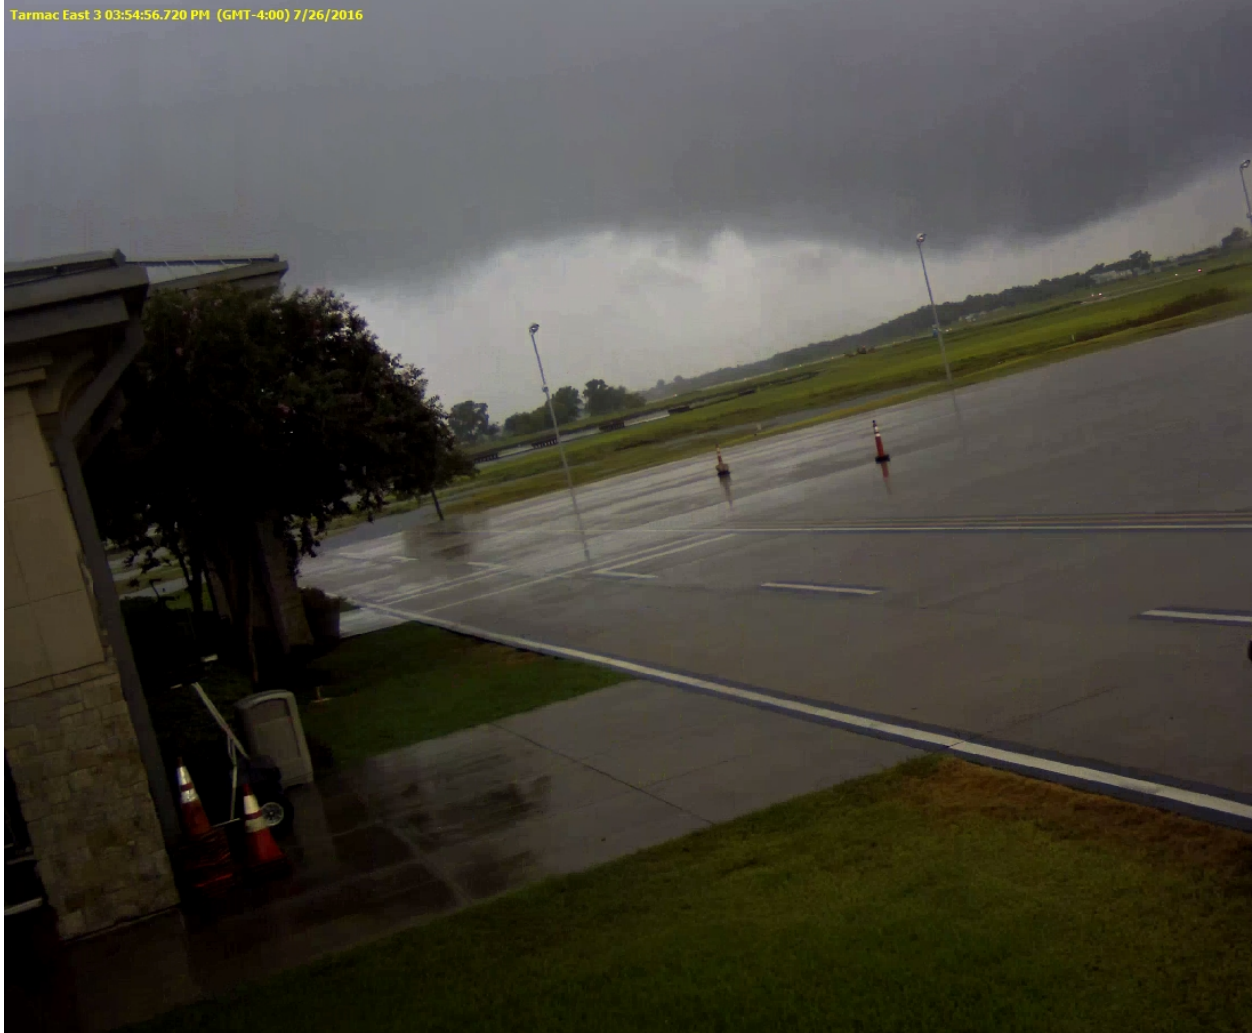
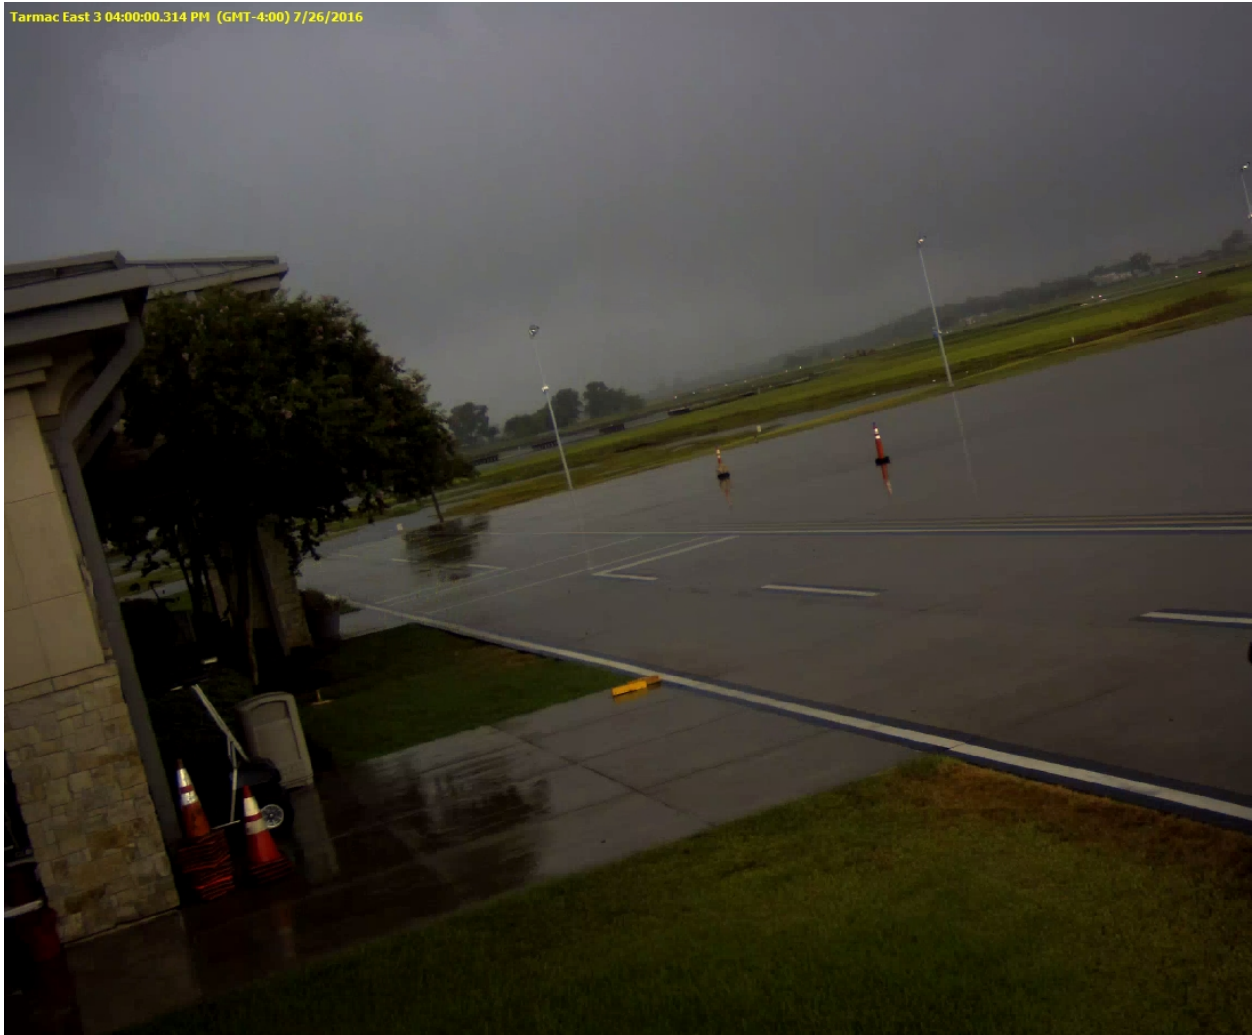
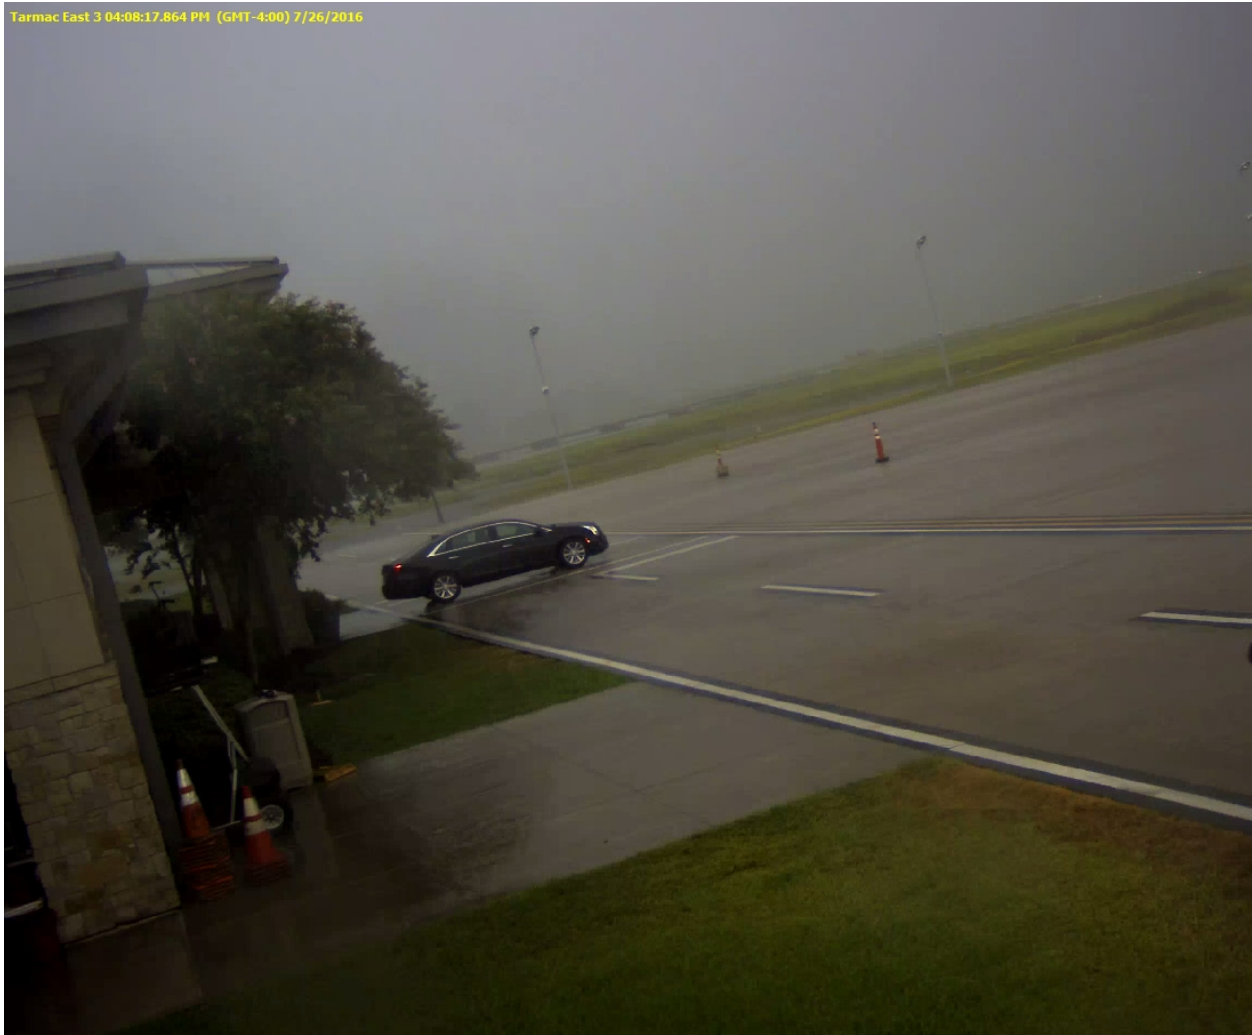
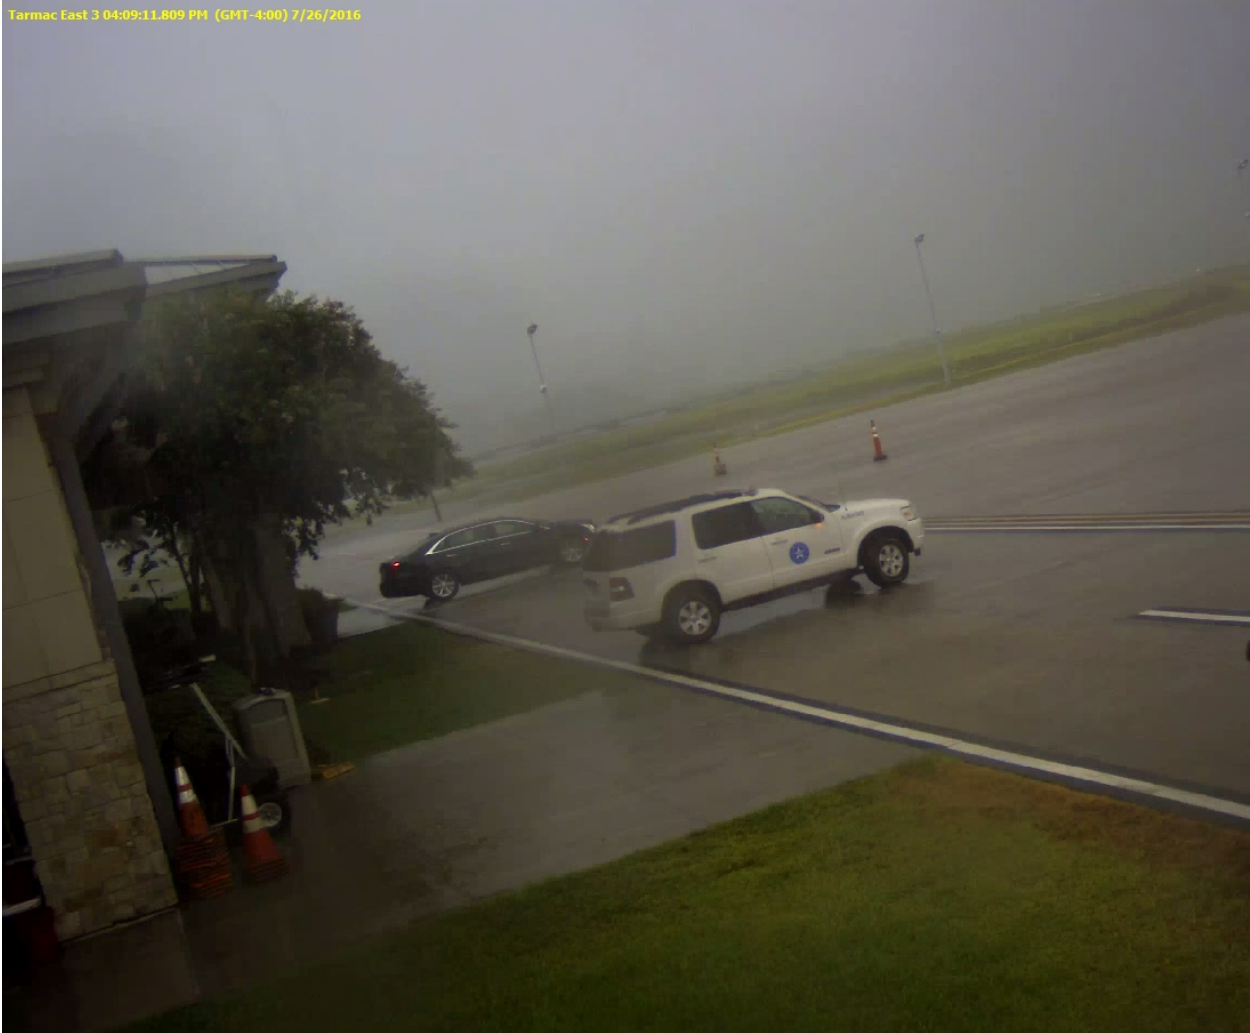
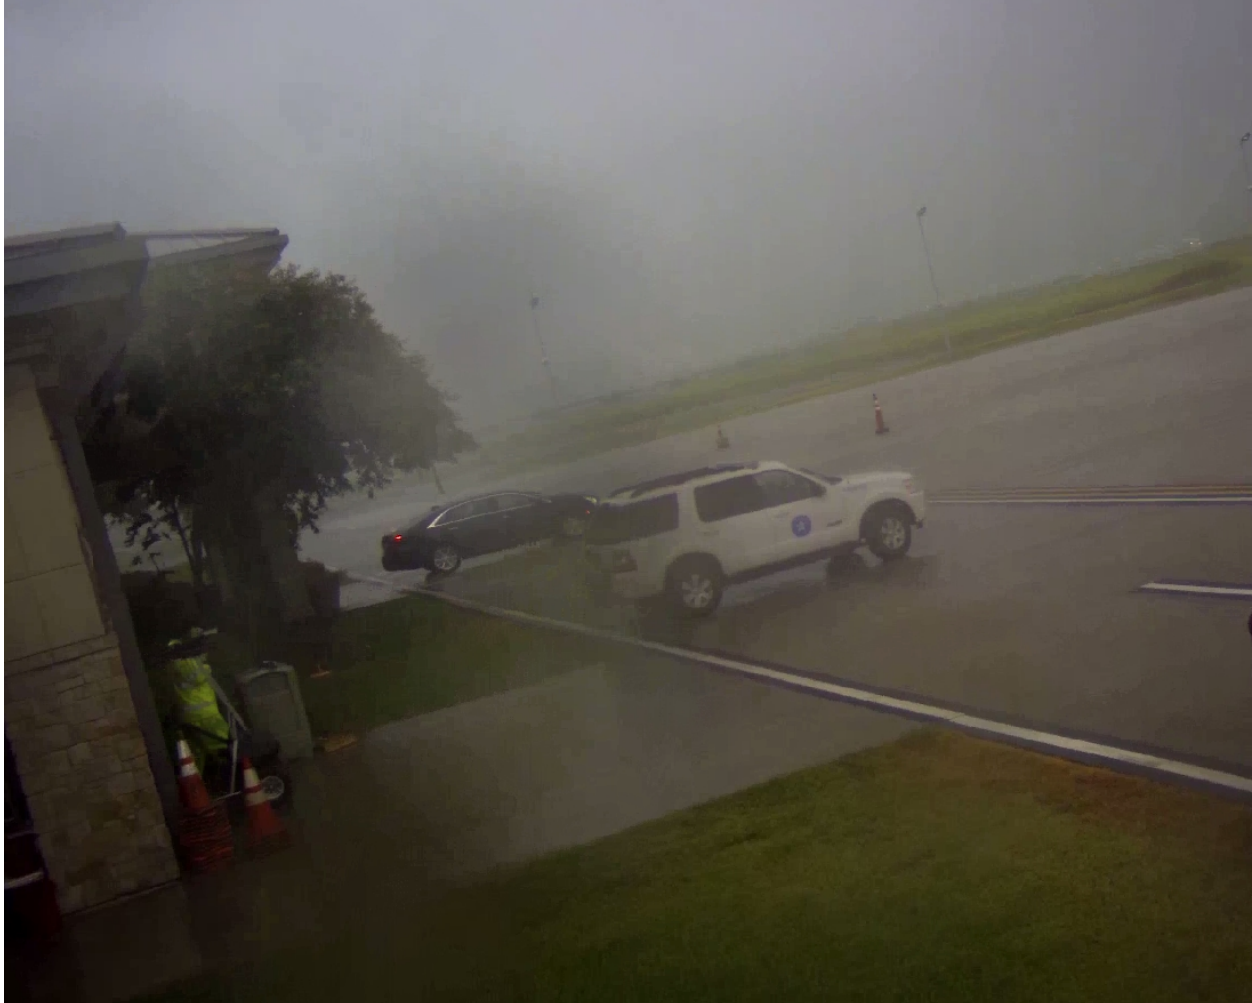
Figure 43 – SGR Security Camera image looking south-southwest towards the south end of the SGR runway at 1450:16 CDT

Figure 44 – SGR Security Camera image looking south-southwest towards the south end of the SGR runway at 1454:56 CDT

Figure 45 – SGR Security Camera image looking south-southwest towards the south end of the SGR runway at 1500:00 CDT

Figure 46 – SGR Security Camera image looking south-southwest towards the south end of the SGR runway at 1505:00 CDT

Figure 47 – SGR Security Camera image looking south-southwest towards the south end of the SGR runway at 1508:17 CDT

Figure 48 – SGR Security Camera image looking south-southwest towards the south end of the SGR runway at 1509:11 CDT

Figure 49 – SGR Security Camera image looking south-southwest towards the south end of the SGR runway at 1510:03 CDT

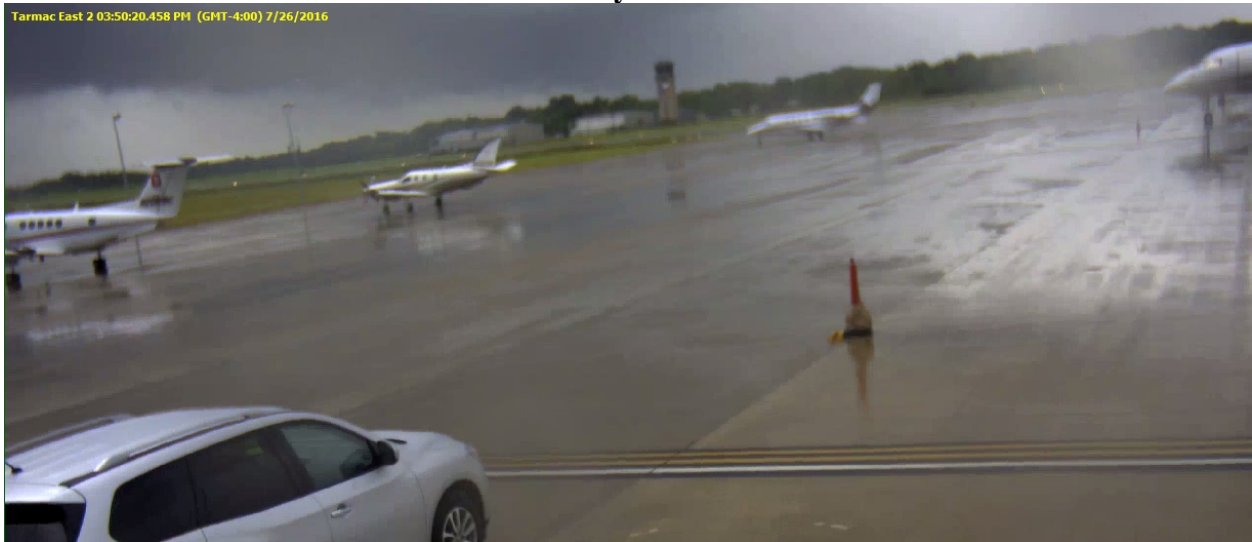
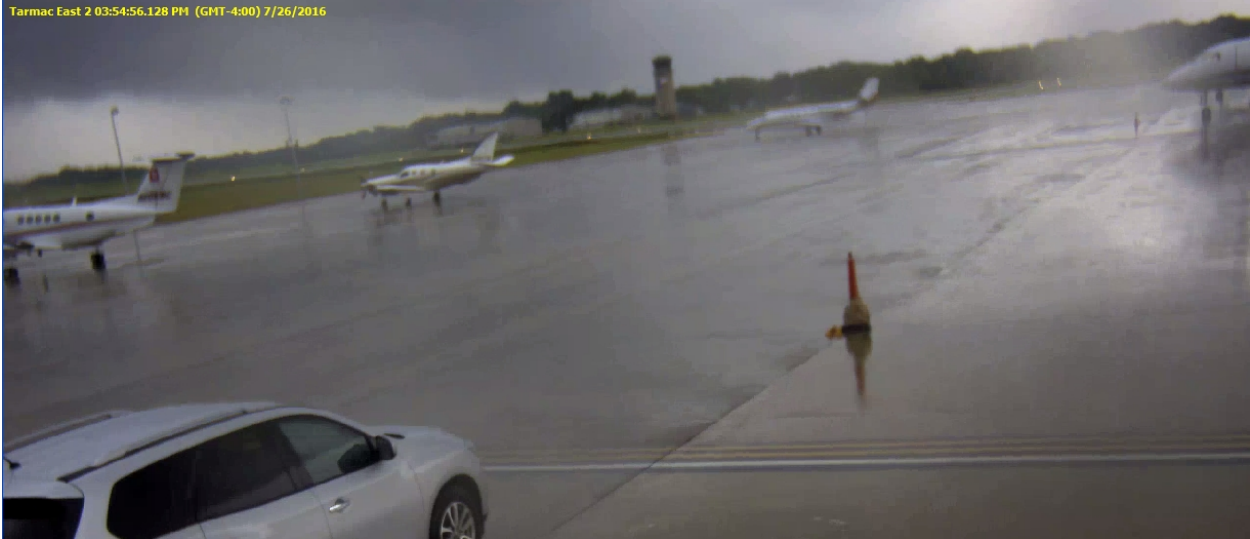
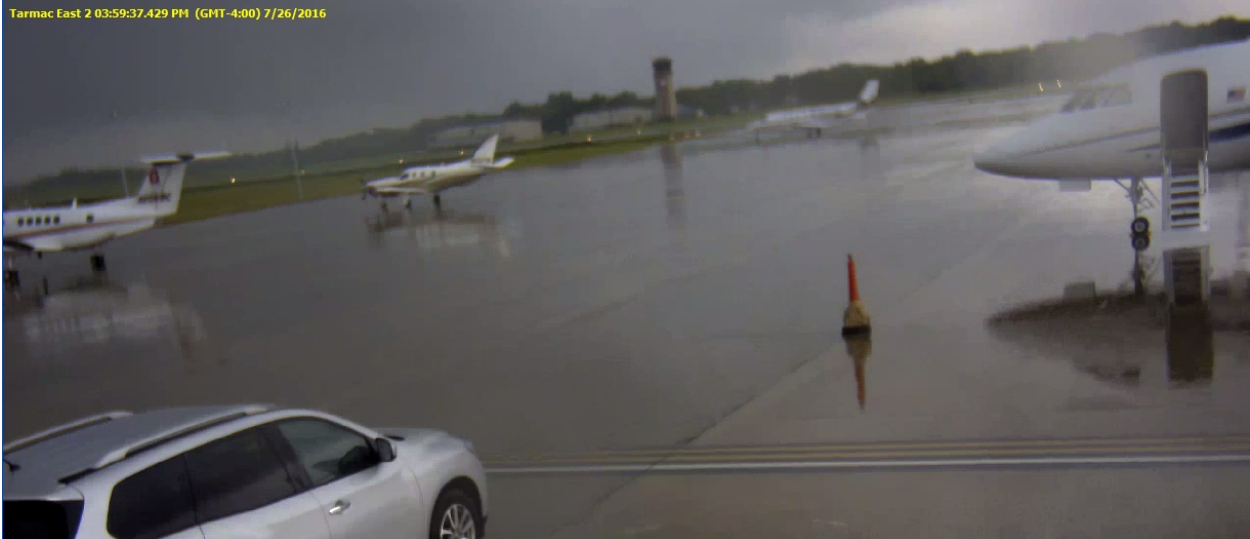
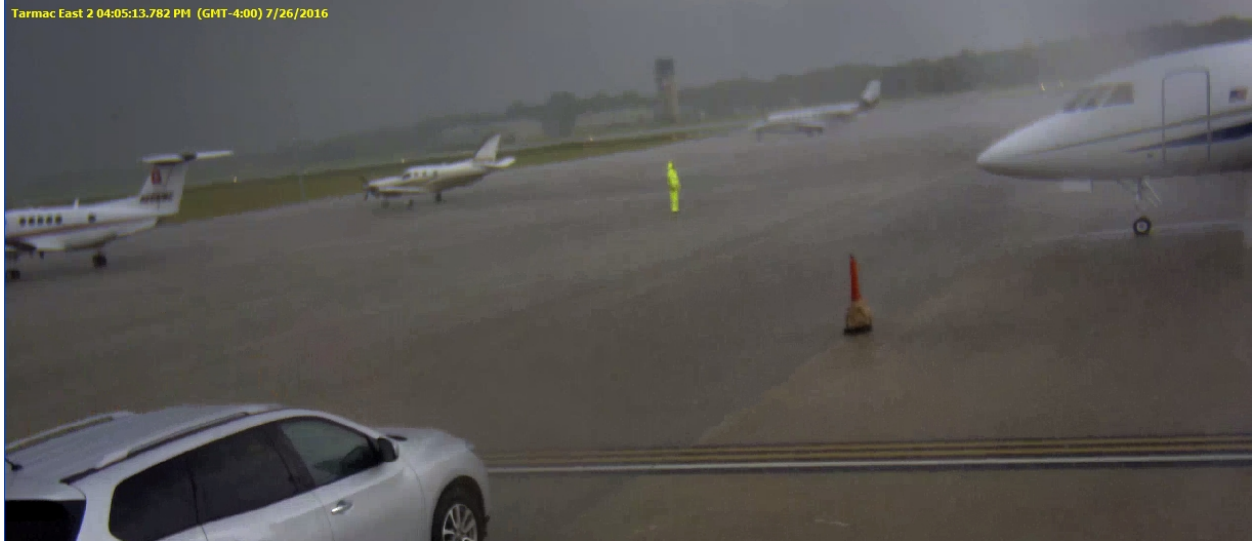
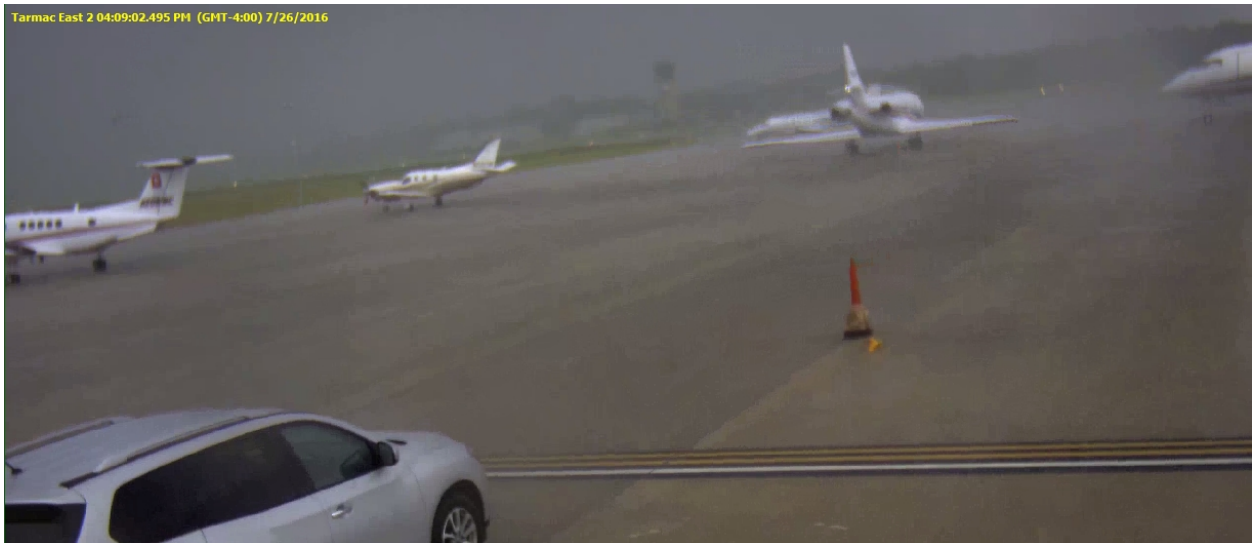
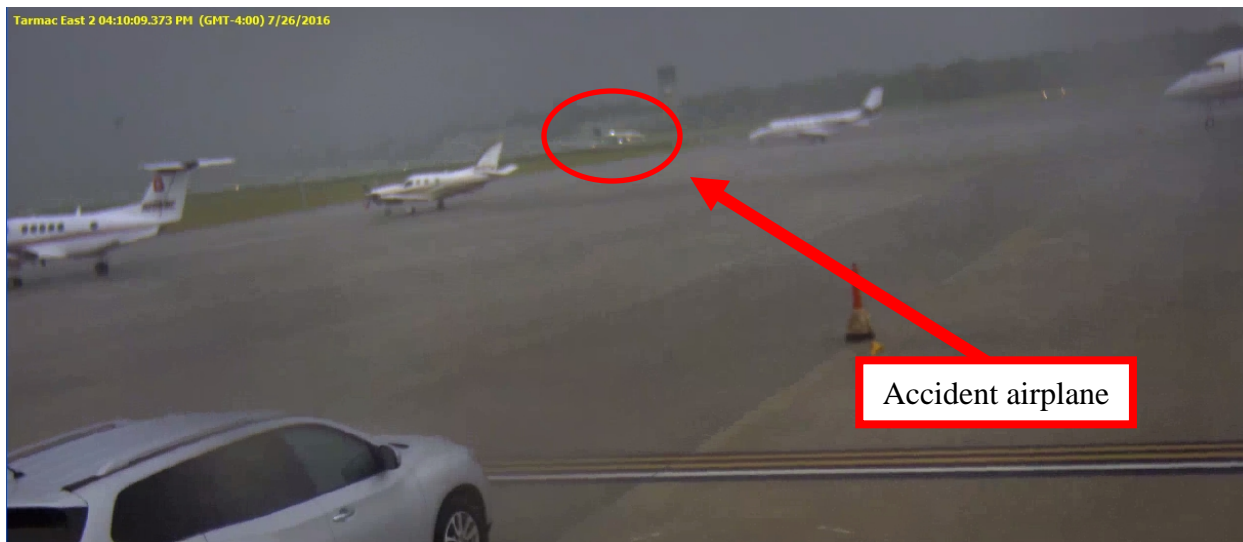
Figure 50 – SGR Security Camera image looking west-southwest towards the air traffic control tower at 1450:20 CDT

Figure 51 – SGR Security Camera image looking west-southwest towards the air traffic control tower at 1454:56 CDT

Figure 52 – SGR Security Camera image looking west-southwest towards the air traffic control tower at 1459:37 CDT

Figure 53 – SGR Security Camera image looking west-southwest towards the air traffic control tower at 1505:13 CDT

Figure 54 – SGR Security Camera image looking west-southwest towards the air traffic control tower at 1509:02 CDT

Figure 55 – SGR Security Camera image looking west-southwest towards the air traffic control tower at 1510:09 CDT
