NATIONAL TRANSPORTATION SAFETY BOARD

Aircraft Performance & Simulation Study

Location: Chamberlain, South Dakota
Date: November 30, 2019
Time: 12:33 Central Standard Time (CST)
Aircraft: Pilatus Aircraft Ltd. PC-12/47E, registration N56KJ
NTSB#: CEN20FA022

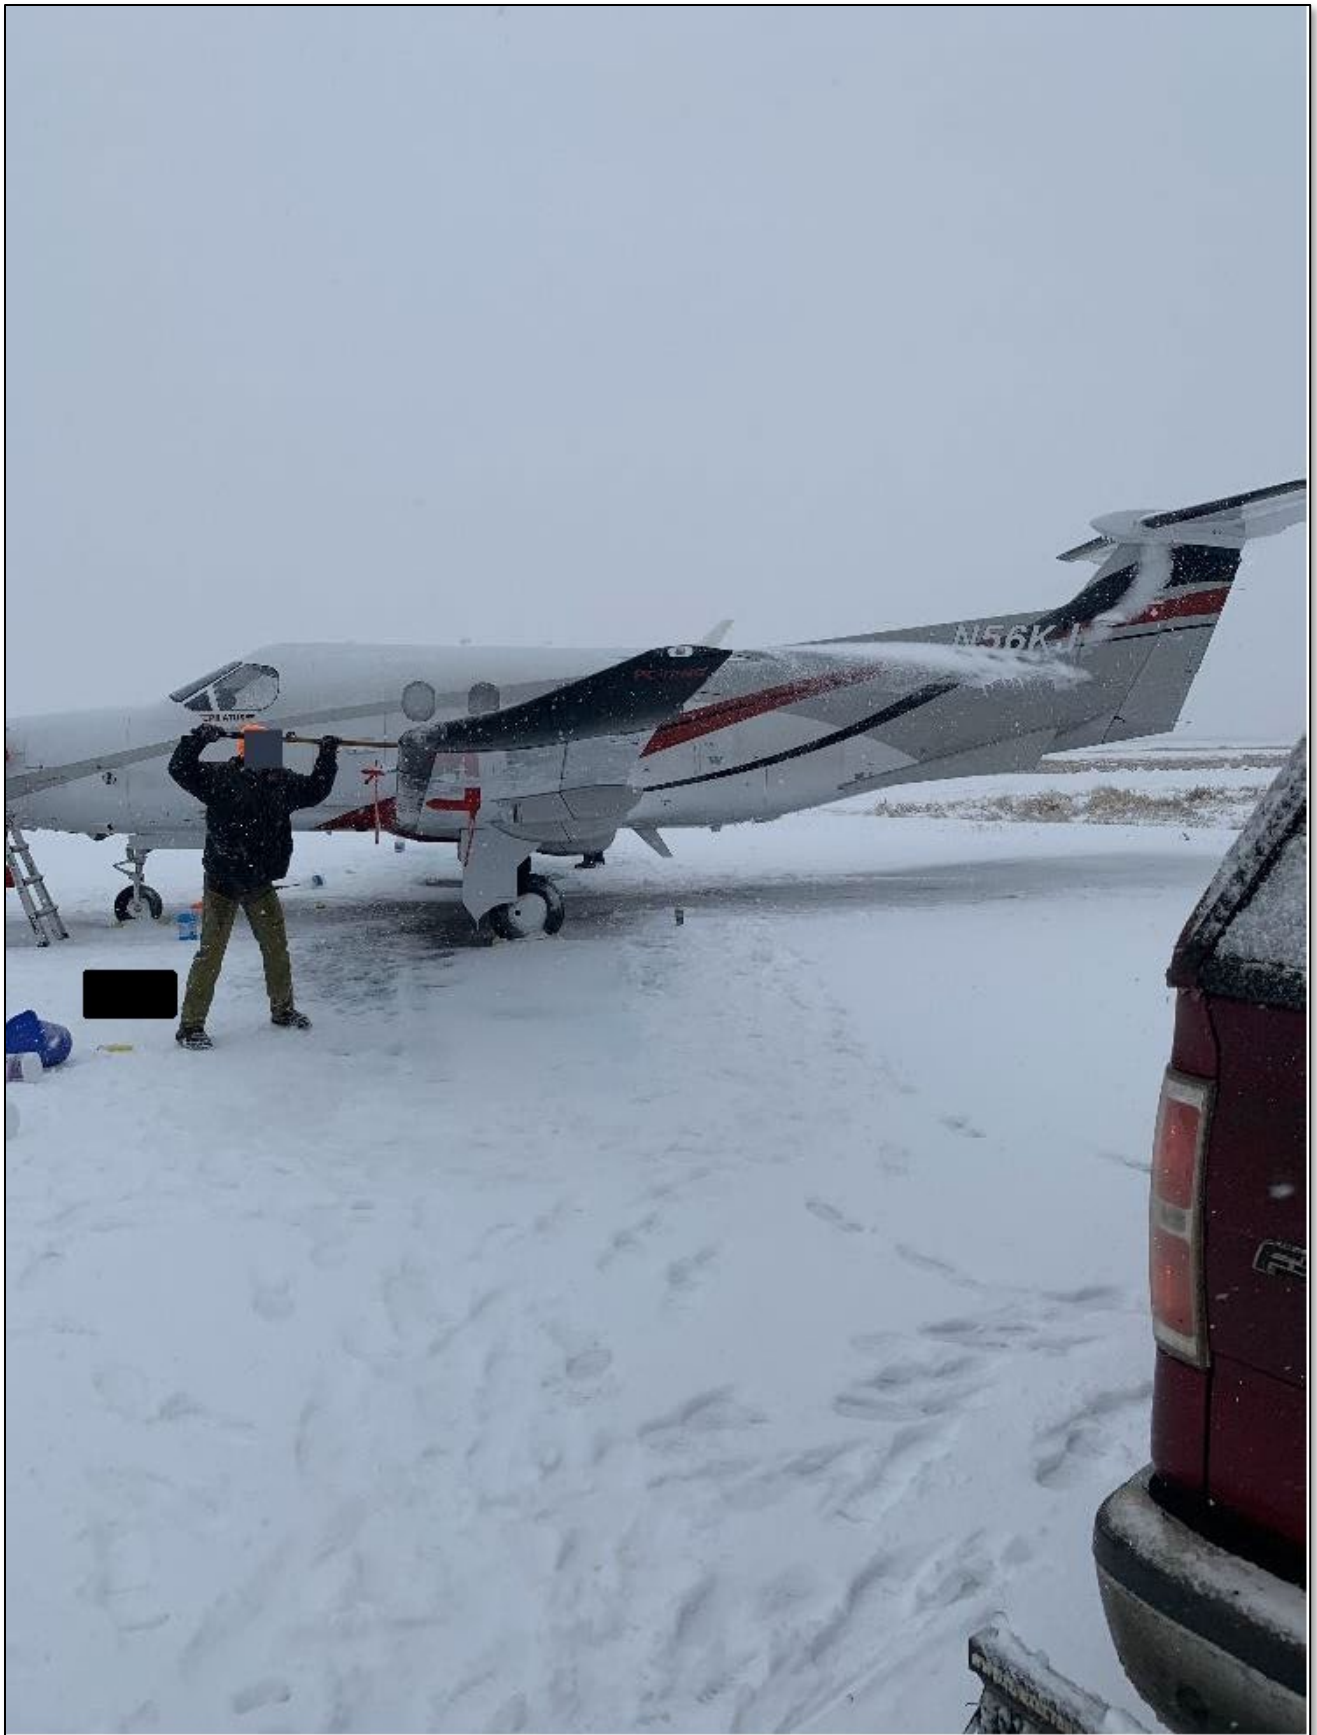
Figure 1. Photograph of N56KJ taken at 11:02:49 CST (from Reference 2).

Figure 1, a photograph taken at 11:02:49, shows “a person ... using a tool to deice the left wing” (Reference 2). There is “visible moisture” (that appears to be snow) falling in the photo. Figure 2 compares the vertical tail portion of the airplane shown in Figure 1 with a similar photo taken at 12:21:40 and with a photo of an exemplar PC-12. Reference 2 notes that, compared to the “clean” exemplar photo, the 11:02:49 photo

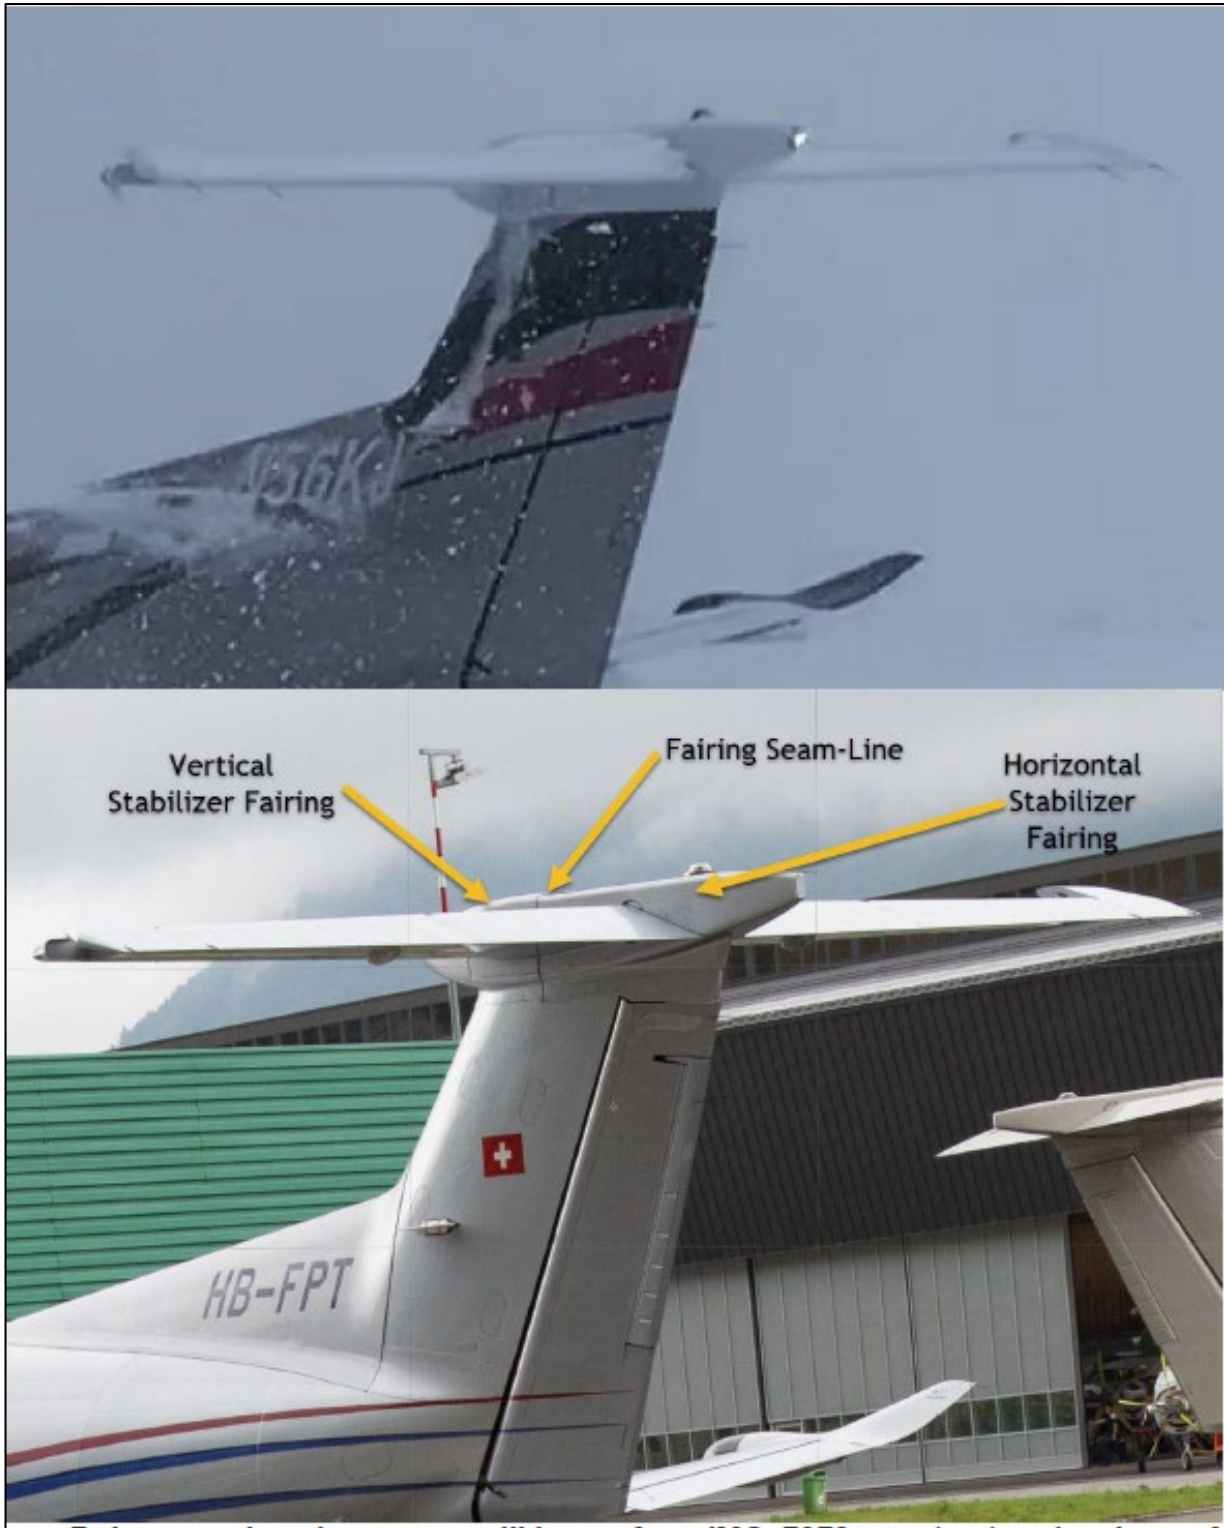
Figure 3. Comparison of N56KJ's horizontal tail area before takeoff on the accident flight with an exemplar airplane (from Reference 2).

Similarly, the 12:21:40 photo

shows accumulated precipitation forward of the horizontal stab's leading edge. The comparison shows accumulated precipitation build-up above the leading edge of the horizontal stab. It also shows accumulated precipitation build-up on the vertical stab and icicles were present on the horizontal stab bullet fairing.

As noted in Reference 2, in the 12:21:40 photo "there is additional accumulated precipitation" and "there is more visible moisture ... falling" than in the 11:02:49 photo.

- The most aft computed CG (245.76 in.) is 5.49 inches aft of the aft CG limit (240.27 in.)
- The aft CG is consistent with the observation by Pilatus that when taking the exemplar photograph shown in Figure 3, "we couldn't recreate the viewpoint of a person standing on the ground, even after loading 200 kg of sandbags into the rear of the fuselage. Instead, the photographer had to stand on a ladder. This further corroborates that the accident aircraft was sitting on the ground tail-low (nose-high)."

Values of α_c for flap angles between 0° and 15° are determined by linear interpolation. As shown in Figures 9, 11, 22, and 24, the modified simulation matches the FDR climb performance better than the unmodified simulation. Moreover, the differences between the modified simulation results and the FDR data during the accident takeoff are similar to those during the KIDA takeoff, and so the simulator matches do not reveal any significant degradation in performance due to the snow and ice accumulations shown in Figures 2 & 3.

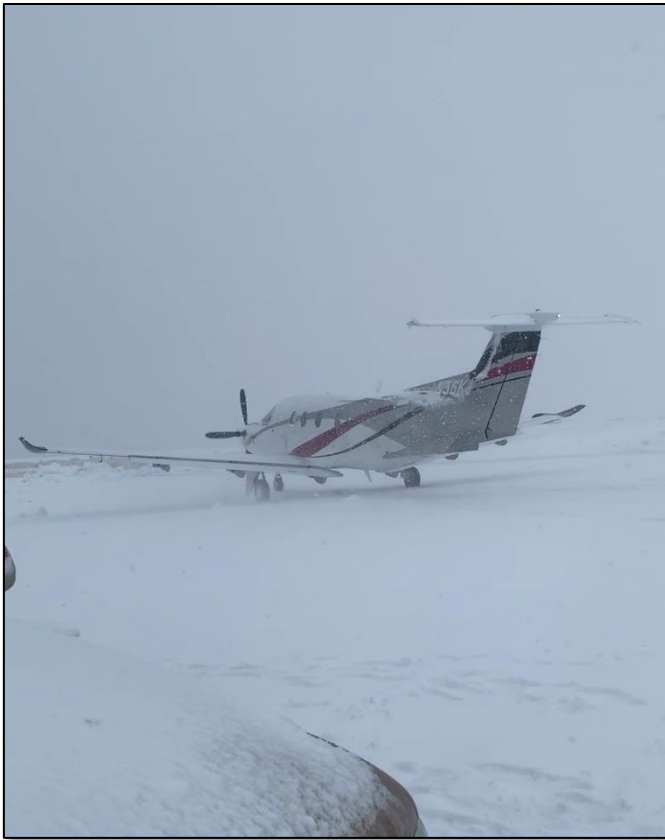
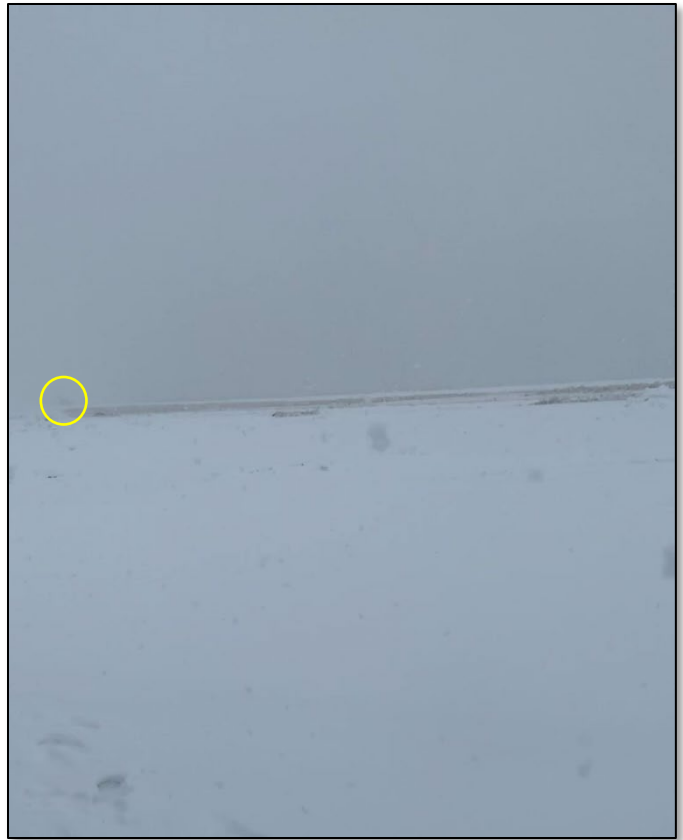
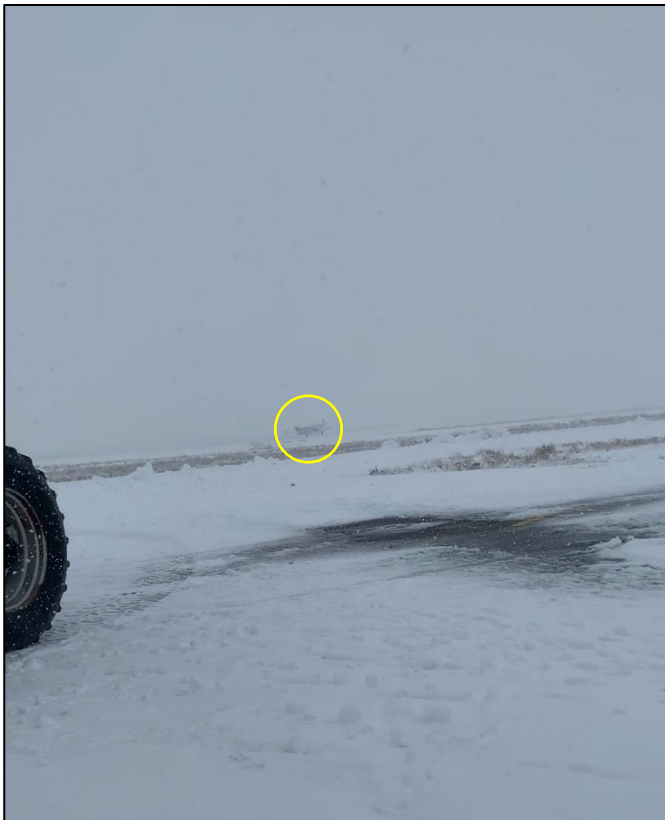
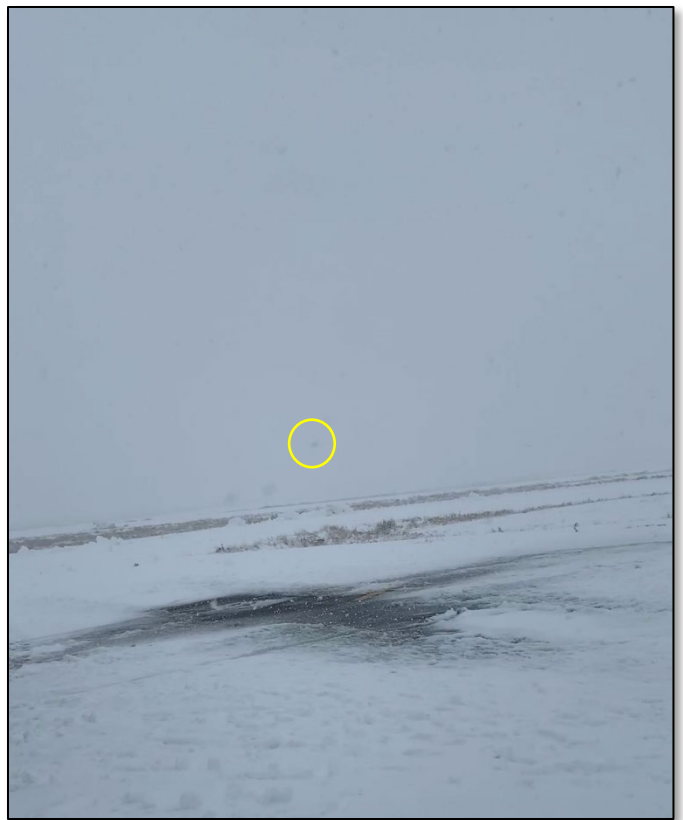
Figure 4. Video frames showing (a) taxi towards runway; (b) start of takeoff roll; (c) approximate liftoff point; and (d) N56KJ turning left and climbing into low overcast.

An individual at K9V9 took pictures and videos of the accident airplane on the ramp prior to its departure, during its taxi to the runway, and during its takeoff roll and liftoff. The pictures and videos were provided to the NTSB, as described in the NTSB *Image/Video Study* for this accident (Reference 2). Selected images from Reference 2 are duplicated here as Figures 1-3.

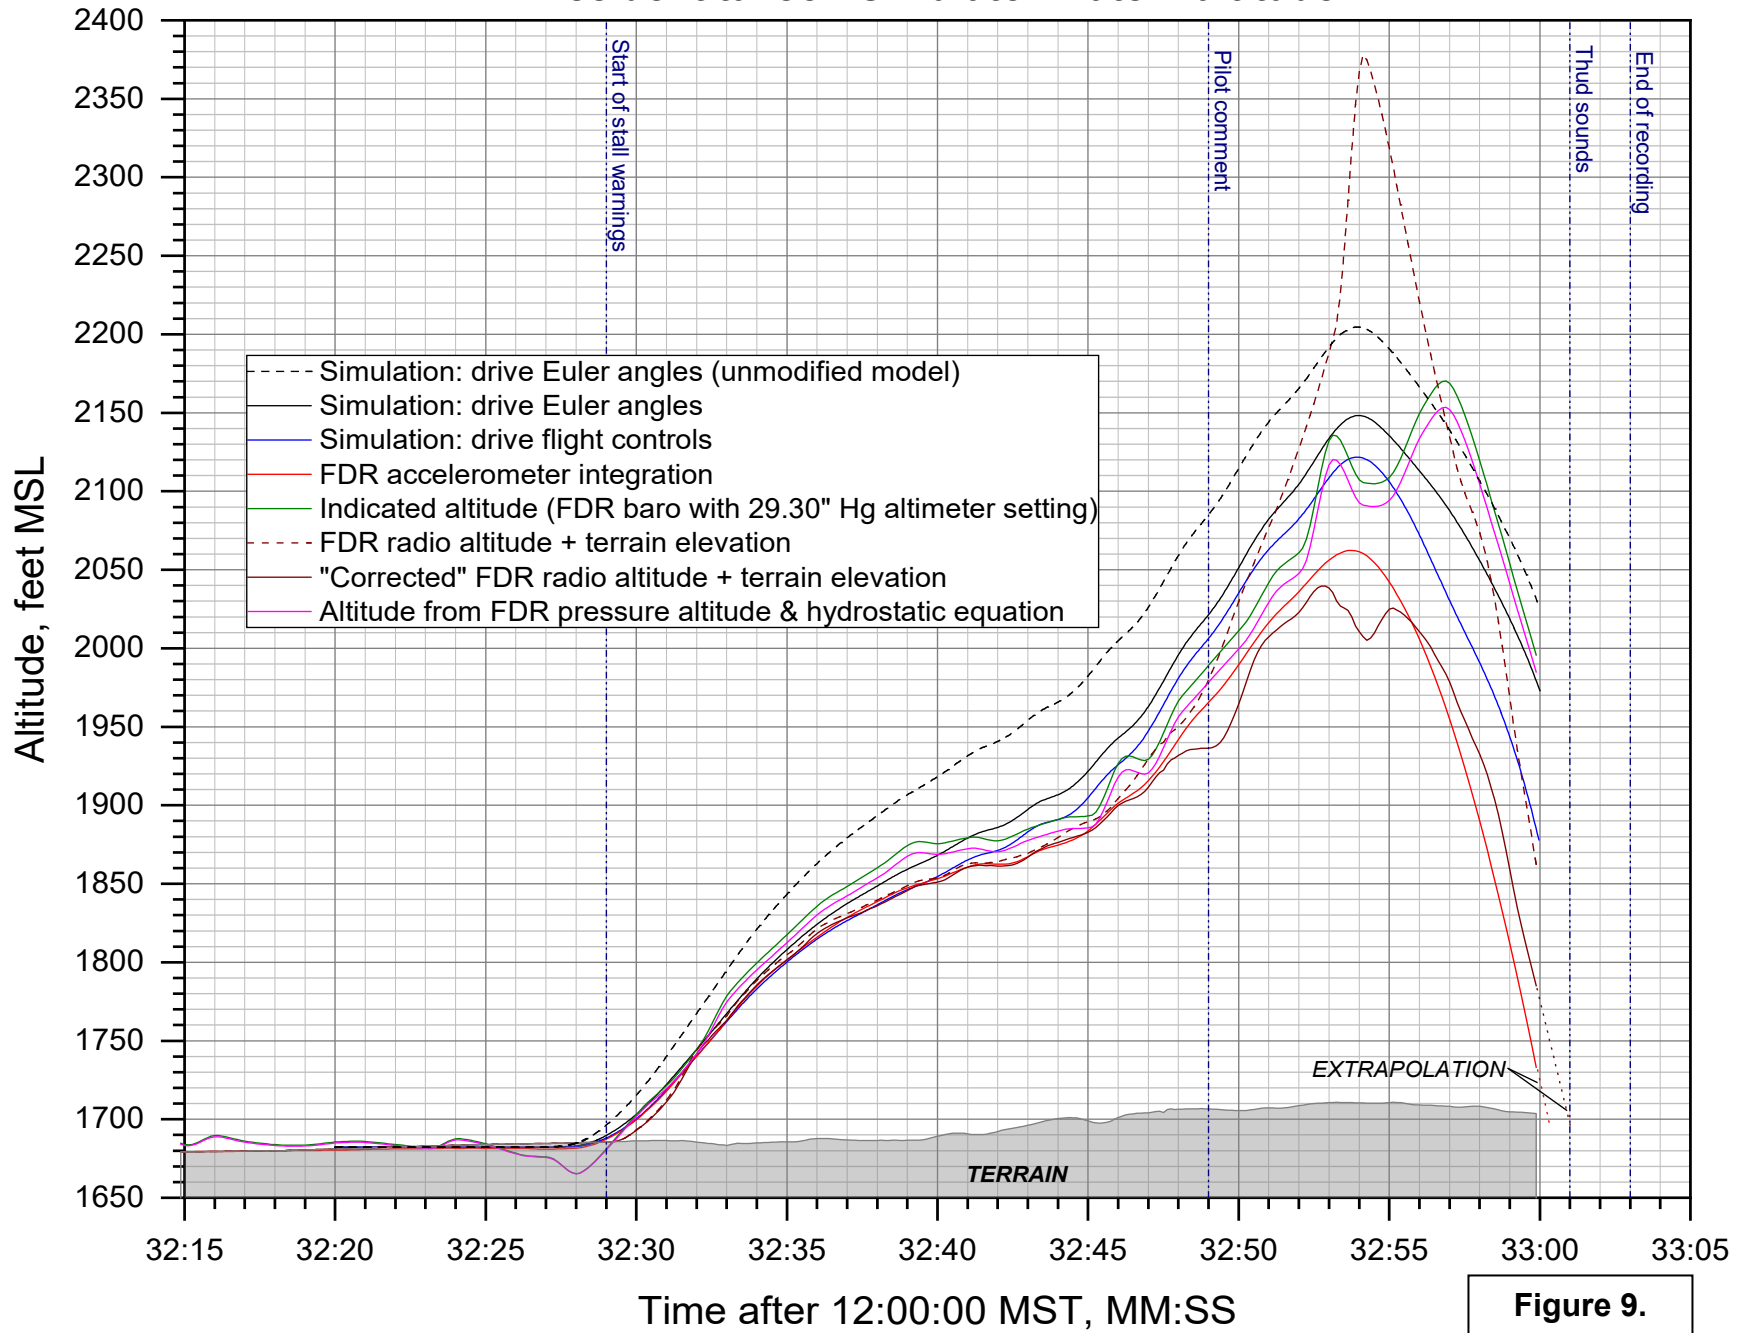
Figure 9.

The result of this calculation is shown in Figure 9 as the magenta line labeled “Altitude from FDR pressure altitude & hydrostatic equation.” The FDR pressure altitude is about 580 ft. above the magenta line.

The indicated altitude is the altitude shown on the airplane’s altimeters. It is the pressure altitude corrected for the non-standard altimeter setting only (29.30 “Hg), and is shown in Figure 9 as the green line. Note that the indicated altitude (green line) deviates slightly from the hydrostatic-derived altitude (magenta line) as altitude increases; this deviation results from the non-standard lapse rate of pressure with altitude.

Note also that the barometric-based altitudes in Figure 9 (the indicated altitude and hydrostatic equation altitude) contain erratic oscillations near the end of the data, starting around time 12:32:52. These oscillations might be the result of erroneous static pressure readings at the static ports, caused by disrupted airflow around the fuselage at large α , and by the large, oscillatory pitch rates present at the time. As will be discussed further below, the airplane likely exceeded the flaps 15 stall α (between 12.9° and 13.9°) a little after 12:32:52.

Accident takeoff simulator match: altitude

The line labeled “Simulation: drive Euler angles (unmodified model)” in Figures 9 and 11 shows that driving the original (unmodified) simulation model with the FDR Euler angles results in a rate of climb and maximum altitude notably higher than those computed from the accelerometer integration. Reasons for this might include inaccuracies in the simulator model itself, and / or a degradation in N56KJ’s aerodynamic performance (specifically, decreased lift and increased drag) due to snow and ice accumulation on the airframe.¹⁵

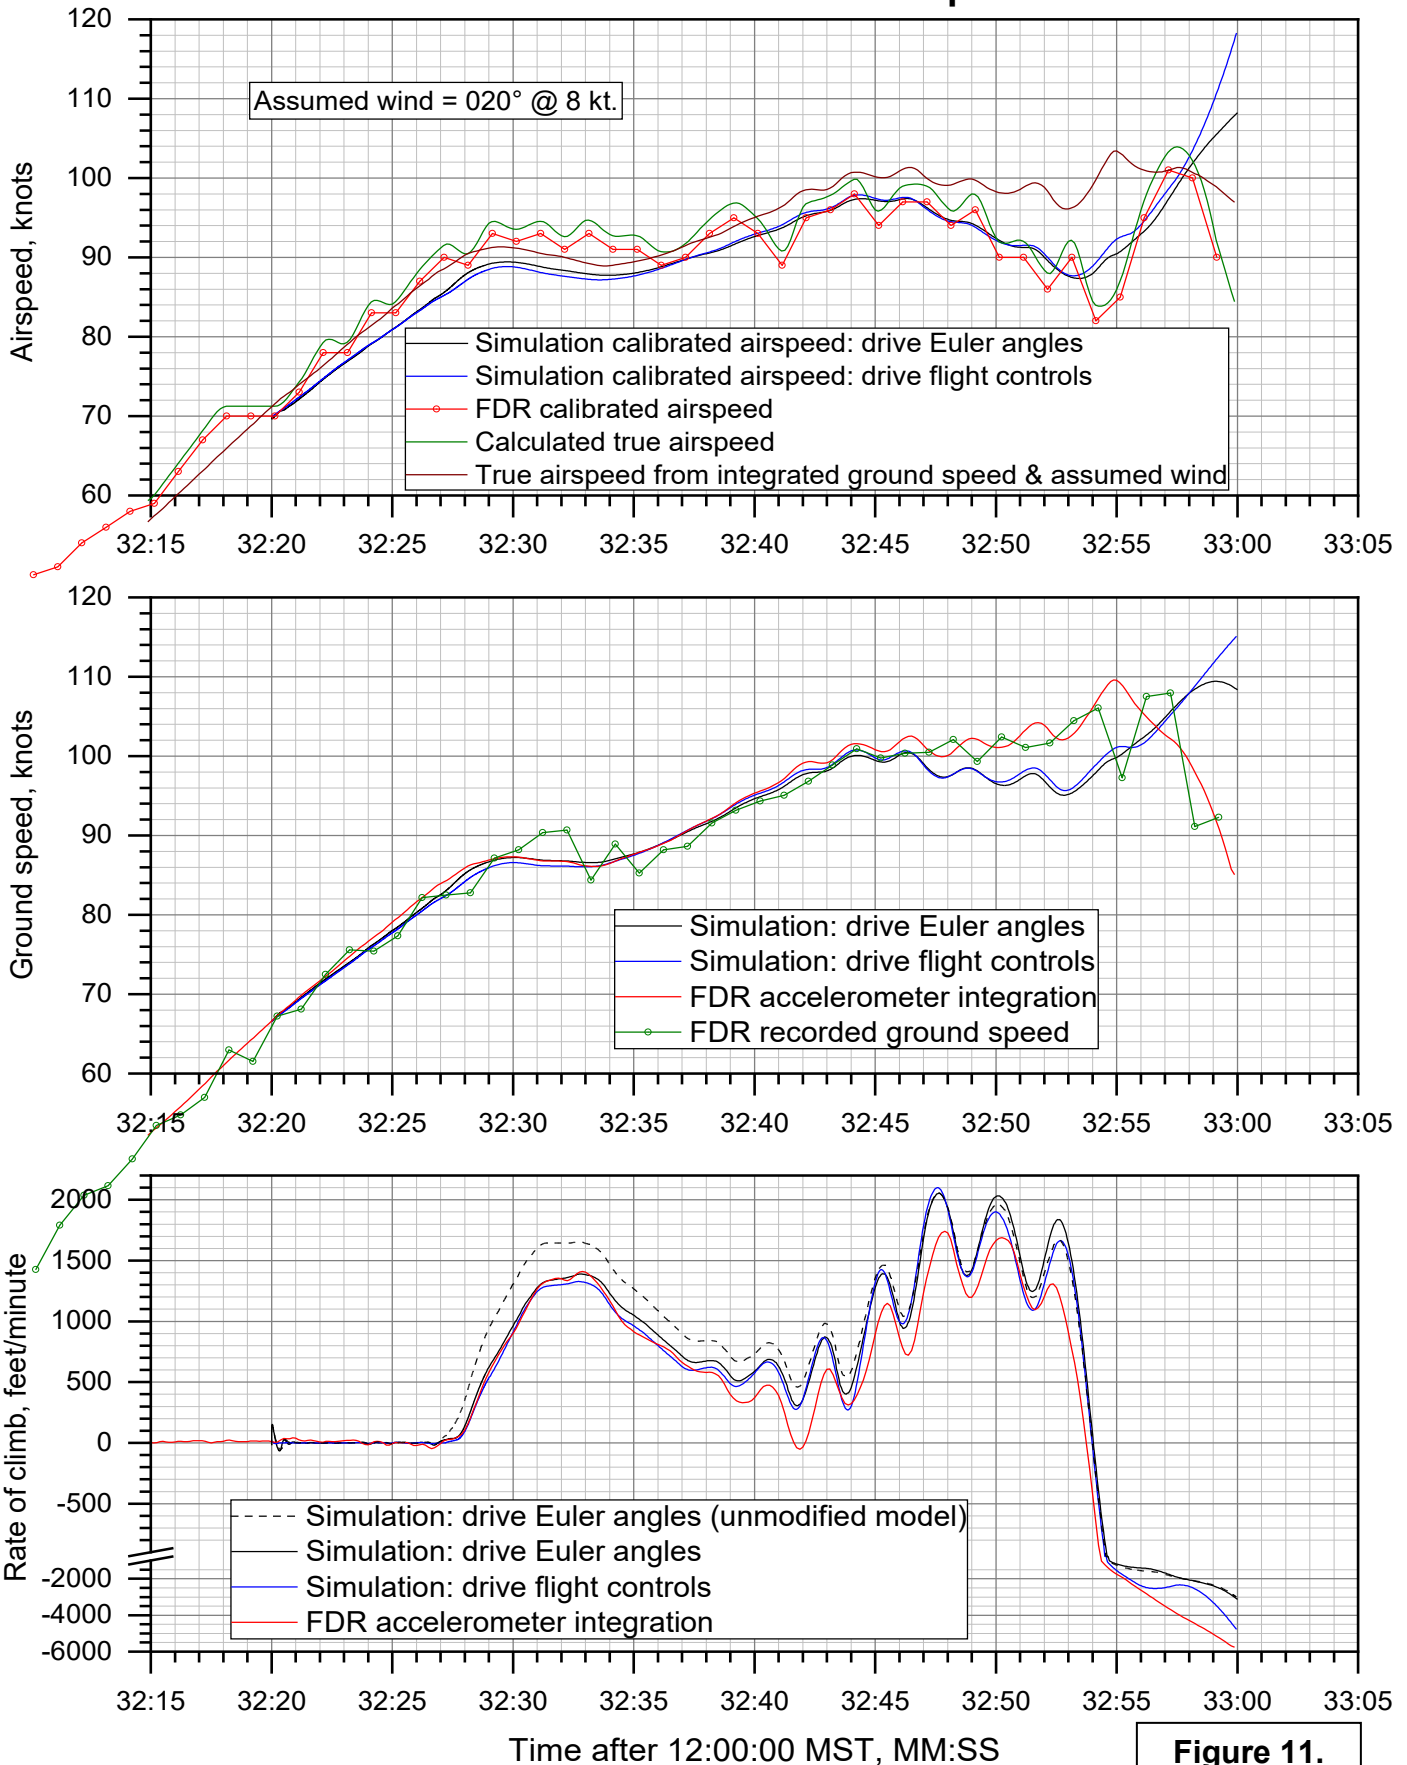
Figure 11.

Figure 11 shows the results of the true airspeed calculation, compared with the indicated (calibrated) airspeed recorded by the FDR. For the accident flight conditions, the true airspeed is about 2 knots higher than the calibrated airspeed.

Accident takeoff simulator match: speeds vs. time

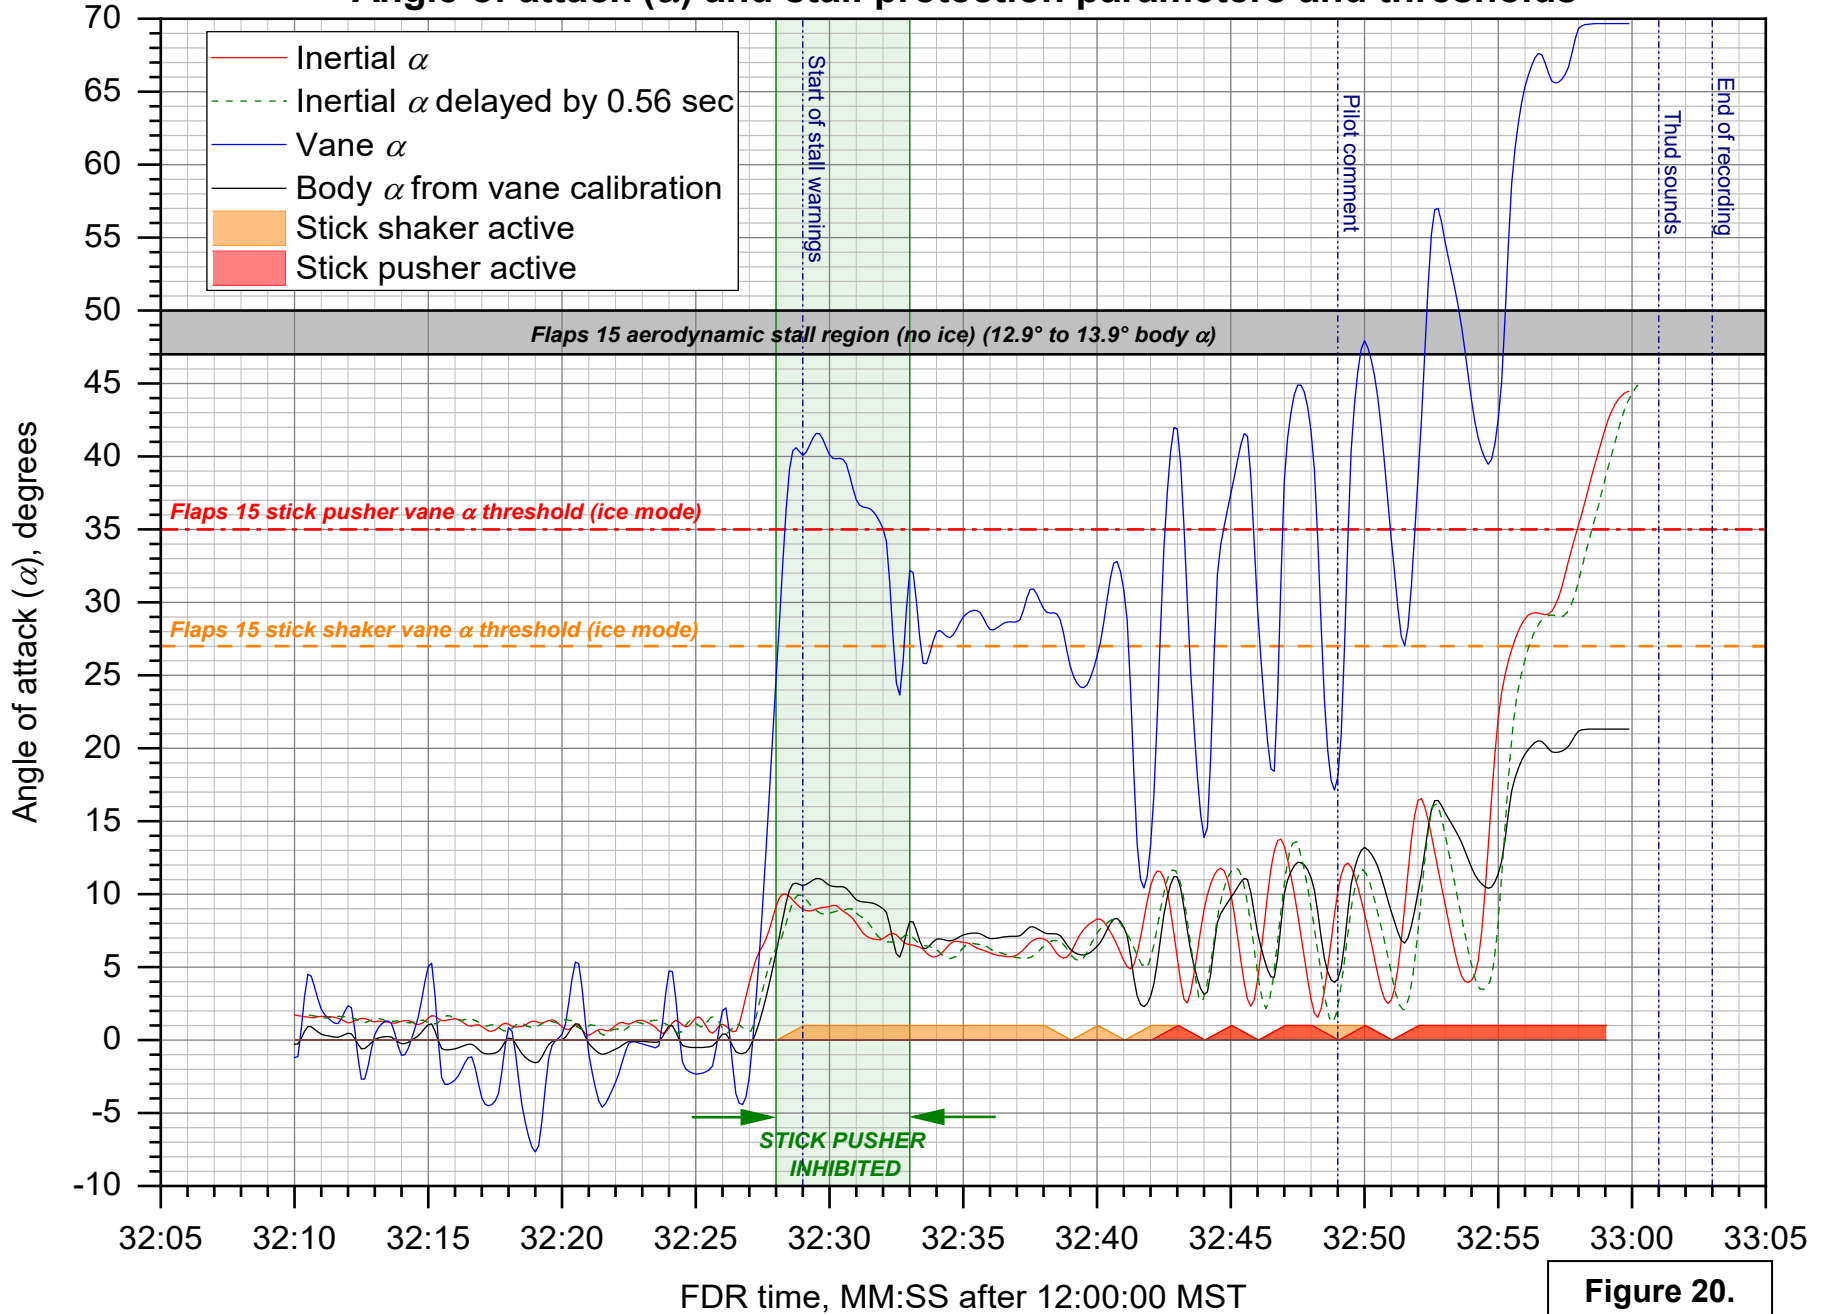
Figure 20.

Figure 20 shows that on the accident flight, the FDR vane angle first enters the stall region at about 12:32:50, and penetrates deeply into the stall region after about 12:32:52. Consequently, after these times separated flow over portions of the wings is likely, and the fidelity of the aerodynamic model will degrade. The divergence between the airplane and FDR flight paths shown in Figures 8 and 9 is consistent with this premise. However, up to the stall, the agreement between the (modified) simulation model and the FDR data is relatively good. Consequently, using the simulation to infer other, unrecorded information about the flight up to the stall is reasonable; of particular interest are the flight control inputs, forces, and control surface

Angle of attack (α) and stall protection parameters and thresholds

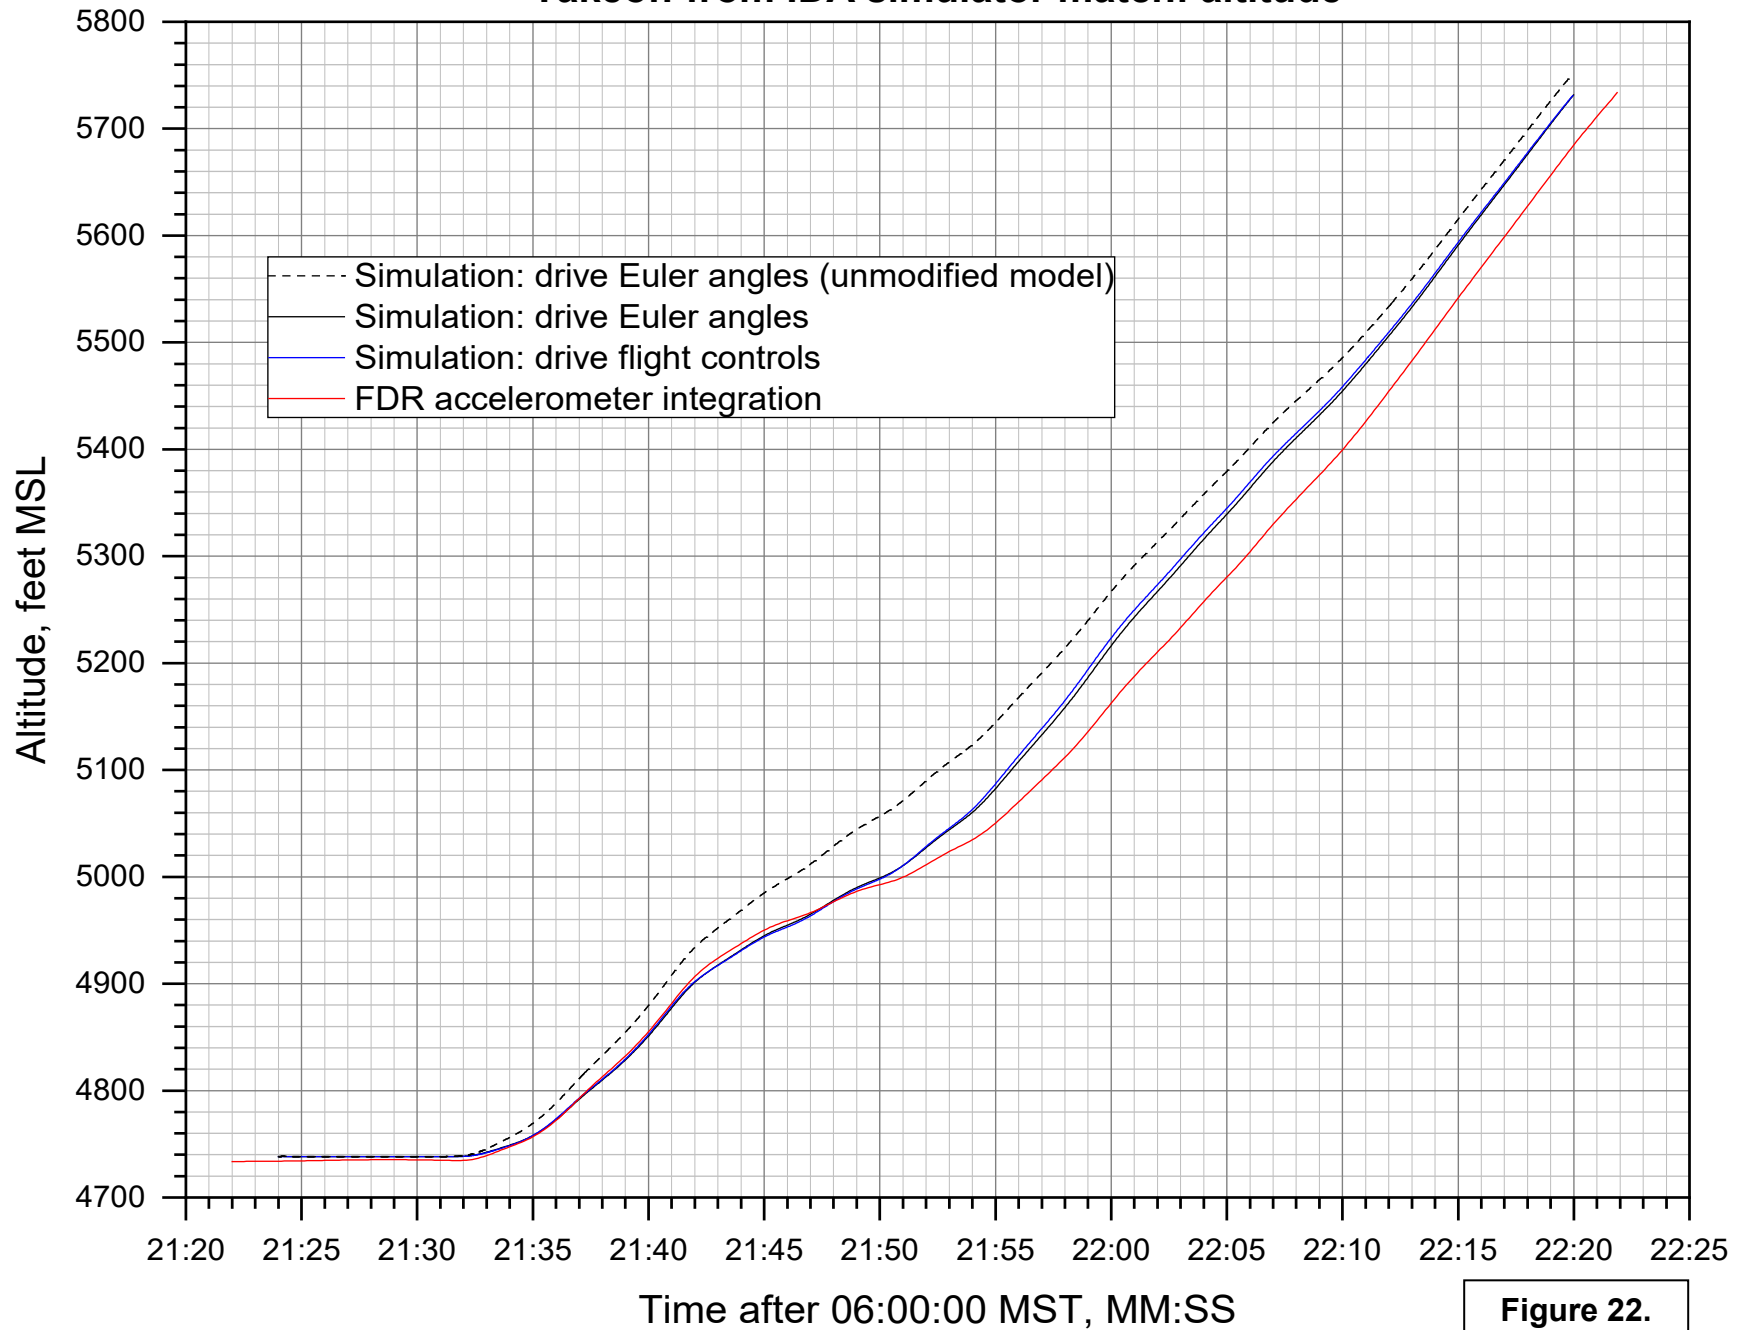
Figure 22.

CEN20FA022: Pilatus PC-12/47E, N56KJ, Chamberlain, SD, 11/20/2019
Takeoff from IDA simulator match: altitude

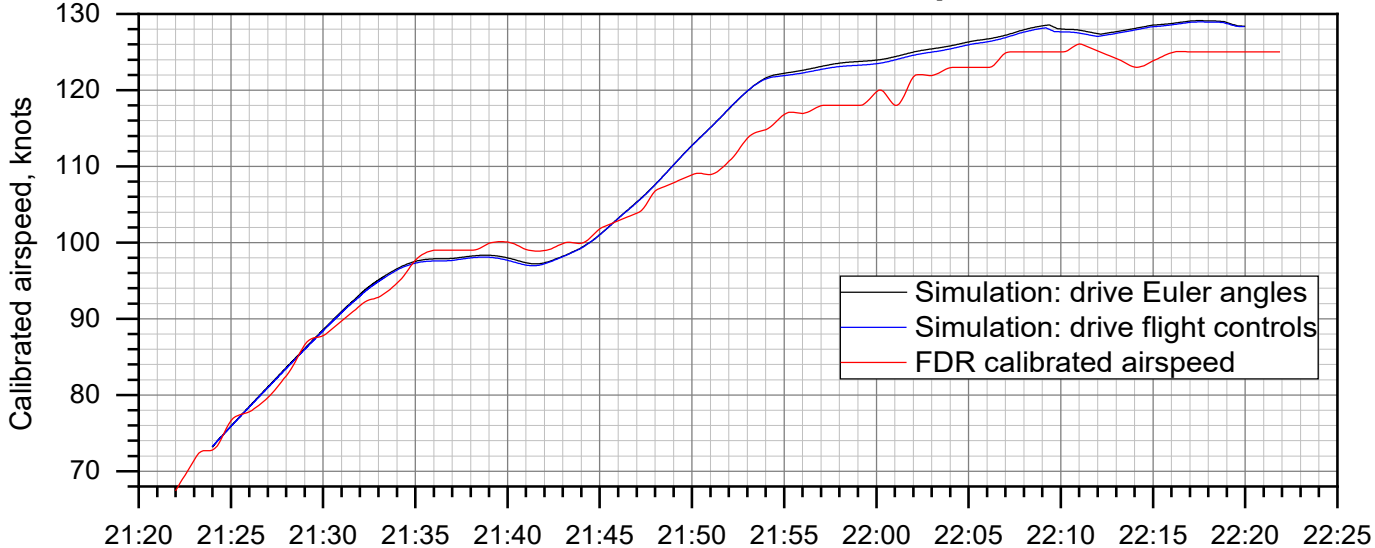
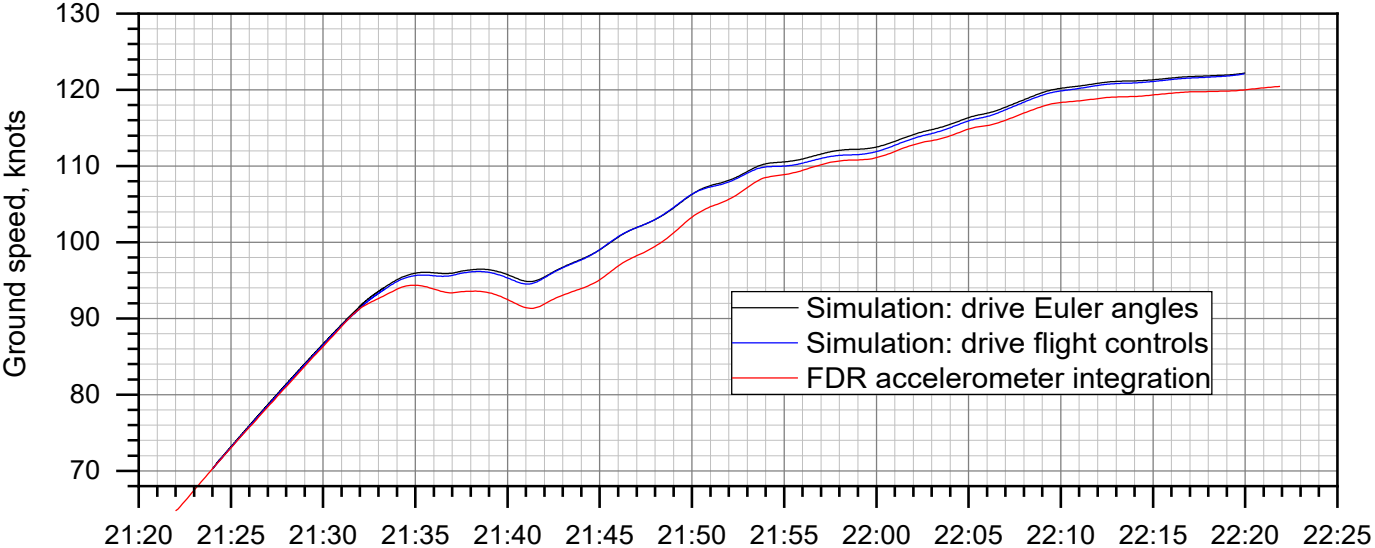
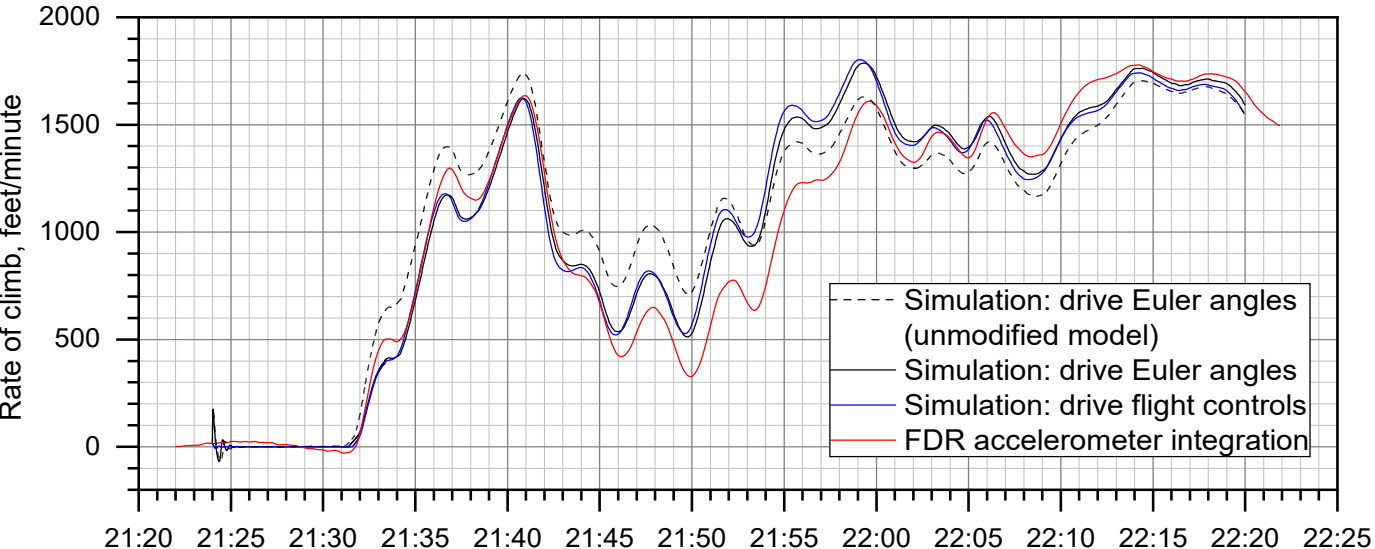
Figure 24.

Takeoff from IDA simulator match: speeds vs. time
