NATIONAL TRANSPORTATION SAFETY BOARD

Vehicle Recorder Division

Cockpit Displays – Recorded Flight Data

Specialist's Factual Report
by Sean Payne

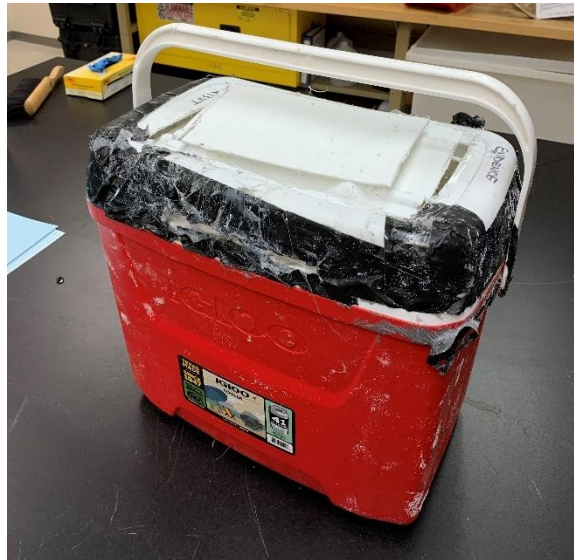
The aircraft and avionics were recovered from a river at the accident site and the avionics were water damaged. The avionics were delivered to the NTSB Vehicle Recorder Laboratory in water to inhibit the corrosion process and facilitate possible recovery. Figure 1 is a photo of the devices shipped to the lab in a sealed cooler. Figure 2 is a photo of the devices receiving a deionized-water rinse in a bucket.

Figure 1. Photo of devices as delivered to the laboratory.

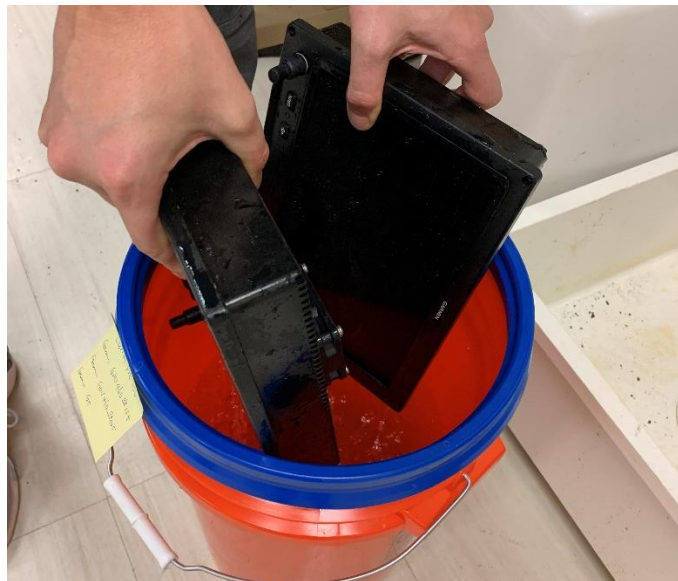
Figure 2. Photo of being rinsed in fresh water.

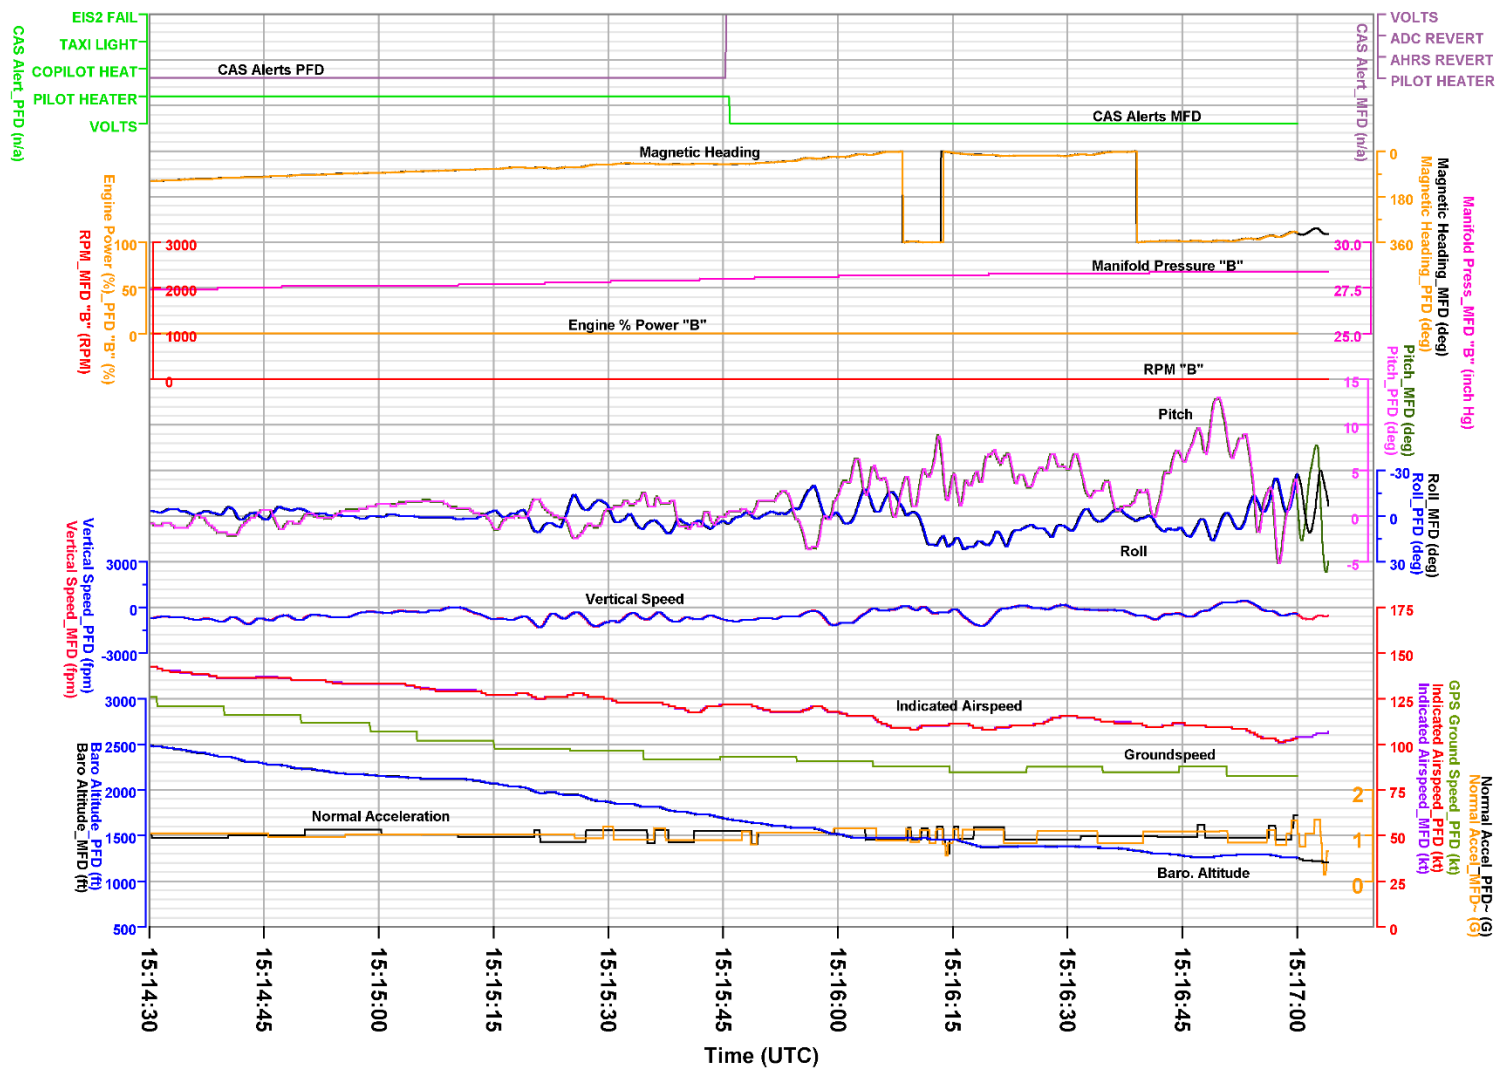
Figure 12 is a super-expanded timescale plot of basic aircraft performance, systems and engine parameters for the end of the accident recording.

Figure 12. A super-expanded timescale plot of basic aircraft performance, systems and engine parameters for the end of the accident recording.

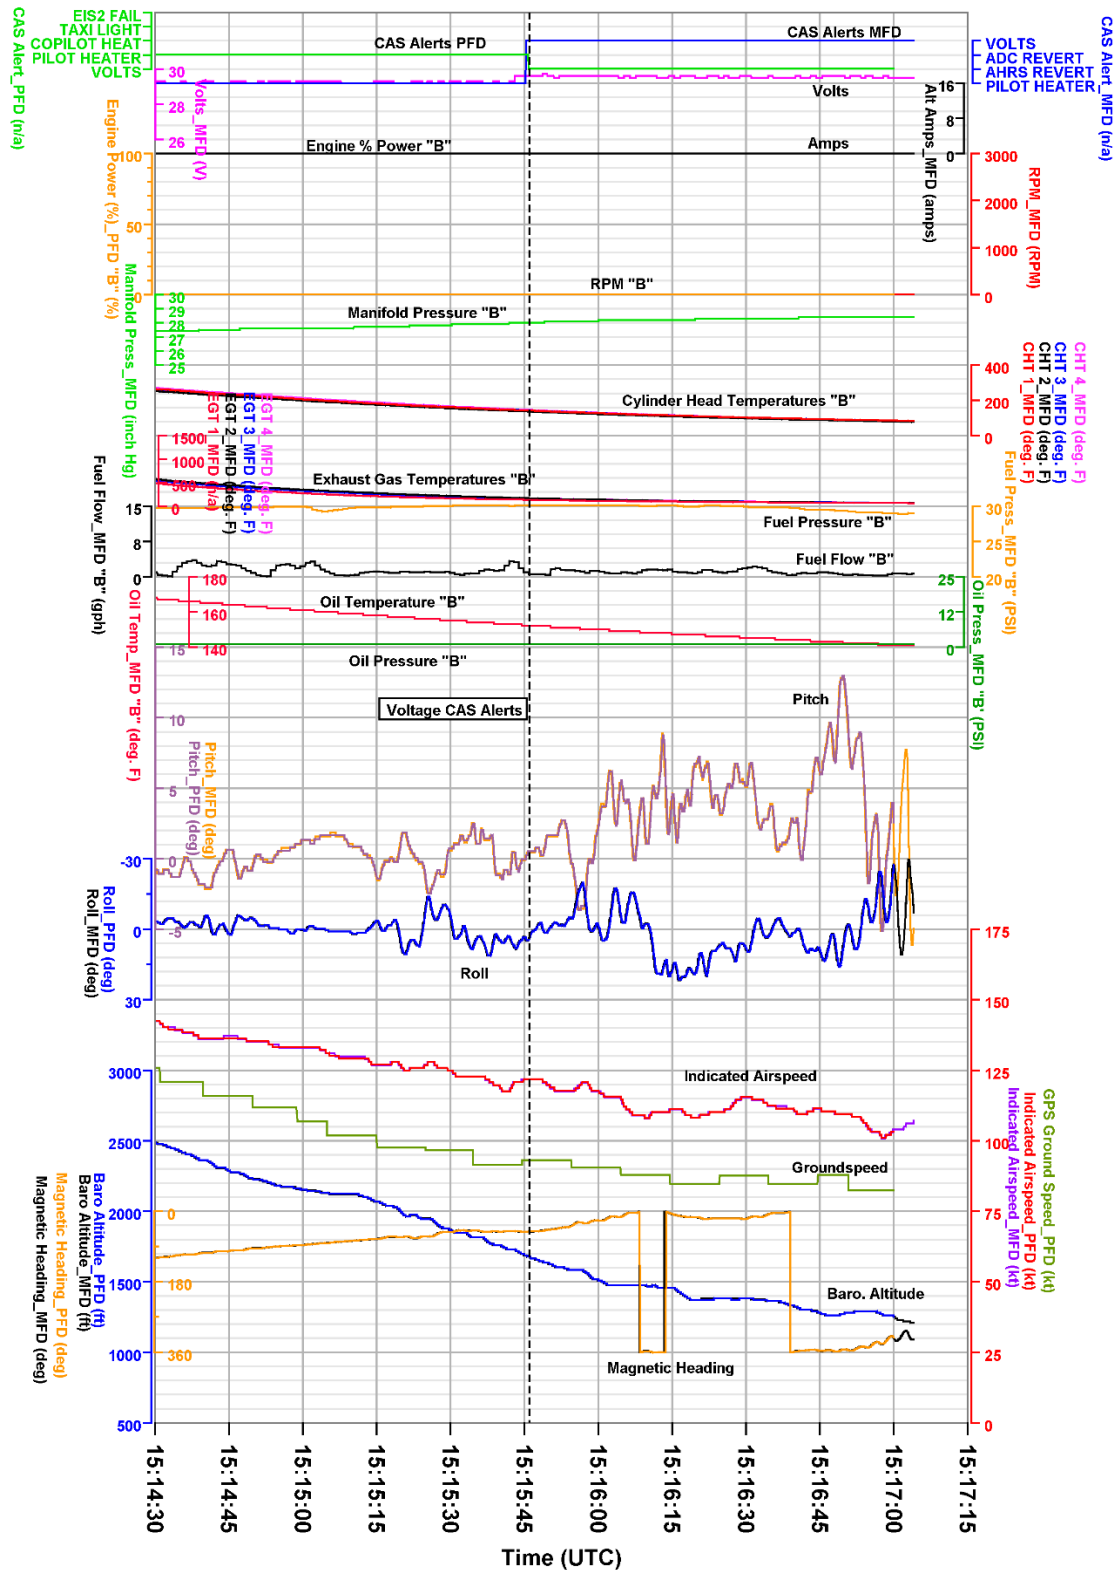
Figure 15 is a plot of basic aircraft performance parameters and all available and validated engine performance data for Engine “B” for the end of the accident recording.

Figure 15. A plot of basic aircraft performance parameters and all available and validated engine performance data for Engine "B" for the end of the accident recording.

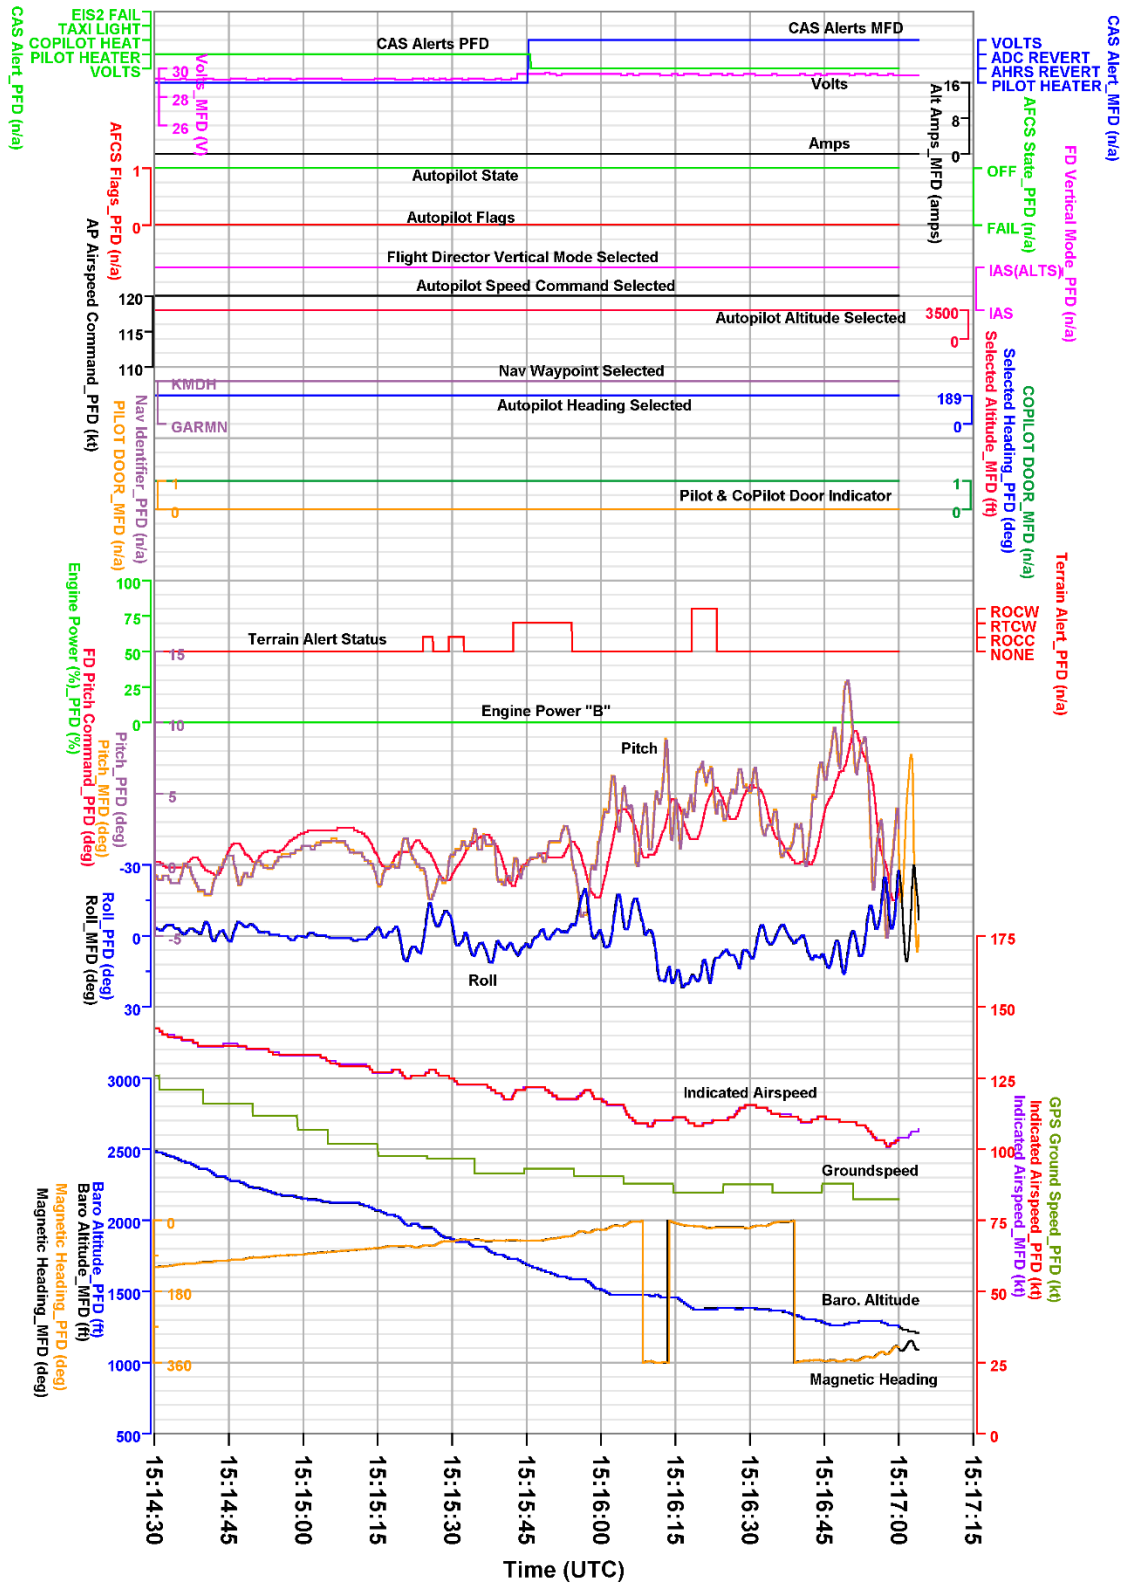
Figure 18 is a further expanded plot of basic aircraft performance parameters and all available and validated aircraft systems data for the final portion of the accident recording.

Figure 18. A plot of basic aircraft performance parameters and all available and validated aircraft systems data for the final portion of the accident recording.
