# NATIONAL TRANSPORTATION SAFETY BOARD

## ELECTRONIC DEVICES

### Specialist's Factual Report By Michael Portman

Location: Danville, Arkansas  
Date: April 23, 2021  
Aircraft: Piper PA-46-310P  
Registration: N461DK  
Operator: Private  
NTSB Number: CEN21FA198

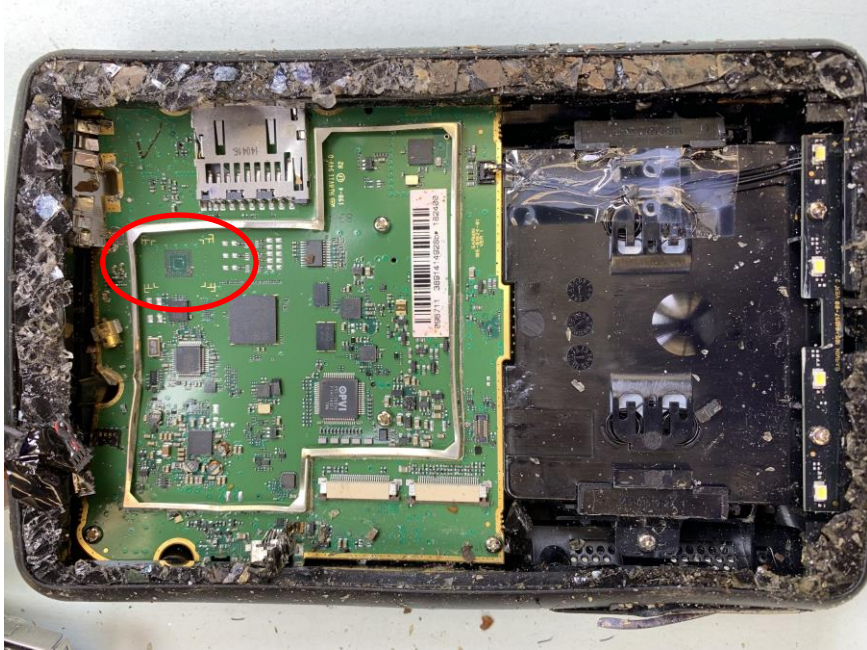
Upon arrival at the Vehicle Recorder Laboratory, an examination revealed the unit had sustained impact damage. The device was opened, and the built-in memory chip was identified, having been dislodged from its housing, likely during impact. The internal components of the device are shown in figure 1, with the location of the dislodged chip mounting highlighted in red. The recovered memory chip is shown in figure 2.

**Figure 1.** The internal components of the device, with the location of the memory chip mounting highlighted in red.

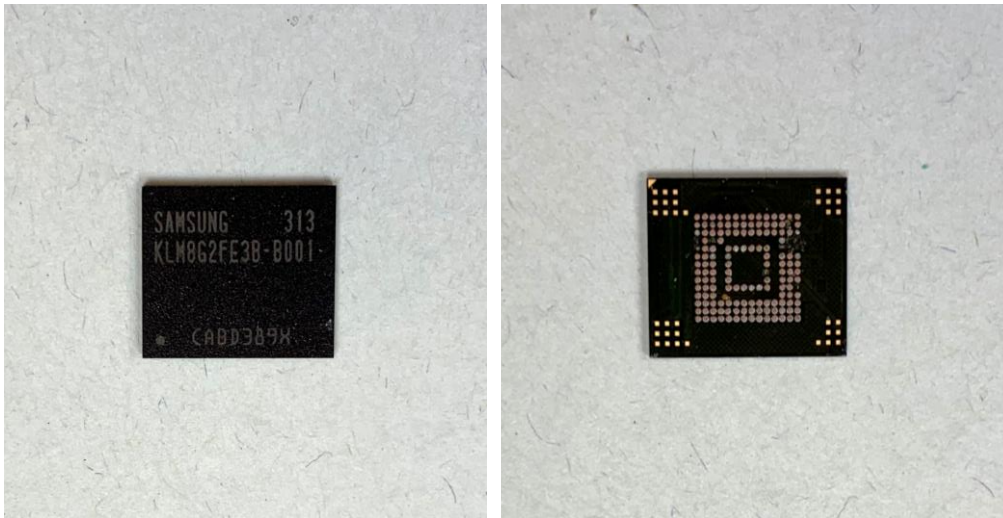
**Figure 2.** The recovered memory chip front (left) and back (right).

This device is capable of storing data in non-volatile memory (NVM). The extent of the damage precluded normal recovery procedures. The chip was cleaned and x-rayed, which revealed damage to several connector pads. In contract with the State University of New York at Binghamton's Integrated Electronics Engineering Center, the chip was sent to their lab for further evaluation and repair. Their report is included in the docket as Attachment 1 to this report. Upon completion of the repairs, the chip was returned to the NTSB's recorder lab, and further readout attempts were

made. However, the level of internal damage to the chip prevented any useful data from being recovered. Therefore, no data pertinent to the event were recovered.

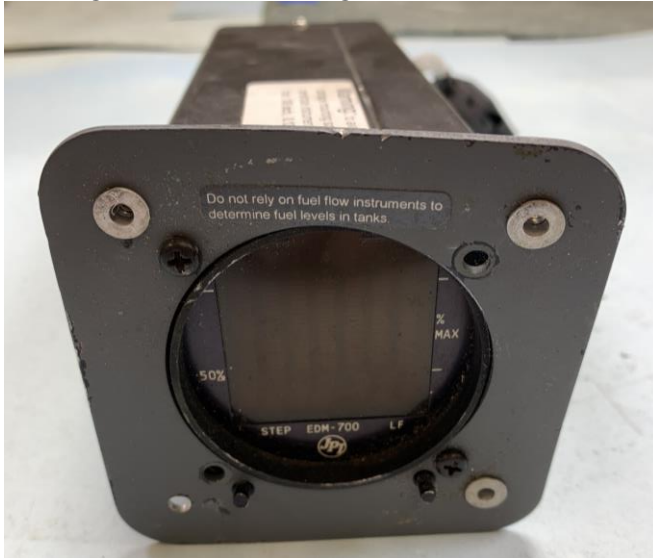
Upon arrival at the lab, it was evident that the device had suffered minor impact damage, as shown in figure 3.

**Figure 3.** Exterior of the JPI, as received.

This particular model of the EDM-700 was built in 1995, and therefore, according to the manufacturer, does not record data. Therefore, no data were recovered from this device.

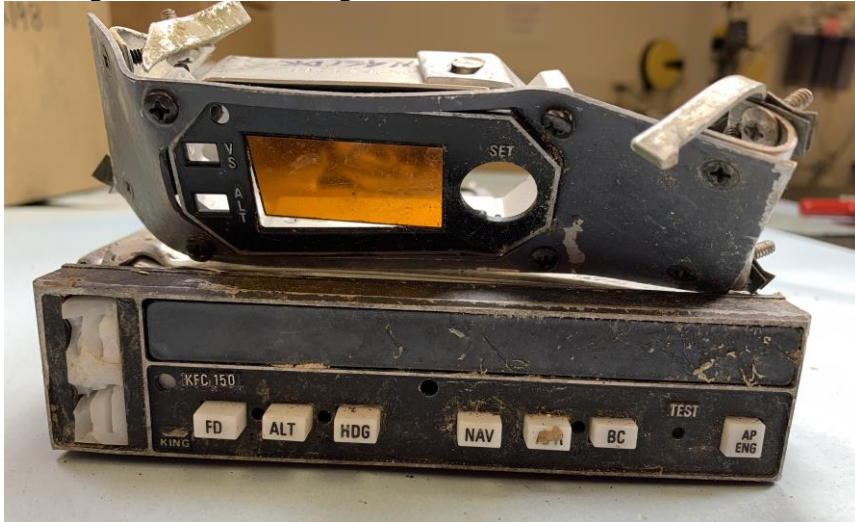
Upon arrival at the lab, it was noted that the device had suffered minor impact damage, as shown in figure 4.

**Figure 4.** Exterior of the KFC-150, as received.

Upon consultation with the device manufacturer, it was noted that this device is not capable of storing data. Therefore, no data were recovered from this device.

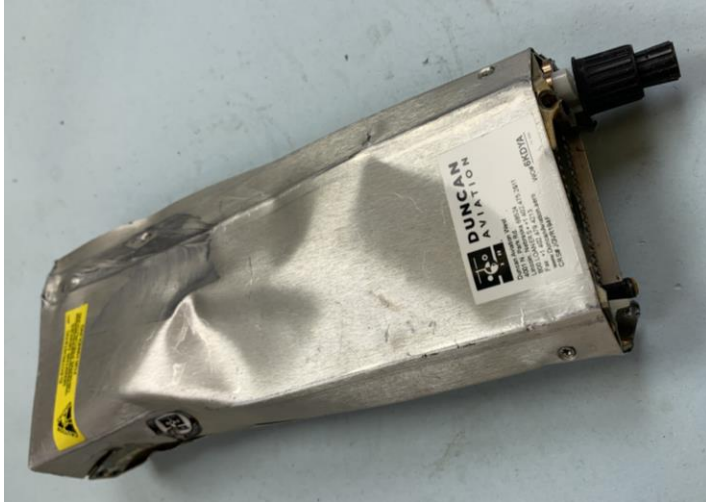
Upon arrival at the lab, it was noted that the device had suffered minor impact damage, as shown in figure 5.

**Figure 5.** Exterior of the KAS-297B, as received.

Upon consultation with the device manufacturer, it was noted that this device is not capable of storing data. Therefore, no data were recovered from this device.

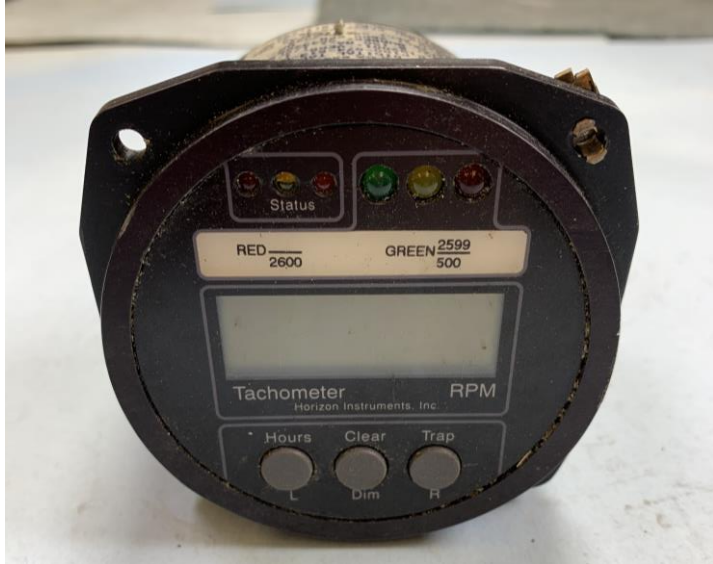
Upon arrival at the lab, it was noted that the device has suffered minor impact damage, as shown in figure 6.

**Figure 6.** Exterior view of the P-1000 tachometer, as received.

The device is not capable of storing data. Therefore, no data were recovered from this device.
