**NATIONAL TRANSPORTATION SAFETY BOARD
Office of Research and Engineering
Vehicle Recorder Division
Washington, D.C. 20594**

GROUP CHAIRMAN'S FACTUAL REPORT OF INVESTIGATION

CEN22FA100

Onboard Image, Audio and Data Recorder

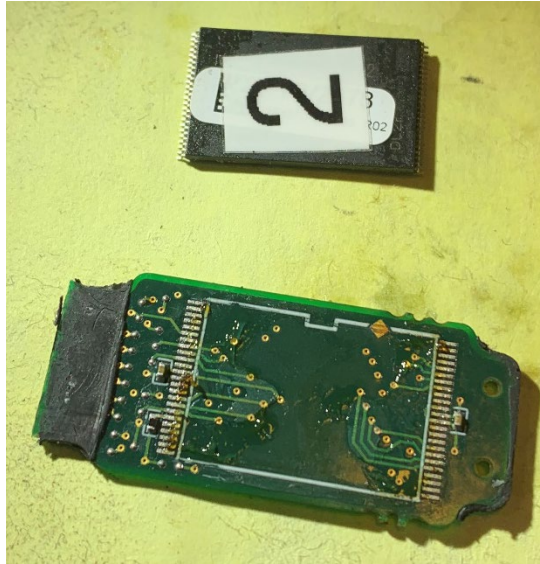
Figure 3. The Appareo Vision 1000 memory board after removal of one TSOP FLASH chip.

The unit's memory module was removed from the silver-colored crash case, soaked in deionized water, cleaned, and dried in a vacuum drying oven (see figure 2). The ribbon cable used to transfer data from the PCB² was ripped from the board due to the forces of the accident. Two TSOP³ FLASH memory integrated circuits (chips) that stored the recorded data were mounted on each face of the PCB. These were desoldered from the damaged memory board, cleaned, and re-soldered onto an undamaged memory board. This board was then interfaced into a surrogate Appareo 1000 using the built-in ribbon cable and a normal download performed using manufacturer software.

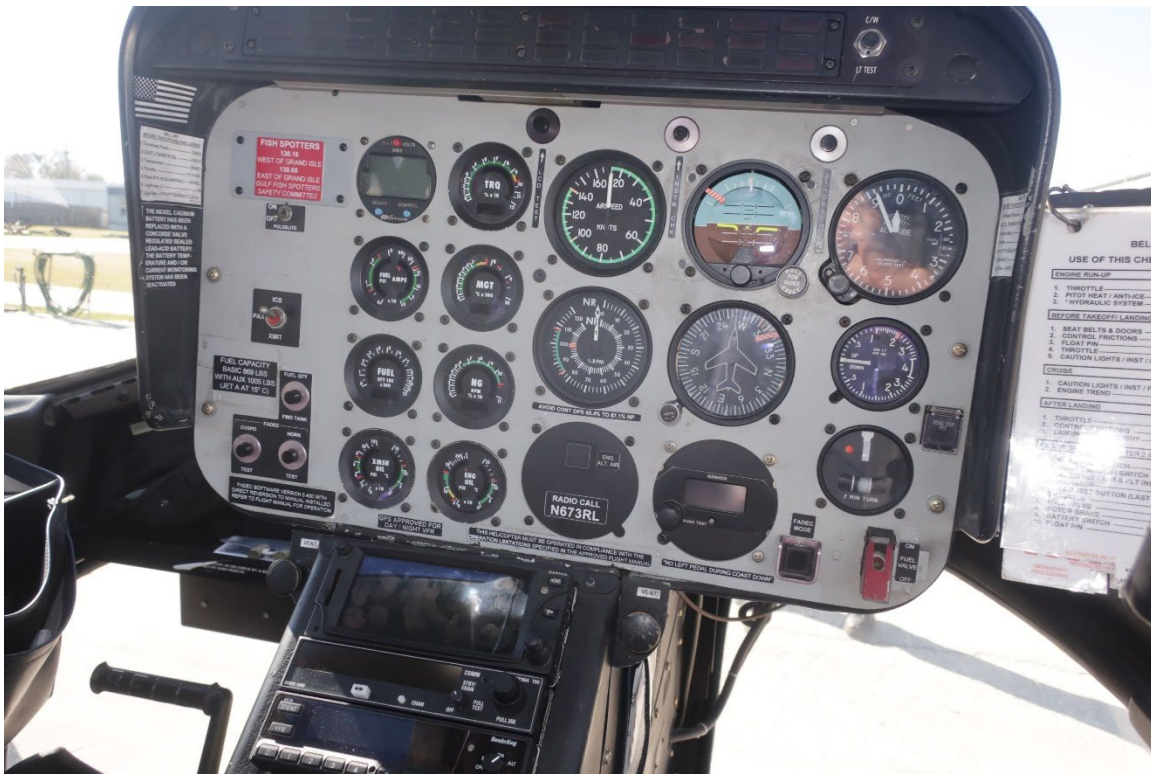
Figure 4. A capture from an Appareo image recorder installed on a sister helicopter.

Figure 4 is an image from a sister ship to the N167RL, showing the Appareo V1000's field of view of the instrument panel. While this panel is similar to, but not identical with, the instrument panel in N167RL, it does give a good sense of the location of all the instruments described in the following summary.
