### ATC Services Review Worksheet

### PRELIM Summary Information - SAFTI

*On January 17, 2023, about 1039 central standard time, a Piper PA-46-350P JetProp DLX airplane, N963MA, sustained substantial damage when it was involved in an accident near Yoakum, Texas. The pilot and copilot sustained fatal injuries. Two passengers sustained fatal injuries and one passenger sustained serious injuries. The airplane was operated as a Title 14 Code of Federal Regulations Part 91 business flight.*

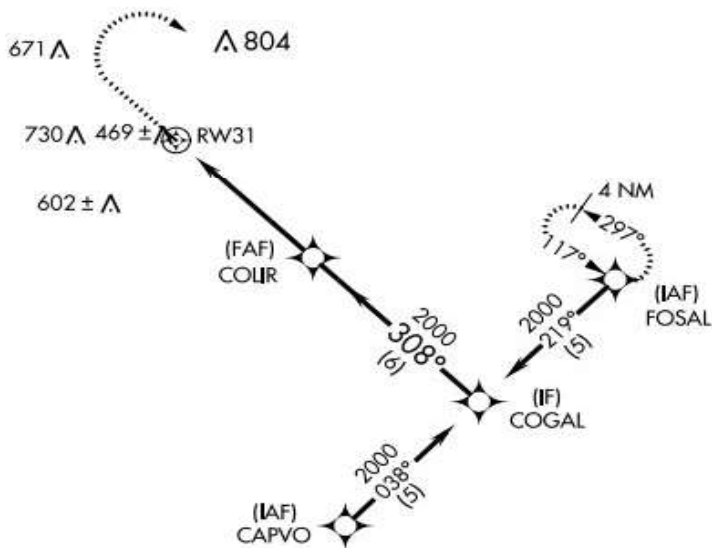
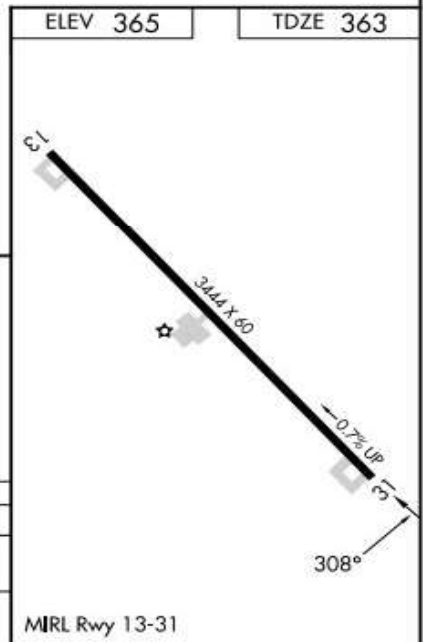
**RNAV (GPS) RWY 31**  
YOAKUM MUNI (T85)

RNP APCH-GPS.		MISSED APPROACH: Climb to 1000 then climbing right turn to 2000 direct FOSAL and hold.
▼	Use Victoria Rgnl altimeter setting. Procedure NA at night.	
▲ NA	Rwy 31 helicopter visibility reduction below ¾ SM NA.	
VCT ASOS	HOUSTON CENTER	CTAF
119.025	132.8 343.7	122.9

1000	2000	FOSAL	COLIR	COGAL
↑	↷	✧		
RW31		Procedure Turn NA		
5 NM		6 NM		
CATEGORY	A	B	C	D
LNAV MDA	840-1	477 (500-1)	840-1¼ 477 (500-1¼)	NA
CIRCLING	920-1	555 (600-1)	1200-2½ 835 (900-2½)	NA

- 1022 The R87 controller asked the pilot of N963MA what approach they were requesting into T85, and the pilot requested the RNAV RWY 31 approach (included below), and commented that the weather showed broken at 3,000 feet but it looked pretty solid.

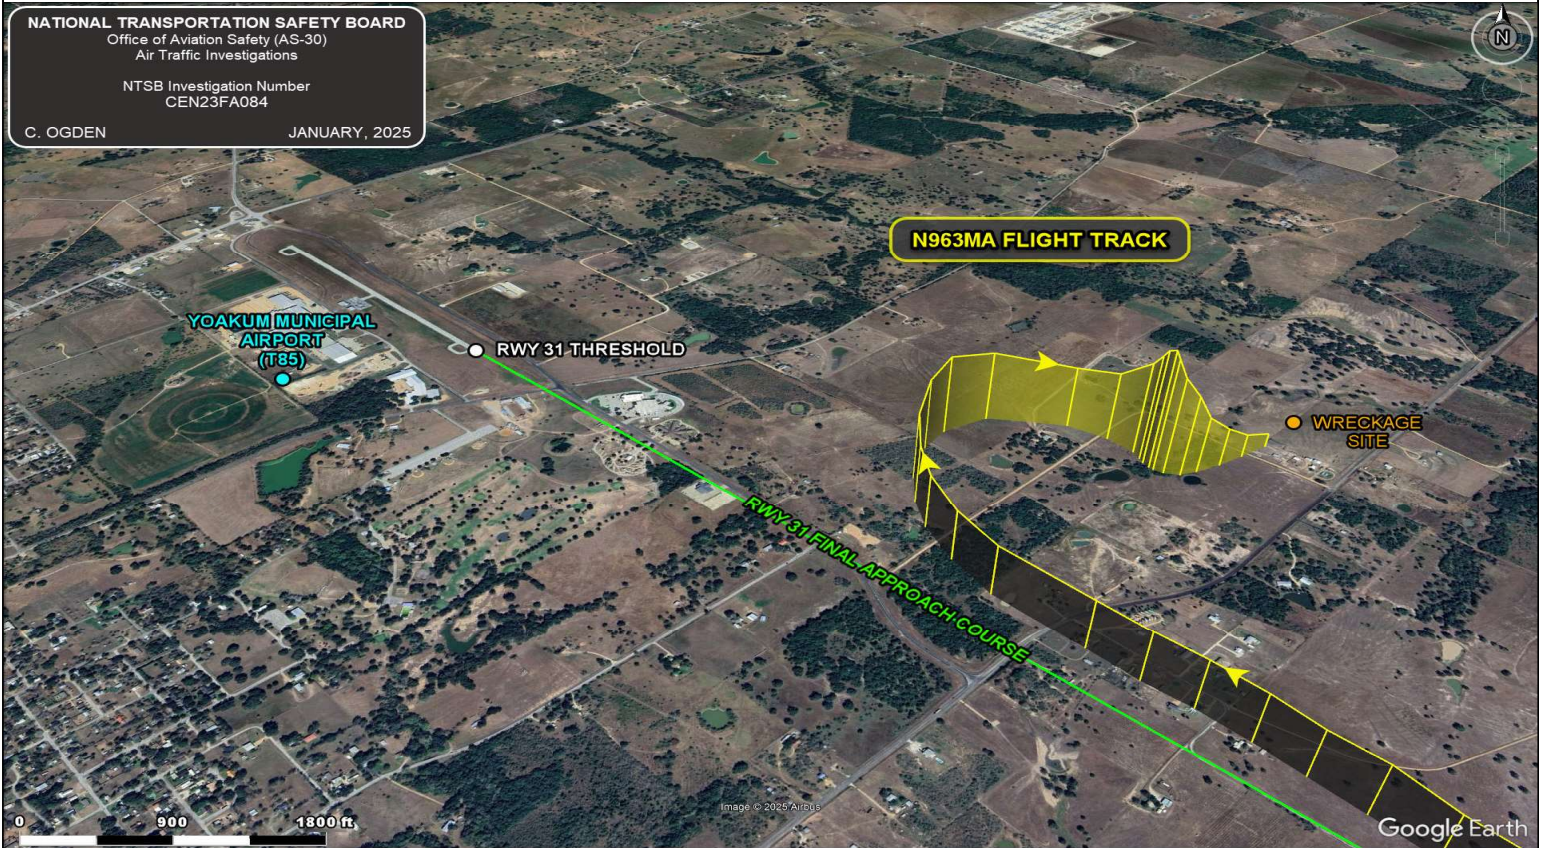
Figure 3

Caption: Profile view of the final segment of the accident flight track.

*Figure 3. Profile view of the final segment of the accident flight track.*
