National Transportation Safety Board

CEN23FA125

GLOBAL POSITIONING SYSTEM DEVICE

Specialist's Factual Report

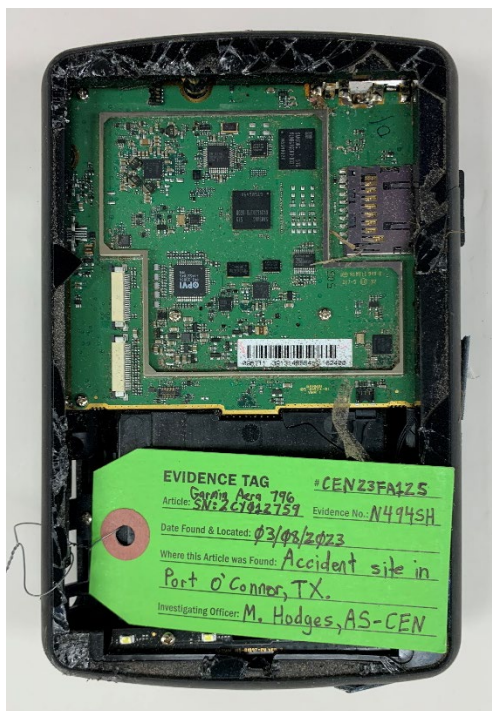
The device sustained impact damage, as shown in figure 1, and was received without its display. The internal electronics were installed in a functional lab surrogate and data were downloaded normally using the manufacturer's procedures.

Figure 1. Garmin aera 796 as received.

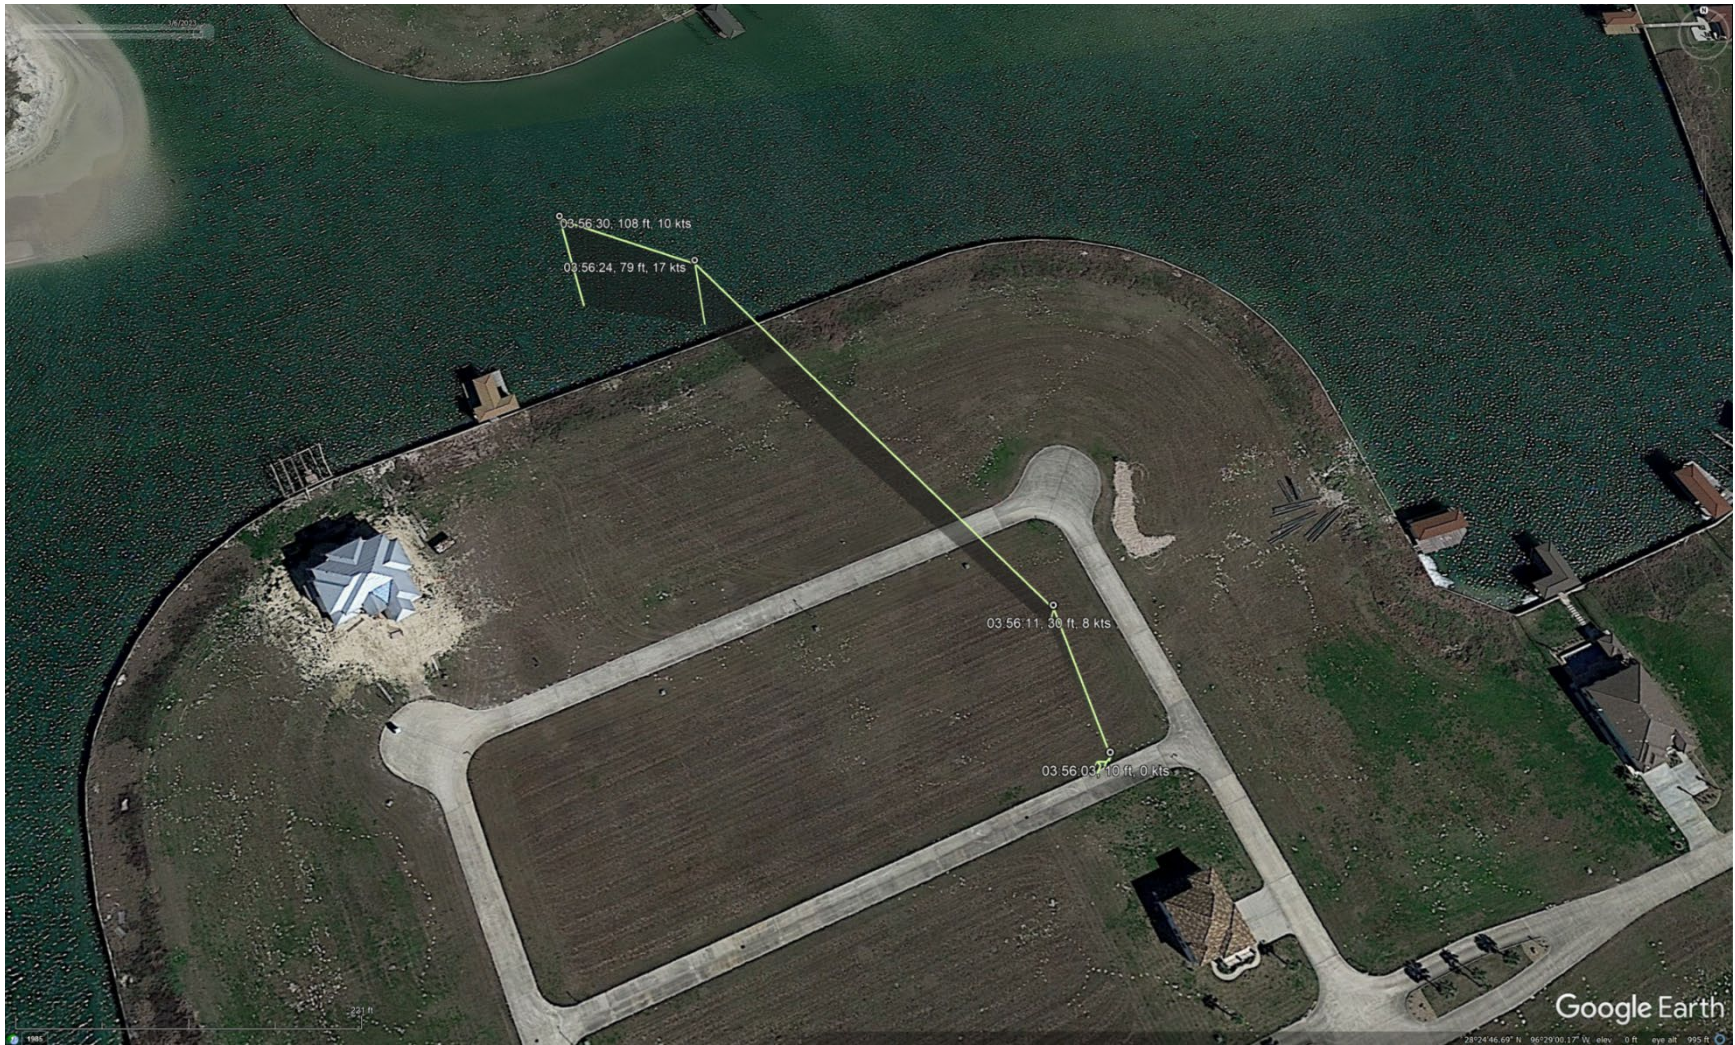
Figure 2 is a graphical overlay generated using Google Earth for the accident session. Due to data buffering in the device, the end of the session may not have been recorded. The weather and lighting conditions in Google Earth are not necessarily the weather and lighting conditions present at the time of the recording.

Figure 2. Google Earth overlay of the accident session recorded on the Garmin aera 796.

The corresponding tabular data used to create figure 2 is provided in electronic comma-separated value (CSV) format as attachment 1 to this report.
