National Transportation Safety Board

CEN23FA333

GLOBAL POSITIONING SYSTEM DEVICES

Specialist's Factual Report

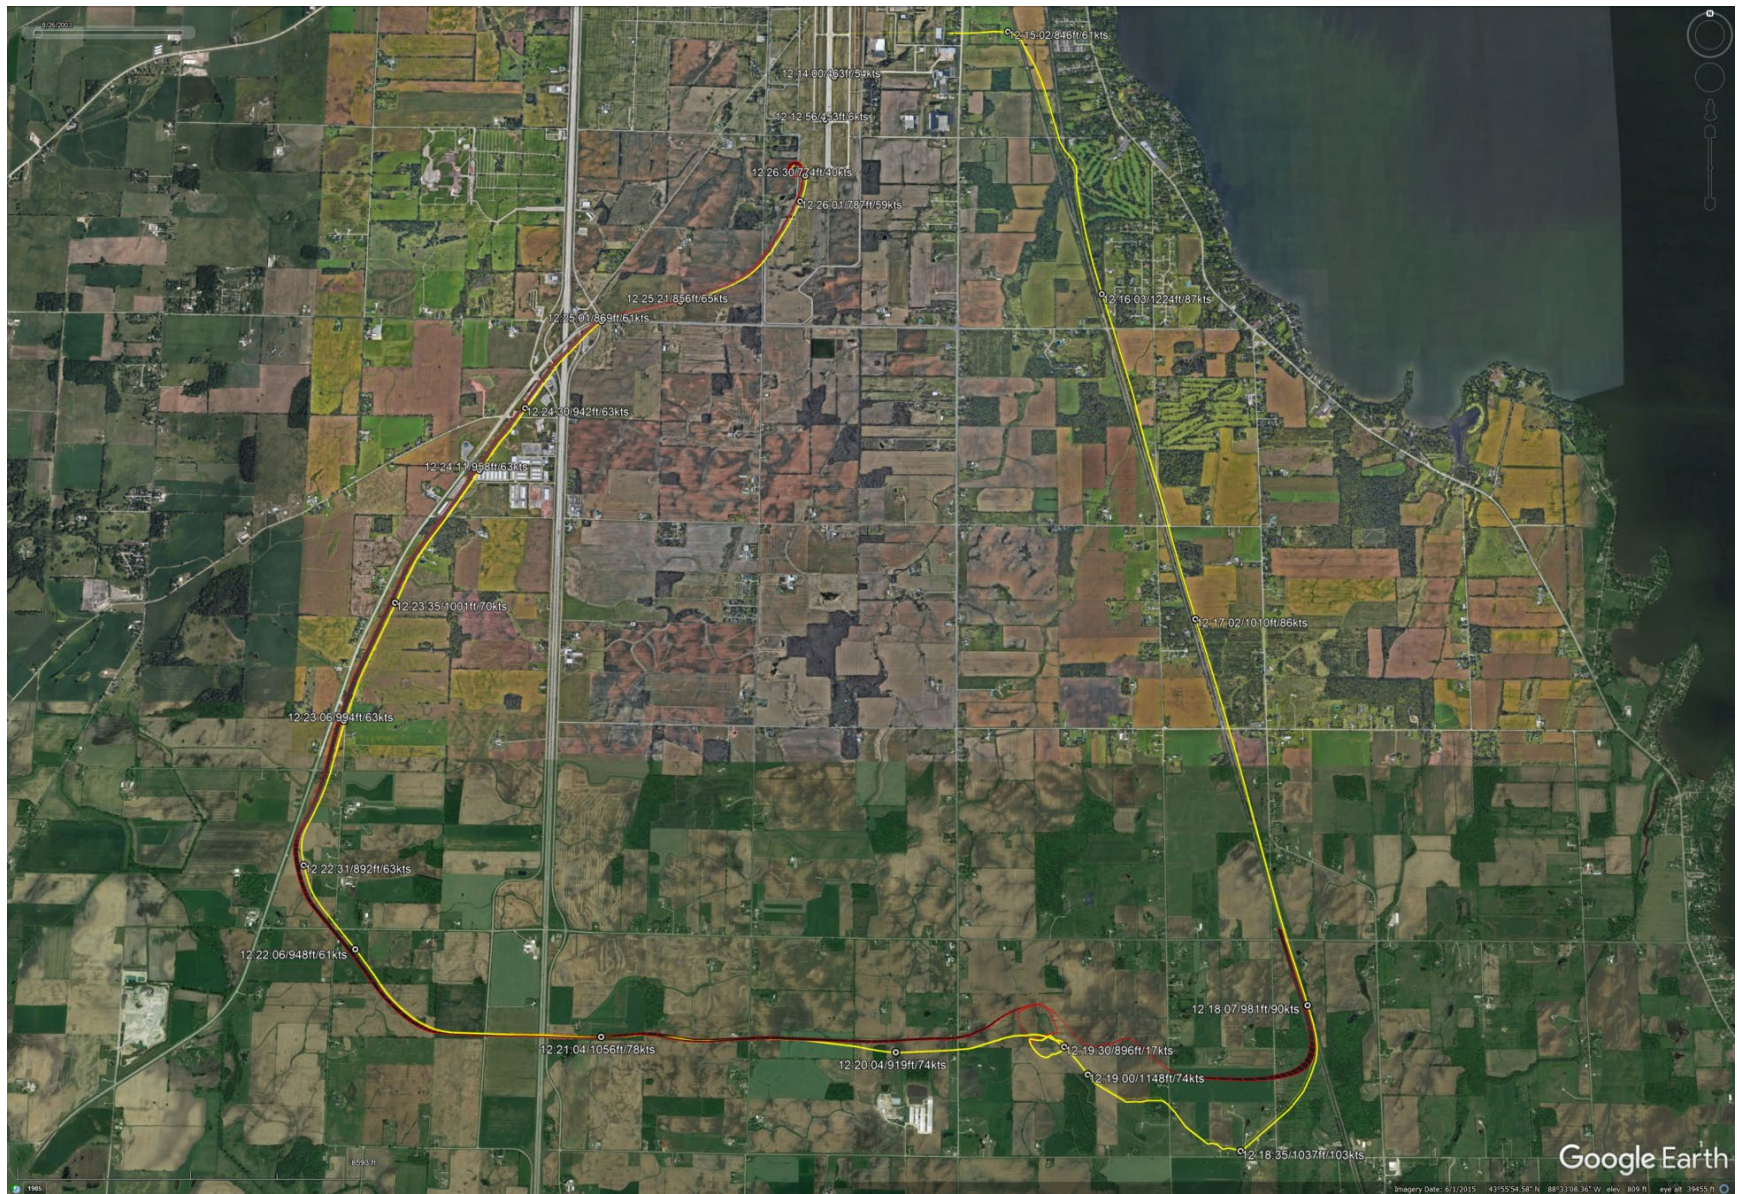
Figure 3. Google Earth overlay of the entire accident session recorded on the front (red track) and back (yellow track) displays.

Figures 3 and 4 are graphical overlays generated using Google Earth for the accident session. Data from the front card are shown in red and data from the back card are shown in yellow. The weather and lighting conditions in Google Earth are not necessarily the weather and lighting conditions present at the time of the recording. Figure 3 is an overview of the entire flight and Figure 4 shows the end of the flight. Figure 5 shows the end of the flight and includes the ground track from N193AZ (shown in cyan) from available GPS data.

The corresponding tabular data used to create figures 3 through 6 are provided in electronic comma-separated value (CSV) format as attachments 1 and 2 to this report. The corresponding tabular data used to create figures 7 and 8 are provided in electronic comma-separated value (CSV) format as attachments 3 and 4 to this report. The corresponding tabular data used to create figures 9 and 10 are provided in electronic comma-separated value (CSV) format as attachments 4 and 5 to this report. Not all parameters recorded were validated by the recorder specialist.

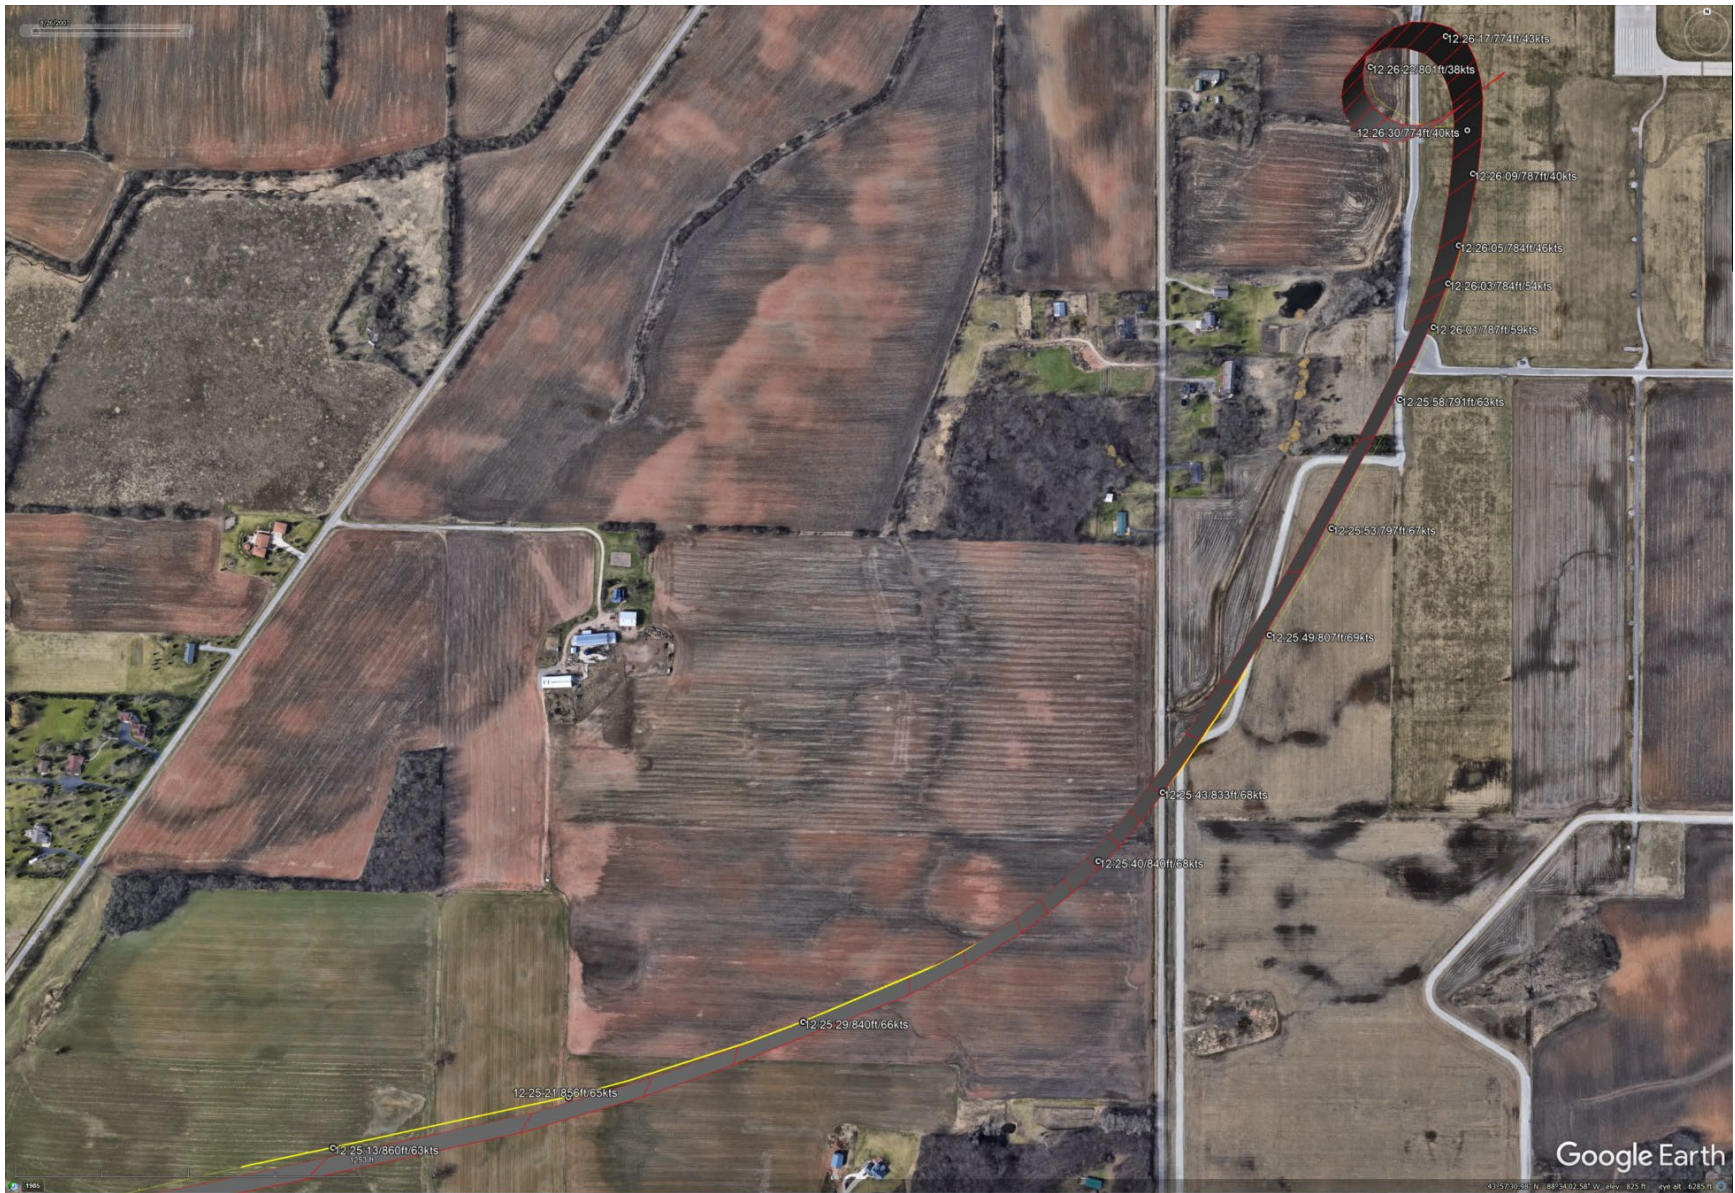
Figure 4. Google Earth overlay of the end of the accident flight recorded on the front (red track) and back (yellow track) displays.

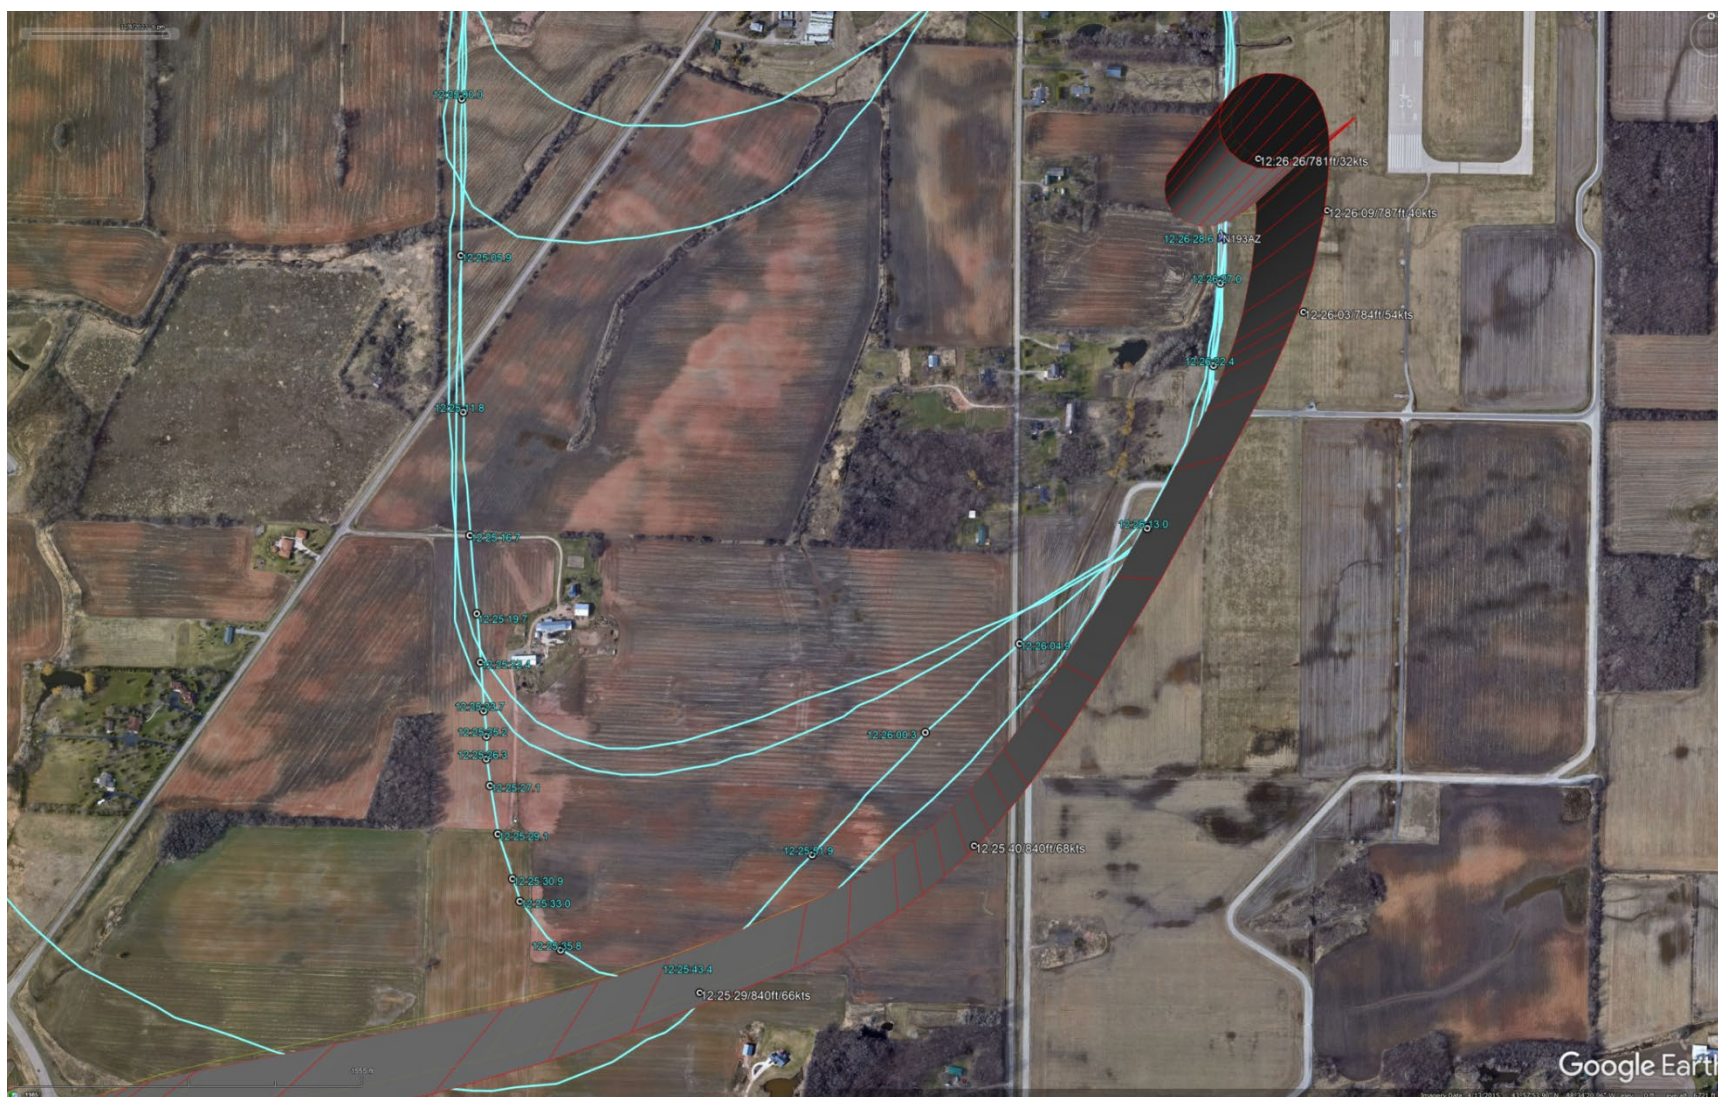
Figure 5. Google Earth overlay of the end of the accident flight that includes available GPS data from N193AZ shown in cyan.

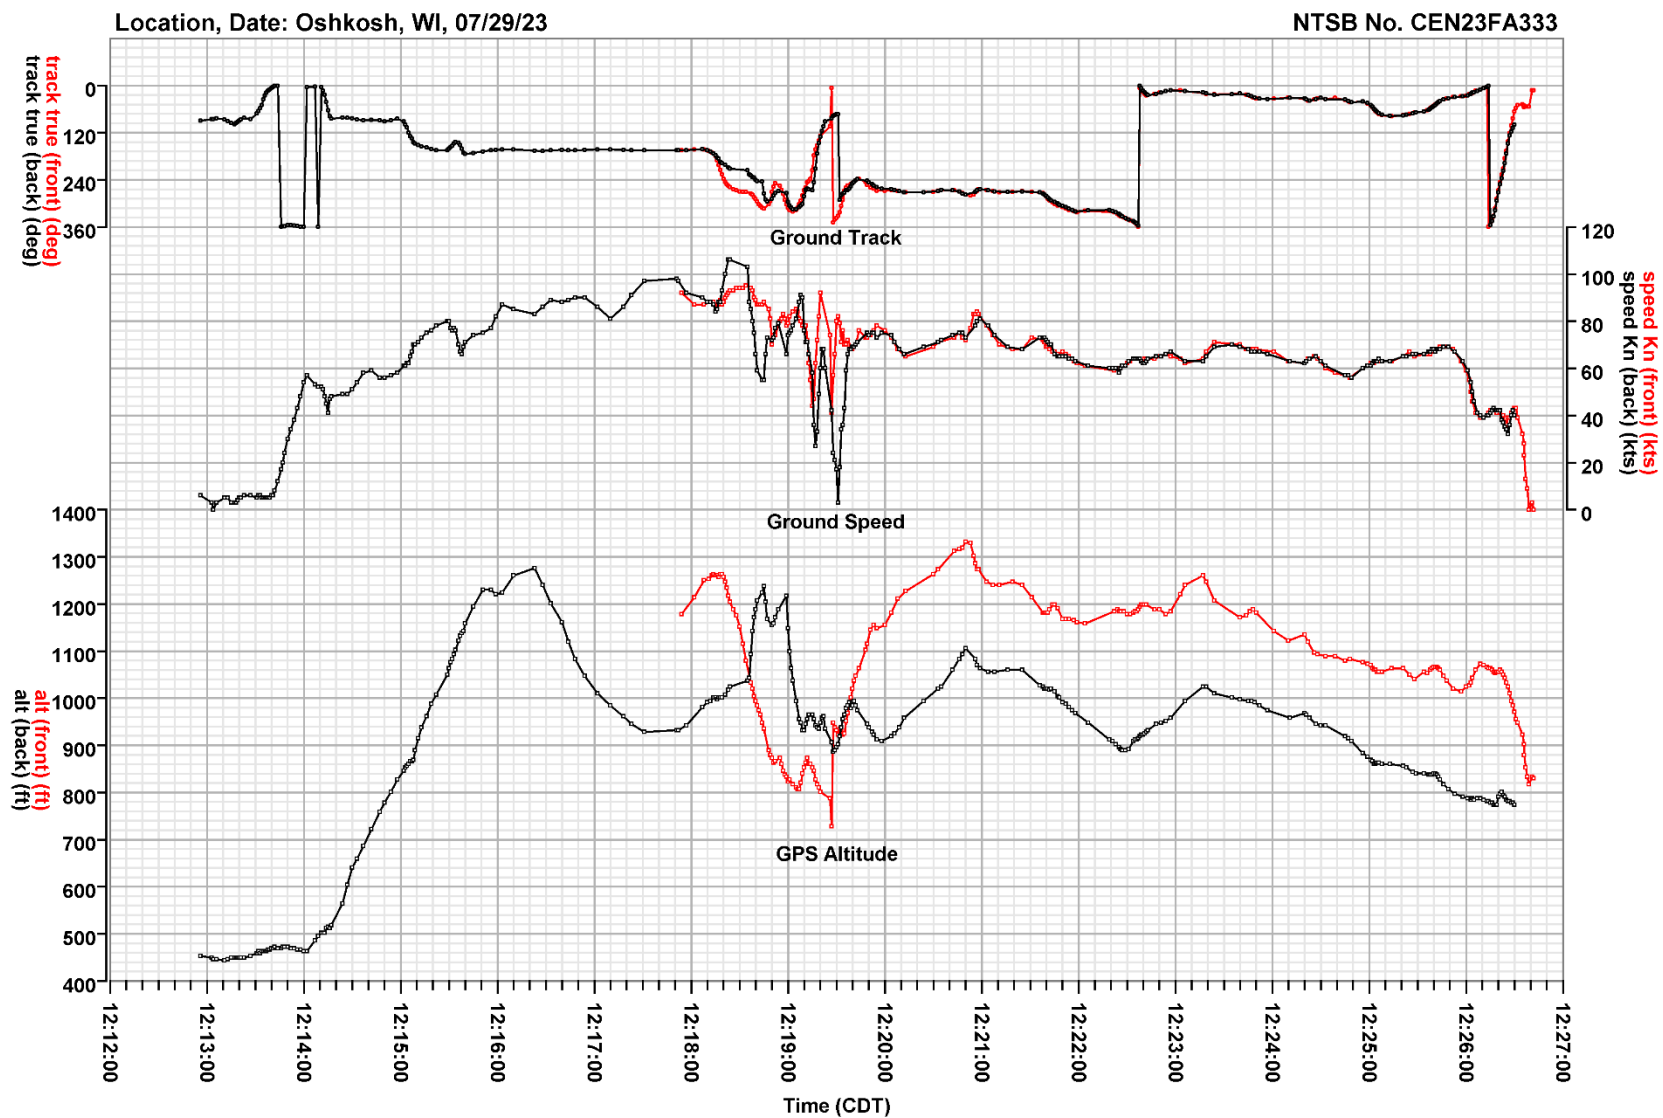
Figure 6. Plot of parameters from the accident flight. Back parameters are shown in black and front parameters are shown in red.

Figure 6 is a plot of parameters for the accident session. The time displayed is 12:12:00 to 12:27:00 CDT. Parameters for the front card are shown in red and parameters from the back card are shown in black. The session from the front card did not start until the airplane was already in flight.

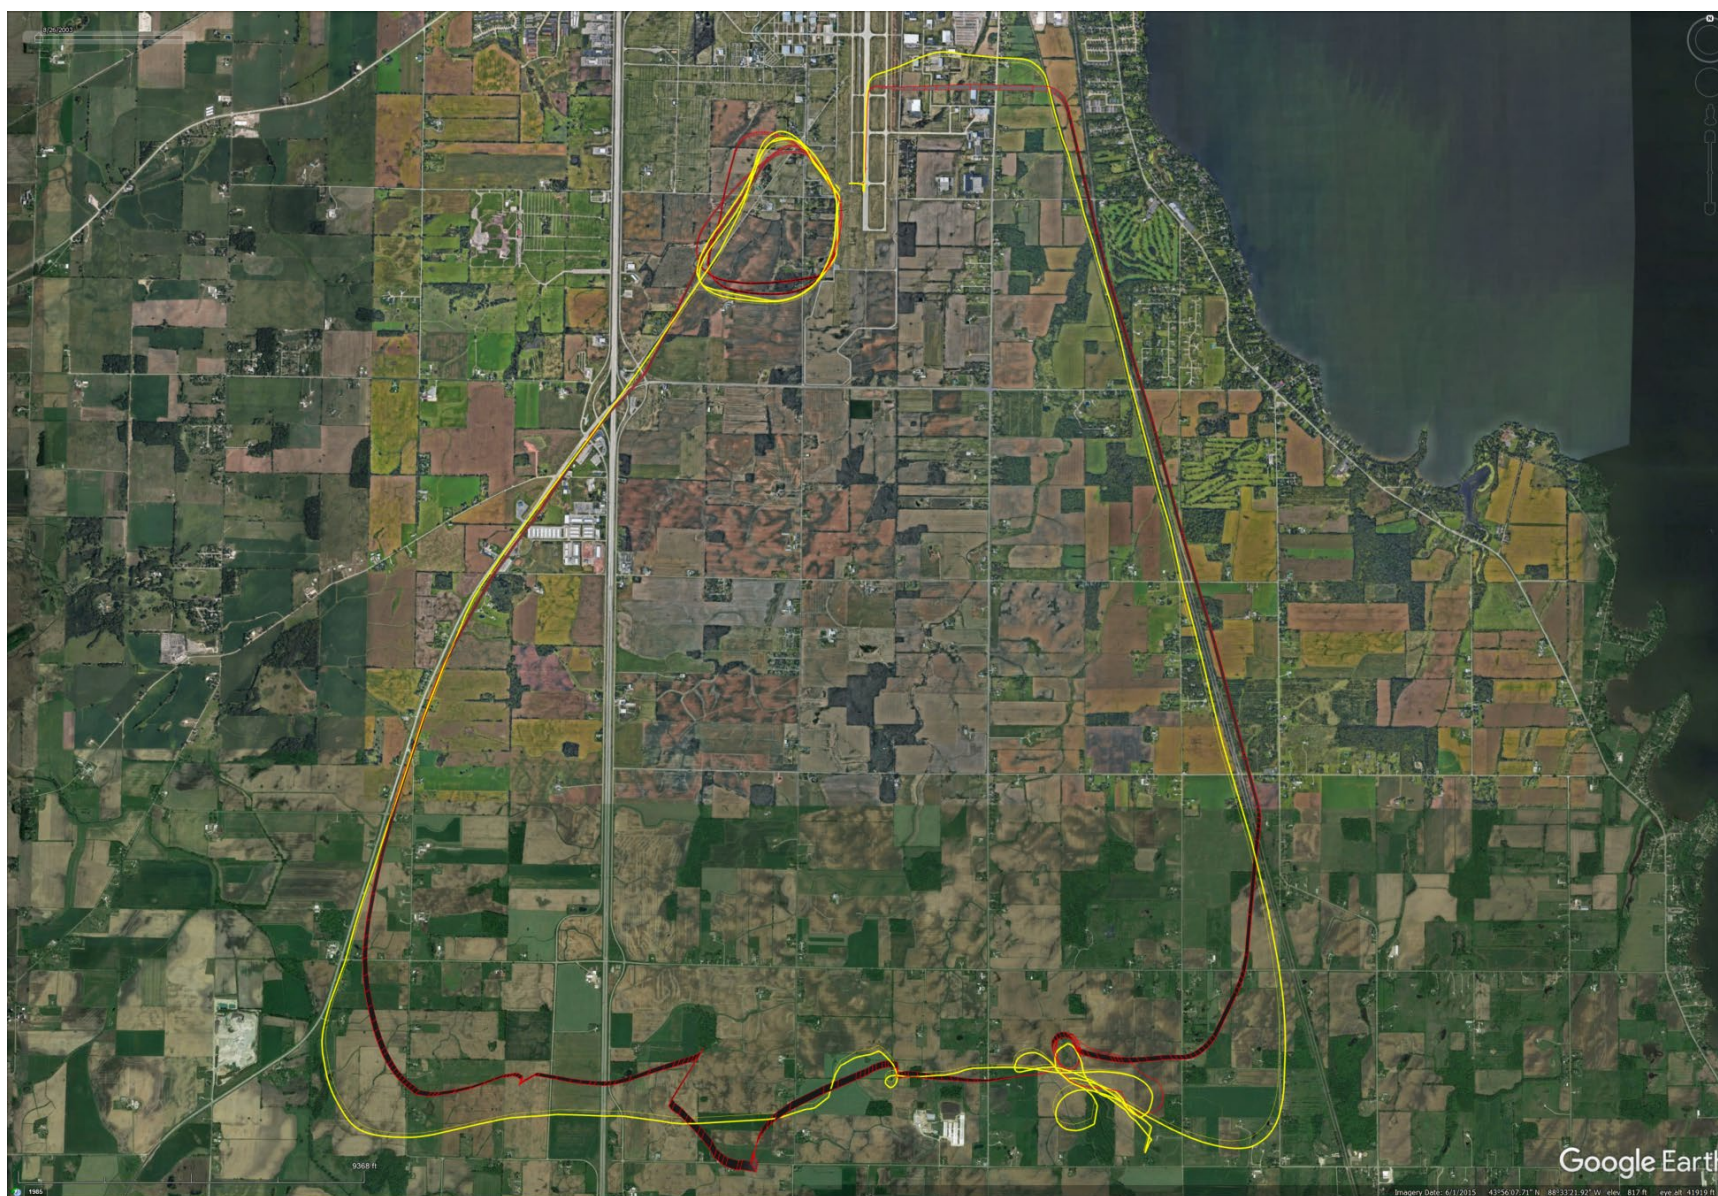
Figure 7. Google Earth overlay second session recorded on July 28, 2023, on the front (red track) and back (yellow track) displays.

Figure 7 is graphical overlay generated using Google Earth for the sessions recorded prior to the accident session on each card. Both sessions were recorded on July 28, 2023, however, they do not appear to correspond to the same flight. The back card solely appeared to record a flight, subsequently followed by a flight solely on the front card. Data from the front card are shown in red and data from the back card are shown in yellow.

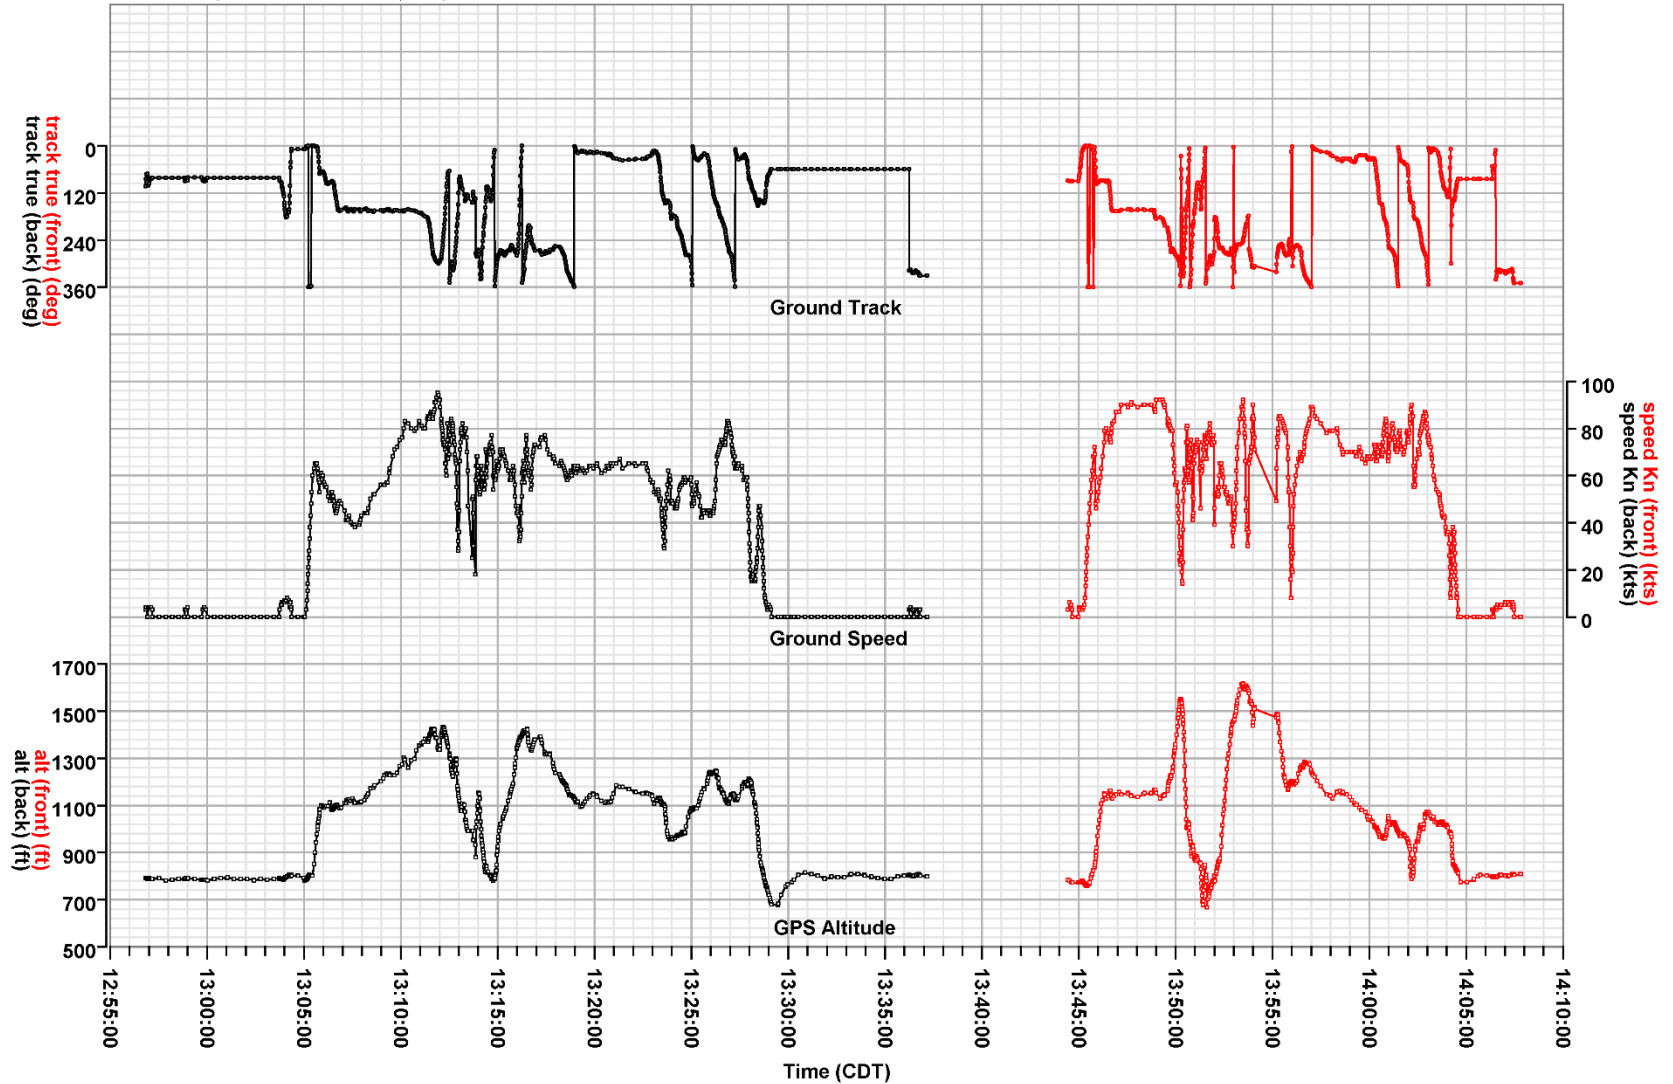
Figure 8. Plot of parameters from the second flight recorded on July 28, 2023. Back parameters are shown in black and front parameters are shown in red.

Figure 8 is a plot of parameters for the sessions recorded prior to the accident session on each card. The time displayed is 12:55:00 to 14:10:00 CDT on July 28, 2023. Parameters for the front card are shown in red and parameters from the back card are shown in black.

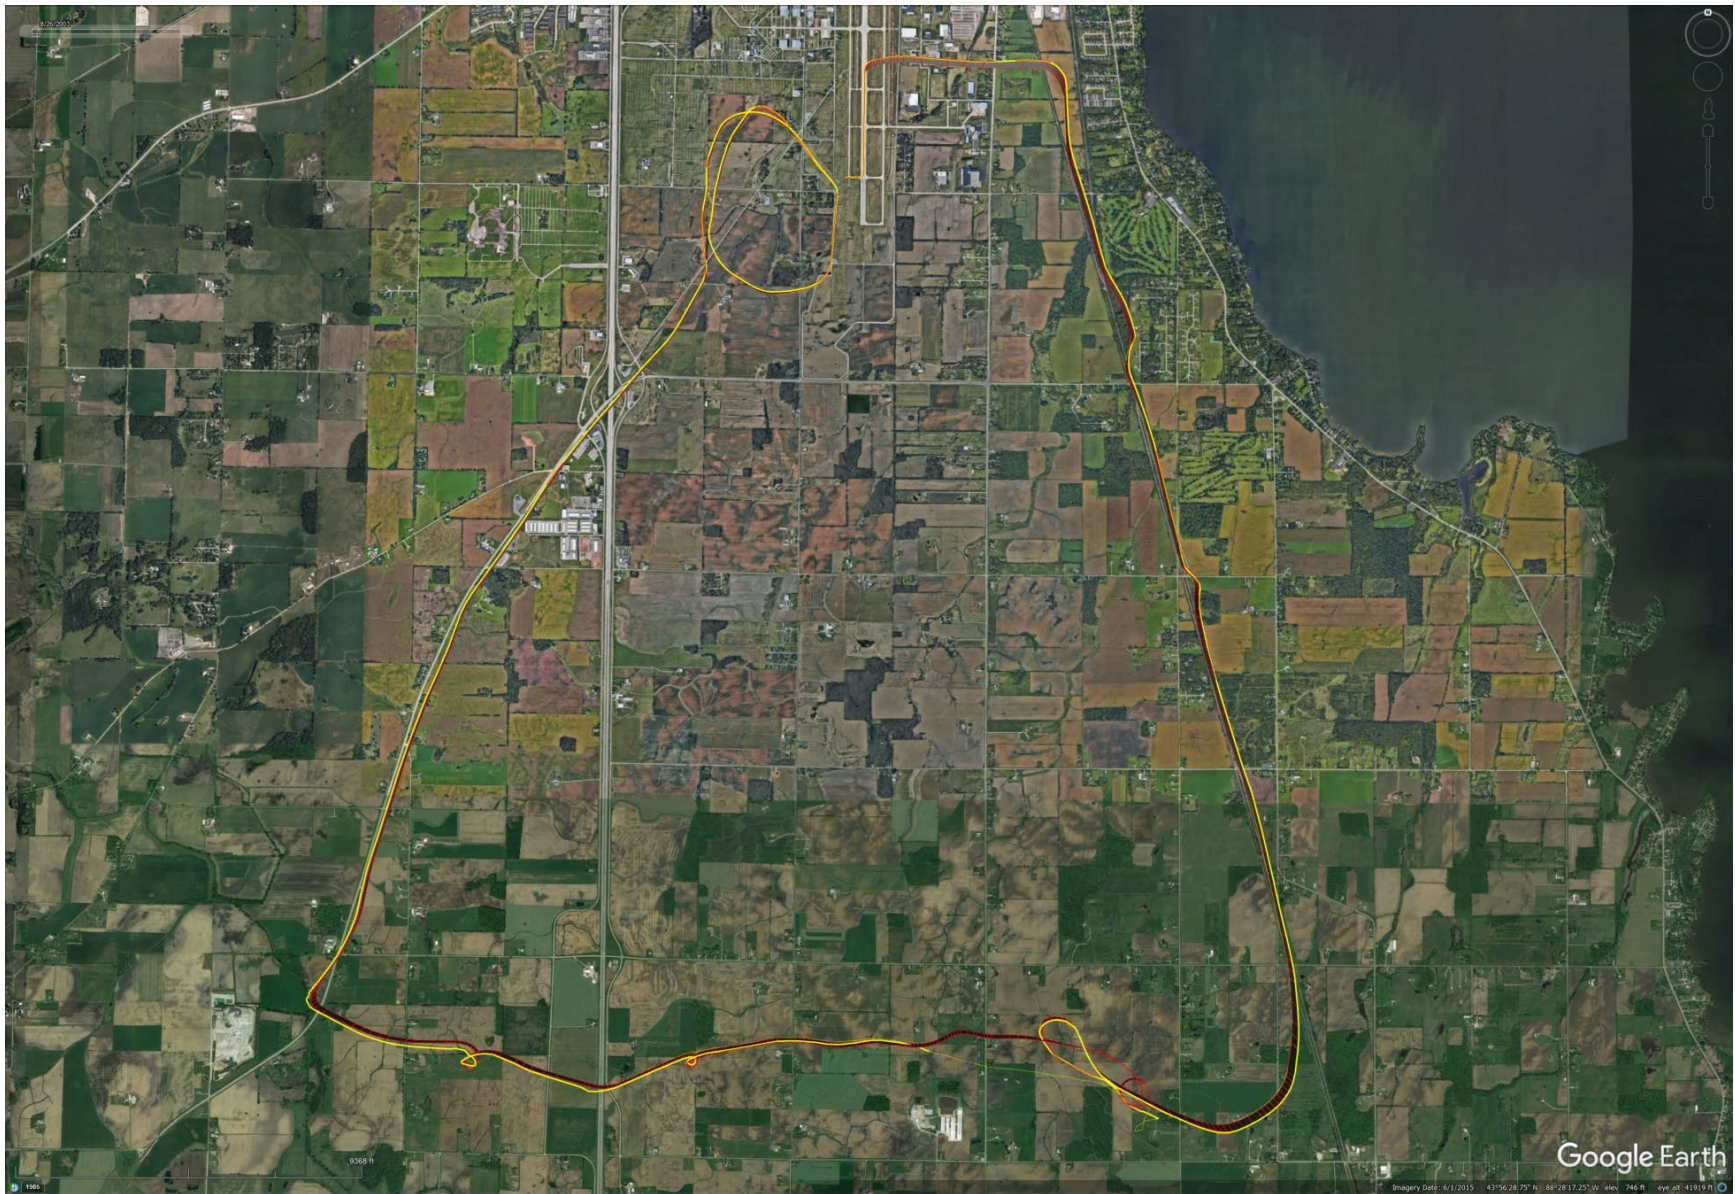
Figure 9. Google Earth overlay first session recorded on July 28, 2023, on the front (red track) and back (yellow track) displays.

Figure 9 is graphical overlay generated using Google Earth for the first session recorded on July 28, 2023. Data from the front card are shown in red and data from the back card are shown in yellow.

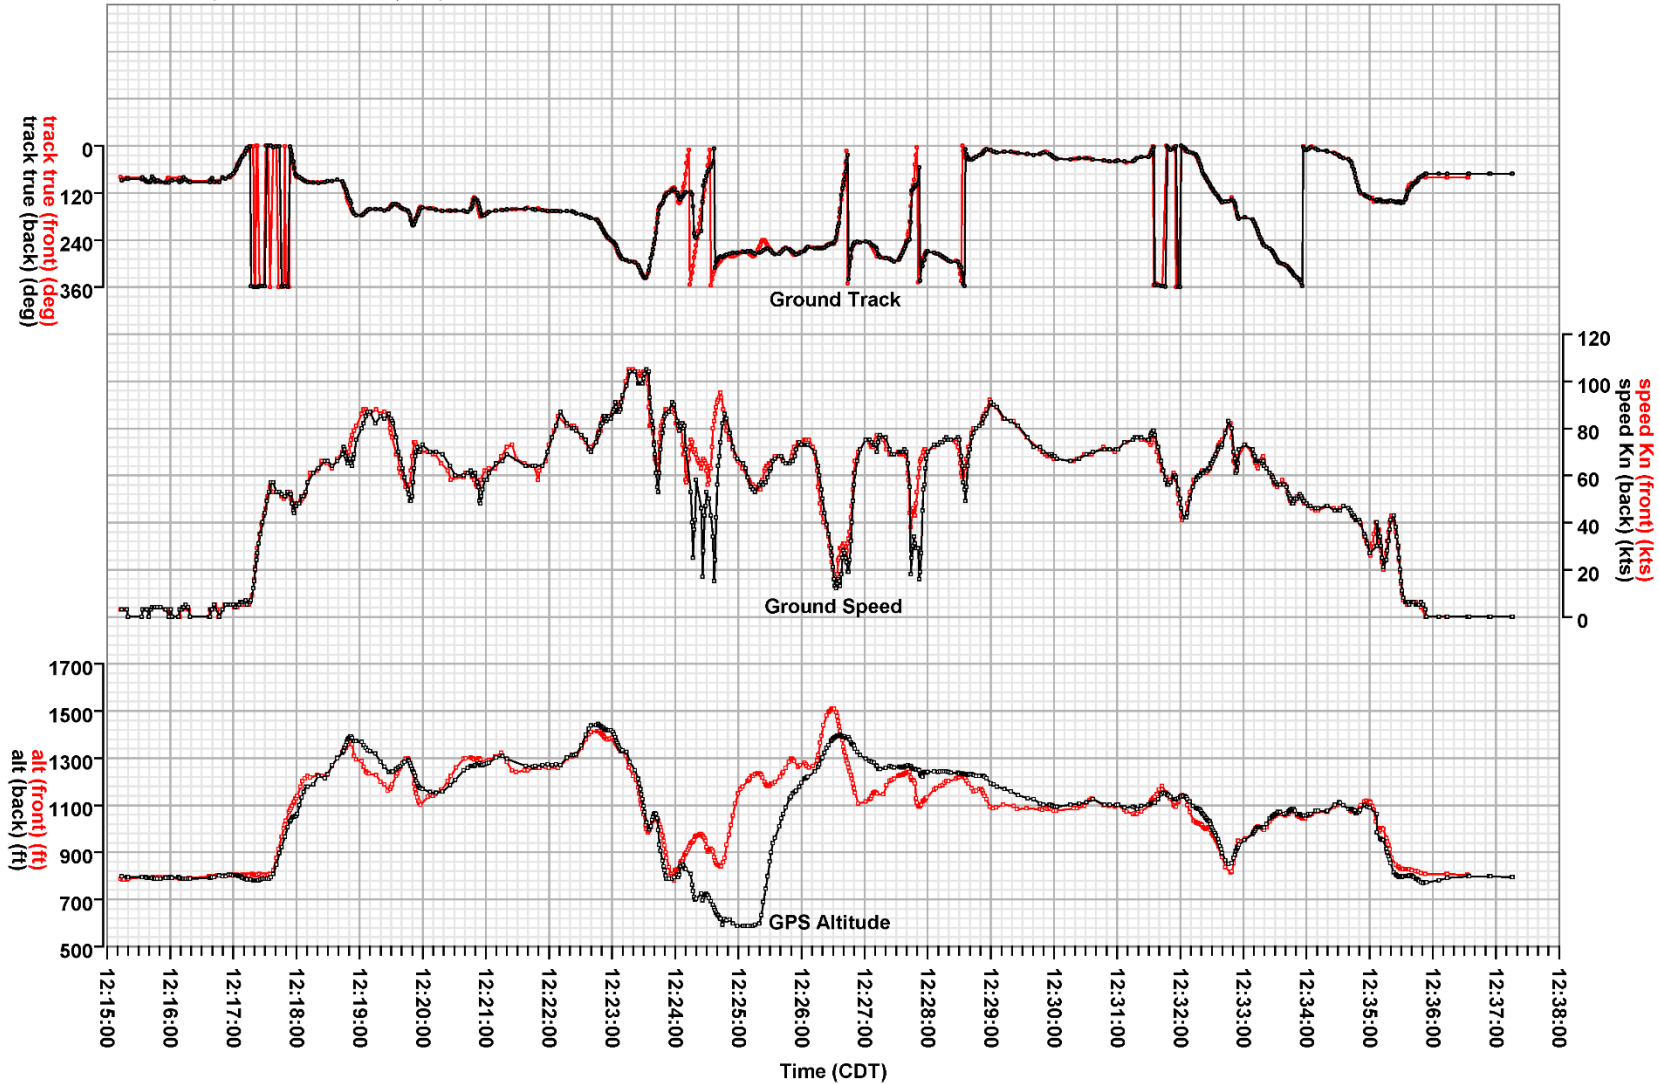
Figure 10. Plot of parameters from the first flight recorded on July 28, 2023. Back parameters are shown in black and front parameters are shown in red.

Figure 10 is a plot of parameters for the first session recorded on July 28, 2023. The time displayed is 12:15:00 to 12:38:00 CDT. Parameters for the front card are shown in red and parameters from the back card are shown in black.
