# **Best Practices Guide**

## **Maintaining Exhaust System Turbocharger to Tailpipe V-band Couplings / Clamps**

JASC 8100 Exhaust Turbine System (reciprocating)  
JASC 8120; Exhaust Turbocharger

**April 2018**

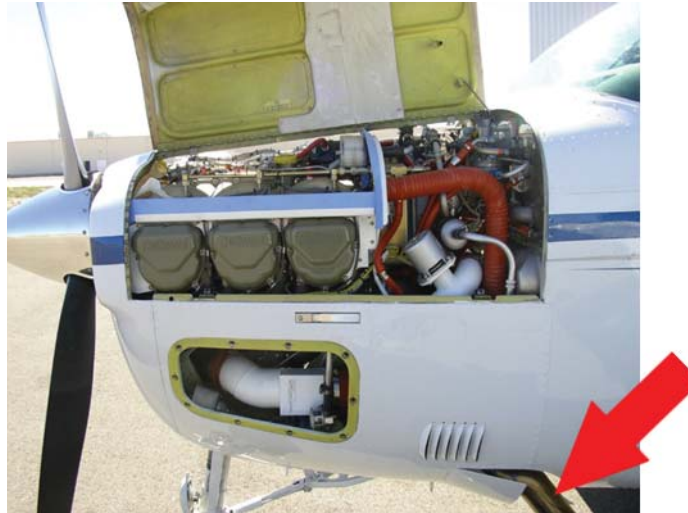
Below is a single engine airplane with engine cylinder exhaust ports located at the bottom of each cylinder. The upper cowl is open and a lower access panel is removed. As you can see the turbocharger in this application is not readily visible nor is the V-band coupling/clamp. The Design Approval Holder (DAH) also incorporated heat protection features in their type design to prevent exhaust heat from impinging on the surrounding area. The heat protection features typically include a set of sheet metal heat shields or fireproof foil type insulation in the form of a blanket or a combination thereof. The heat protection features that are a necessity also work well to obscure visibility of the turbocharger, and V-band coupling/clamps. The large red arrow denotes the tailpipe.

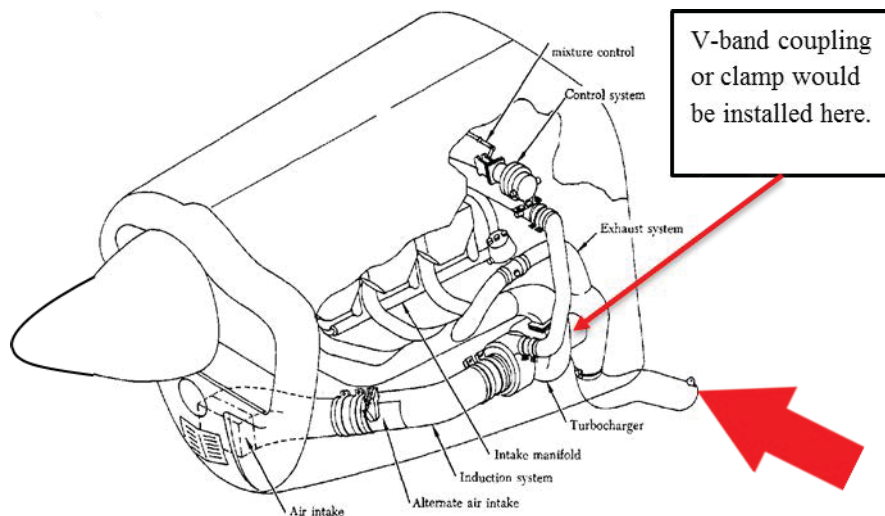
The diagram below depicts the turbocharger installation for the airplane above and the LH-side of the exhaust system. Notice none of the type design required heat protection features are shown installed. This is a typical retractable landing gear, single turbocharged engine airplane. The large red arrow denotes the tailpipe. The other arrow points to where the V-band coupling/clamp should be found. The V-band coupling/clamp in this application would not be readily visible during a pre-flight type inspection.

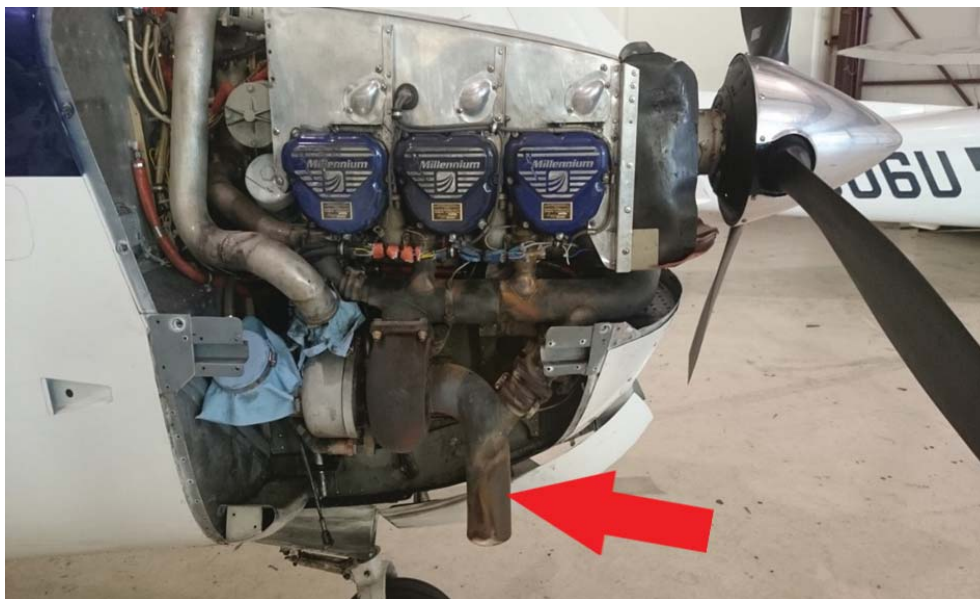
Another turbocharged single engine airplane, with engine cylinders with bottom exhaust ports is depicted below. The cowling has been removed. You can't see the turbocharger clearly with the lower cowling installed. The large red arrow denotes the tailpipe which is connected directly to the turbocharger exhaust exit flange just up and aft on the tailpipe. The tailpipe V-band coupling/clamp is not visible below. As you can see by the installation, the turbocharger in this application is not readily visible without a significant amount of maintenance activity, nor is the V-band coupling/clamp. In other words, this coupling /clamp installation would also not be readily accessible for pre-flight inspection.

In the two examples above, the interface to the turbocharger housing is such that the coupling partly resides within the turbochargers envelope. Seeing the turbocharger side of the coupling during inspection is not readily accomplished, even with a mirror and bright light. Turbochargers installed low on the engine (4 or 8 o'clock) like the two above make pre-flight viewing almost impossible. Inspection and maintenance of the turbocharger and tailpipe also have additional challenges, especially on retractable landing gear airplanes with non-removable lower cowlings and fixed structures.

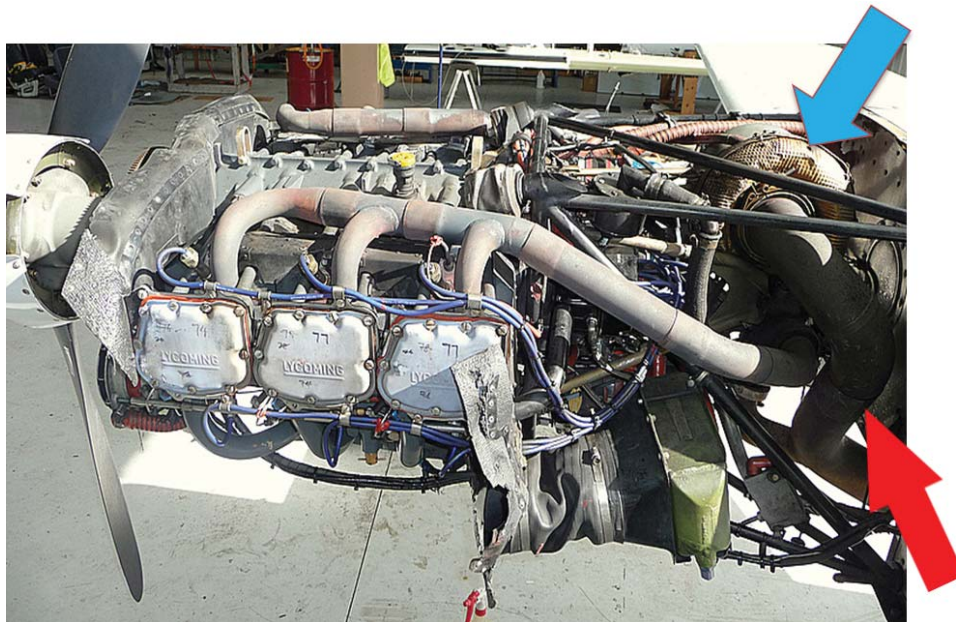
On the next page is a twin turbocharged engine airplane with an engine with top exhaust ports. The lower red arrow denotes the large tailpipe, and the circular housing just inboard of the tailpipe is the turbocharger which in this application is under a heat insulation blanket. The upper blue arrow points to the threaded end of the T-bolt of the multi-segment V-band coupling attaching the tailpipe to the turbocharger. On this type of turbocharger installation, you may see more of the turbocharger and heat protection features when the cowling is removed for an annual/100-hr. inspection. However, even then one would be hard pressed to find a crack anywhere along the multi-segment, V-band coupling, V-retainer inner surface when installed.

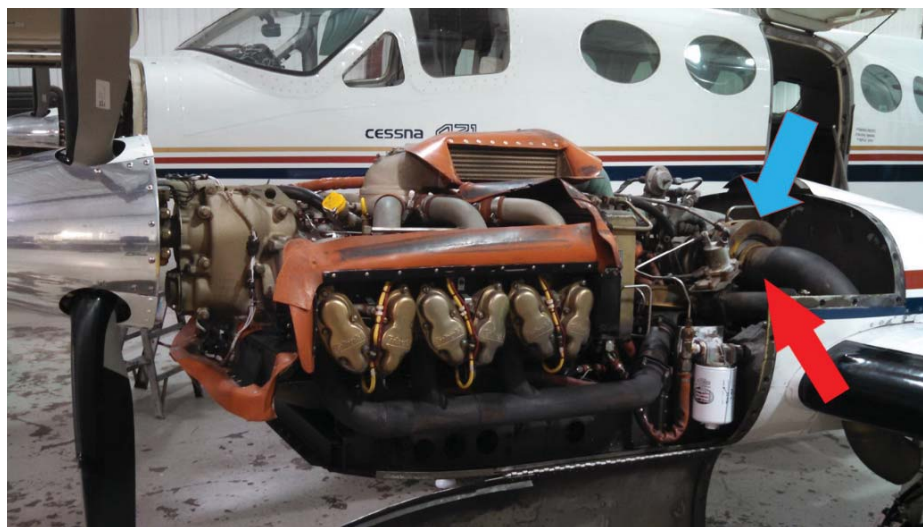
Another twin engine airplane, this one with engine cylinders incorporating bottom exhaust ports is depicted below. The lower red arrow denotes the large tailpipe entrance. The circular housing just inboard of the tailpipe is the turbocharger under a heat shield and insulation blanket, denoted by the upper blue arrow.

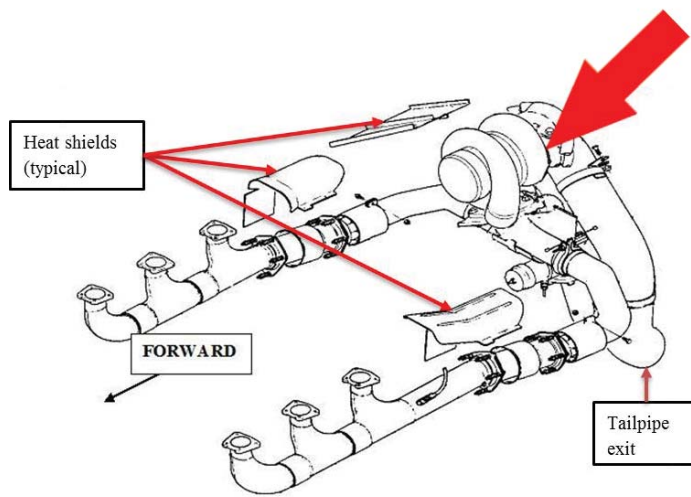
Below is a diagram of a typical full exhaust system for a twin engine airplane utilizing engine cylinders with bottom exhaust ports. The large red arrow would be the tailpipe coupling or clamp location. Some of the heat protection features are also shown therein.

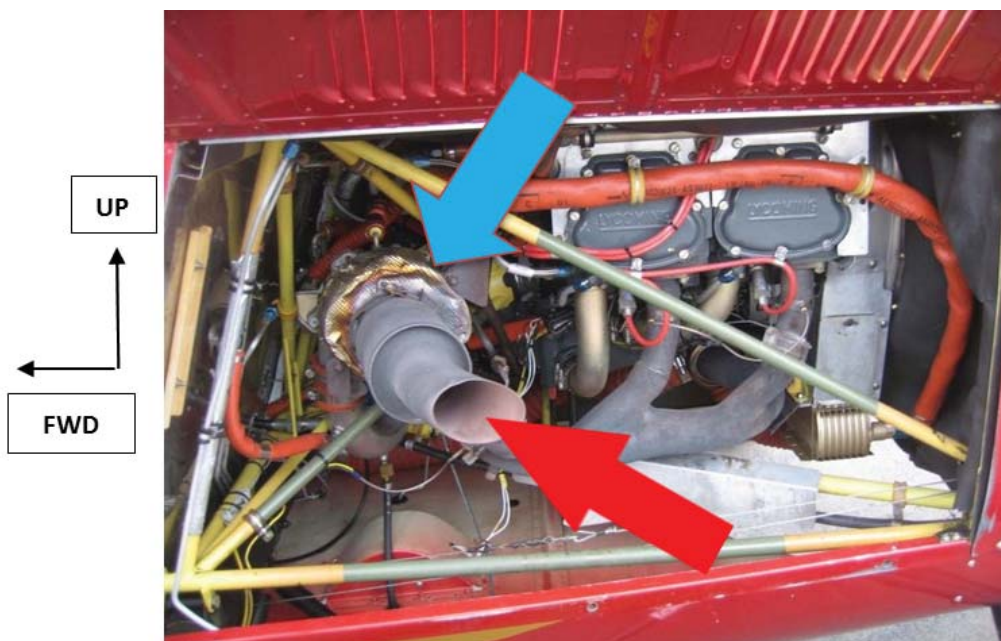
And finally, depicted below is a turbocharged engine used in a rotorcraft application with a LH forward turbocharger installation. The engine has cylinders with bottom exhaust ports. The hinged upper cowling door is open. The lower red arrow denotes the tailpipe/muffler assembly which is connected directly to the turbocharger exhaust exit flange just inboard of the muffler body on the tailpipe. The upper blue arrow points to the tailpipe multi-segment, V-band coupling just in front of the turbocharger heat insulation blanket. This type of installation may allow a very good pre-flight inspection of the tailpipe and coupling.

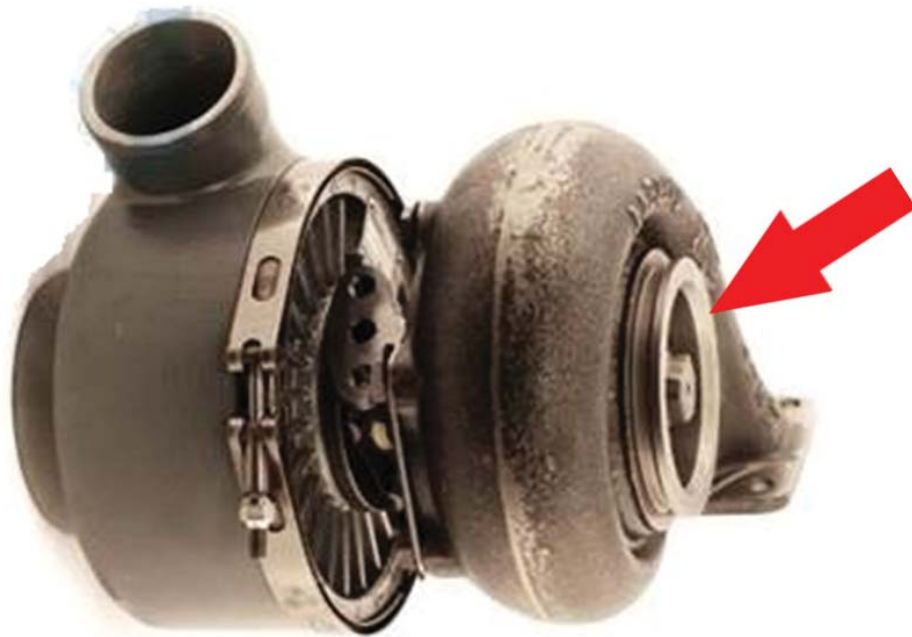
The photograph below is a typical new or freshly overhauled turbocharger assembly. The red arrow denotes the turbocharger exhaust exit flange where the tailpipe mates and is subsequently secured via a V-band coupling/clamp which is not shown in the photograph below. The tailpipe is attached to that flange on the RH cast iron side of the assembled turbocharger. The coupling that is shown below on the LH side of the turbocharger is used in this application to attach the compressor housing side of the turbocharger, which is not part of this Best Practice Guide. You will note that the exit flange is flush or already within the cast iron housings envelope. The upstream area of the exit flange is even further within that envelope. This is typical of the standard turbocharger found on many legacy aircraft products.

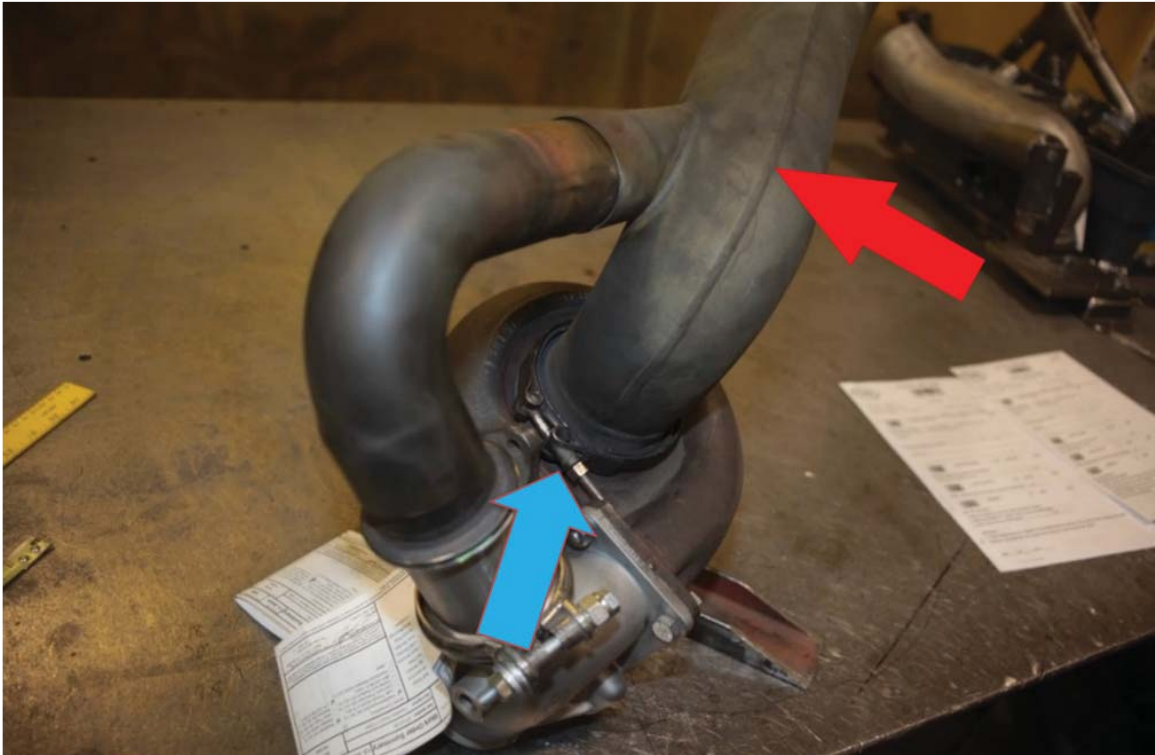
Another turbocharger assembly is depicted on the next page (looking at the exhaust end on the bench). This version has the tailpipe (with a wastegate pipe and valve installed) installed on the turbocharger exhaust exit with a V-band coupling. The tailpipe is denoted by the upper red arrow and the multi-segment, V-band coupling is denoted by the lower blue arrow. Finally, even with the turbocharger assembly on the bench, a thorough inspection of the V-band coupling as installed is difficult. It is unlikely that one would be able to assess the interior of the coupling in hopes of finding a crack that lurks in a V-retainer inner radius on the coupling

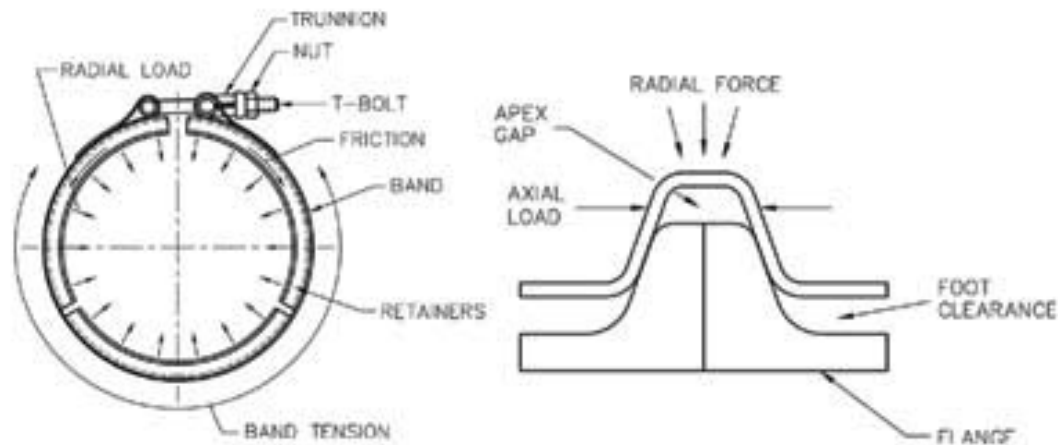
All turbocharger exhaust tailpipe V-band couplings or clamps are intended to couple and retain the exhaust tailpipe to the turbocharger housing, exhaust exit flange. The exhaust tailpipe V-band coupling/clamp does this by converting the radial load of the coupling band tension or clamp body to an axial load on the flanges due to the wedging action of the 'V' retainer segments or clamp body itself, as shown below.

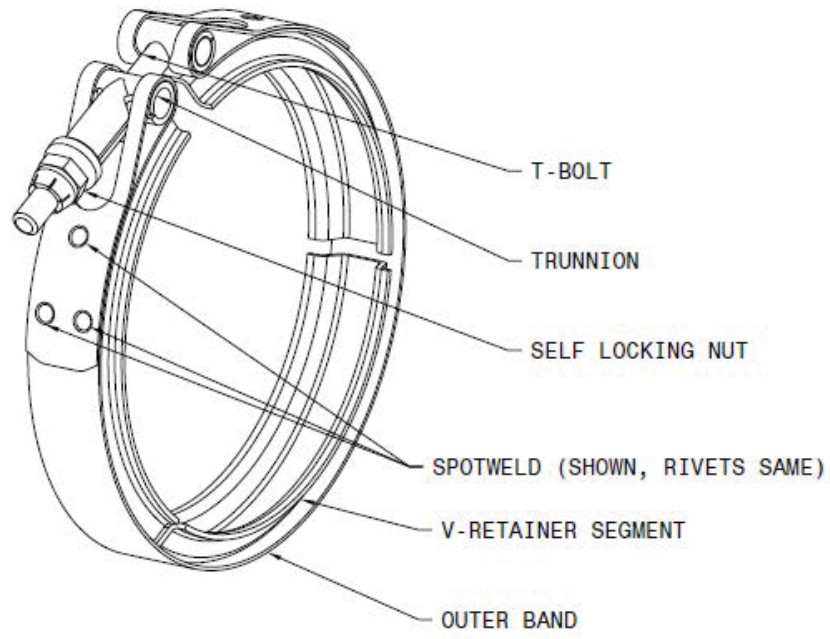
Multi-Segment, V-band *Couplings* come in two varieties: spot-welded and riveted (aka; collared fastener). The two varieties typify the method of joining of the outer flat band to the inner V-retainer segments, and all other metal-to-metal joints on the coupling. In this application, the couplings come in either two or three segment varieties. The segments are the number of V-retainer segments, which are attached to the outer band via spot-welds or rivets. Materials used throughout are various stainless steel alloys or Inconel's. The single-piece T-bolt may be straight or have a manufactured bend at the 'T' head by design. Couplings may also have a quick release latch to capture the T-bolt head. The self-locking nut is typically a high temperature steel alloy that is often silver coated. The self-locking nut is all-metal and the locking feature is a mechanical interference type with no polymer inserts. Couplings typically do not use washers under the nut as the trunnion housing is formed flat to act as a washer surface for the nut. Refer to Figures 1 thru 6 on the following pages.

**Figure 1**  
**Multi-Segment, V-band Coupling**  
**3-segment**

Although not as widely used as the spot-welded, multi-segment V-band couplings, riveted (aka; collared fastener) multi-segment, V-band couplings are approved on various make/model aircraft. A riveted coupling is almost identical with the exception of spot-welds being replaced with a similar number of rivets or collared fasteners to join the materials. Refer to Figure 1, 2, and 6.

- a. Crack in the coupling outer band (flat) material, potentially at or near a spot-weld or rivet. Refer to Figures 1, 2, 4, 5, 6, 15, 19, 21, & 22.
- b. Cupping, bowing or crowning of the coupling outer band beyond 0.062 inches in depth. Refer to Figures 14, 19, 20 & 22.

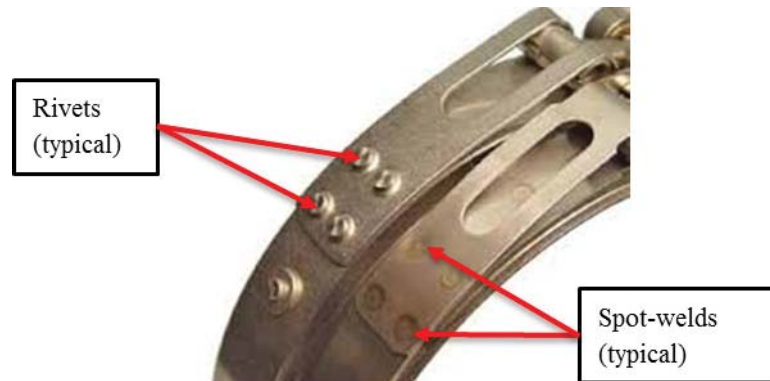
**Figure 2**  
**Multi-Segment, V-band Couplings**  
**LH riveted (aka, collared fastener) & RH spot-welded**

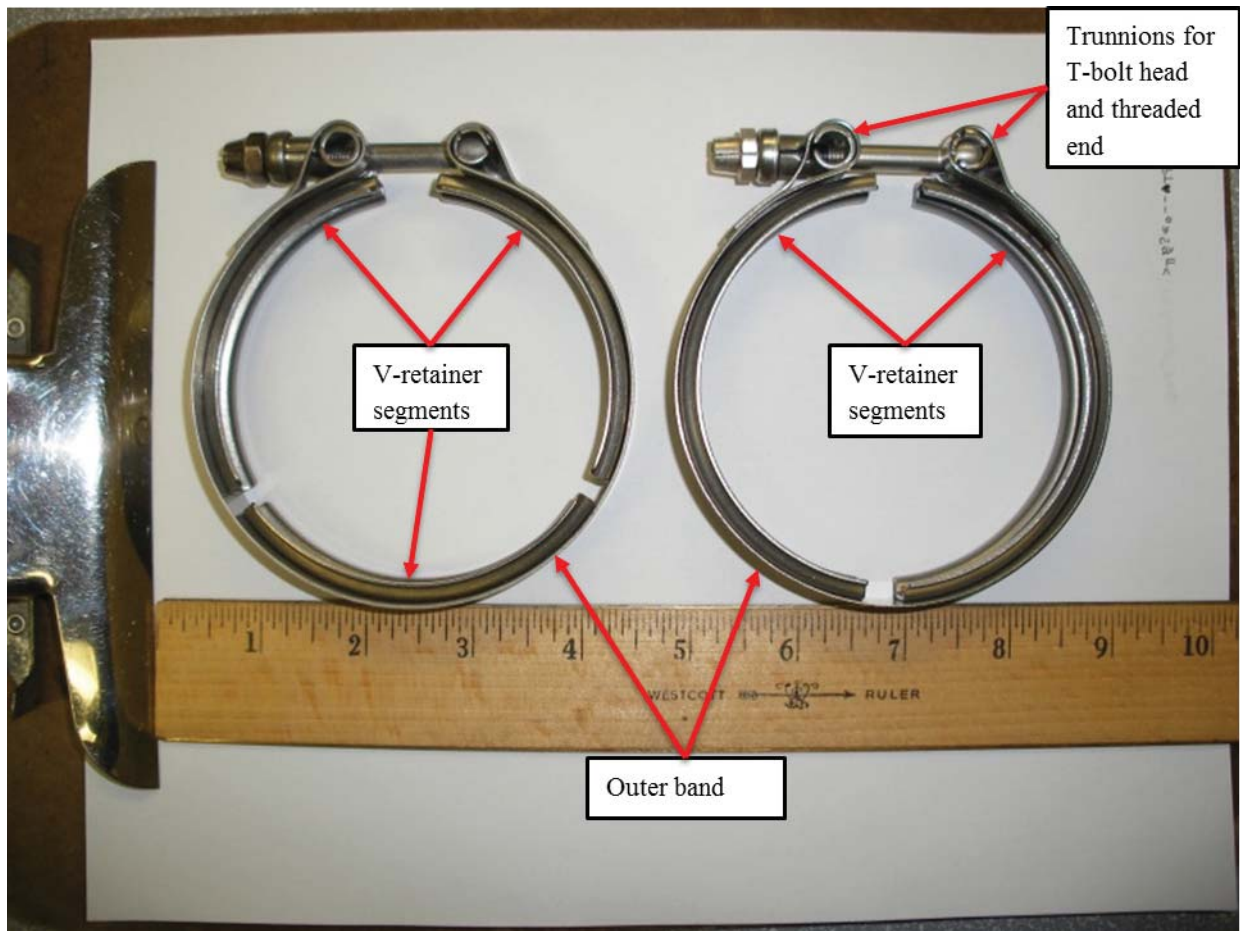
**Figure 3**  
**Spot-Welded, Multi-Segment, V-band Couplings**  
**3-segment LH                      2-segment RH**  
**3.750-inch size**

Spot-welds (typical)  
Rivets would be in similar  
locations

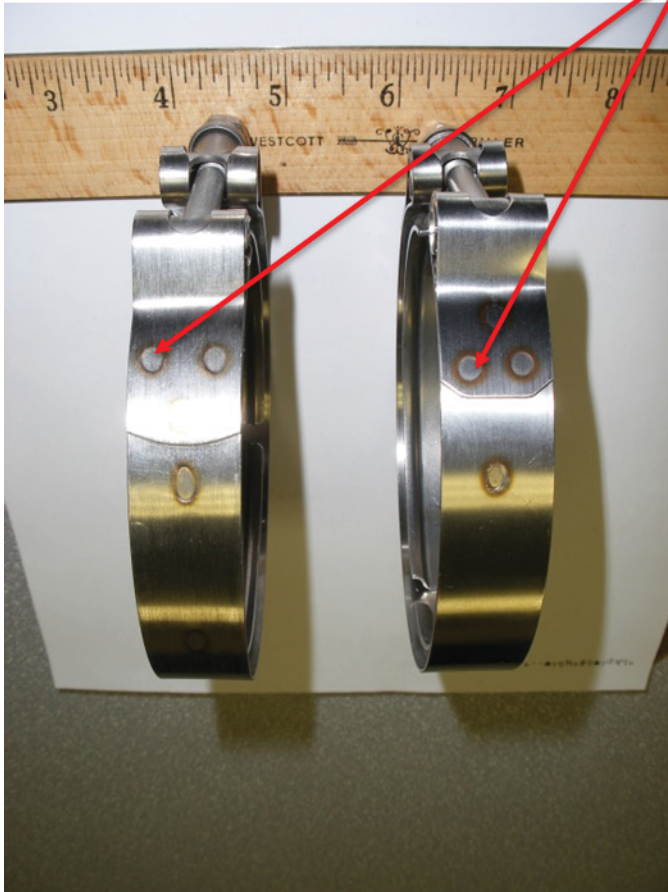
**Figure 4**  
View looking at T-bolt head trunnion end

**Spot-Welding, Multi-Segment, V-band Couplings**

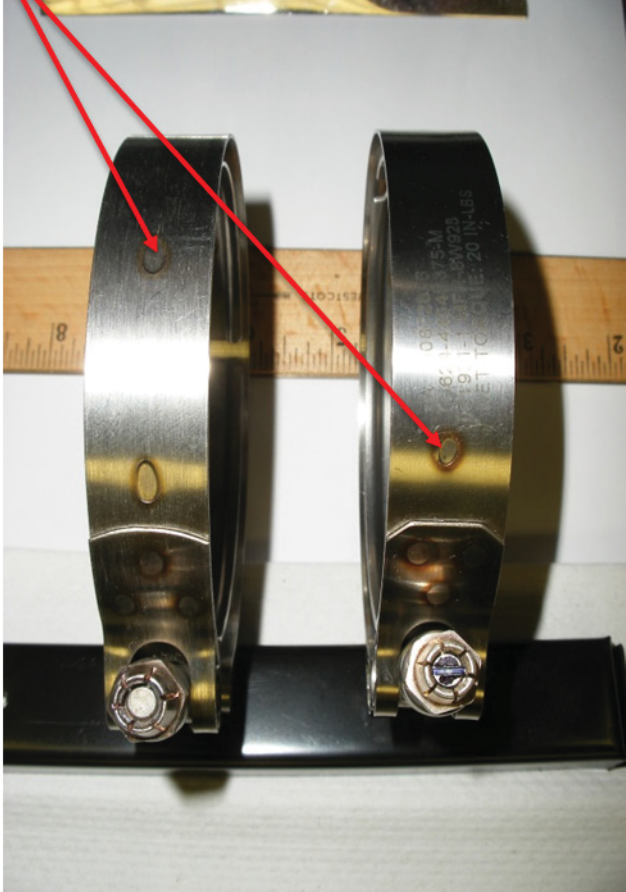
**Figure 5**  
View looking at lock-nut trunnion end

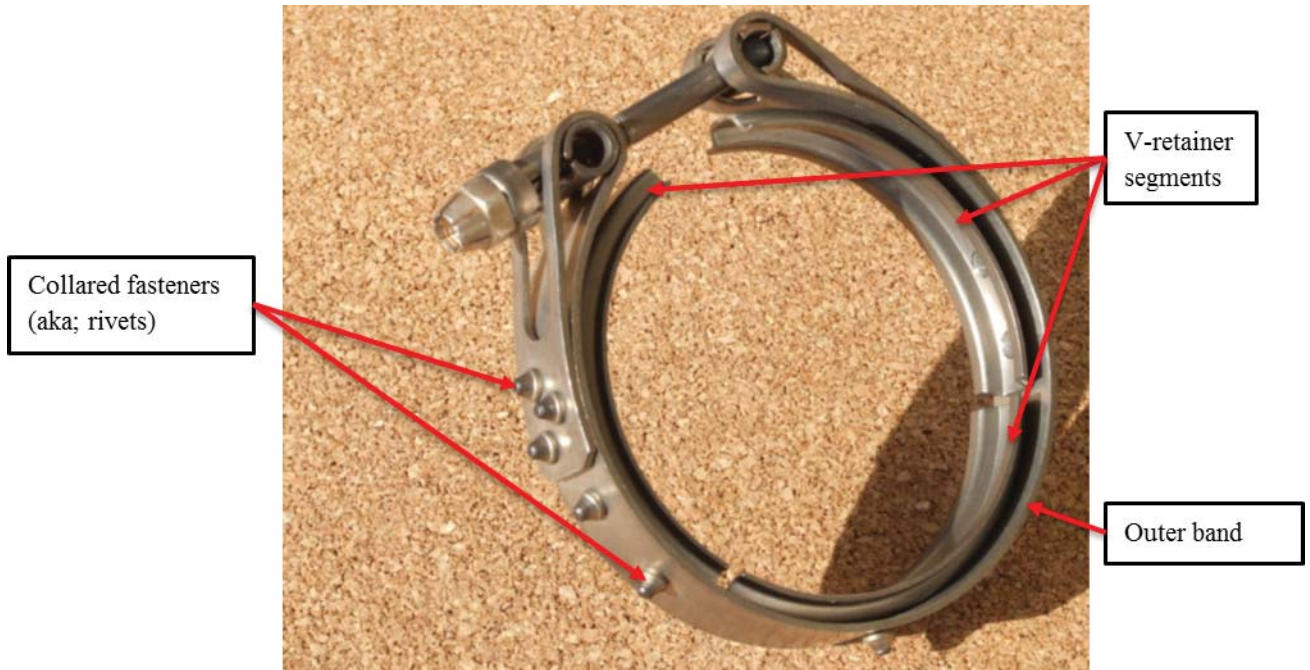
**Figure 6**  
**Riveted (aka, Collared Fastener), Multi-Segment, V-band Coupling, 3-Segment,**  
**Unknown size**

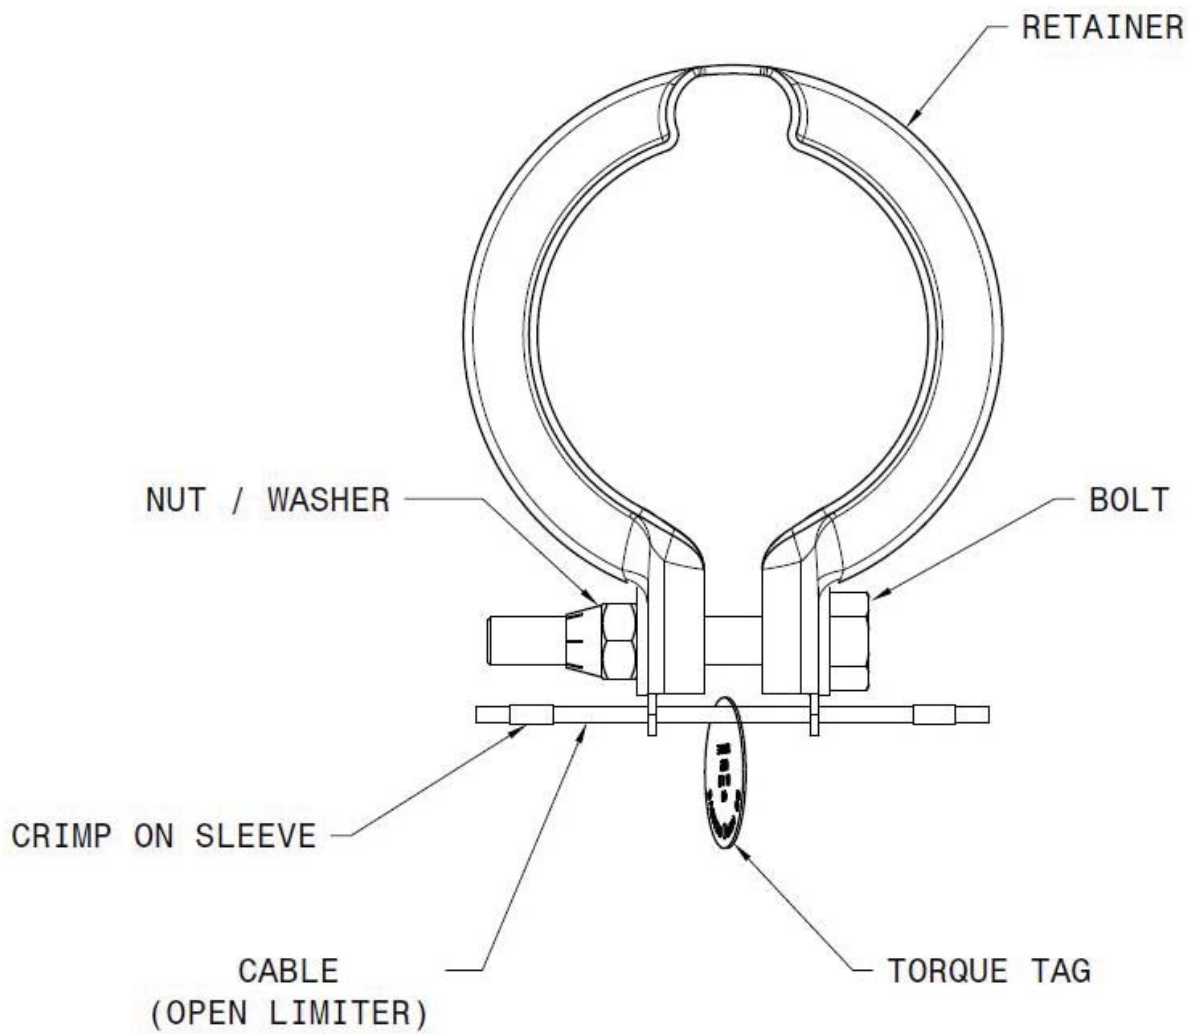
Single-Piece, V-band *Clamps* are stamped and roll formed from one single-piece of base material. Materials used throughout are various stainless steel alloys or Inconel's. The single-piece straight (only) bolt is a stainless steel alloy. The self-locking nut is typically a high temperature steel alloy that is often silver coated. The self-locking nut is all-metal and the locking feature is a mechanical interference type with no polymer inserts. There is typically one washer under the bolt head and one washer under the nut on these clamps. They also typically come with a cable across the open end which acts as an open limiter. Installed on that cable there can be a tag with torque and/or part number and a pair of crimped on sleeves to limit opening. Lack of the cable, torque tag and/or crimp(s) (if applicable to the p/n) that appear replaced should make the clamp suspect. Refer to Figure 7 and 8.

**Figure 7**  
**Single-Piece, V-band Clamp**

- f. Crack in the clamp V-band exterior or interior surface along the V-apex, around the perimeter. Refer to Figures 16, 26 & 27.
- g. Clamp open limiter cable (if applicable to the specific part number of clamp) missing or detached. Refer to Figures 7, 8 & 16.

- h. Clamp part number and/or torque tag (if applicable to the specific part number of clamp) missing or detached. Refer to Figures 7, 8 & 16.
- i. Contact of the V-retainer segments ends or clamp ends at any location (e.g. bolt area). Refer to Figures 14 & 16.

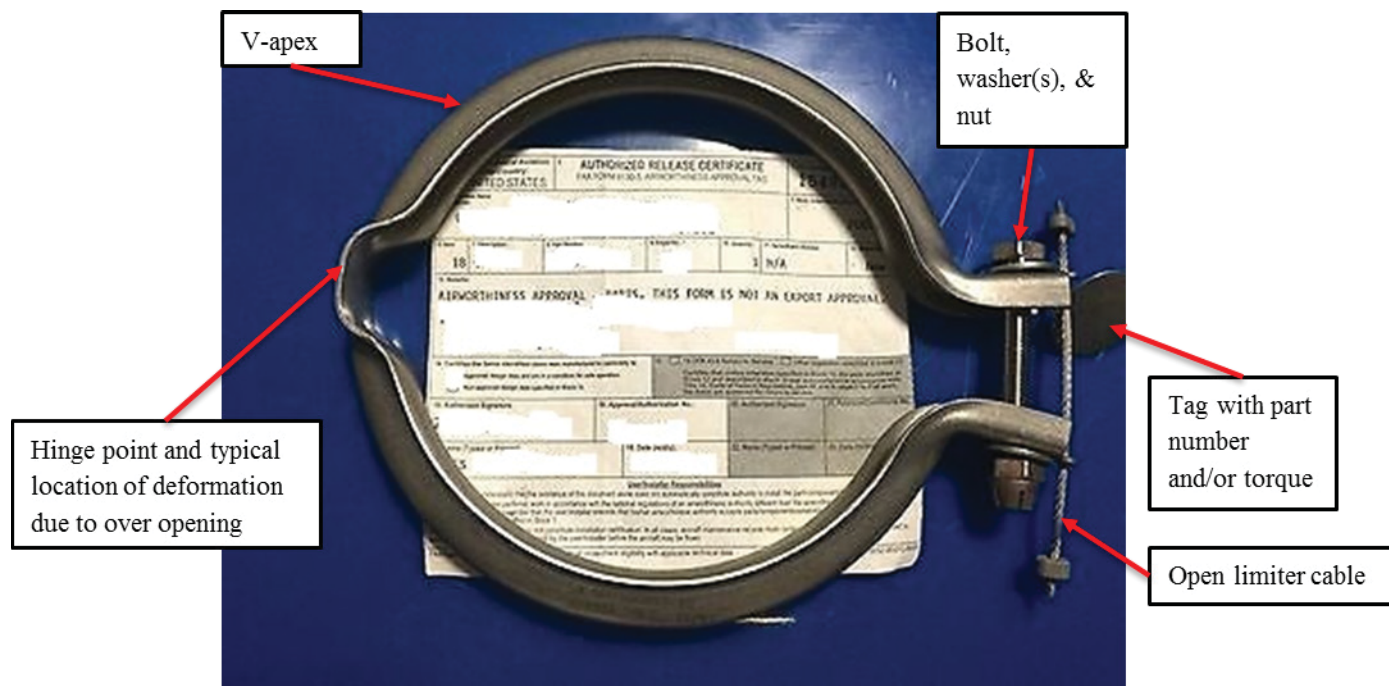
**Figure 8**  
**Single-Piece, V-band Clamp**

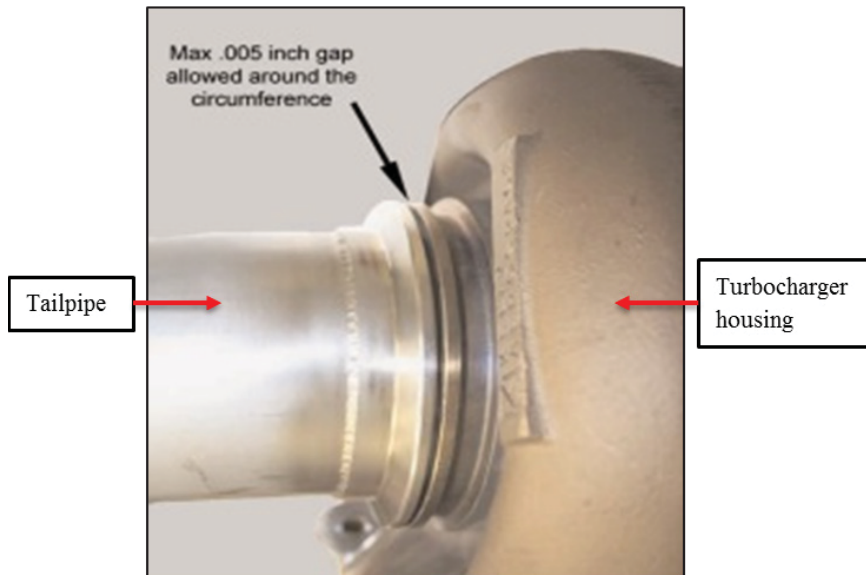
**Figure 9**

Inspect the turbocharger exhaust exit flange and the exhaust tailpipe flange interfaces for any un-flat (0.005 in. or greater) or wavy condition, corrosion, pitting, scaling or deposits (not easily removed) and correct per the manufacturer's recommendations. Refer to Figure 9.

**Typical turbocharger exhaust exit flange to tailpipe interface**

If the coupling/clamp is removed, inspect the turbocharger exit flange and the tailpipe flange interfaces for any un-flat (0.005 in. or greater) or wavy condition, corrosion or deposits (not easily removed) and correct per the manufacturer's recommendations. Refer to Figure 9.

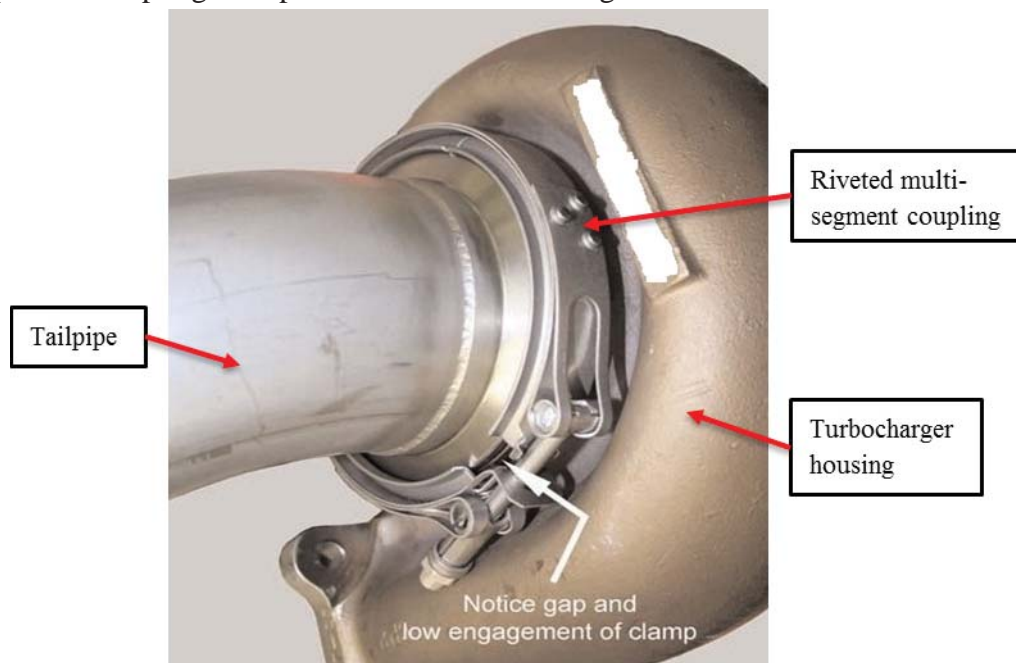
**Figure 10**

- e. Assemble the tailpipe exhaust flange on to the turbocharger exhaust flange, with a new gasket if applicable per the DAH type design configuration or current Instructions for Continued Airworthiness (ICA). Carefully twist the coupling/clamp over the flanges as if to follow the flanges as a nut would on a screw thread. Refer to Figure 10.
- f. Ensure alignment of tailpipe flange and turbo exhaust exit flange with no gaps (maximum 0.005 in.), prior to coupling/clamp installation. Refer to Figure 9 & 10.

**Typical installation of tailpipe and V-band coupling on turbocharger exhaust flange**

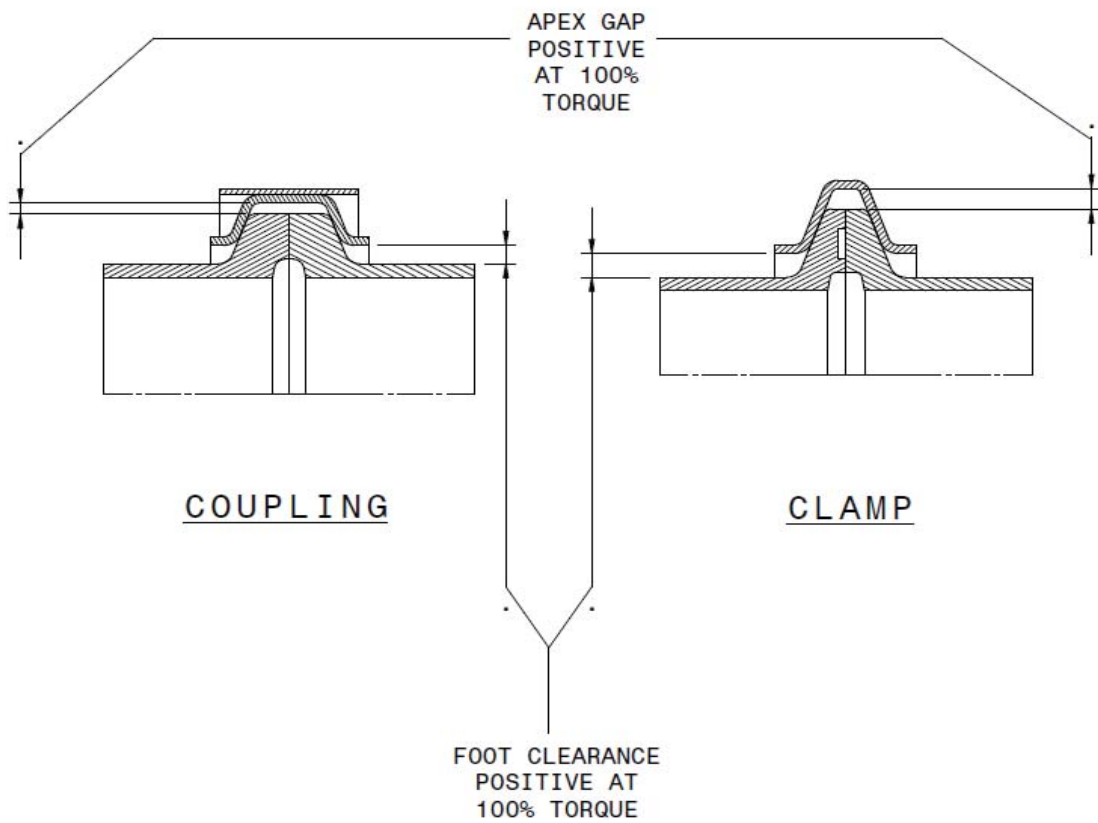
**Figure 11**  
Coupling & Clamp Installation Clearances

- h. With the coupling/clamp properly torqued, visually inspect looking for any Unsatisfactory Condition as defined in Section 5. Refer to Figures 11, 14, 16 & 17.

- i. After any coupling/clamp is re-installed on the same engine only and torqued as required per Section 3, verify there is space between the ends of each V-retainer coupling segment or between the ends of the clamp. If there is no space between any V-retainer coupling segment, or between the ends of the clamp, before further flight, you should install a new coupling/clamp and restart the hours TIS for the repetitive replacement of the coupling/clamp. Refer to Figures 11, 14 & 16.

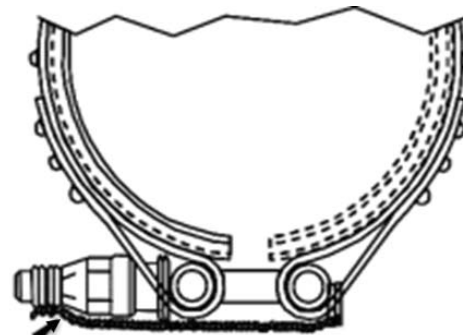
**Figure 12**  
Multi-Segment, Coupling Safety Wired

Safety wire

- l. We recommend safety wire (minimum 0.032 in. stainless steel) per acceptable methods the bolt head to the nut end trunnion of the coupling as applicable to preclude opening of the coupling if the bolt or nut loosens, fails, or separates from the mating fastener after installation. Refer to Figures 12 & 13.

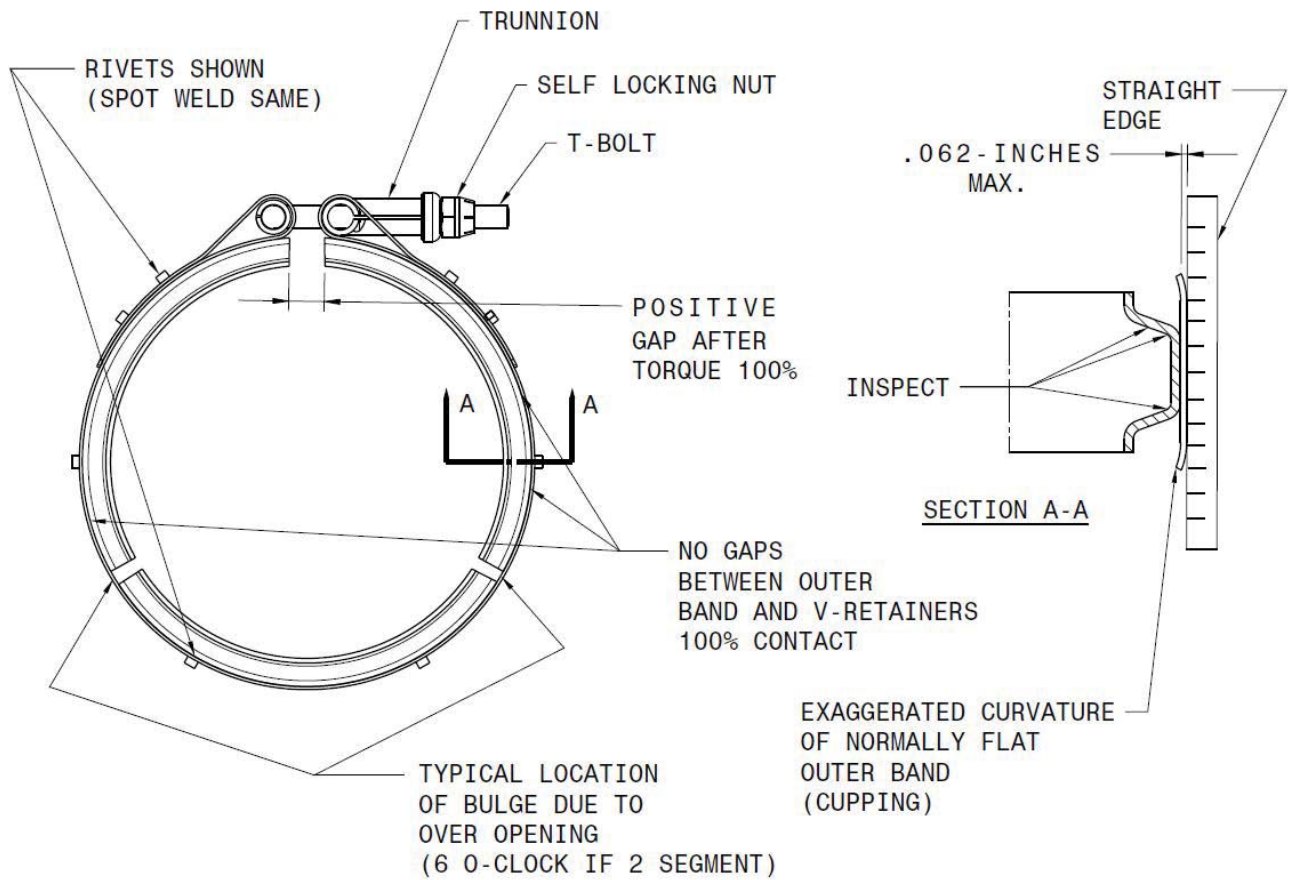
**Figure 14**  
**Multi-Segment, V-band Coupling**

- c. Visually inspect the coupling outer band for flatness using a straight edge. Lay the straight edge across the width of the outer band. The gap between the straight edge and the band must be less than 0.062 inches. Refer to Figure 14.

- g. Visually inspect the outer band and the V-retainer ends of a coupling or the V-band of any clamp opposite the bolt location (6 o'clock) for physical damage (i.e. distortion, creases, bulging, or cracks). Refer to Figures 14 & 16.

- c. Crack in any coupling V-retainer segment interior or exterior surface, e.g. at corner radii. Refer to Figures 14 & 25.
- d. Looseness, separation of the outer band to V-retainer segment(s) at any spot-weld or rivet. Refer to Figures 14 & 15.

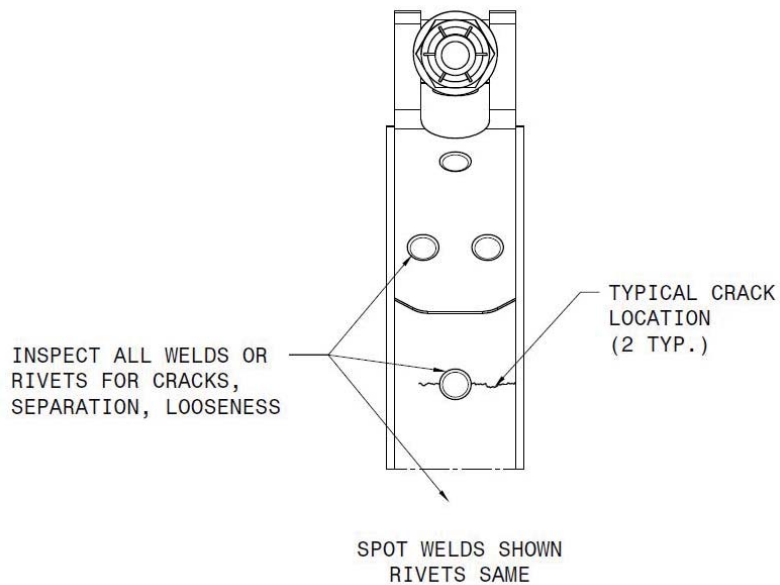
**Figure 15**  
**Multi-Segment, V-band Coupling**

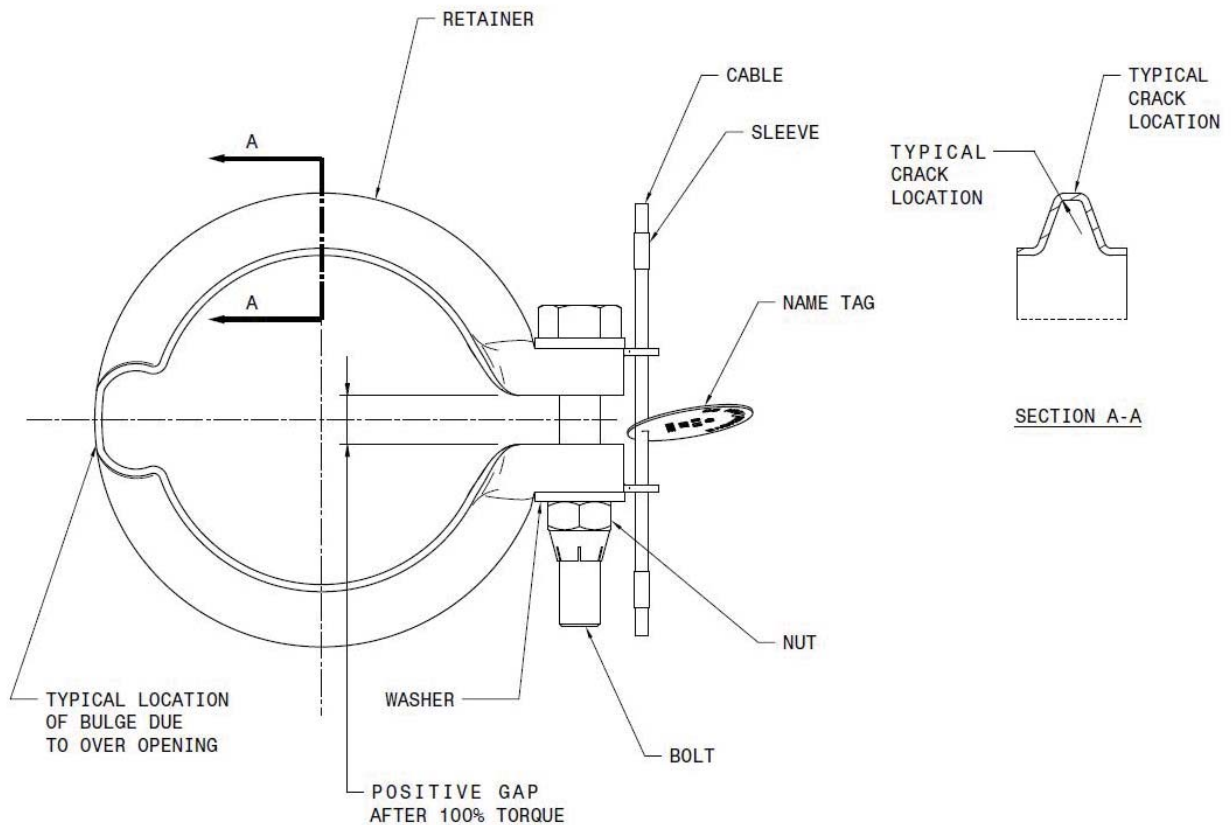
**Figure 16**  
**Single-Piece, V-band Clamp**

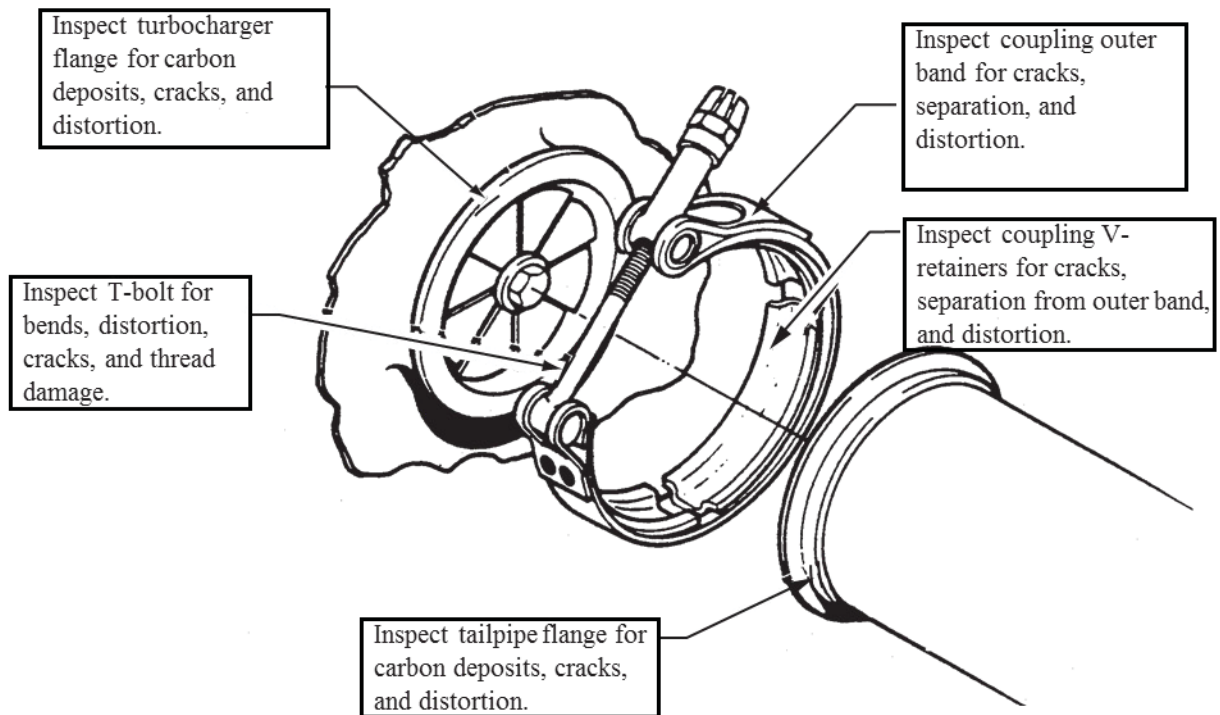
**Figure 17**  
**Typical Turbocharger to Tailpipe Interface Area**

- g. Thereafter, if required, clean engine exhaust components per acceptable or approved methods using acceptable or approved materials. Pay particular attention to the outer band (flat) of a multi-segment V-band coupling, specifically at or near any spot-weld or rivet, and the outer surface of the V-band on a single-piece clamp. Refer to Figures 14-17, 19, 21-23, 26 & 27.

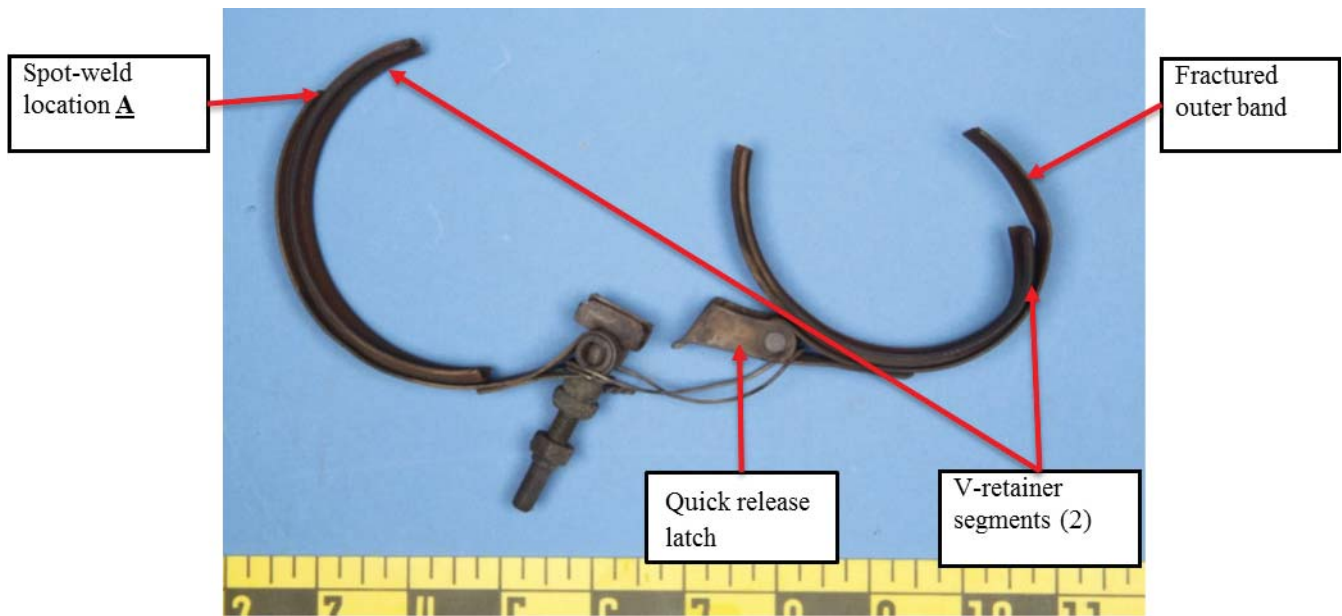
**Figure 18**

**Spot-welded, 2-segment Coupling with Quick Release Latch**

The above failure started as a crack that originated out of the spot-weld. The crack grew to a full transverse outer band crack that caused separation of the coupling. The above failure resulted in loss of the tailpipe, smoke in the cockpit, in-flight fire and fatalities. Note the safety wire is still in place.

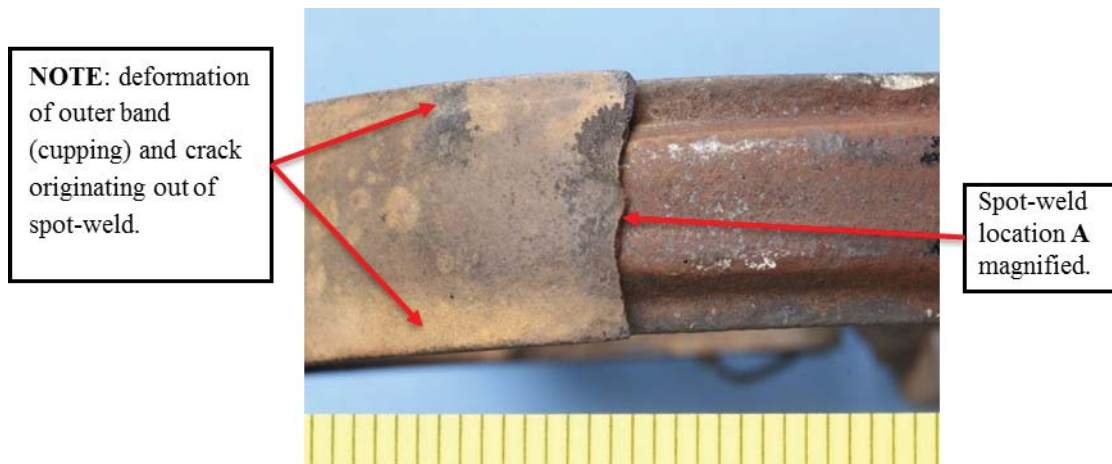
**Figure 19**

**Same coupling above magnified**
