# **Best Practices Guide**

## **Maintaining Exhaust System Turbocharger to Tailpipe V-band Couplings / Clamps**

JASC 8100 Exhaust Turbine System (reciprocating)  
JASC 8120; Exhaust Turbocharger

**April 2018**

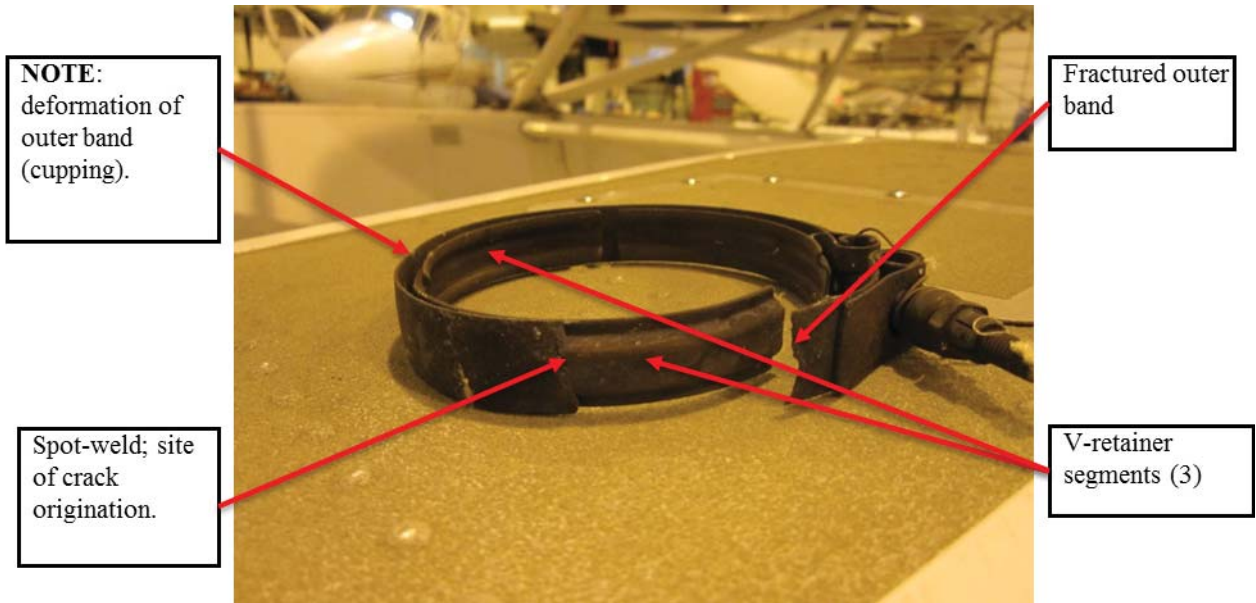
**Figure 20**  
**Spot-welded, 3-segment Coupling**

The above failure started as a crack that originated out of the spot-weld. The crack grew to a full transverse outer band crack that caused separation of the coupling. The above failure resulted in loss of the tailpipe, smoke in the cockpit, in-flight fire and a very quick, direct in approach and landing on fire. There were no fatalities. Note again the safety wire is still in place.

- a. Crack in the coupling outer band (flat) material, potentially at or near a spot-weld or rivet. Refer to Figures 1, 2, 4, 5, 6, 15, 19, 21, & 22.
- b. Cupping, bowing or crowning of the coupling outer band beyond 0.062 inches in depth. Refer to Figures 14, 19, 20 & 22.

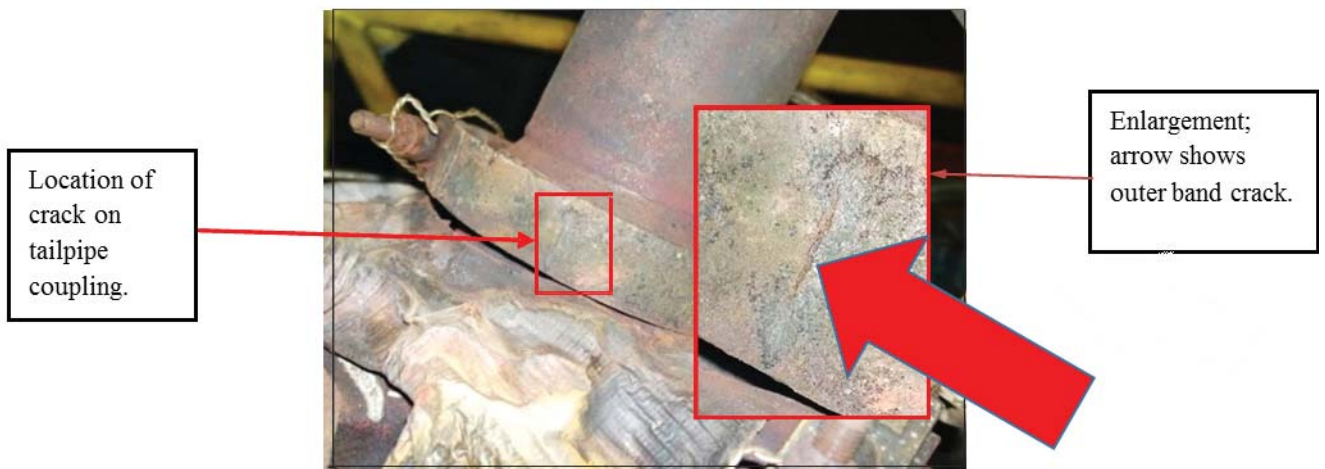
**Figure 21**  
**Spot-welded, Multi-segment Coupling**

The above crack originated at a spot-weld. However, the crack had not grown across the outer band and the coupling had not separated yet. Found on inspection for another issue.

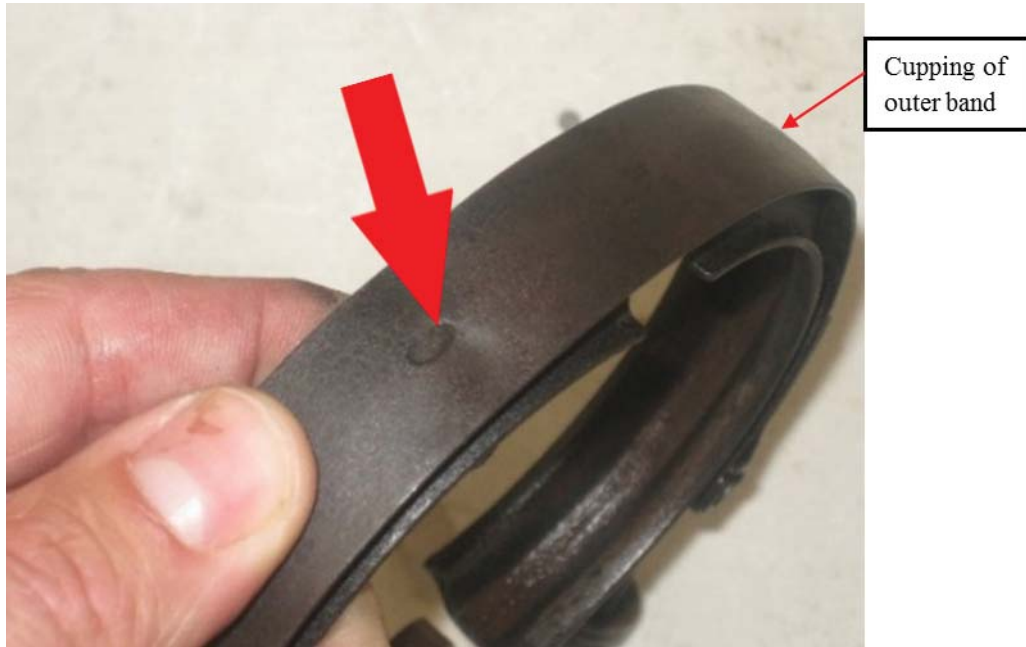
**Figure 22**  
**Spot-welded, 3-segment Coupling**

The red arrow shows where the coupling is deformed at a spot-weld where the crack originated. The crack had not yet grown across the outer band and the coupling had not separated. Found on inspection for another issue.

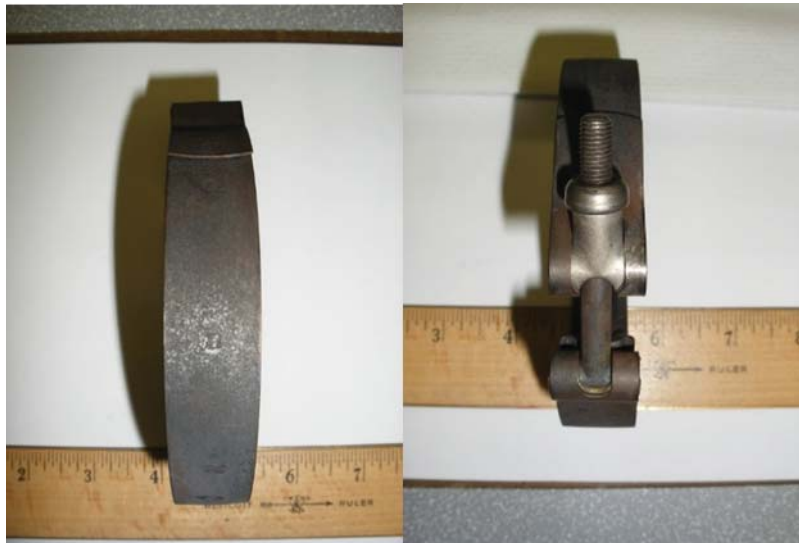
**Figure 24**  
**Spot-welded, 3-segment, Coupling**

Figure 25 is the same coupling as in Figure 24 above. This photograph was taken on a bench with a white top, using back lighting from a flashlight. There is a crack in the V-retainer segment inner corner radius. With the condition of the coupling, this crack was difficult to find with the coupling in-hand. This crack could not be found with the coupling installed. Found during inspection after tailpipe removal. Note the corrosion from salt-water operations.
