HIGHWAY FACTORS
Group Chairman's Factual Report

Fatal Multi-Vehicle Rear-End Accident in a Work Zone
Cranbury, New Jersey

HWY14MH012
(40 Pages)

Highway Group Chairman's Factual Report

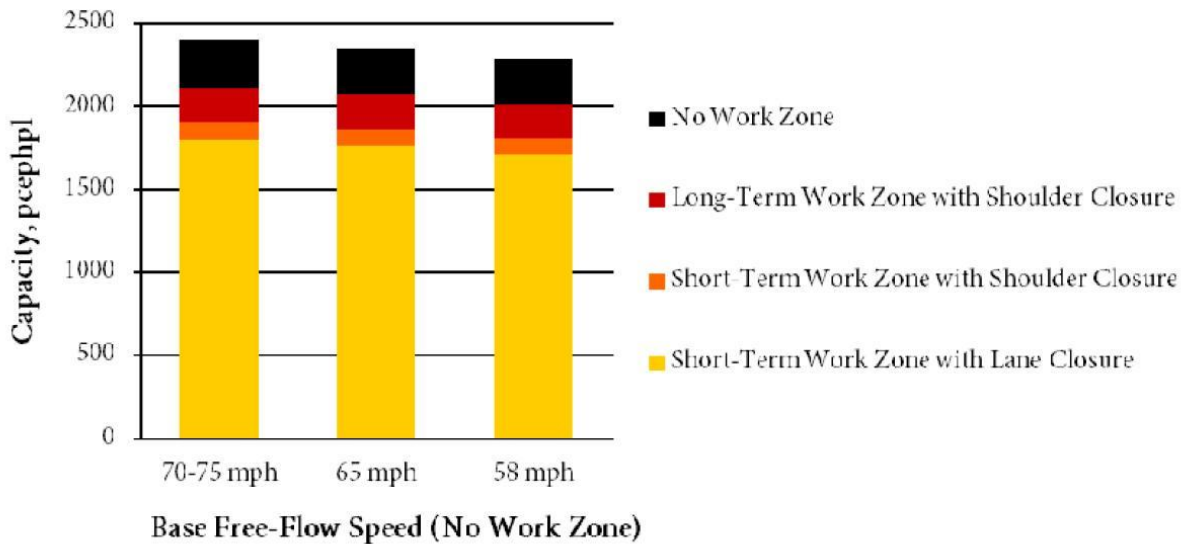
Figure 1.

7. Work intensity factor – 5.7% reduction for high-intensity work or police presence with flashing lights.
8. Short term work zone with a lane closure – Work zone capacity= 1,710, 1,760, and 1800 PCEPHPL with non-work zone free flow speeds ranging from 58, 65, and 70-75 mph. See figure 1.

Adding all of the work zone reduction factors resulted in a 29.2-percent reduction from the estimated 1,800 PCEPHPL capacity, or 1,260 PCEPHPL. The average hourly volume of 488 vehicles indicated the demand or hourly volumes did not exceed the roadway capacity. Consequently, according to the capacity manuals, a queue from congestion should not have developed at this location. Later analysis will provide explanations of why the queue may have developed.

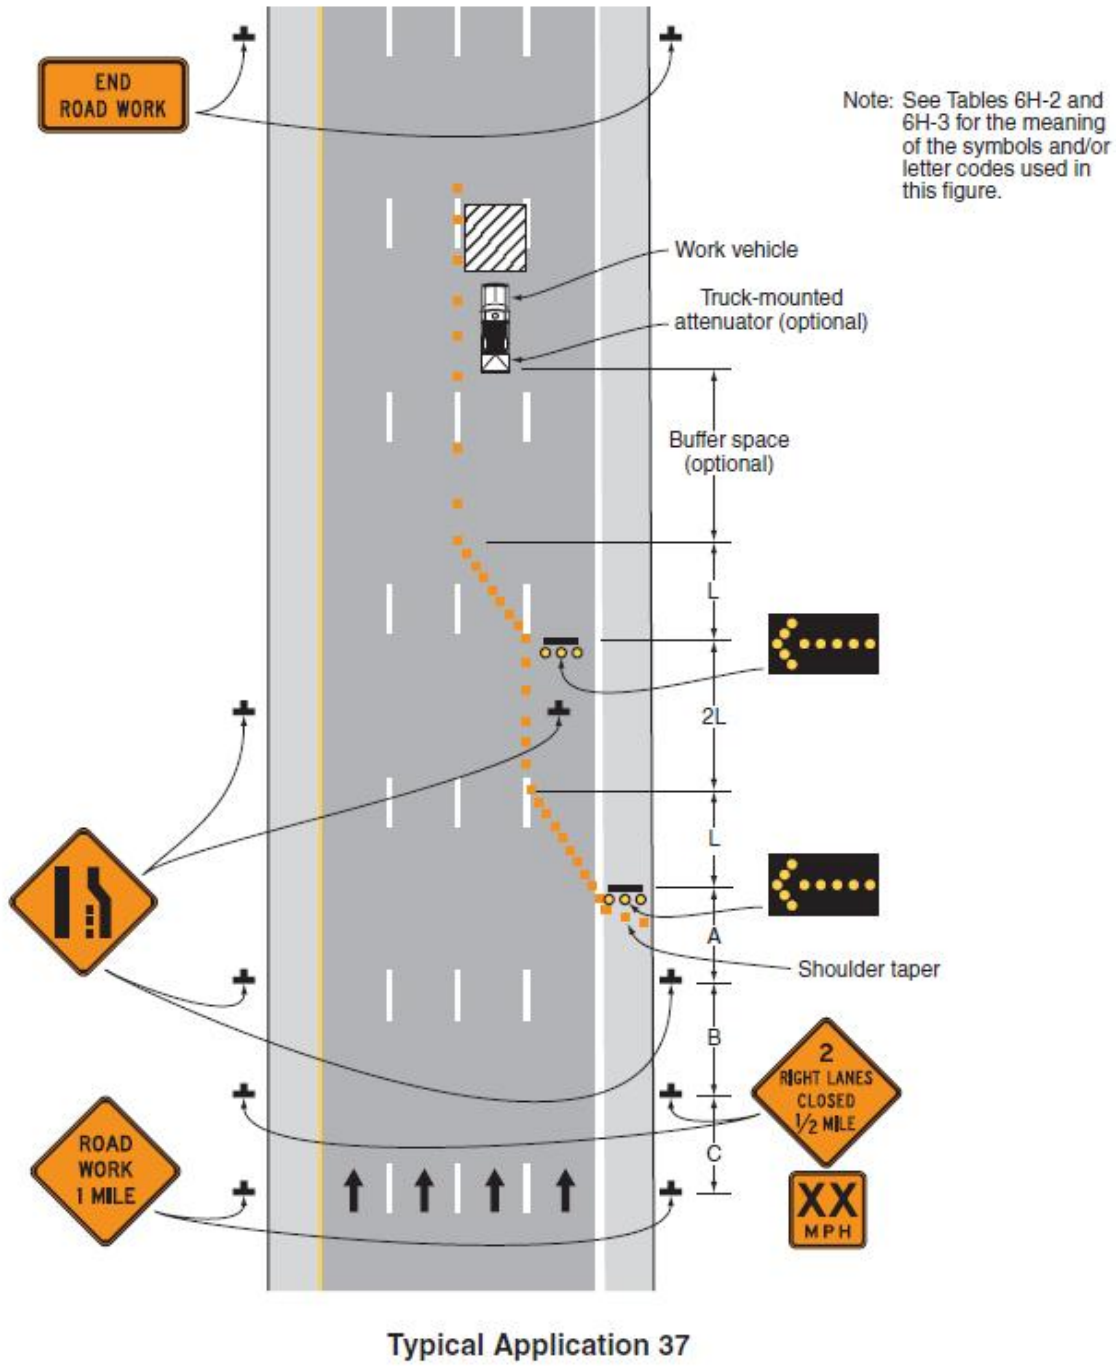
Figure 2.

Section 6G.14 of the 2009 MUTCD, “Work Within the Traveled Way of a Freeway or Expressway,” addresses lane closures and multiple lane closures on high-speed freeways and expressways. The standard requires that an arrow board shall be used when a freeway lane is closed. Also when more than one lane is closed, a separate arrow board shall be used for each closed lane. Examples of proper placement of traffic control devices are given in Typical Application (TA 37). Comparison of TA 37 in the MUTCD and the Standard Drawing for a multiple right lane closure for the NJTA (Traffic Protection (TP3) showed that the NJTA complied with and exceeded the MUTCD standards and guidance for color, sign wording, retro-reflectivity, dimensions, advance warning, and placement. See figure 2 for MUTCD TA-37.

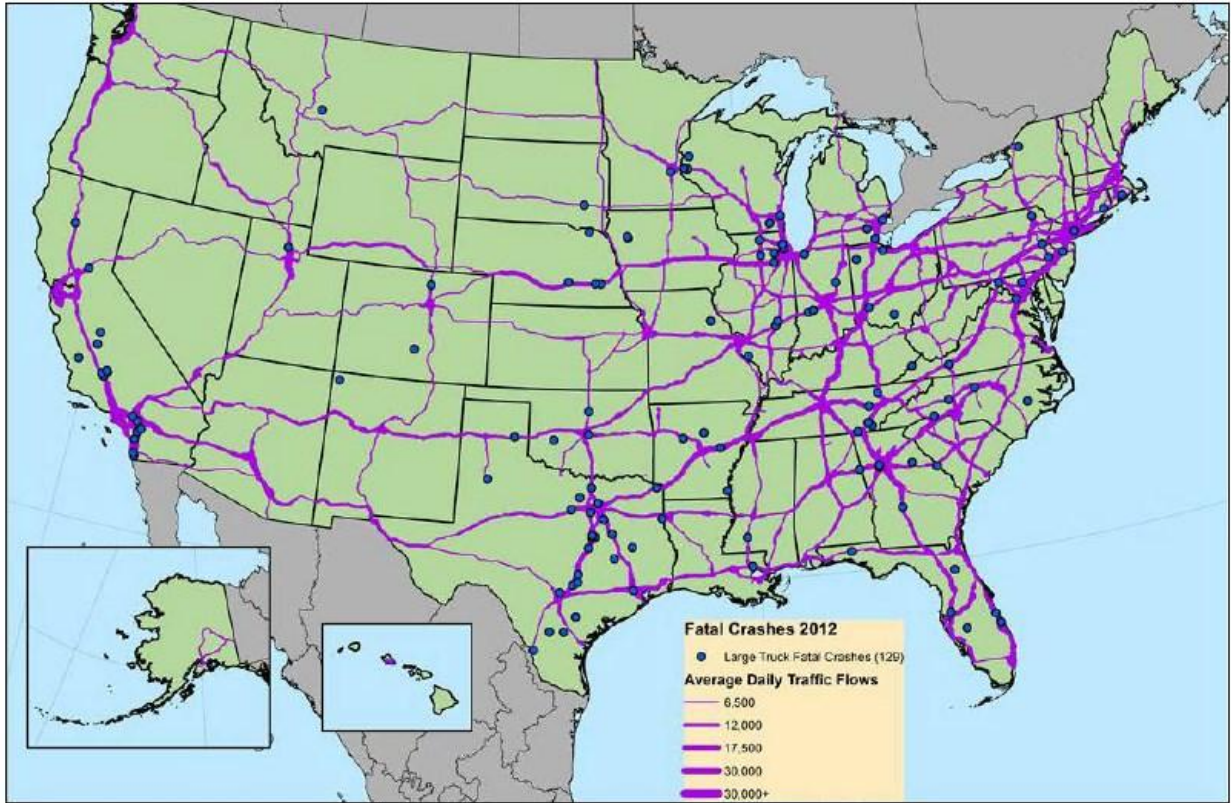
Figure 4.

The map below shows the United States with interstate roadways and their corresponding average daily truck traffic flows, with a colored circle representing each of the 129 fatal work zone crashes in 2012 that involved a large truck.

Note: Average Daily Truck Traffic Flows are based on Freight Analysis Framework (FAF) 3.4.
 Sources: Fatal Crashes - USDOT, NHTSA, FARS, available at: <http://www.nhtsa.gov/FARS>; Traffic Flows - USDOT FHA, FAF Version 3, available at: http://www.ops.fhwa.dot.gov/freight/freight_analysis/faf/.

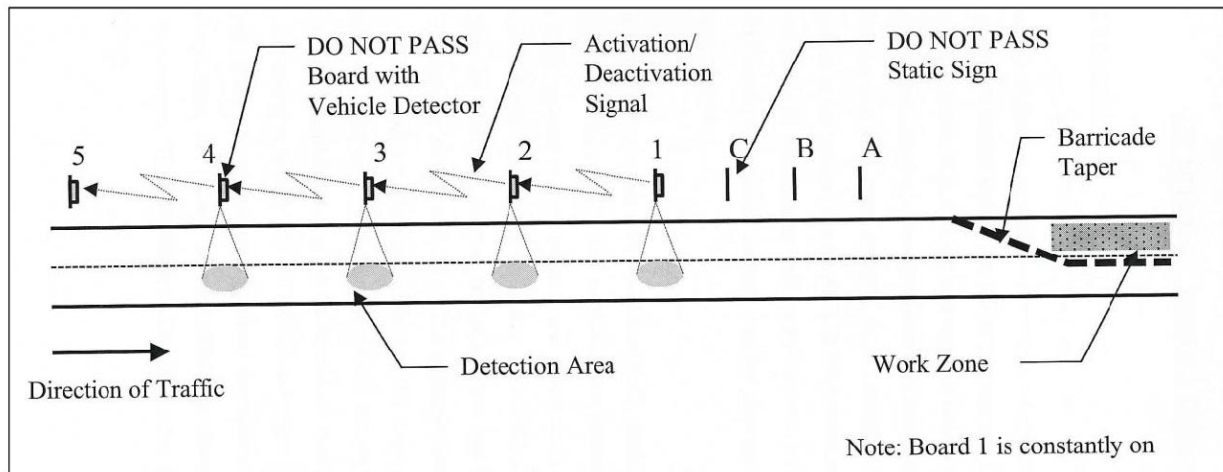
Figure 5.

Dynamic early merge systems can provide warnings over variable distances based on real-time measurements of traffic conditions. Again, heavier congestion and longer queues can develop when these systems are used during heavy peak flows. An example of an early merge dynamic merge control plan used by Indiana is shown below.

As the traffic backs up, the vehicle detectors warn traffic not to pass at farther distances back from the merge point.

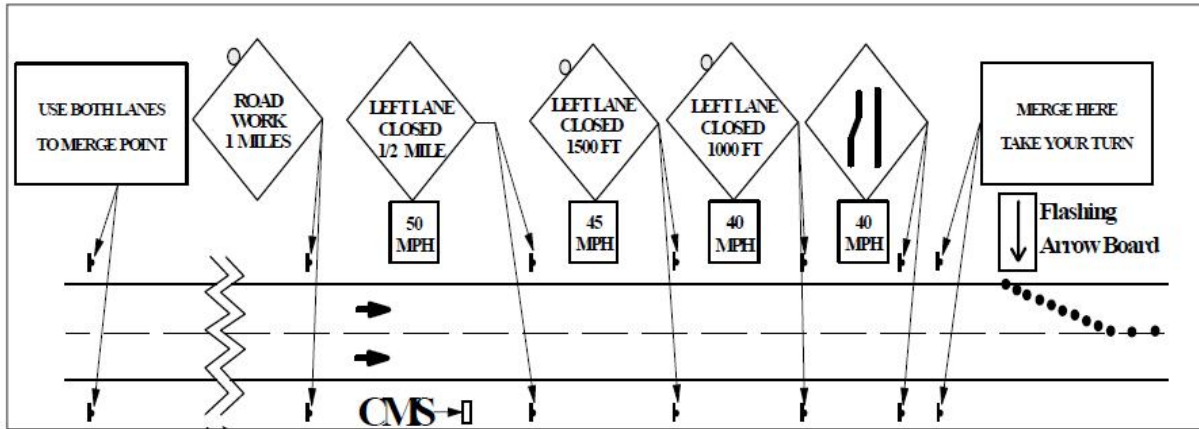
Figure 6.

Another strategy is late merge control, which encourages vehicles to occupy both lanes up to a designated point rather than causing early merging. An example used by the Pennsylvania DOT is shown below.

The advantage of this system is that it allows drivers to use the lane with the shortest queue, up to a designated point. Also, dynamic lane merge systems with vehicle detectors have been used in Maryland, as seen in the figure below.

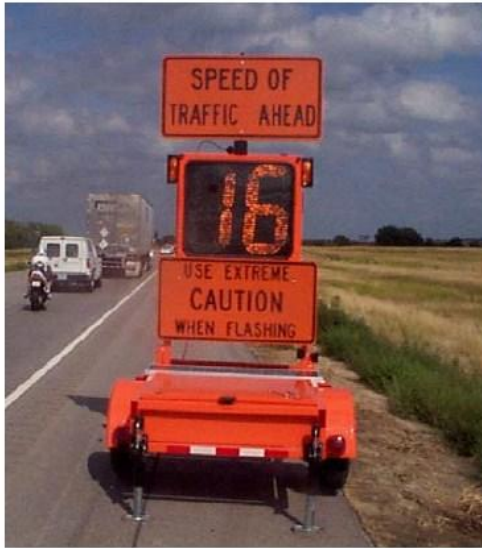
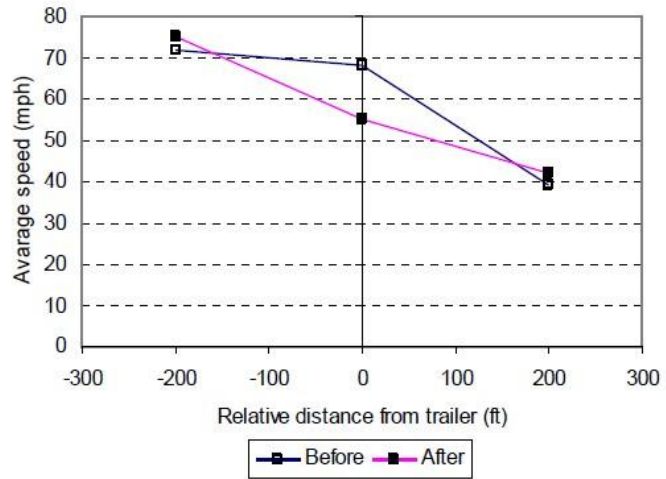
Figure 8.

The results of the analysis showed that the speed messages were effective in reducing the speed of vehicles approaching queued traffic. The change in mean deceleration due to the speed advisory system was statistically significant at the 95-percent confidence level.

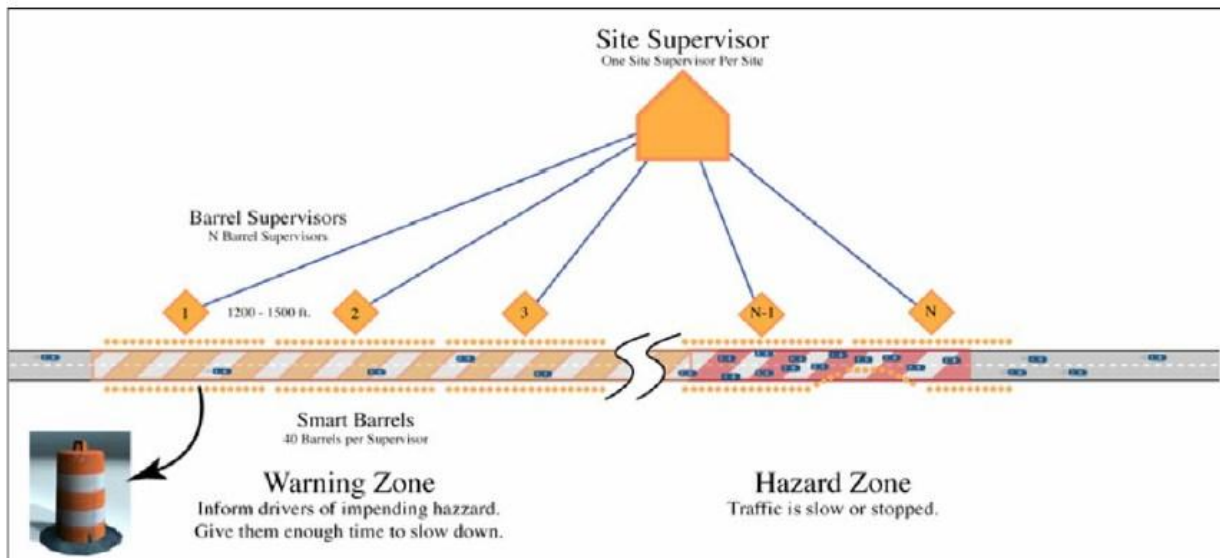
Figure 9.

The University of Michigan developed and evaluated a Work Zone Safety System for adaptive queue warning.²⁶ It was a distributed queue-warning system that automatically adapts to the traffic flow situation within and upstream of the work zone. Figure 9 below illustrates the concept of the adaptive queue-warning system.

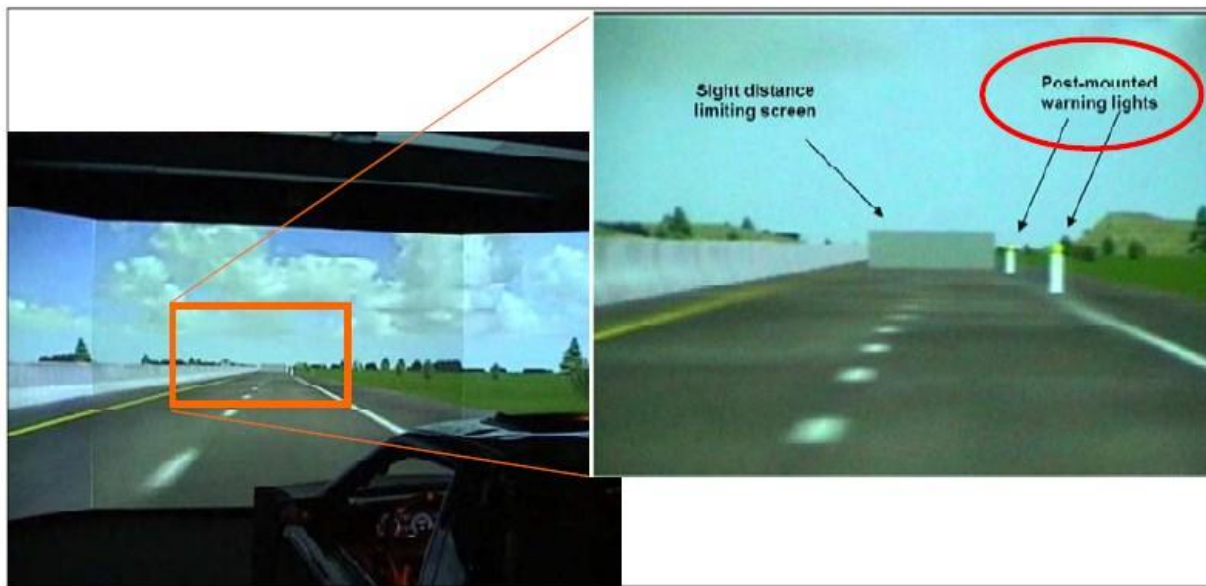
Figure 10

A core component of the system is the so-called “smart barrel” (i-cone). The smart barrel is a typical orange traffic-control barrel equipped with an inexpensive speed sensor; a simple, adjustable signaling system; and the necessary equipment for communication to a central controller. The Michigan study prototyped and tested a simple signaling scheme using a series of pole-mounted warning lights in a driving simulator, as illustrated in figure 10.

Driving simulator results indicated that drivers find adaptive systems more helpful than static road signs. Analysts observed systematic positive change in driving performance, which indicates enhanced safety. The technology shows promise in addressing problems of work zone rear-end crashes.

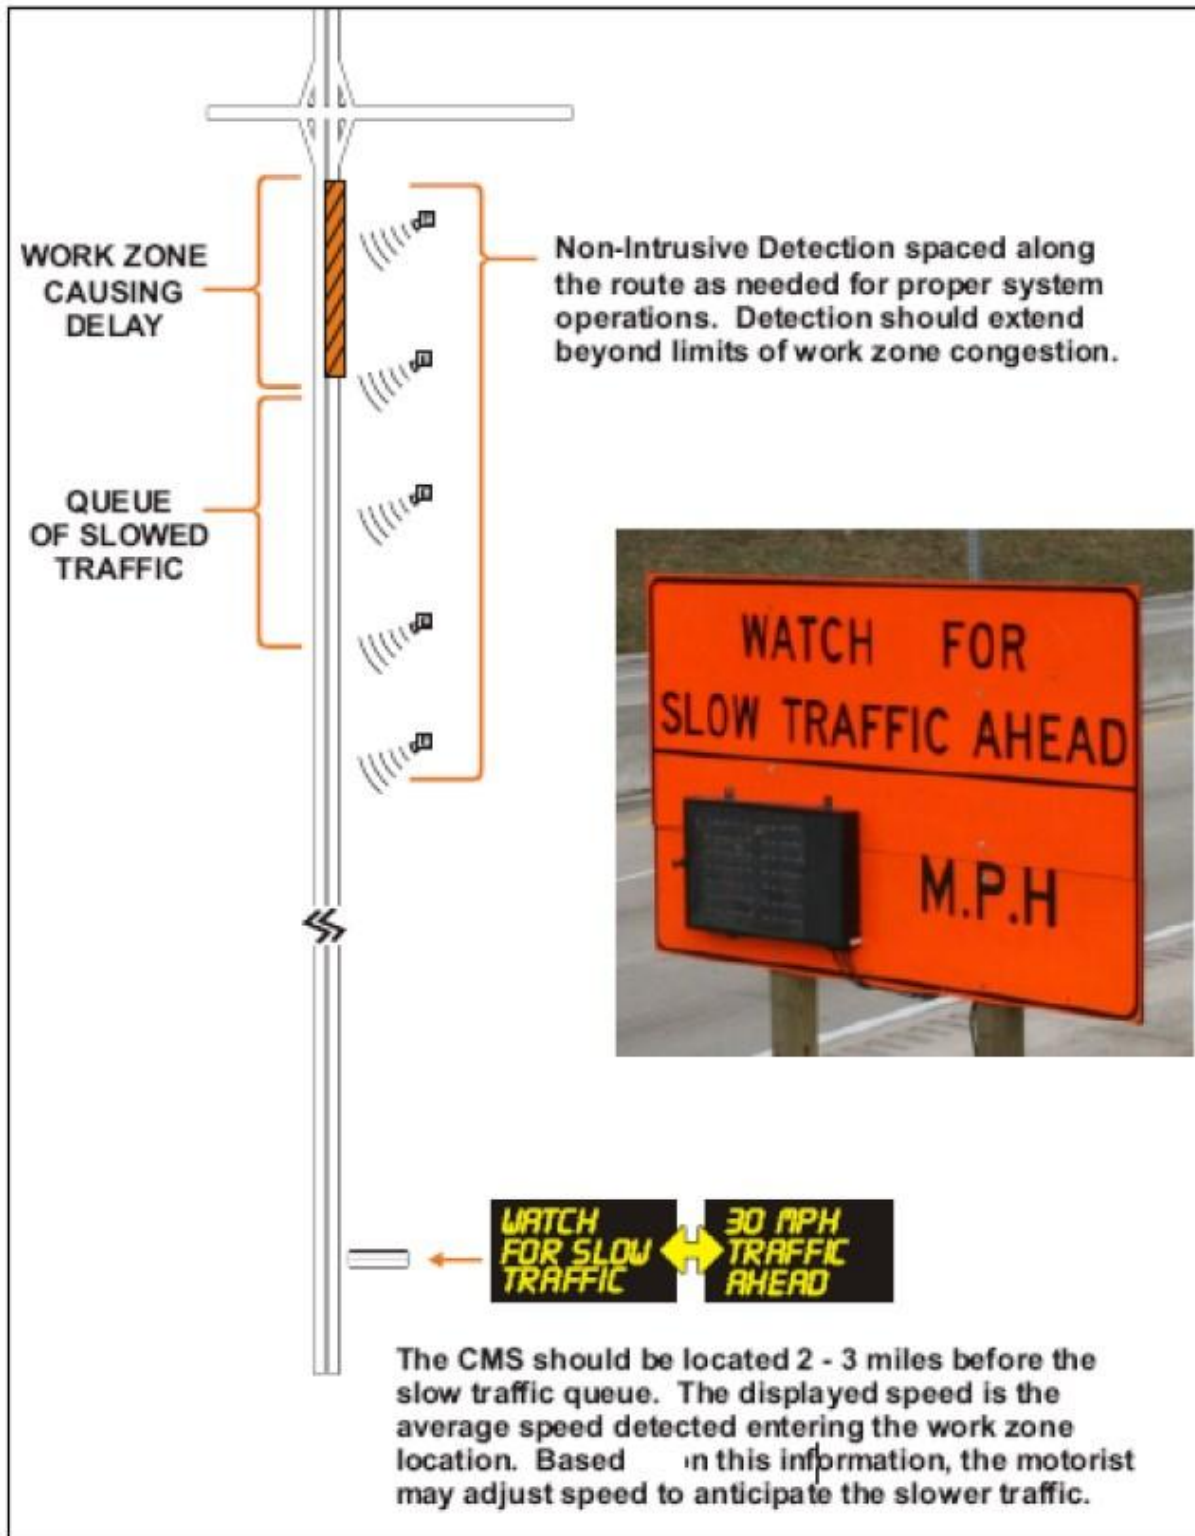
Figure 11.

Another speed advisory system found in the Minnesota DOT’s Intelligent Work Zone tool box is shown in figure 11.

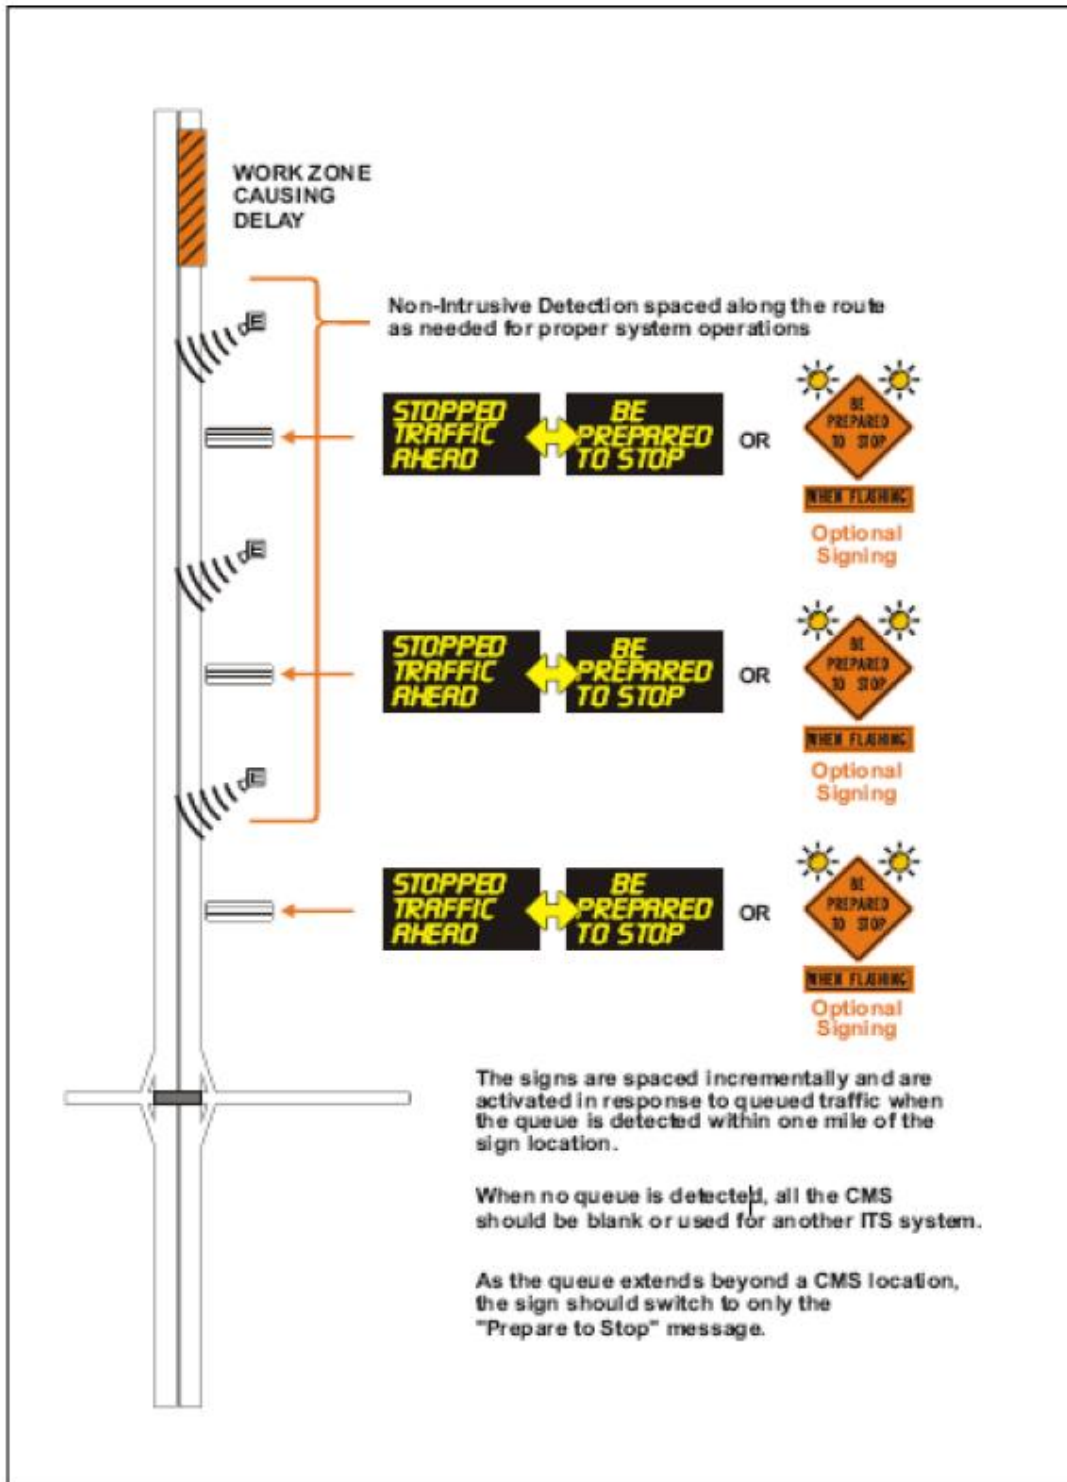
Figure 12.

Minnesota uses a similar dynamic sign set-up to warn of stopped traffic ahead. See figure 12.

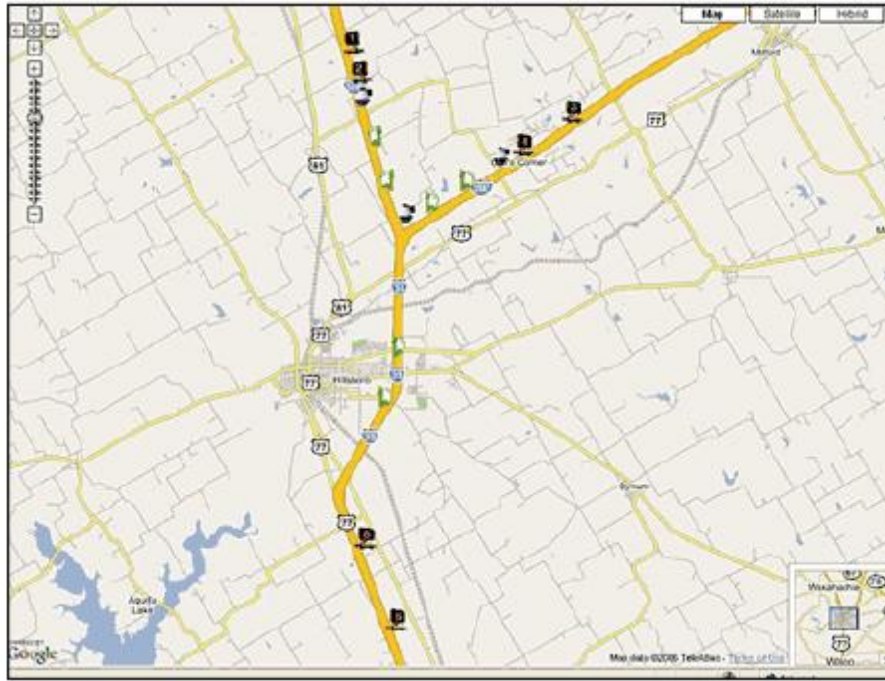
Figure 13.

Researchers examined another ITS project implemented by the Texas Department of Transportation (TXDOT) in October 2006 on I-35 near Hillsboro, Texas. The purpose of the system was to monitor traffic conditions and improve mobility and safety along I-35W, I-35E, and I-35 to the south of the split. Figure 13 shows the Hillsboro area and indicates the work zone.

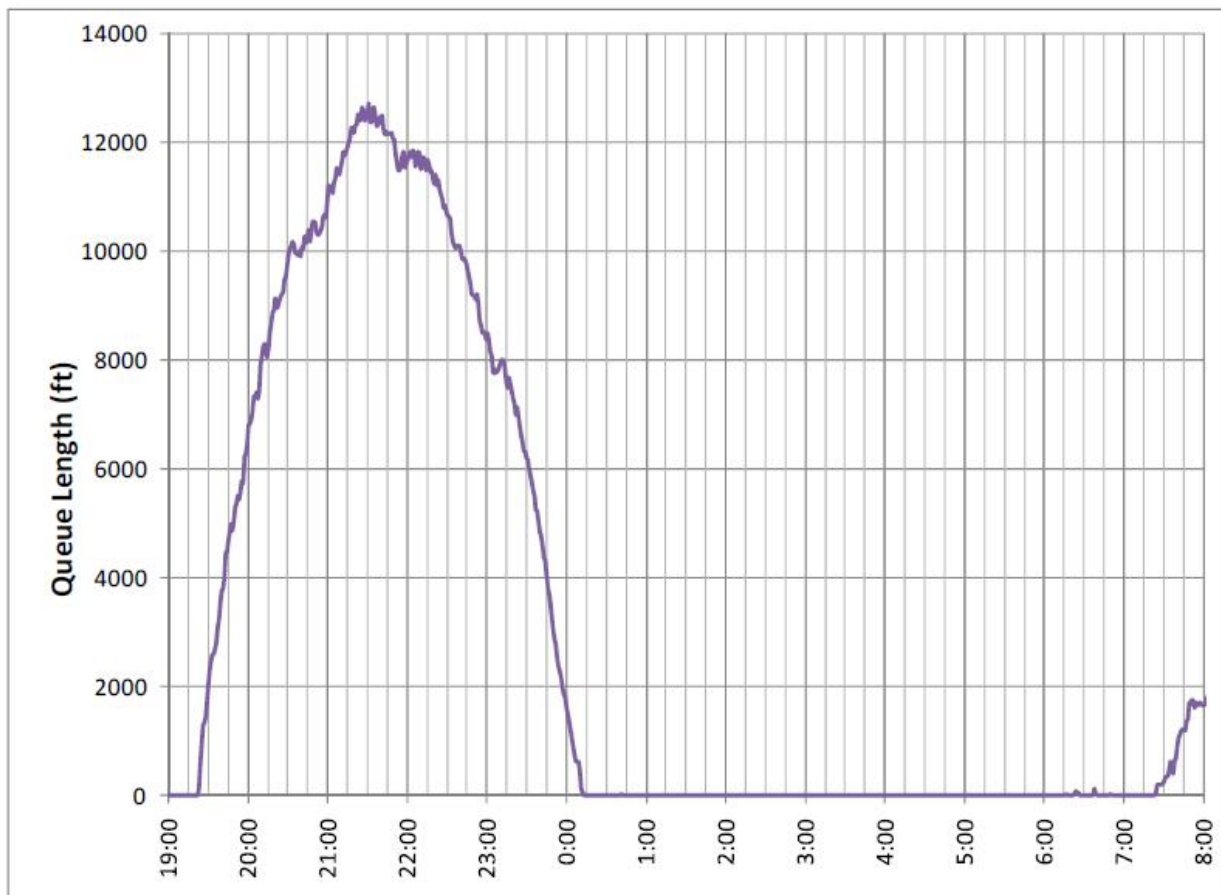
Figure 15.

Figure 15 shows a plot of the queue lengths over the entire period of the simulated nighttime work zone lane closure. The unit of measure is feet, and the distance is measured from the lane closure upstream. The maximum queue length was 2.4 miles, and most of the queuing was between 7 p.m. and midnight.

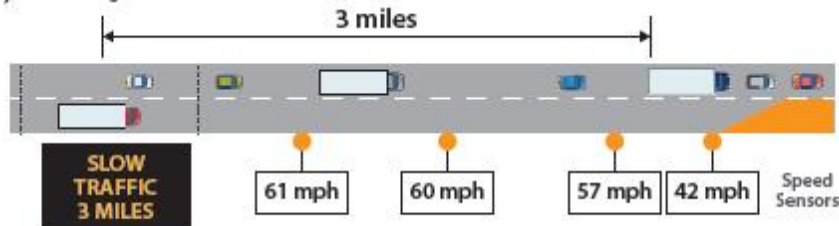
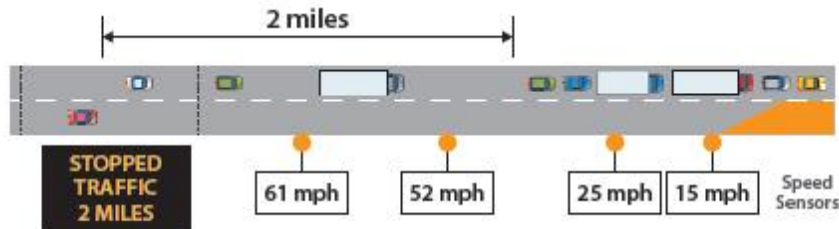
Figure 17.

Drivers are alerted to slow traffic ahead by the sign message changing to "Slow Traffic," with an indication of how far ahead the problem will be encountered. The sign may say 3 miles, 2 miles, or 1 mile ahead, determined by the system's readings.

Drivers are alerted to very slow or stopped traffic by a new message, "Stopped Traffic," and the number of miles ahead the traffic queue is stopped. A distance of 3 miles, 2 miles, or 1 mile may be reported.
