**MOTOR CARRIER FACTORS GROUP CHAIRMAN'S
FACTUAL REPORT**

MULTIPLE VEHICLE ACCIDENT

Cranbury, NJ

HWY14MH012

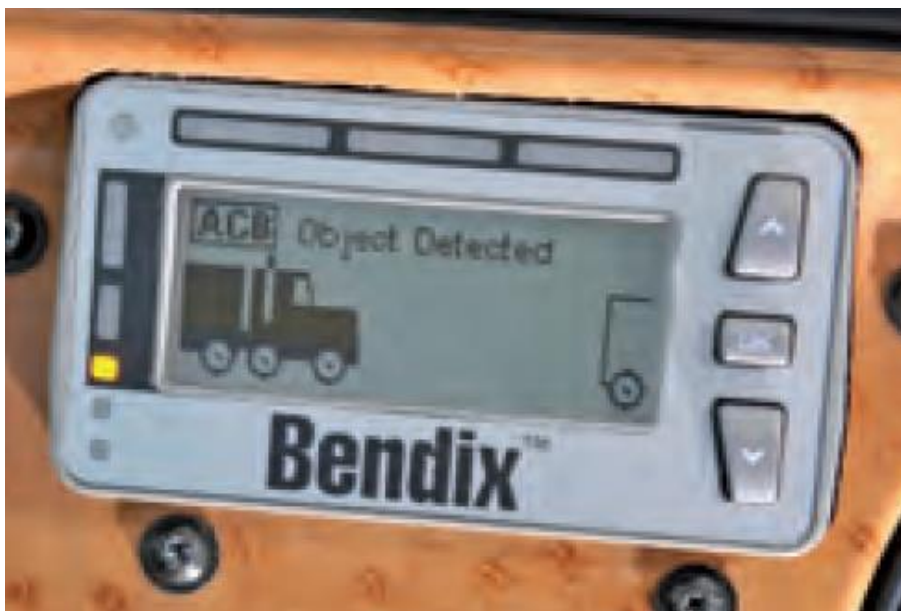
During the inspection of the maintenance facility at the Smyrna DC, a simulation of the Wingman ACB system for a stationary object scenario was demonstrated for NTSB investigators. Walmart safety officials used an exemplar tractor that was identical to the accident tractor.²⁵ The exemplar tractor was the same year, make, model, and configuration as the accident 2011 Peterbilt tractor. With the cruise control device not activated, the Walmart safety official drove close to a stationary object (another tractor). As the driver approached the stationary object, the Bendix system made an audible tone (loud “beep”) and illuminated a light bar on the Bendix display unit. The closer the tractor got to the stationary object, the louder the alert sounded, until the Bendix system displayed all three light bars at the top of the device. An example of the Bendix system showing an stationary object detected is shown in **Figure 1**.

Figure 1. Bendix Wingman Advanced System Showing Object Detected (Source: Bendix Wingman Manual)

Vehicle 1 was equipped with a Bendix “Wingman Active Cruise with Braking” (or ACB) system. The Wingman ACB reacts to vehicles moving in the same direction as the vehicle. The Wingman ACB system provides audible and visual alerts for the driver when approaching another vehicle or object and provides up to a 3.0-second warning. Further description of the Wingman ACB system is detailed in the *Vehicle Group Chairman's Factual Report*.

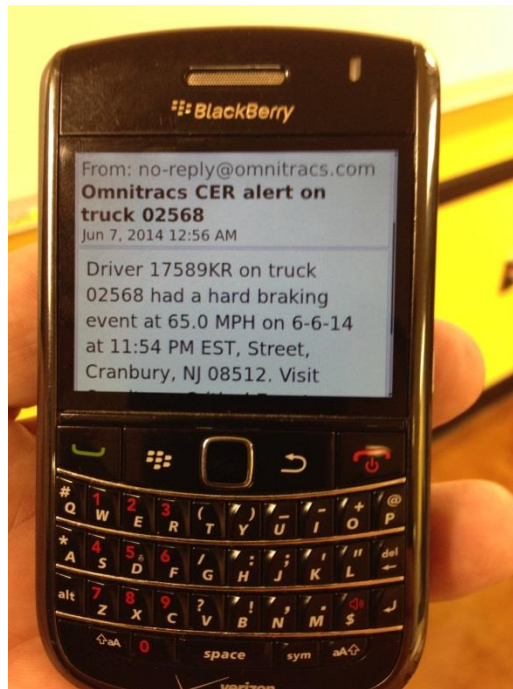
Figure 2. CER message for this accident.

CER events are not monitored or evaluated at the corporate level, but reviewed by the local safety manager at each DC. The carrier has no established limits on the number of CER events generated by a driver. Because a CER is not necessarily indicative of unsafe driving, CERs are evaluated on a case-by-case basis. In some cases, a CER event may represent a safe maneuver by the driver. For example, a driver could produce a hard brake to avoid hitting a vehicle that ran a red light. The system is designed to assist the driver in maintaining adequate following distances as well as to assist the carrier in identifying drivers who fail to observe.
