Vehicle Photos

**Culver City, CA
HWY18FH004**

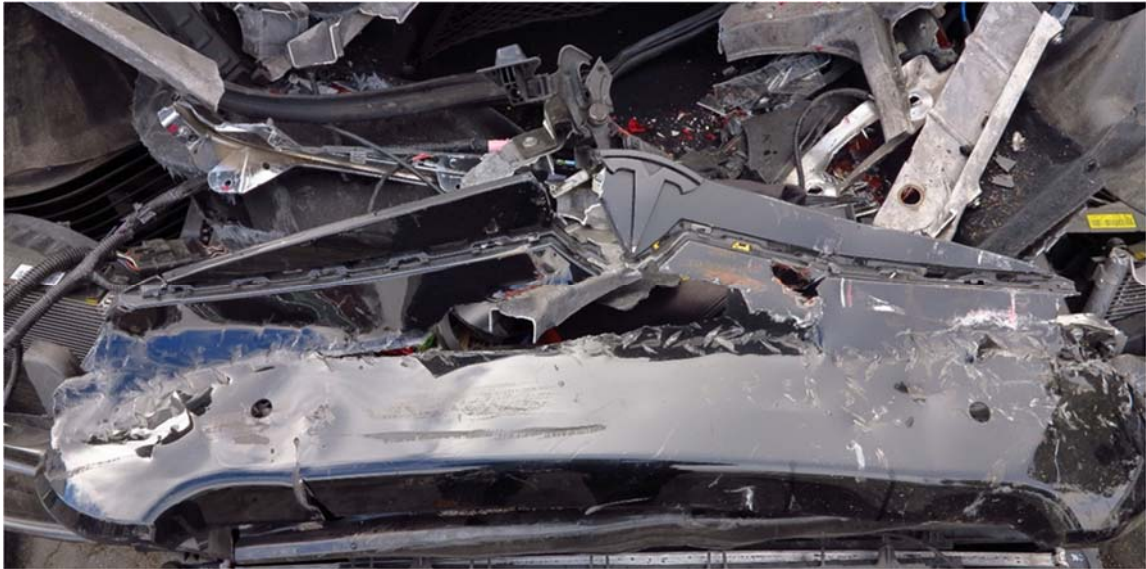
Vehicle Photo 1: This is a view of the design imprint on the upper cowling of the passenger vehicle, that was transferred from the rear of the Fire Truck.

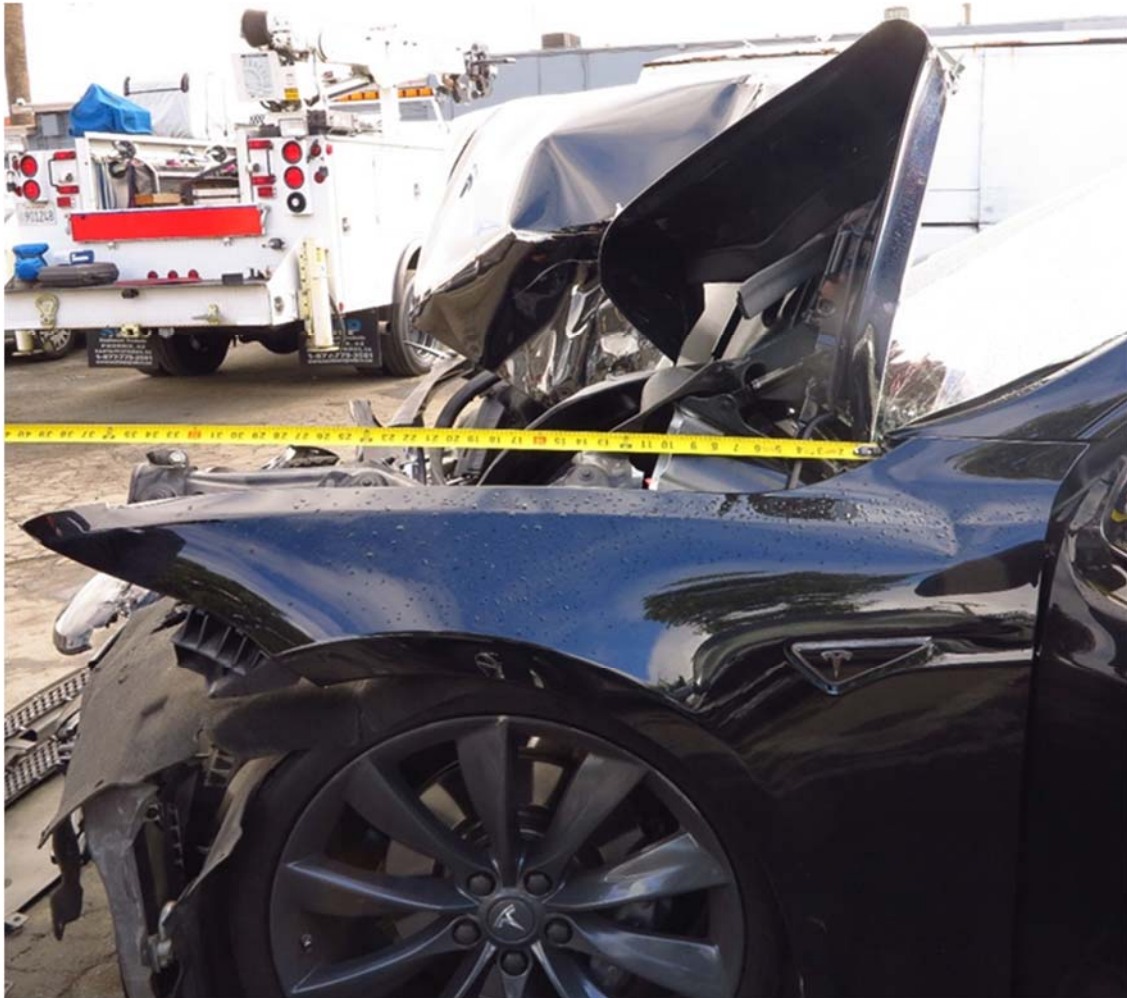
Vehicle Photo 2: This is a view of the damage sustained to the hood of the passenger vehicle.

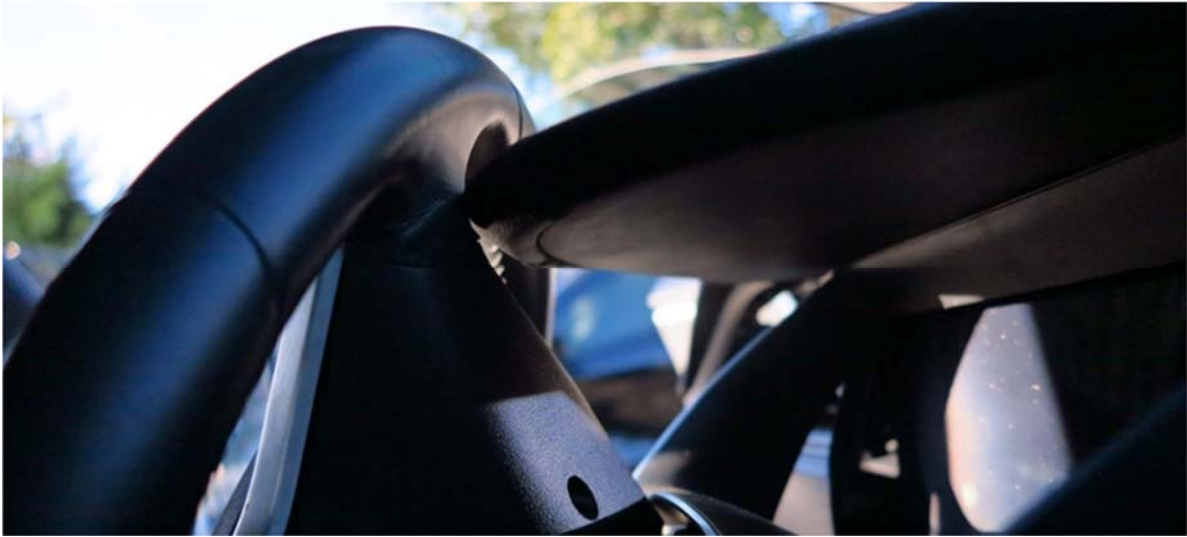
Vehicle Photo 3: This is a view of the contact between the steering wheel and dash.

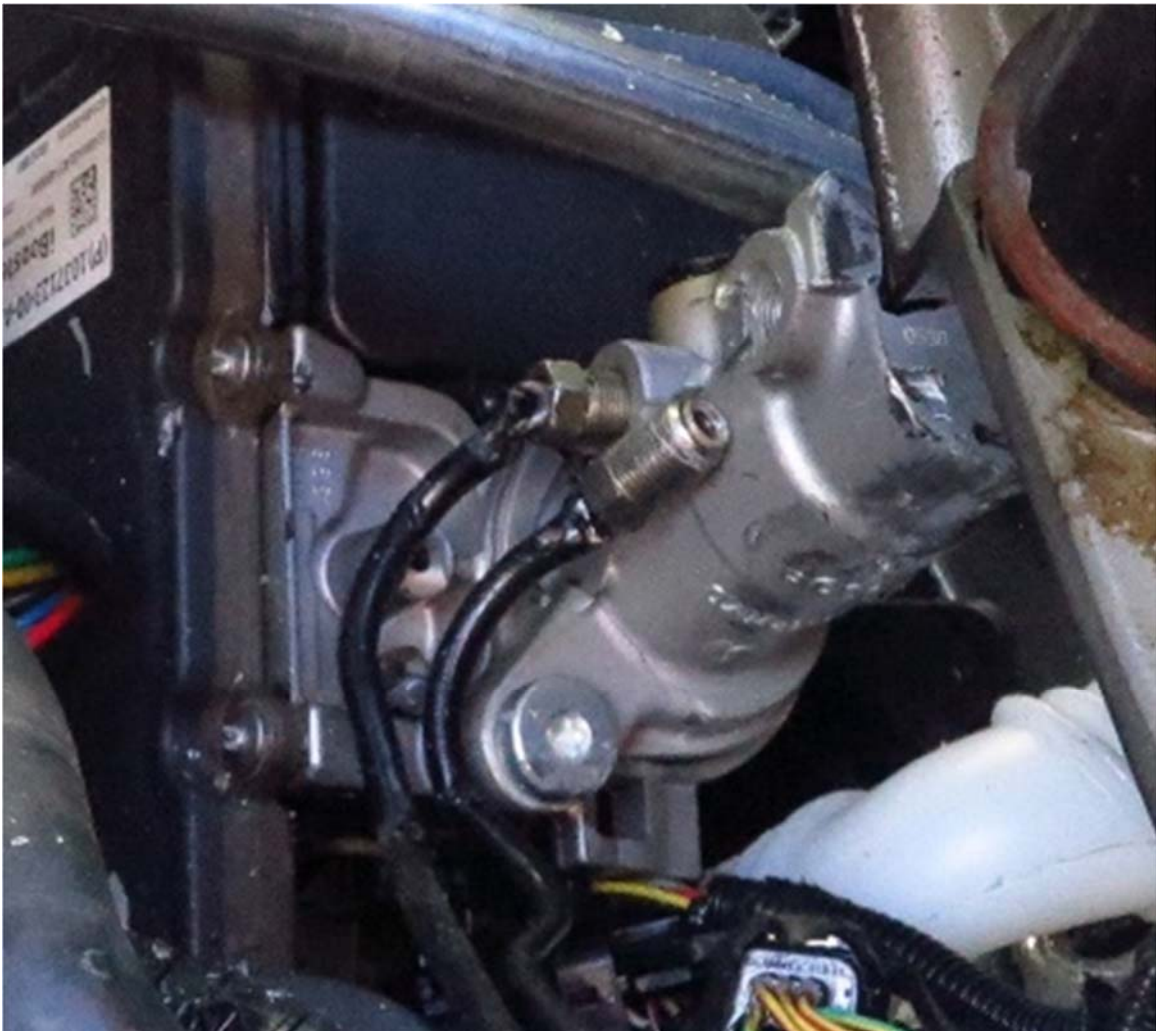
Vehicle Photo 4: This is a view of the damaged brake master cylinder for the passenger vehicle.
