NATIONAL TRANSPORTATION SAFETY BOARD

Group Chairman's Factual Report

METEOROLOGY

DCA14FA058

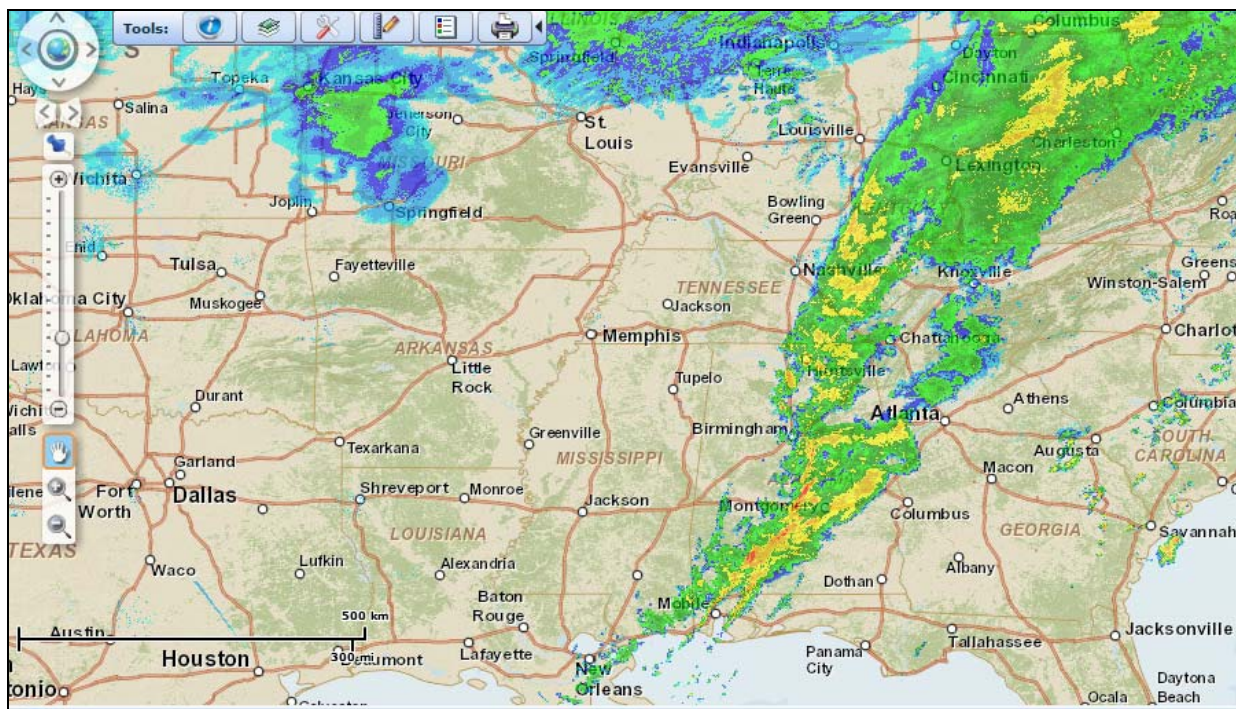
Figure 2 - NWS Radar Mosaic for 0020 CST

Figure 2 is the NWS radar mosaic for 0020 CST and depicted an area of snow showers over Missouri and Illinois north of the Memphis area and a line of rain showers and thunderstorms east of Nashville, Tennessee, which extended southward to the Gulf coast. No significant precipitation echoes were depicted along the route of flight from Houston to Memphis.

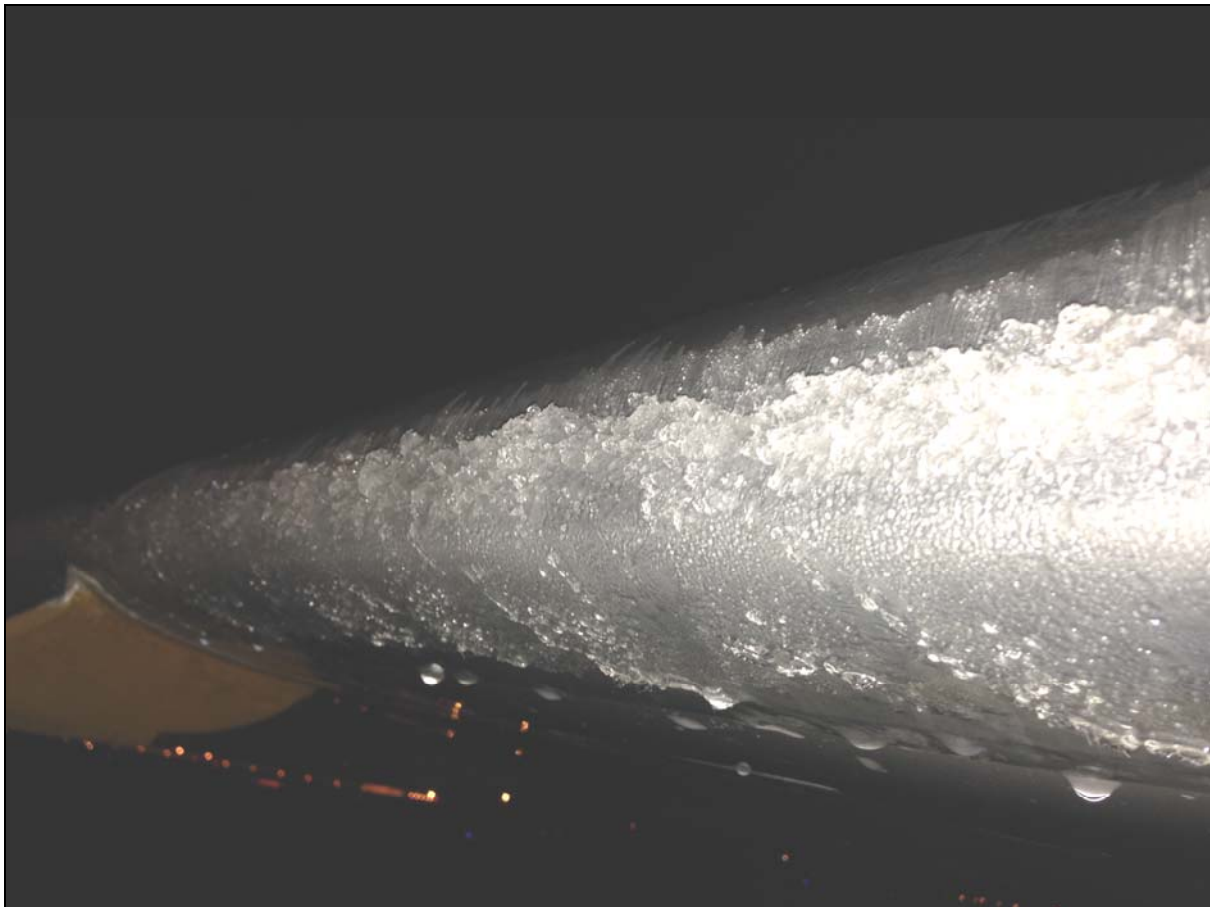
After the Trans States flight 3384 taxied to the gate the captain and first officer observed that all the leading edges of the airfoil and the engine inlets had a significant buildup of mixed icing and photographed the leading edge upon exiting the airplane (figure 19).

Figure 19 - Structural icing left on the wing after the airplane arrived at the gate
