## **NATIONAL TRANSPORTATION SAFETY BOARD**

### **Group Chairman's Factual Report**

# **OPERATIONAL FACTORS/HUMAN PERFORMANCE**

DCA19LA134

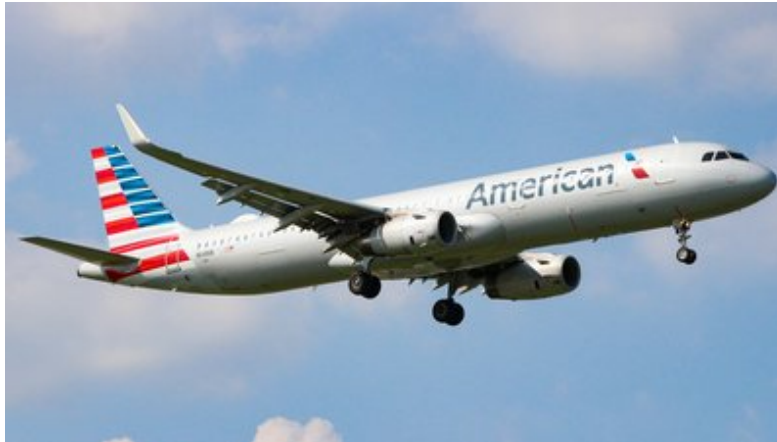
Photo 1: Accident Airplane. (Courtesy of Flightradar.com).

The accident airplane N114NN, Serial No. 6046, was an Airbus A321-231, and was manufactured in 2014. It was owned by Wells Fargo Trust Co., registered on April 11, 2014 as a transport category aircraft, and operated by American Airlines since its original registration. The airplane was powered by 2 IAE V2533-A5 engines. There was no MEL (Minimum Equipment List) and Configuration Deviation List (CDL) deferred maintenance items listed on the flight release.

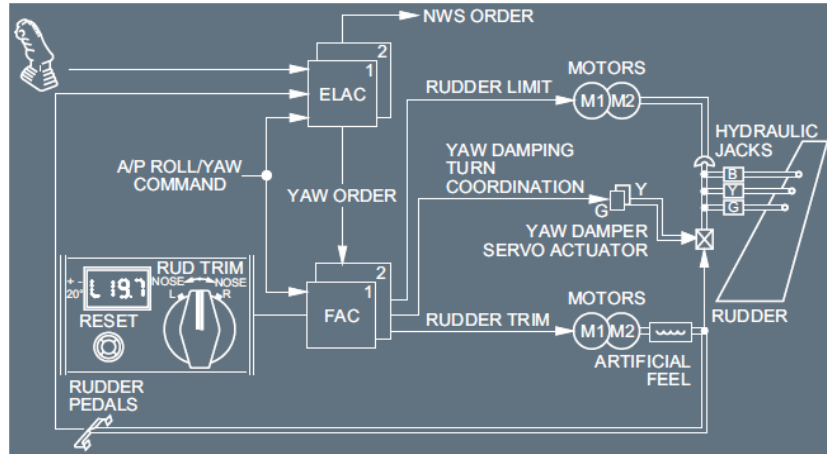
**Figure 7: Yaw Control Diagram.**

Three independent hydraulic servojacks, operating in parallel, actuate the rudder. In automatic operation (yaw damping, turn coordination) a green servo actuator drives all three servojacks. A yellow servo actuator remains synchronized and takes over if there is a failure. There is no feedback to the rudder pedals from the yaw damping and turn coordination functions.

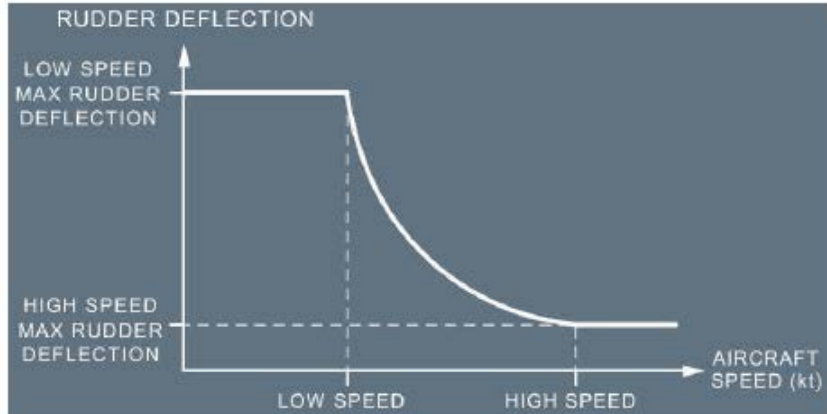
**Figure 8: Rudder Deflection Travel Limit Chart.**

The maximum rudder travel deflection gradually reduces as the speed increases, to avoid structural loads:

In the case of a failure that causes loss of the Rudder Travel limit system, the rudder deflection limit stops at the last value reached. At slats extension, full rudder travel authority is recovered. In all cases, the available rudder deflection provides sufficient yaw control within the entire flight envelope. This includes the case of maximum asymmetric thrust.

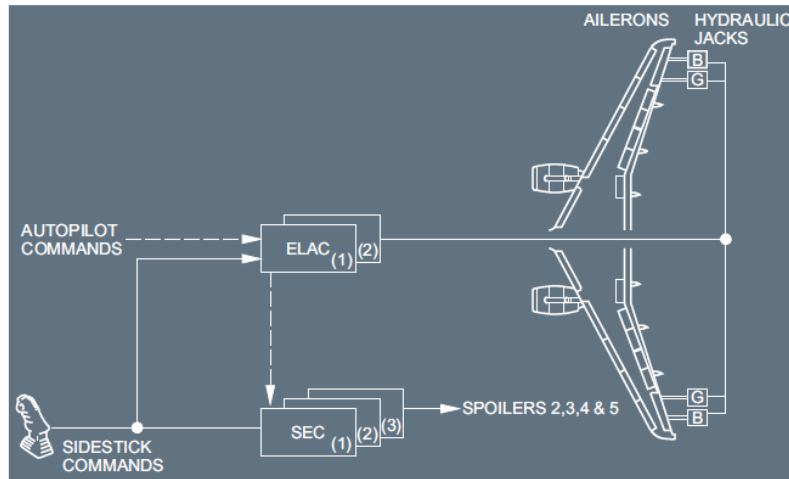
**Figure 10: Roll Control Diagram.**

*A319/A320 – 35 °*

A321 – 35 ° for spoilers 2, 4, and 5 and 7 ° for spoilers 3.

- *The ELAC 1 normally controls the ailerons. If ELAC1 fails, the system automatically transfers aileron control to ELAC2. If both ELACs fail, the ailerons revert to the damping mode.*
- *SEC3 controls the N° 2 spoilers, SEC1 the N° 3 and 4 spoilers, and SEC2 the N° 5 spoilers. If a SEC fails, the spoilers it controls are automatically retracted.*

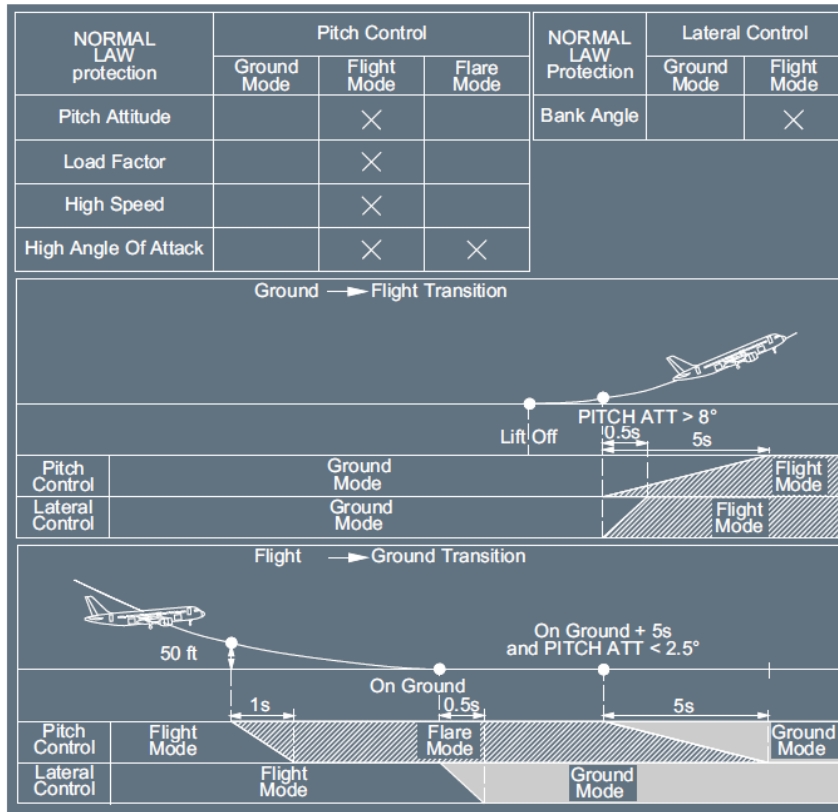
**Figure 12: Normal Law Protection Range.**

Flight control normal law covers:

- three-axis control
- flight envelope protection
- alleviation of maneuver loads
