National Transportation Safety Board

DCA22FA132

UNCREWED AIRCRAFT SYSTEM / AERIAL IMAGERY

Specialist's Factual Report

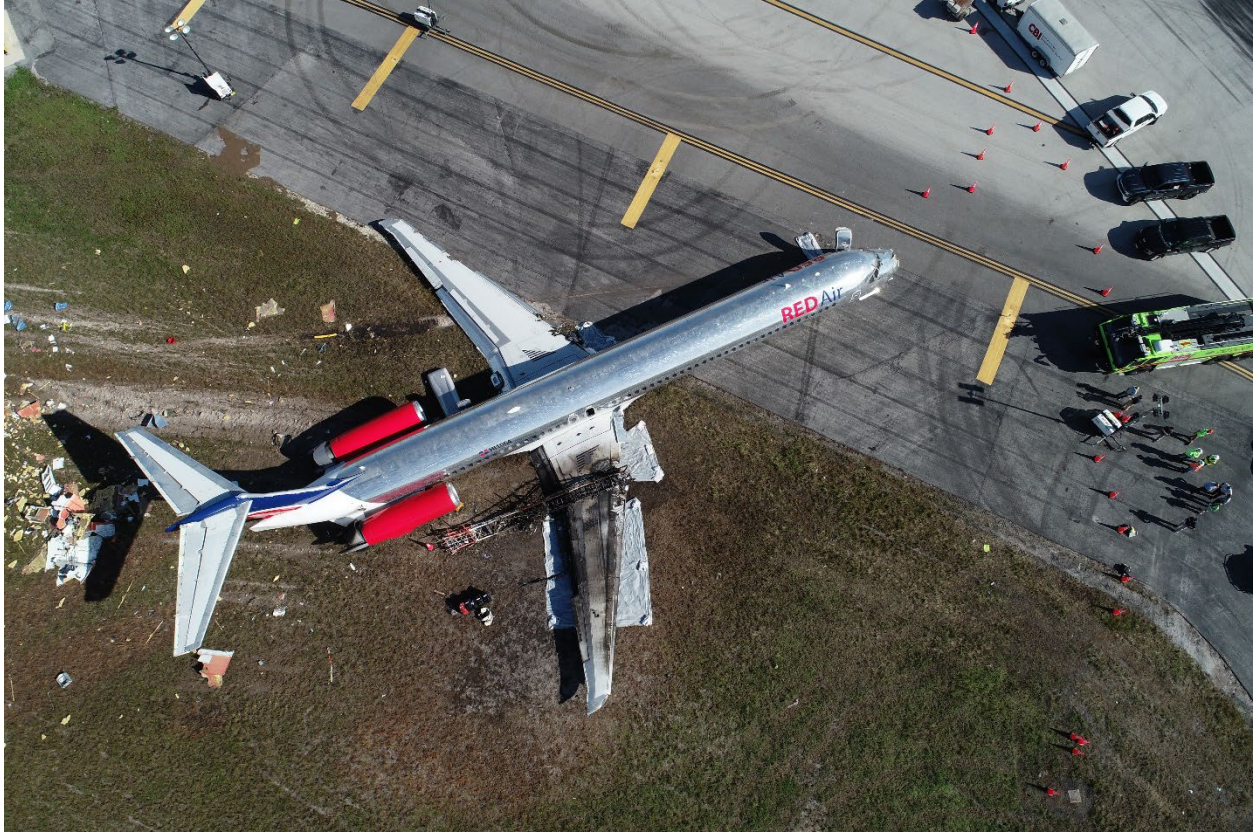
Figure 2. Overhead image of the wreckage captured by the sUAS. (Source: DJI_0043.jpg)

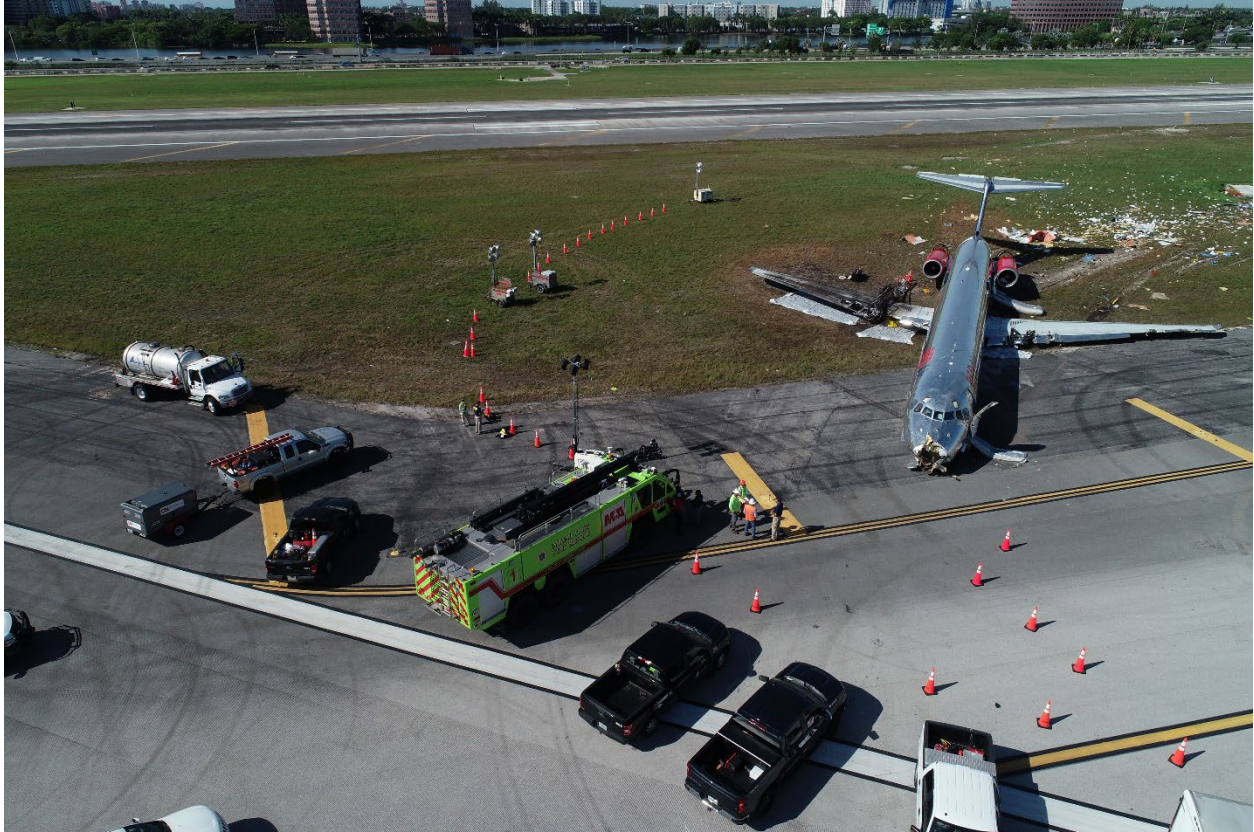
Figure 3. Cropped overhead image of the wreckage captured by the sUAS. (Source: DJI_0214.jpg)
