# National Transportation Safety Board

DCA22MA009

## **FLIGHT DATA RECORDER**

Location: Brookshire, Texas  
Date: October 19, 2021  
Time: 1000 central daylight time (CDT)  
Airplane: McDonnell Douglas MD-87, N987AK

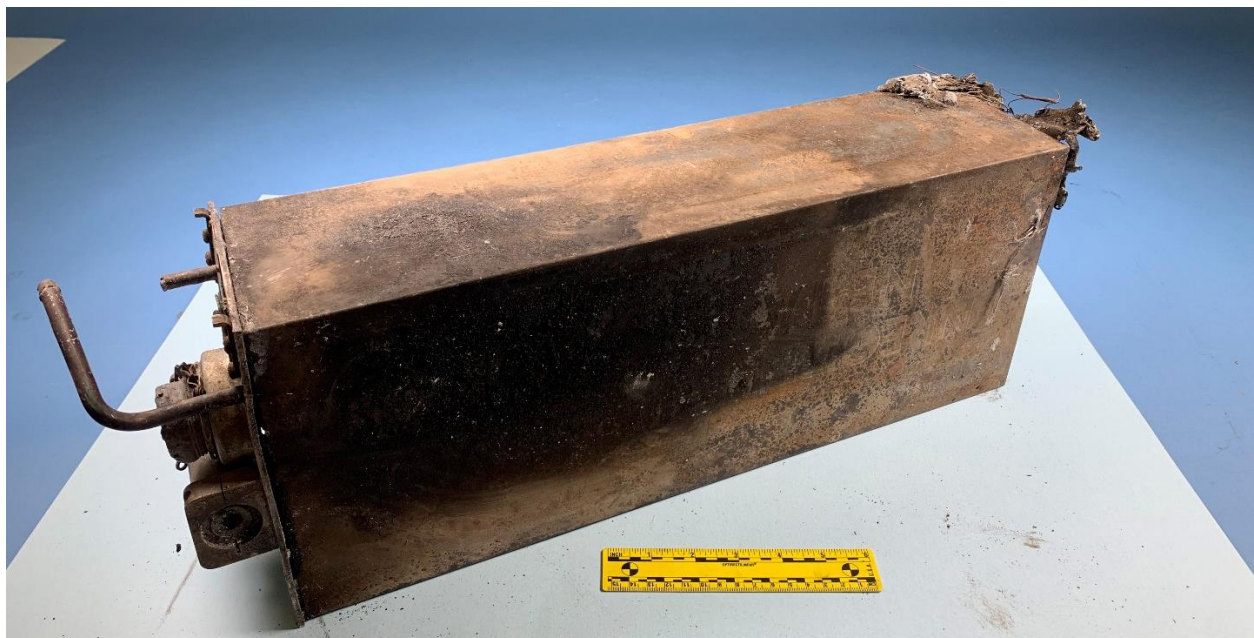
The recorder sustained heat damage as shown in figure 1. The memory module was removed from the recorder and opened, as seen in figure 2. The magnetic tape was removed and found to have had minor damage at the extreme ends of the tape, as shown in figure 3. The cause of the damage is undetermined. The data were transcribed from the tape medium to computer hard drive for analysis using the NTSB's laboratory equipment.

**Figure 1.** Damaged exterior of flight data recorder.

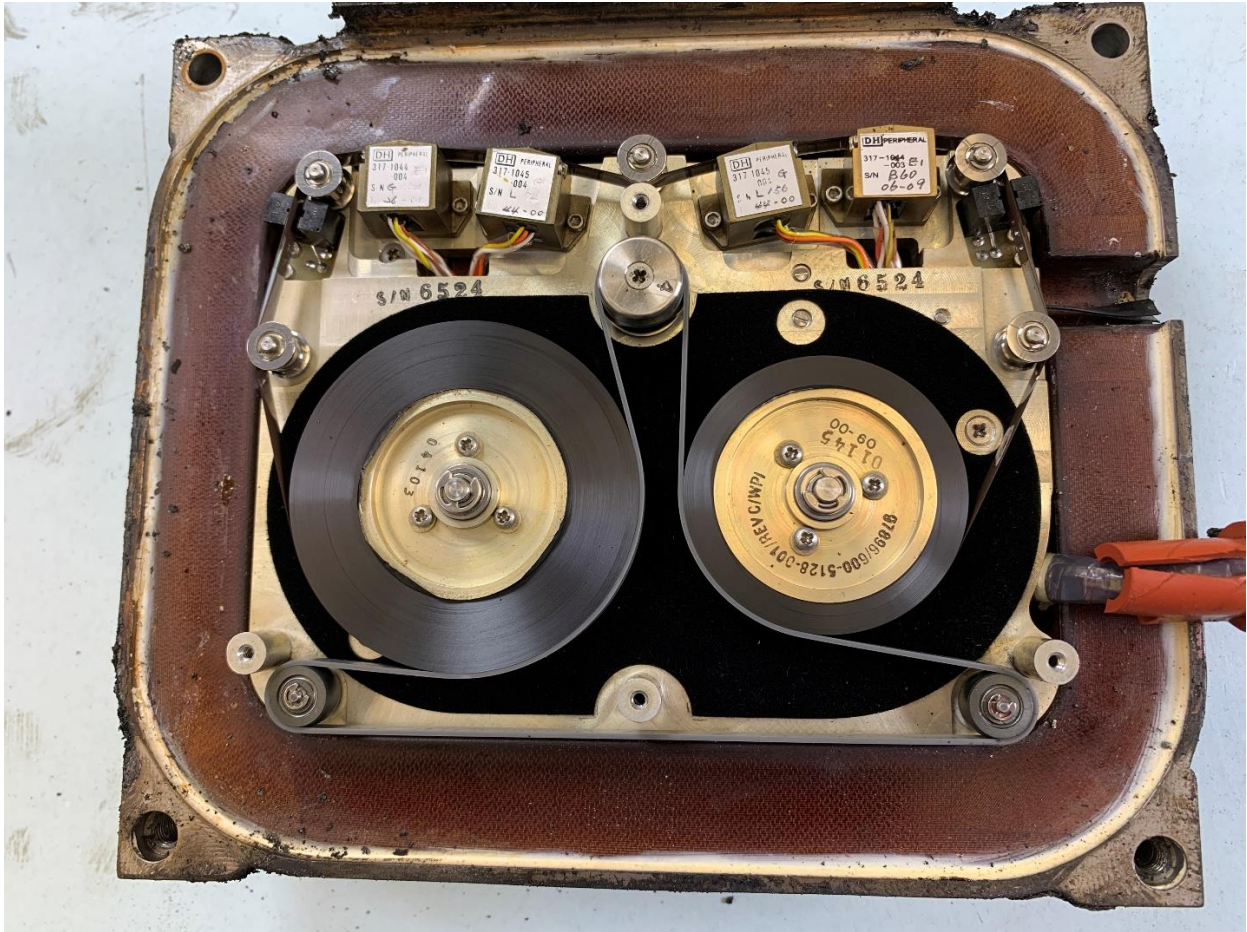
**Figure 2.** Interior of the Crash Survivable Memory Unit (CSMU) showing the magnetic tape mechanism.

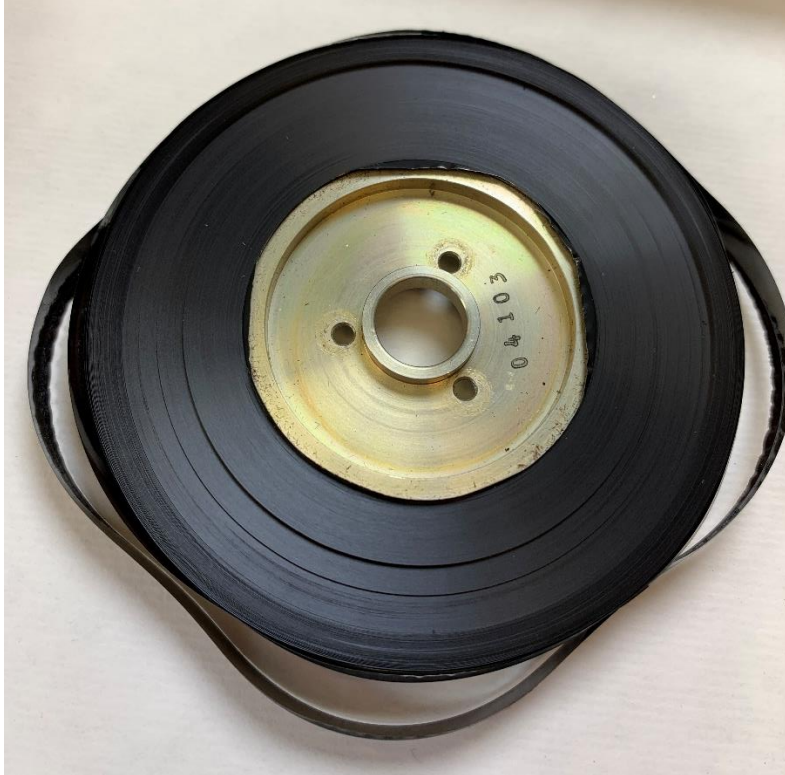
**Figure 3.** Magnetic tape removed from recording mechanism showing deformed tape wrapped around the center spool.

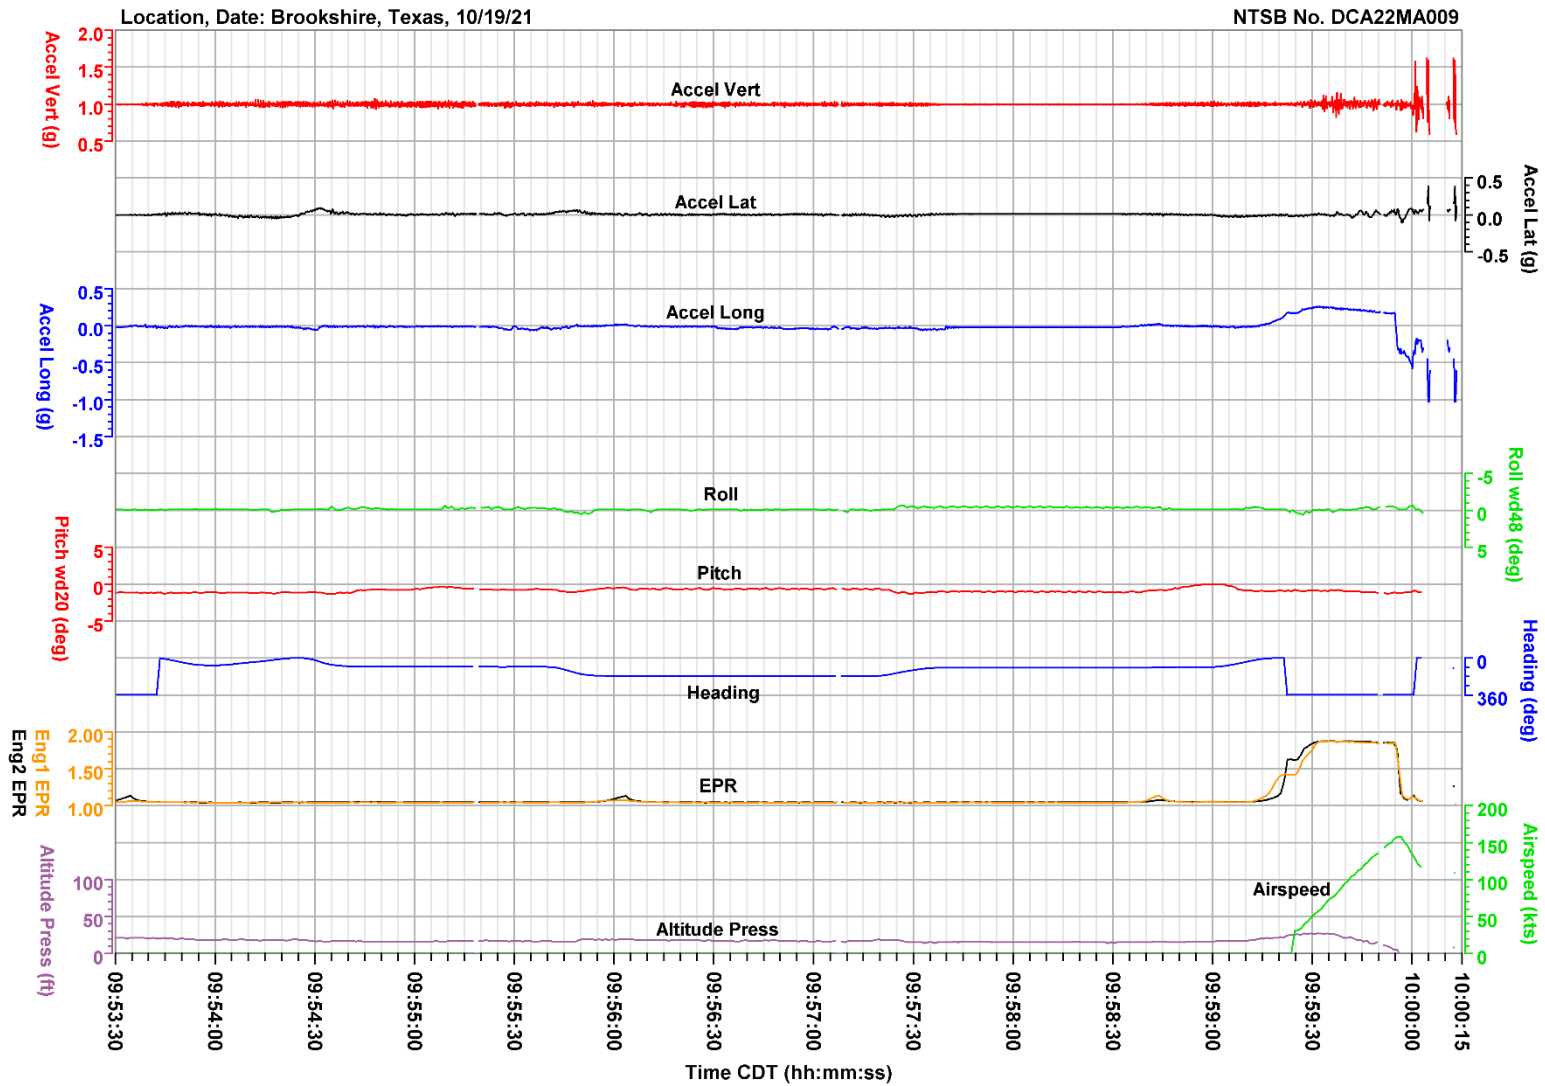
Basic Parameters for Taxi through Takeoff

**Figure 4.** Plot of basic parameters for the entire accident recording.

Figures 4, 6, and 8 show data for the entire accident recording of general parameters, control parameters, and engine parameters, respectively. Figures 5, 7, and 9 are zoomed plots showing a detailed view of the takeoff sequence of general parameters, control parameters, and engine parameters, respectively.

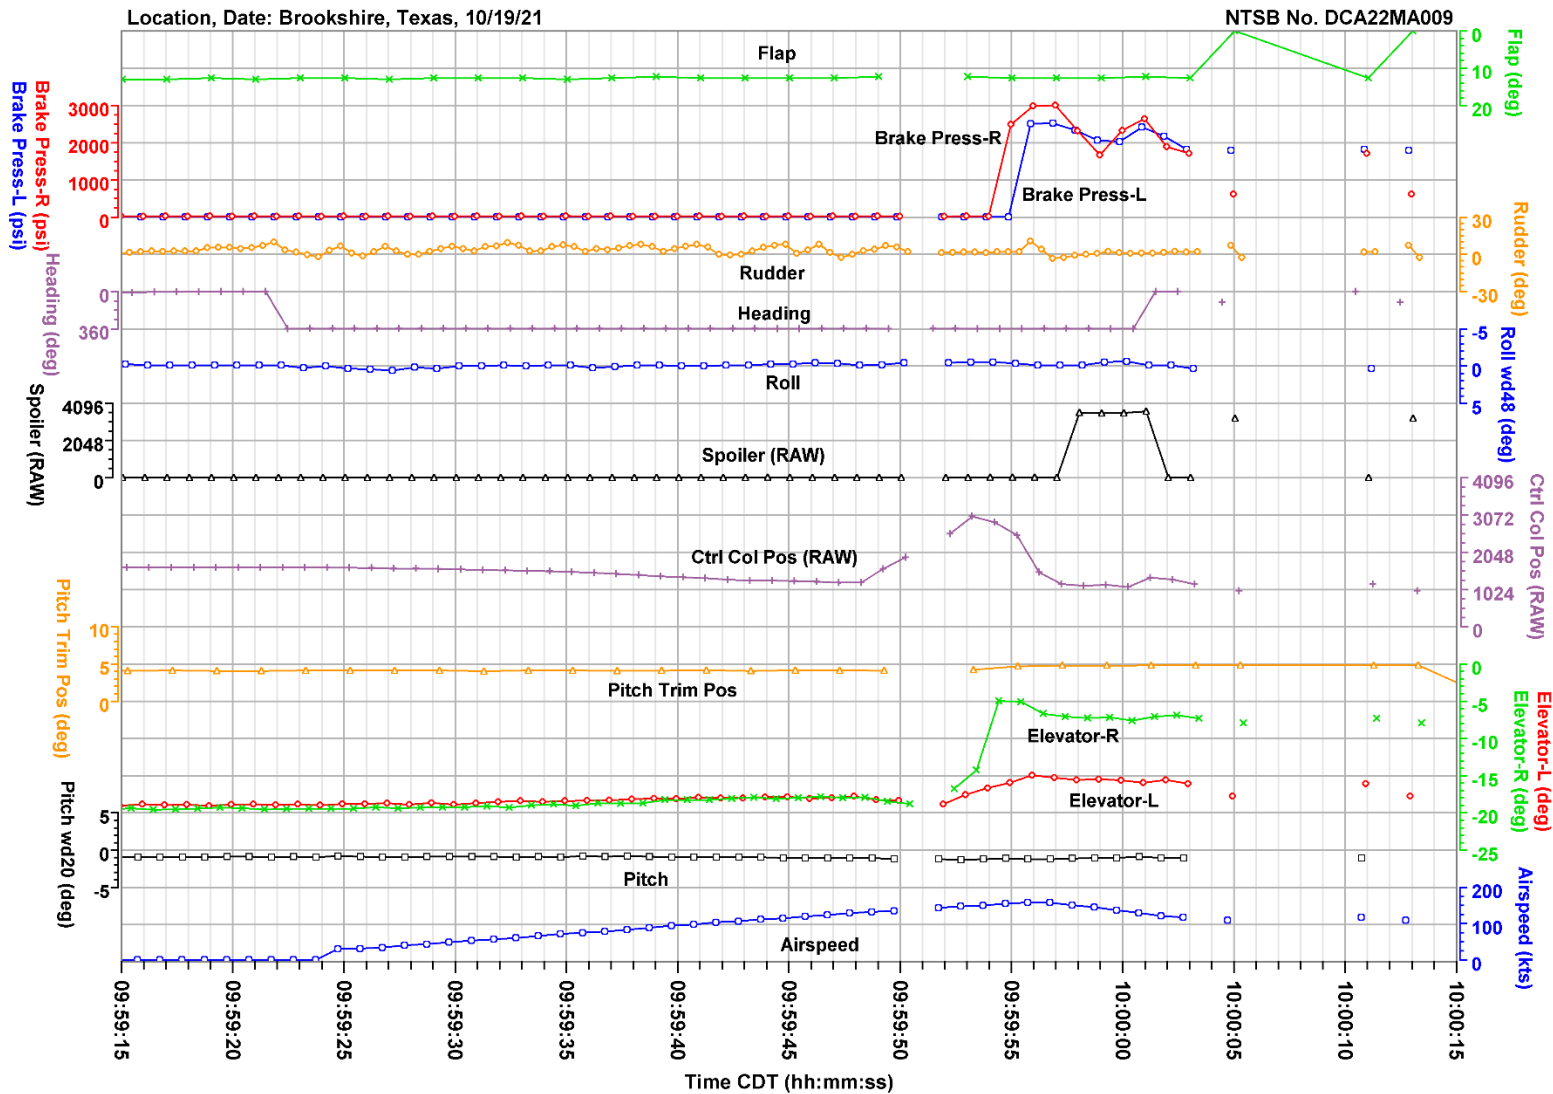
Control Parameters for Takeoff

**Figure 7.** Plot of control parameters for the accident takeoff.

surfaces were recorded consistently around 20 degrees nose down, beyond the documented valid parameter range of 15 degrees nose down to 25 degrees nose up. As the aircraft reached rotation speed, movements of the control wheel were noted, and the elevators appeared to move to a maximum deflection of 5 degrees nose down. As the aircraft failed to rotate significantly, thrust was reduced, and brakes, spoilers, and thrust reversers were applied, consistent with a rejected takeoff. The aircraft reached a maximum recorded airspeed of 158 knots at 09:59:56. Valid recorded data ended at approximately 10:00:03.

As part of the investigation, previous flights data were examined to evaluate the behavior of the elevator control surfaces. Generally, the elevators are free floating and will record deflections with changes in the wind. As the aircraft accelerates down the runway, the elevator deflections will gradually converge around or slightly below 0 degrees, until rotation, at which point the elevators will deflect in a nose-up, or positive, direction. This pattern was noted in the flight data of both previous takeoffs, but not in the accident takeoff.

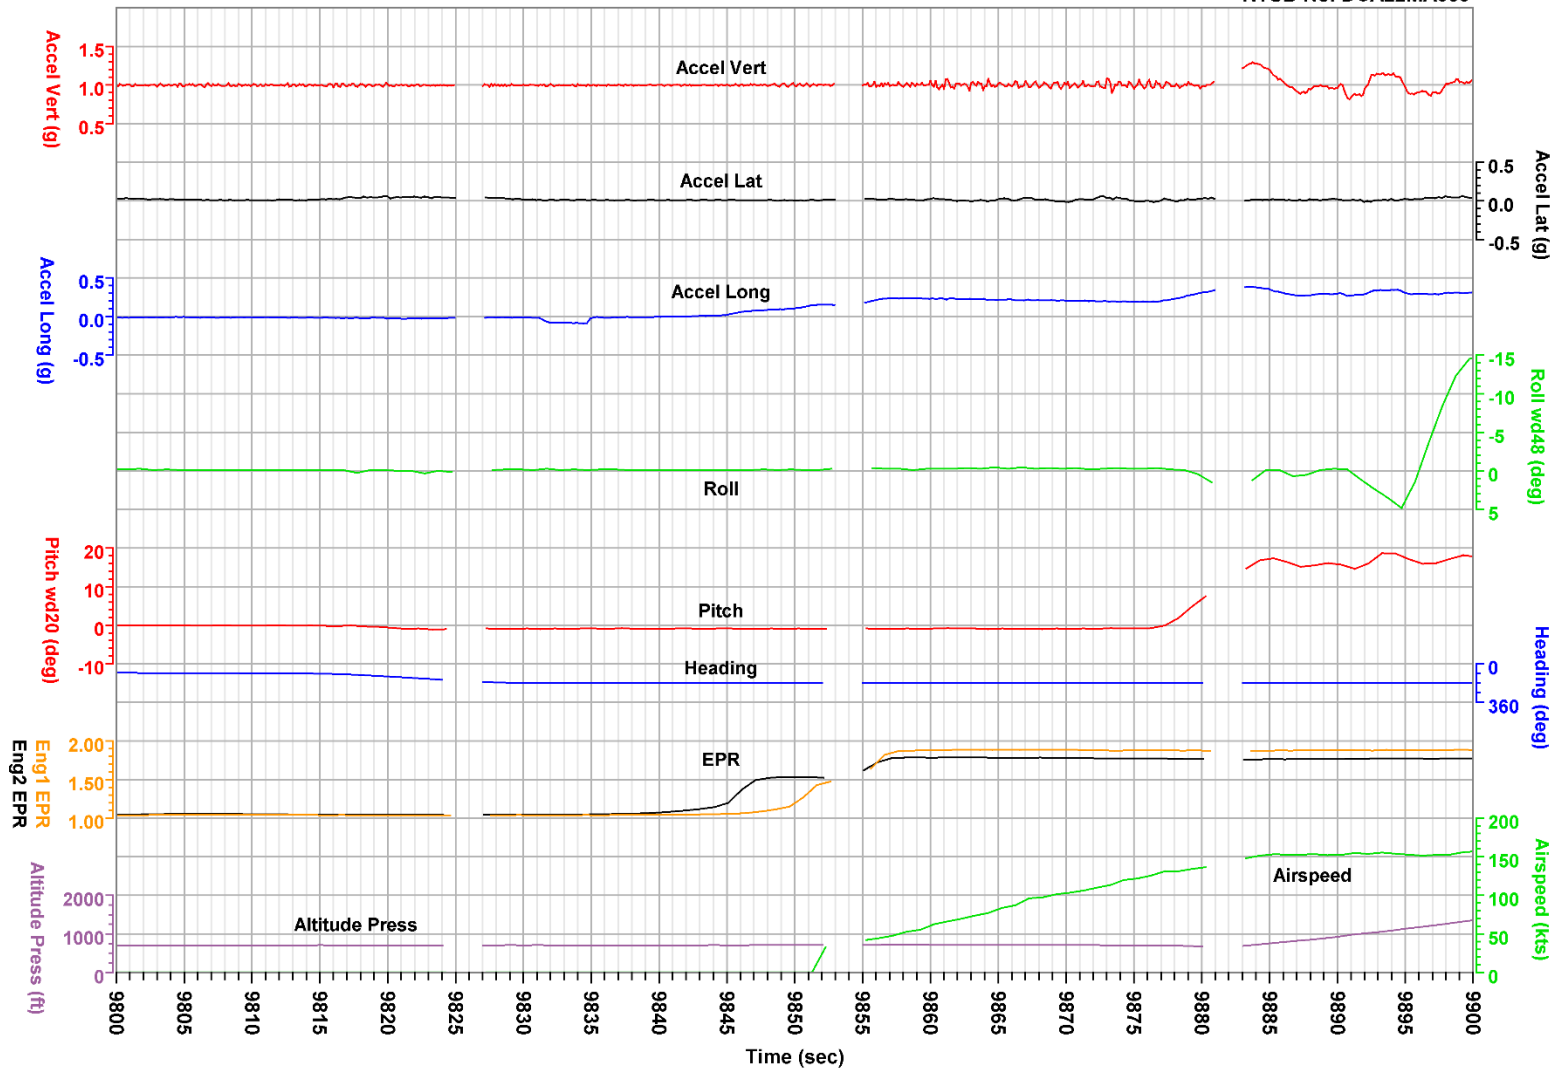
**Figure 10.** Plot of basic parameters for the previous takeoff from Laredo, Texas.

Figures 10, 11, and 12 show flight data for the preceding takeoff from Laredo, Texas, of general parameters, control parameters, and engine parameters, respectively. Figures 13, 14, and 15 show flight data for the preceding takeoff from Cabo San Lucas, Mexico, of general parameters, control parameters, and engine parameters, respectively.

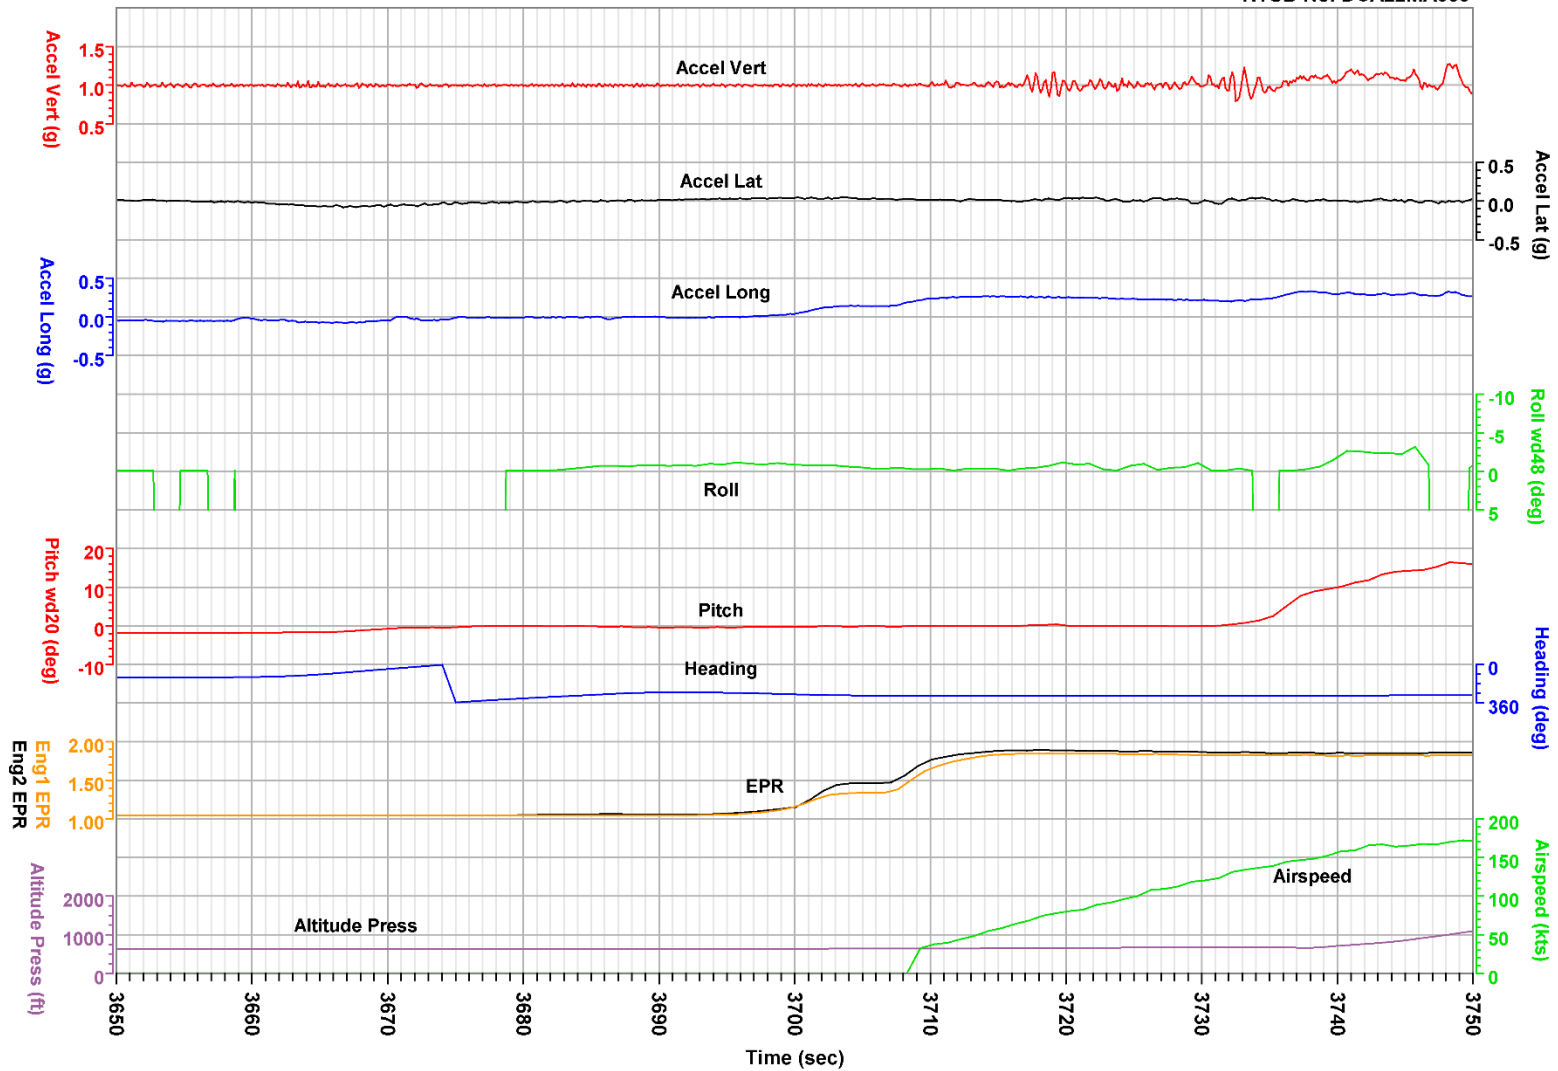
**Figure 13.** Plot of basic parameters for the previous takeoff from Cabo San Lucas, Mexico.

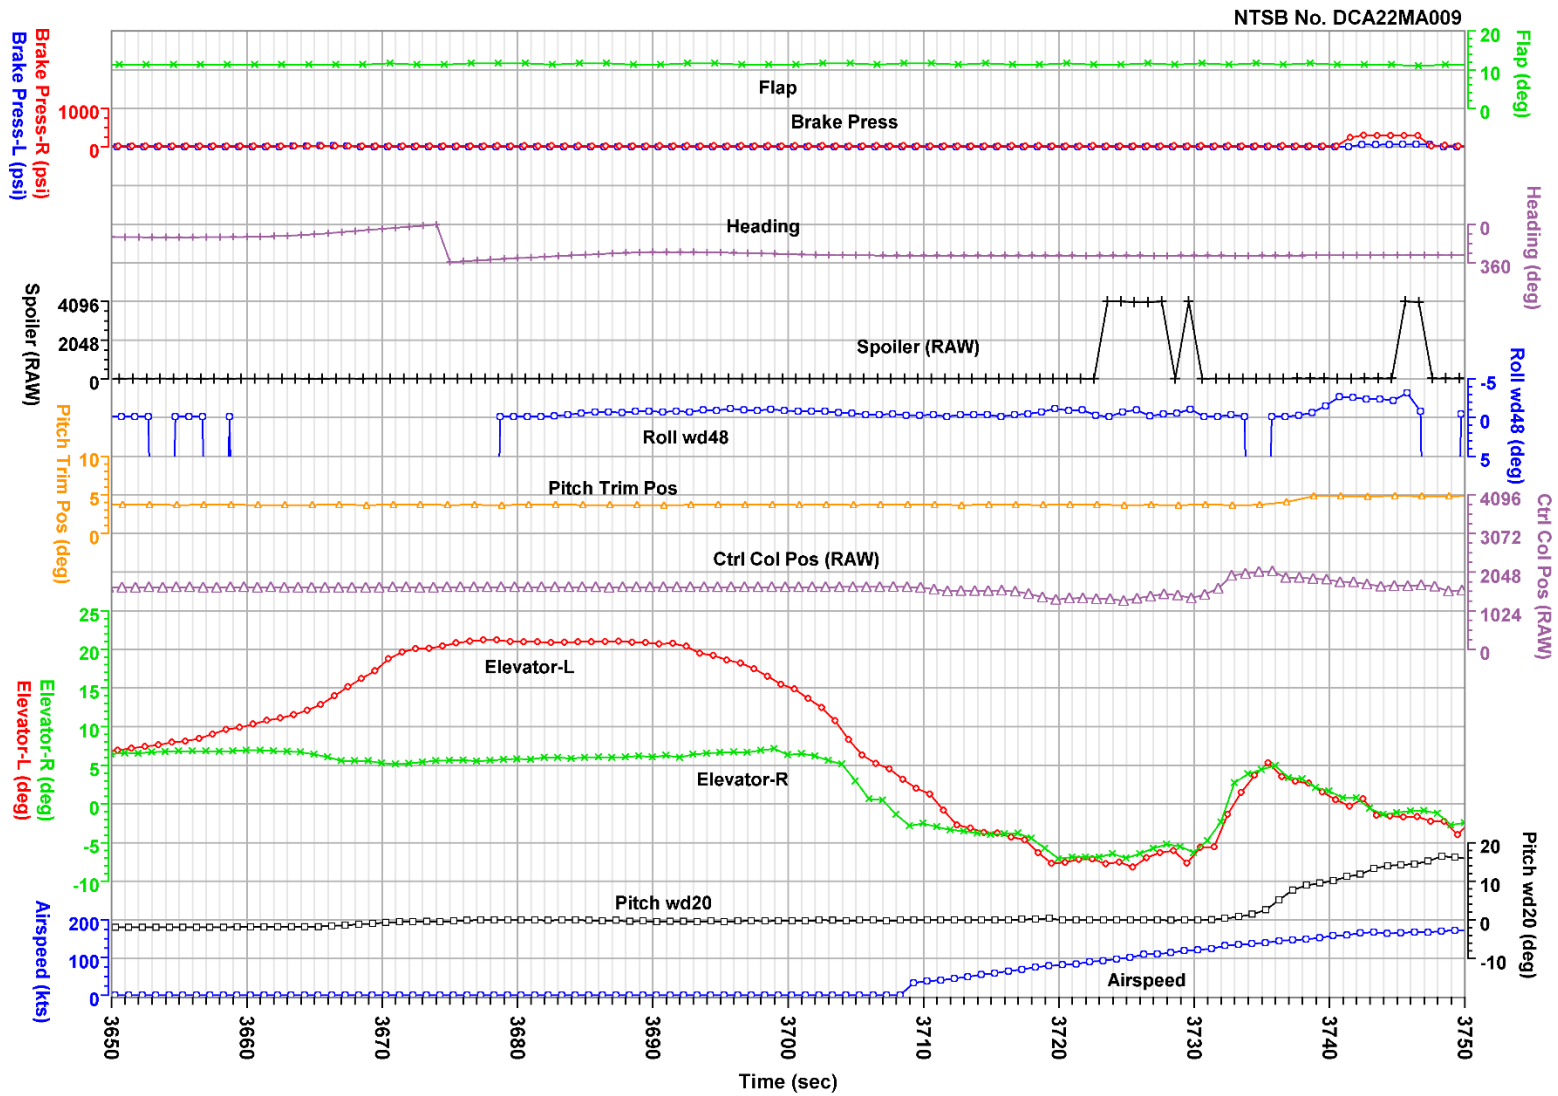
**Figure 14.** Plot of control parameters for the previous takeoff from Cabo San Lucas, Mexico.

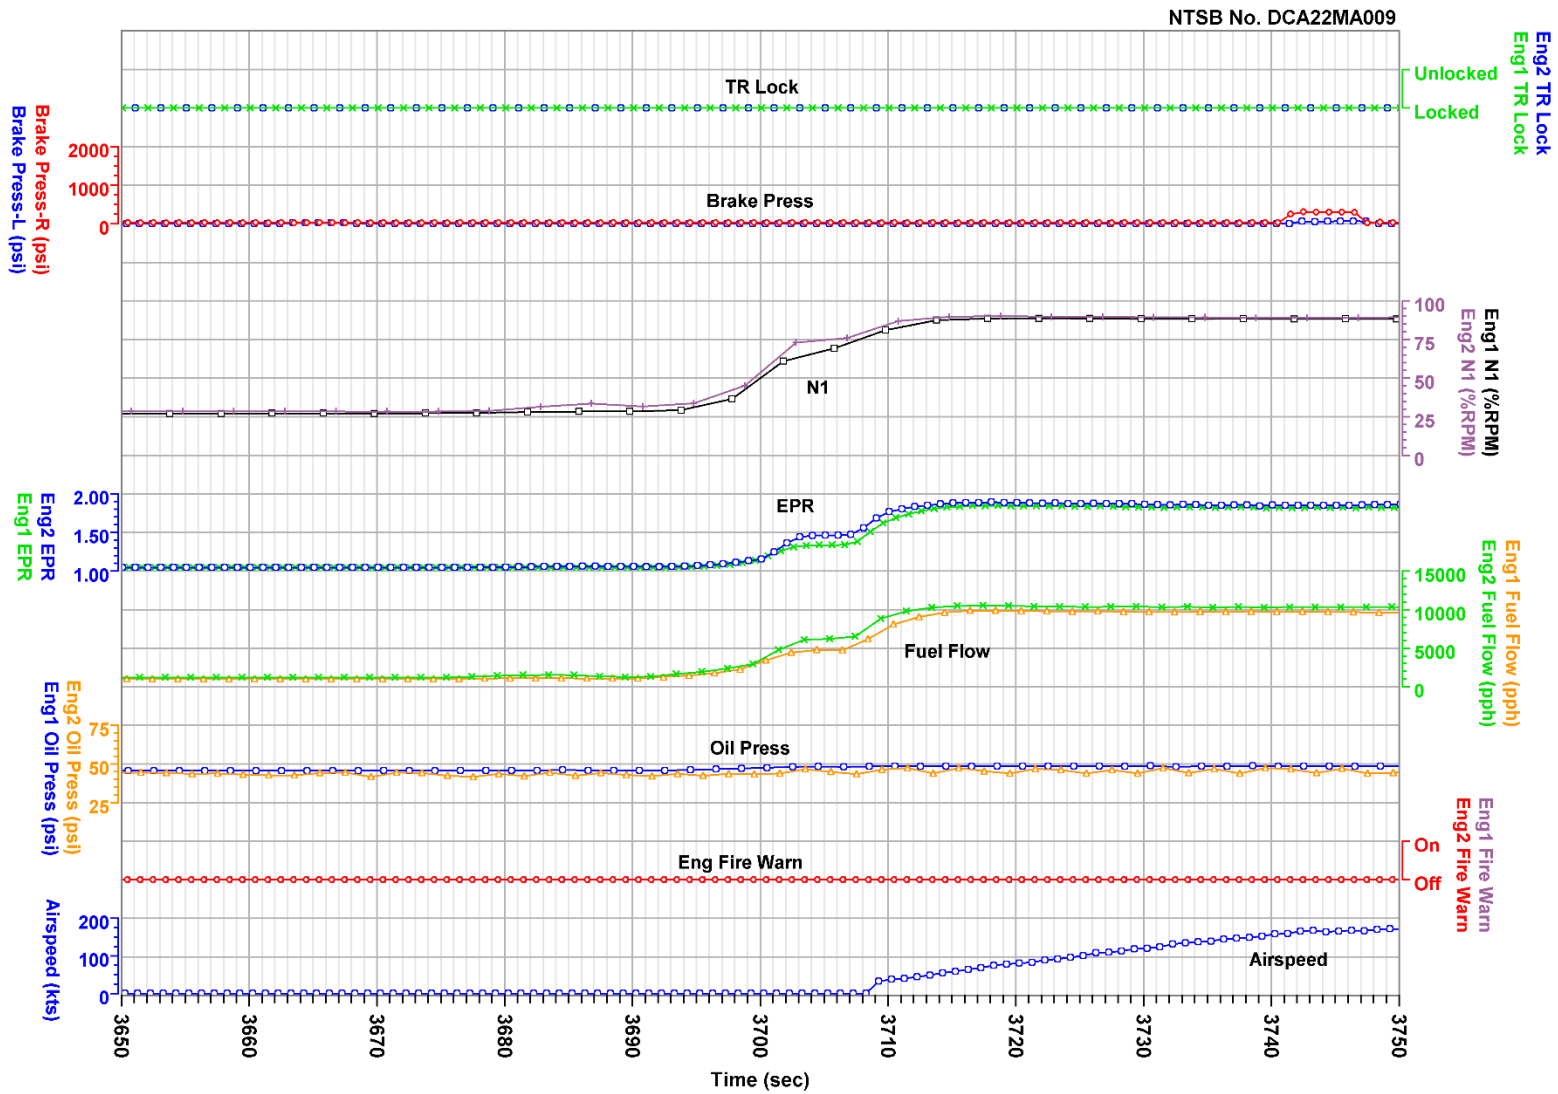
**Figure 15.** Plot of engine parameters for the previous takeoff from Cabo San Lucas, Mexico.
