National Transportation Safety Board

DCA22MA193

SEARCH AND RECOVERY

Group Chair's Factual Report

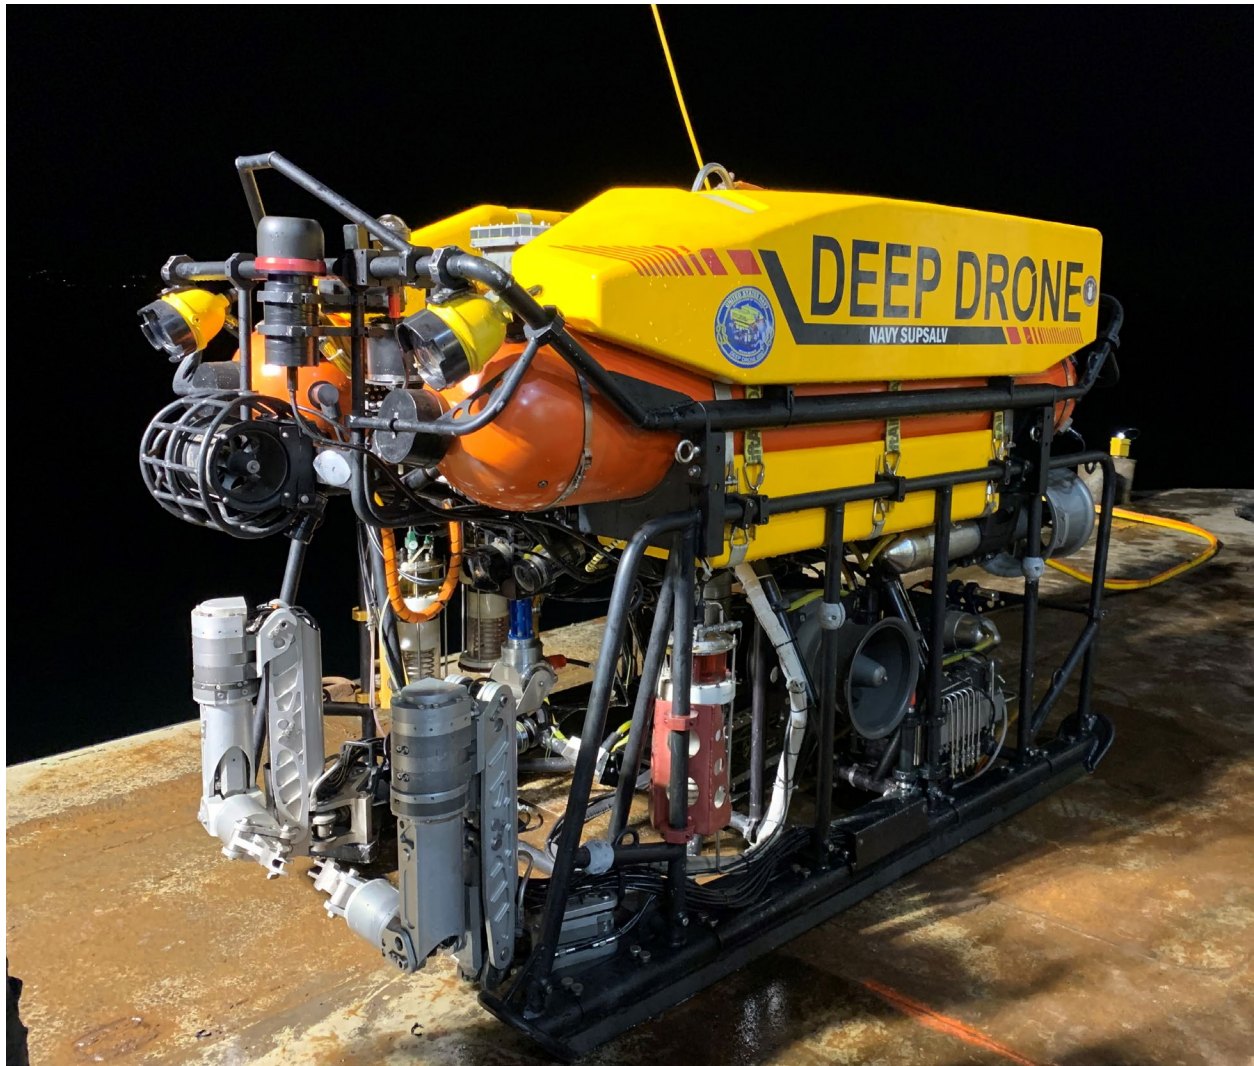
Figure 6. Deep Drone 8000 ROV

SUPSALV utilized the services of a contractor for the vessels required for the work. Pacific Pile & Marine supplied the *Derrick Barges (D/B) Mister Ed* and *Lush* with the tugs *Gretchen H* and *Jennifer H*. The Deep Drone 8000 ROV (Figure 6) and support equipment was mobilized on the *D/B Mister Ed* and the *D/B Lush* was outfitted with a crawler crane for wreckage retrieval. A refrigerated container was mobilized on the *D/B Mister Ed* for storage of any victim's remains recovered.

The Deep Drone 8000 ROV is a 4,100 lb vehicle designed for the Navy by Phoenix International. The ROV is controllable in all six degrees of freedom by the pilot and is equipped with a Kongsberg 375-675 kHz scanning sonar for target detection and two 7-function manipulator arms. One high-definition color camera and several other standard definition black and white cameras were installed. The ROV and all support equipment were shipped from the Phoenix facilities in Largo, Maryland, and mobilized on the barges at the Pacific Pile and Marine facilities in Seattle.

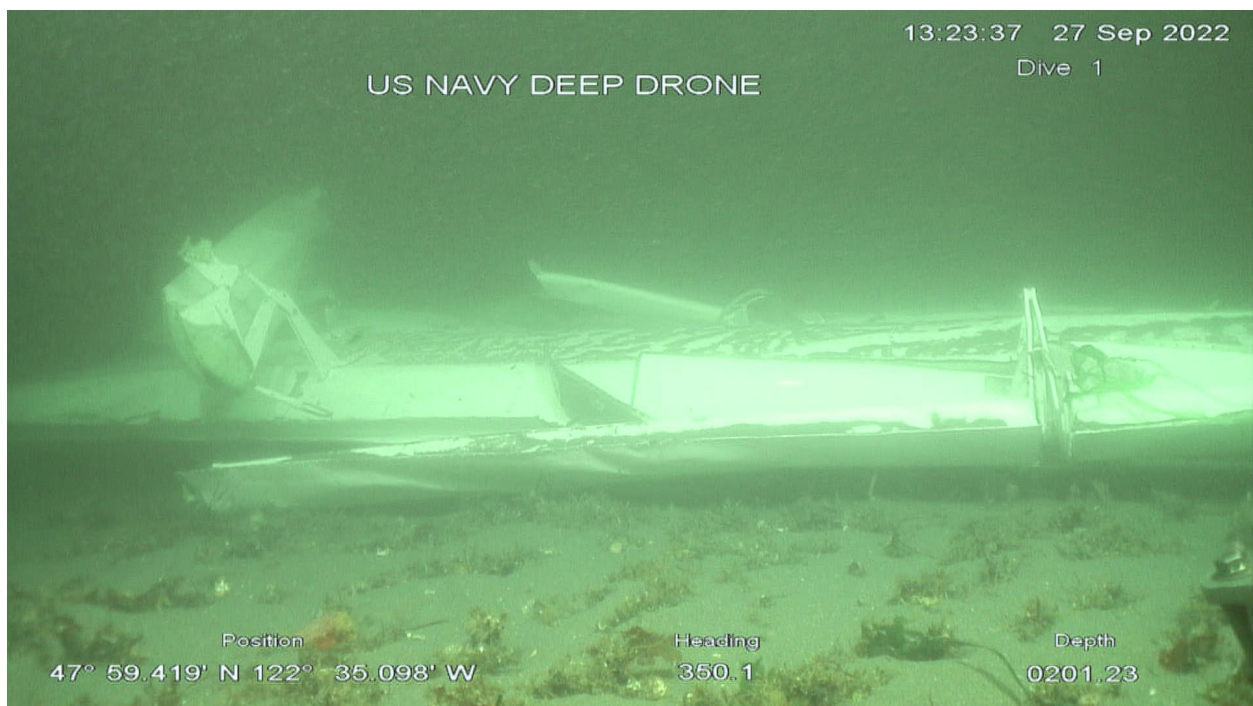
Figure 7. Left wing inboard end on seafloor

The ROV was deployed for the first time on September 27 at 0900 PDT for a survey of the main wreckage location identified by APL-UW. Visibility in the water was limited to about 10-15 feet during most of the operation. Investigators identified the left wing with fore flaps attached first (Figures 7 and 8). About 40 feet northwest of the left wing was a large area of wreckage that contained most of the fuselage, the upside down empennage (Figure 9), the right wing, and the floats. All the wreckage was highly fragmented and crushed. The left and right elevators were not attached to the horizontal stabilizer. During the initial survey it was discovered that one of the barge anchor lines was laying on the main wreckage (Figure 10). Following the dive, it was decided to have the anchor line reset so it wouldn't interfere with recovery operations.

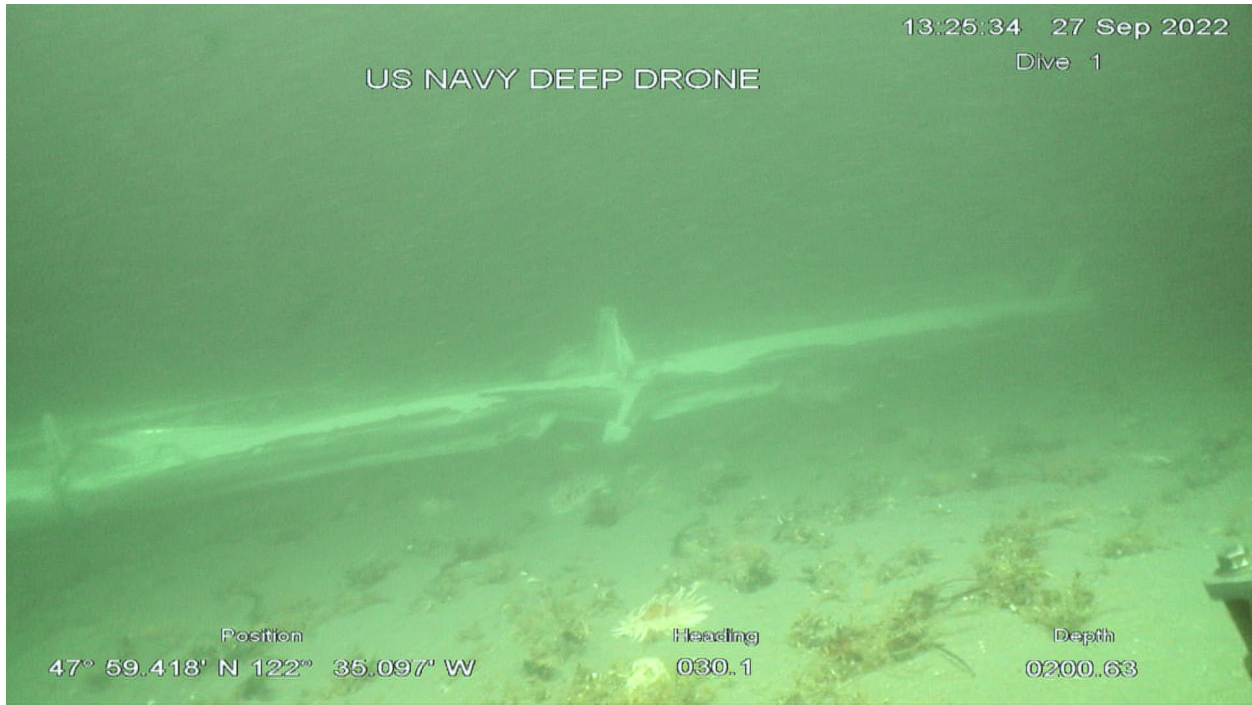
Figure 8. Left wing outboard end on seafloor

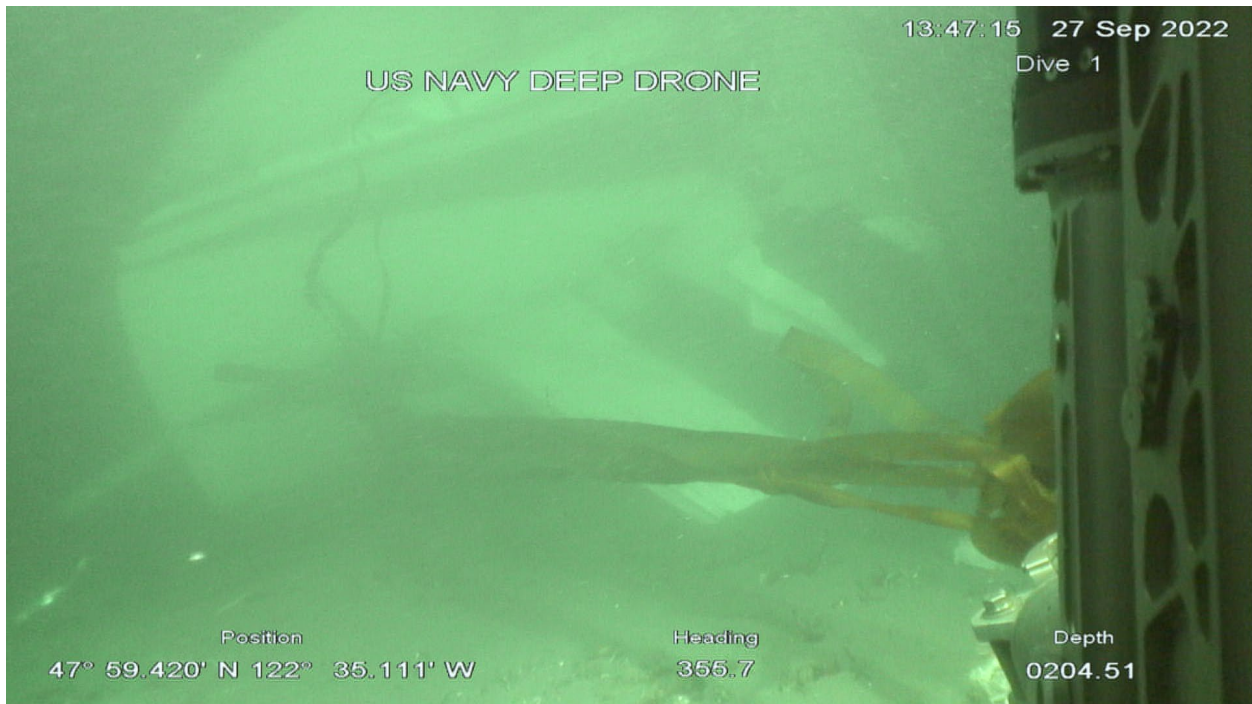
Figure 9. Empennage upside down on seafloor

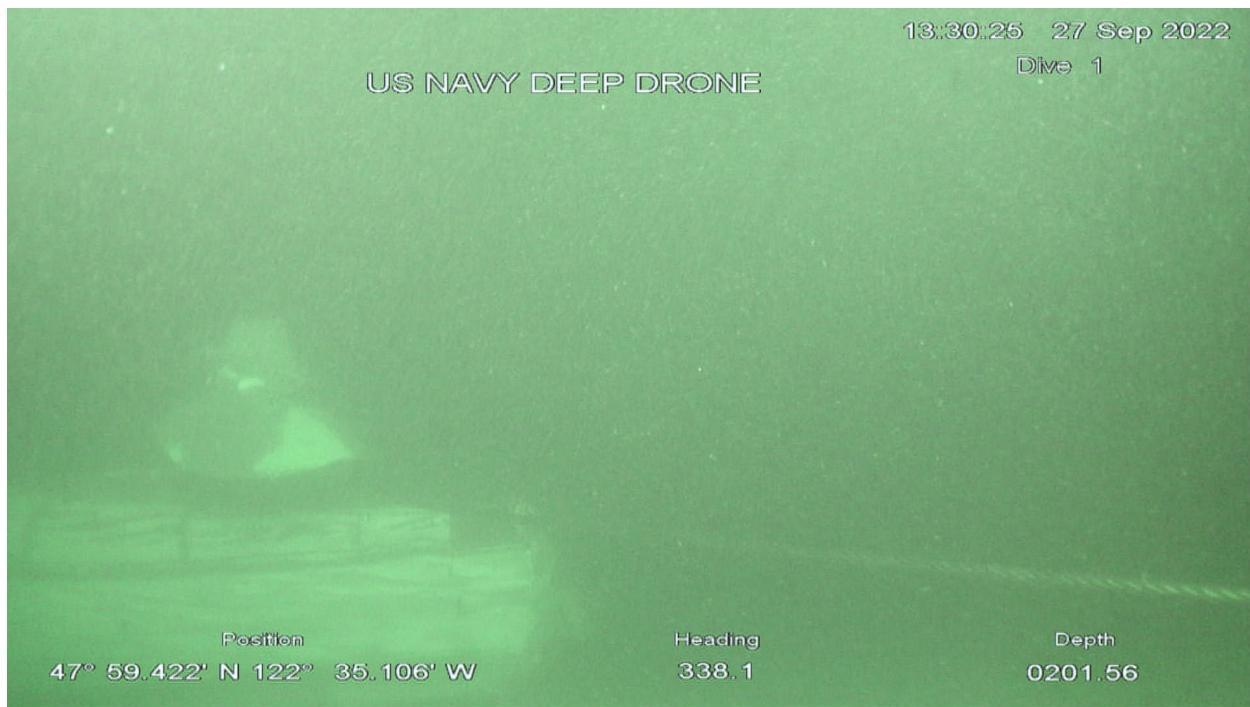
Figure 10. Right wing and float wreckage on seafloor with anchor cable

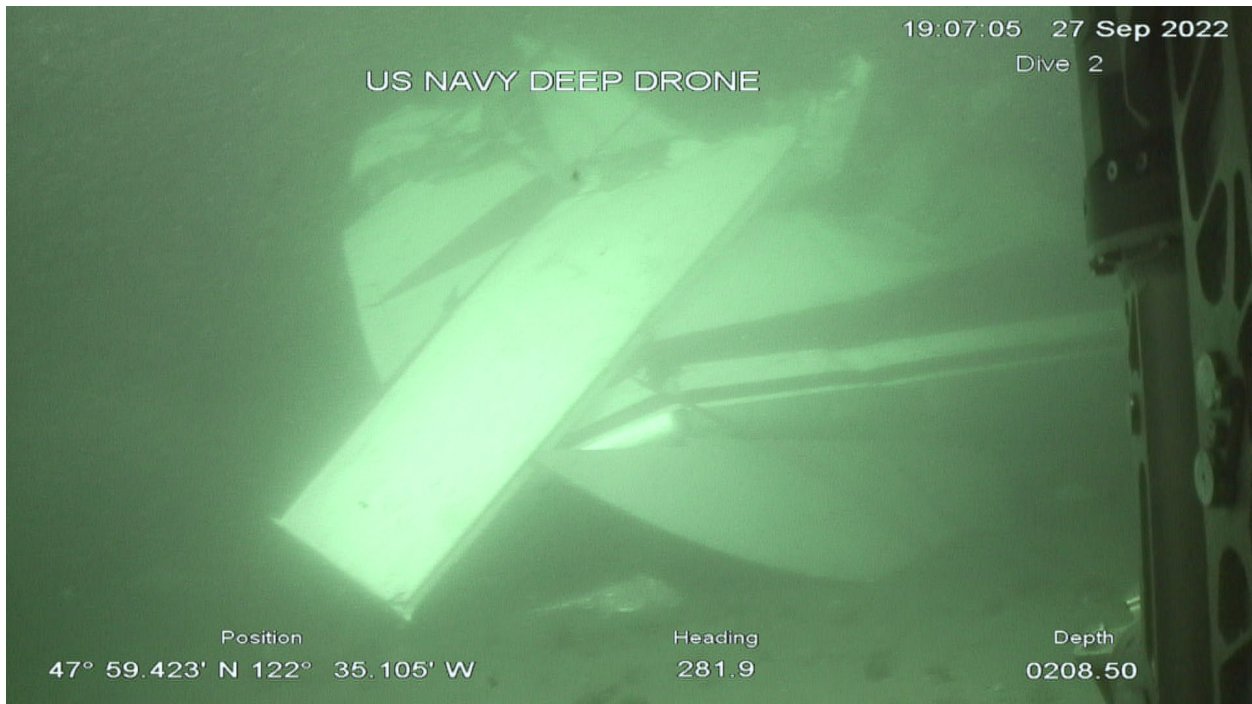
Figure 12. Empennage upright and right side of horizontal stabilizer on seafloor

The barge crew reset the northwest anchor after the initial survey. On the second dive it became evident that the main wreckage had been moved by the anchor line and was in a completely different orientation than before. Specifically, the empennage was now situated in an upright position on the seafloor (Figures 11 and 12). The right side of the horizontal stabilizer was now partially attached to the empennage, deformed down against the vertical stabilizer, and rotated leading edge aft. On this dive the separated engine (Figure 13), separated right elevator (Figure 14), and human remains were also identified. The decision was made to recover the accessible remains before proceeding with rigging the main wreckage or other wreckage recovery. A basket with the accessible remains was recovered the afternoon of September 28. The ROV then rigged the separated engine and recovered it to the barge the afternoon of September 28. The main fuel tank was identified the evening of September 28 on Dive 7 (Figure 15).

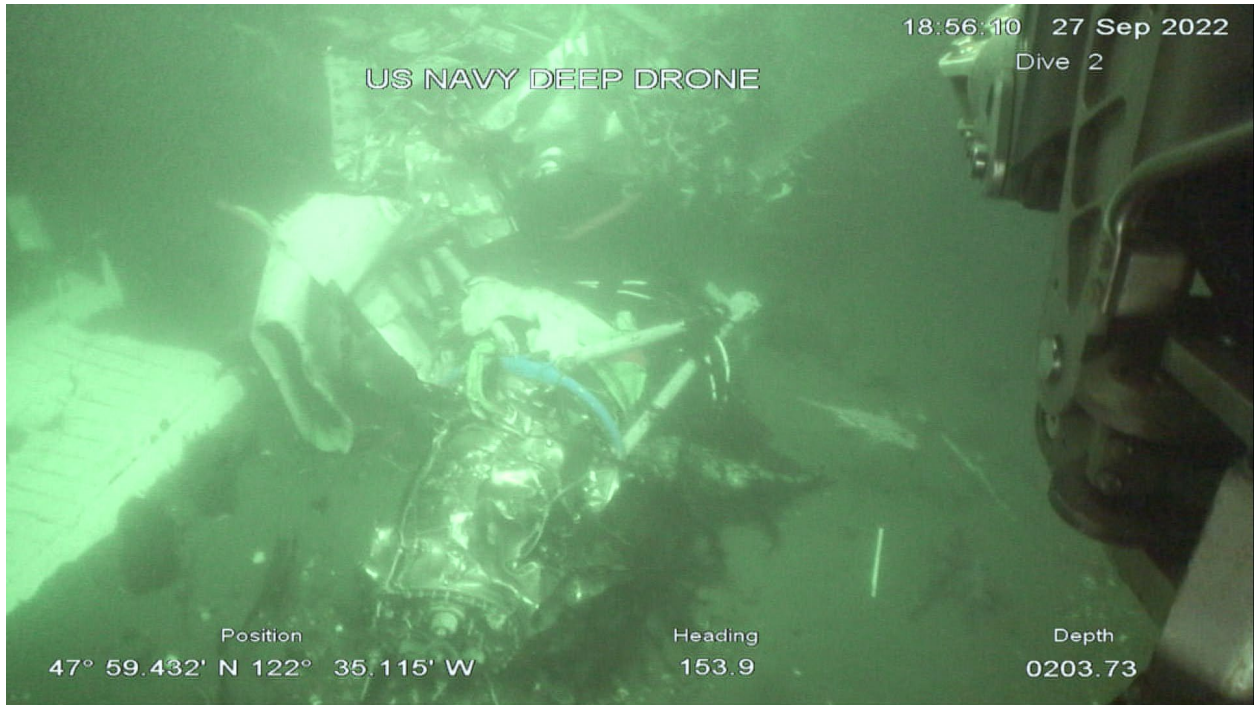
Figure 13. Engine on seafloor

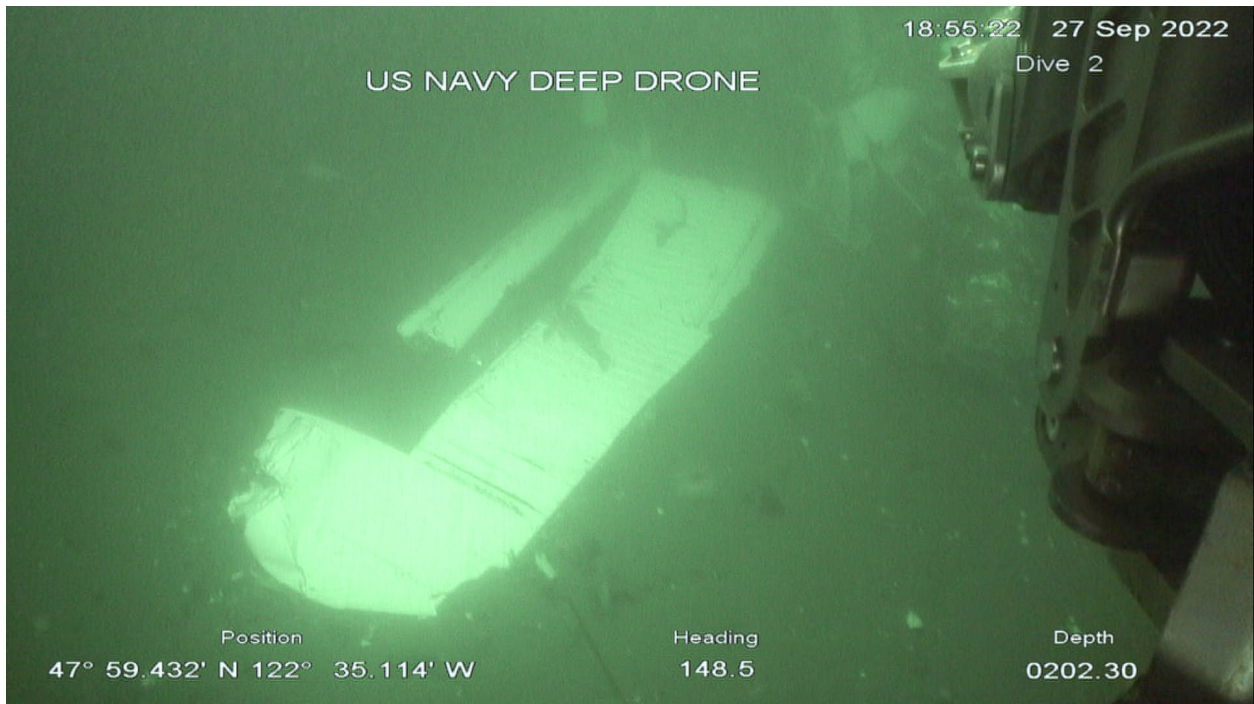
Figure 14. Right elevator on seafloor

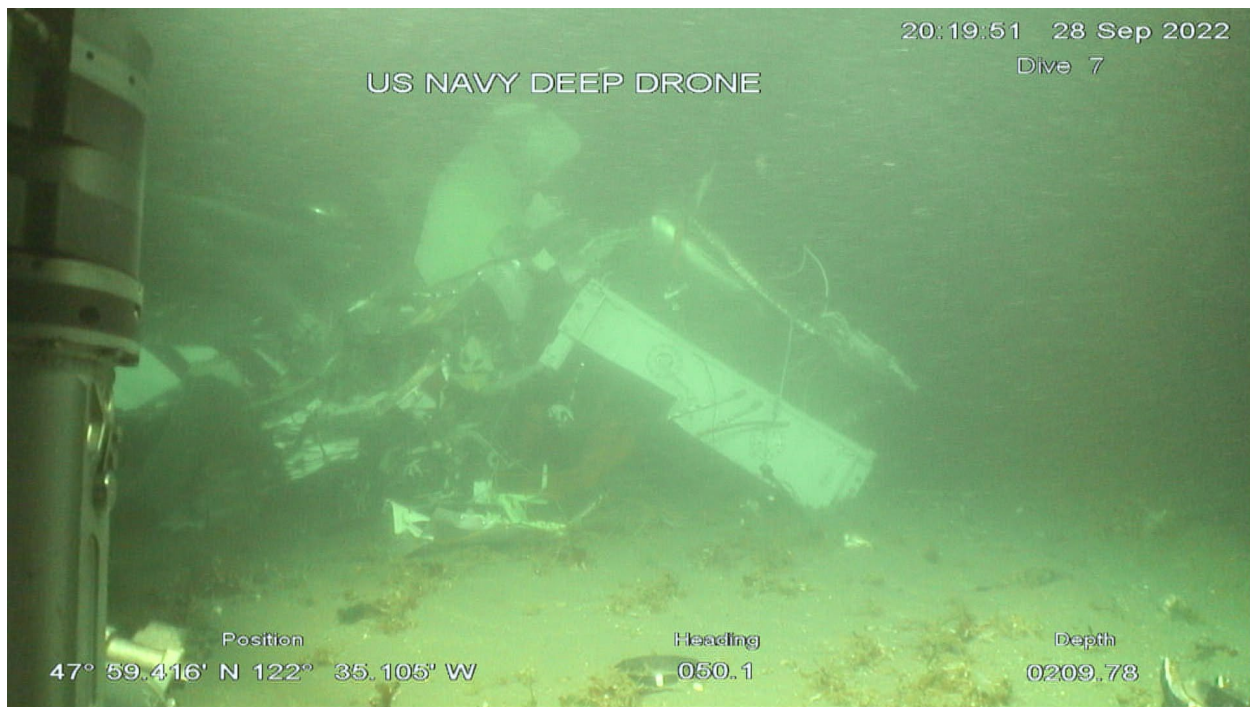
Figure 15. Main fuel tank on seafloor

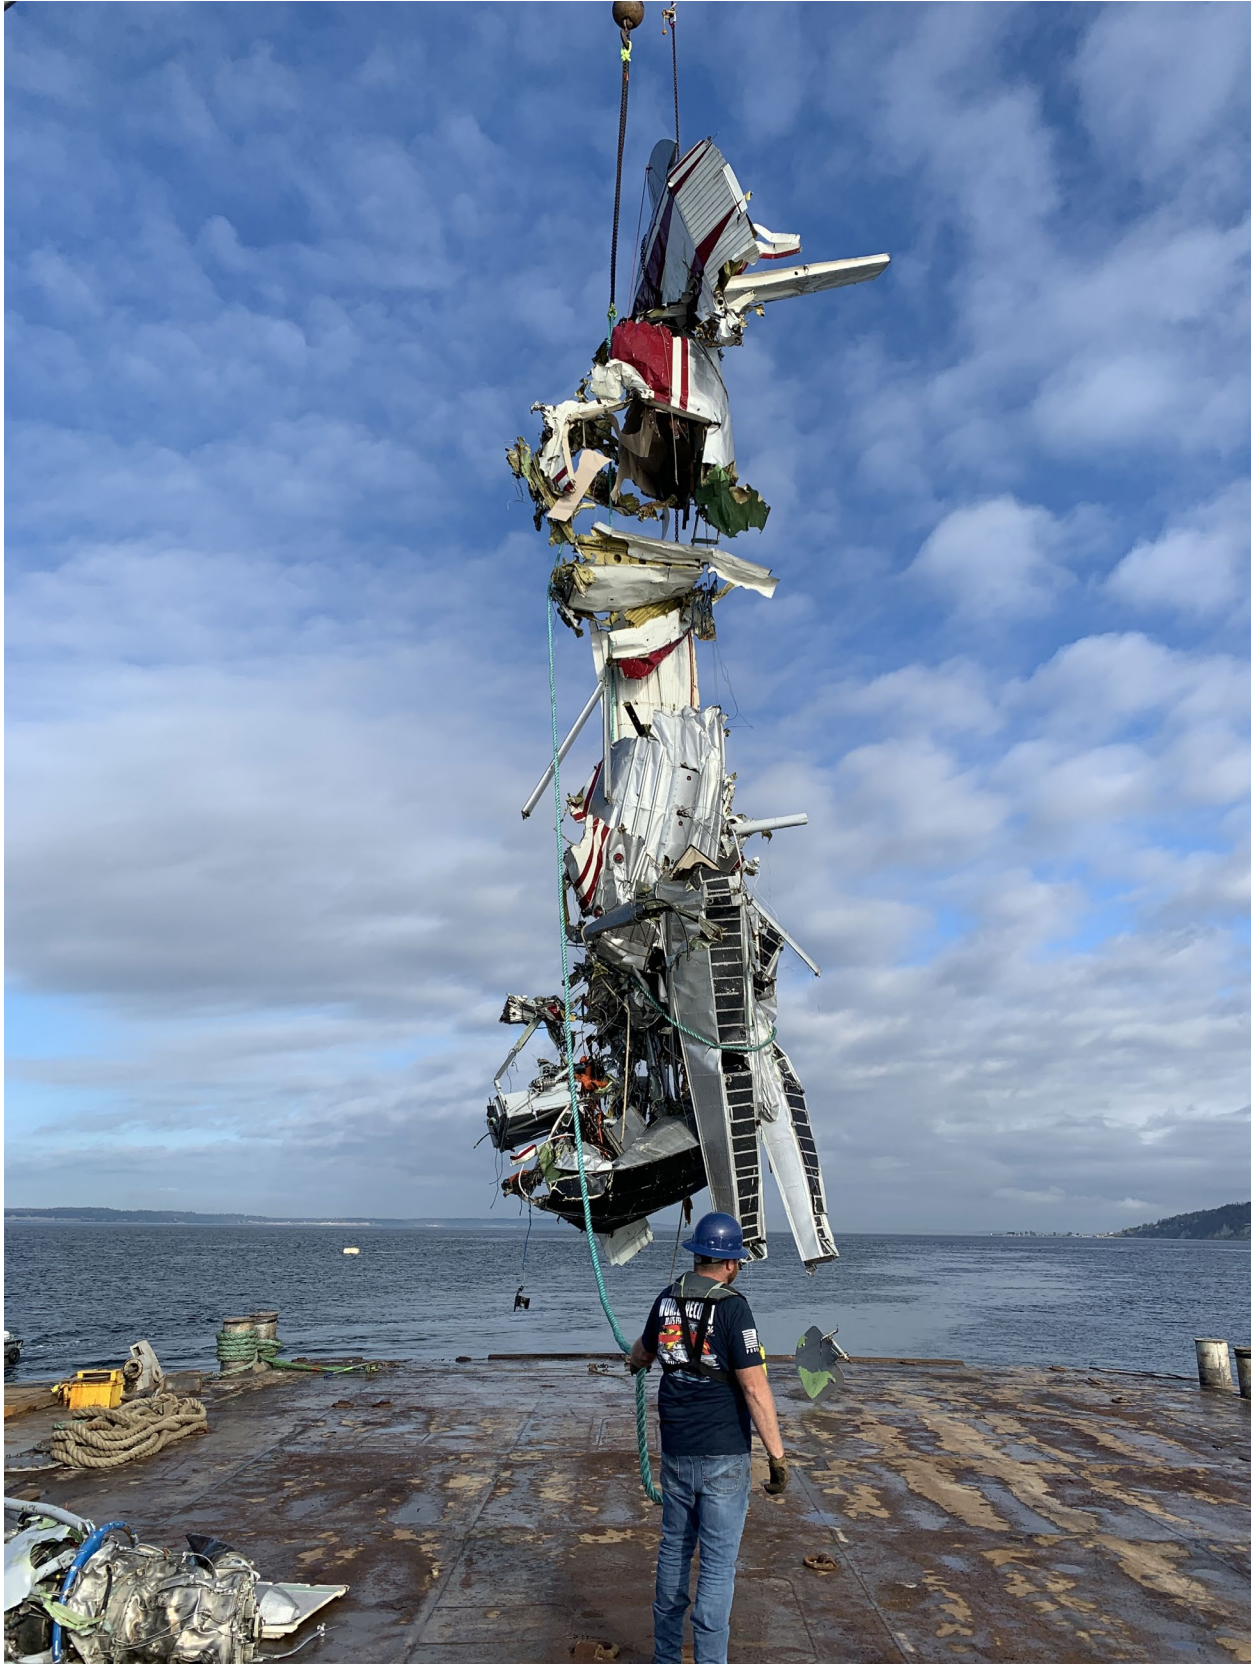
Figure 16. Main wreckage being lifted onto barge

The main wreckage was rigged with a chain around the aft fuselage forward of the vertical stabilizer in a choke configuration and a chain around the root area of the right wing in a choke configuration. The two chains were rigged to a third chain in a choke configuration. The rigging was connected to the crane hook by the ROV on the morning of September 29. The ROV developed a leak in the electronics compensator and had to be recovered before the lift to repair the leak. Therefore, the ROV did not observe the lift of the wreckage. The empennage broke the surface first and as it was lifted the group discovered that the rigging on the left wing had slid most of the way off and only the empennage flight control cables were holding the forward fuselage and floats to the empennage. An additional lifting rope was wrapped around the forward fuselage and floats and connected to the crane whip line for lifting onto the deck of the Mister Ed (Figure 16).

Detailed examination of the wreckage showed that a majority of the fuselage, empennage and the floats were recovered. The empennage consisted of the vertical stabilizer and attached rudder, the ventral fin, and the left side of the horizontal stabilizer. The right side of the horizontal stabilizer did not remain attached. About 1-½ floats were recovered. One victim was recovered in the fuselage wreckage.
