# National Transportation Safety Board

DCA23FA149

## **FDR AND ADS-B STUDY**

Aircraft Performance Study

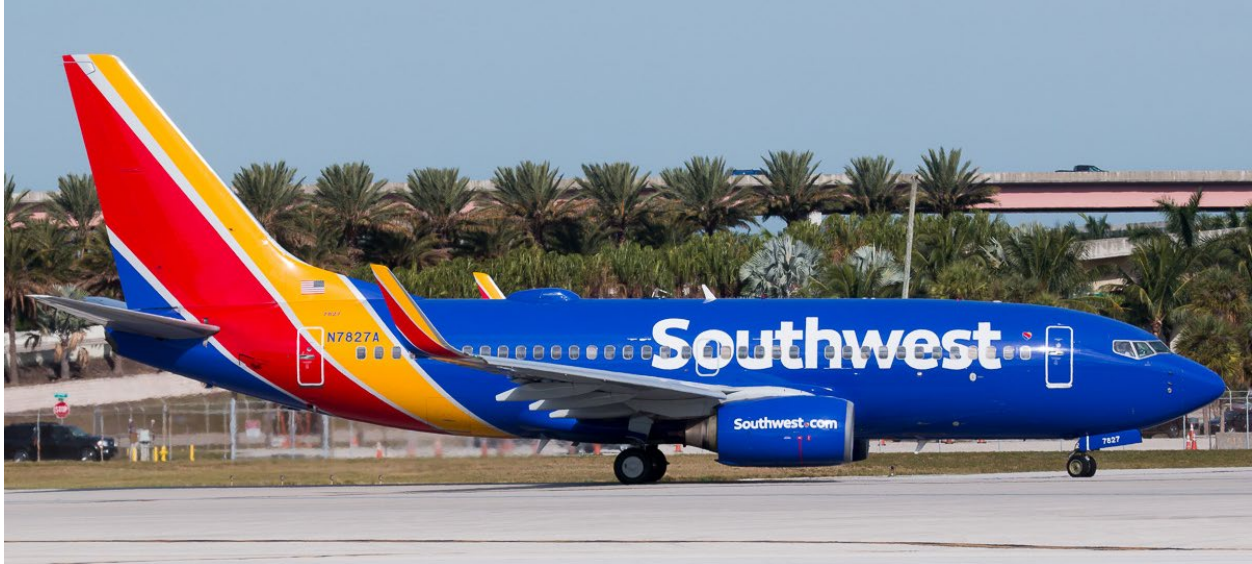
**Figure 1.** N7827A.

The Boeing 737-700 is a narrow-body jet aircraft. It is 110 ft 4 in (33.6 m) long and 41 ft 2 in (12.5 m) tall at the tail. Figure 1 is a photograph of the Southwest 737 passenger aircraft involved in the runway incursion, N7827A.

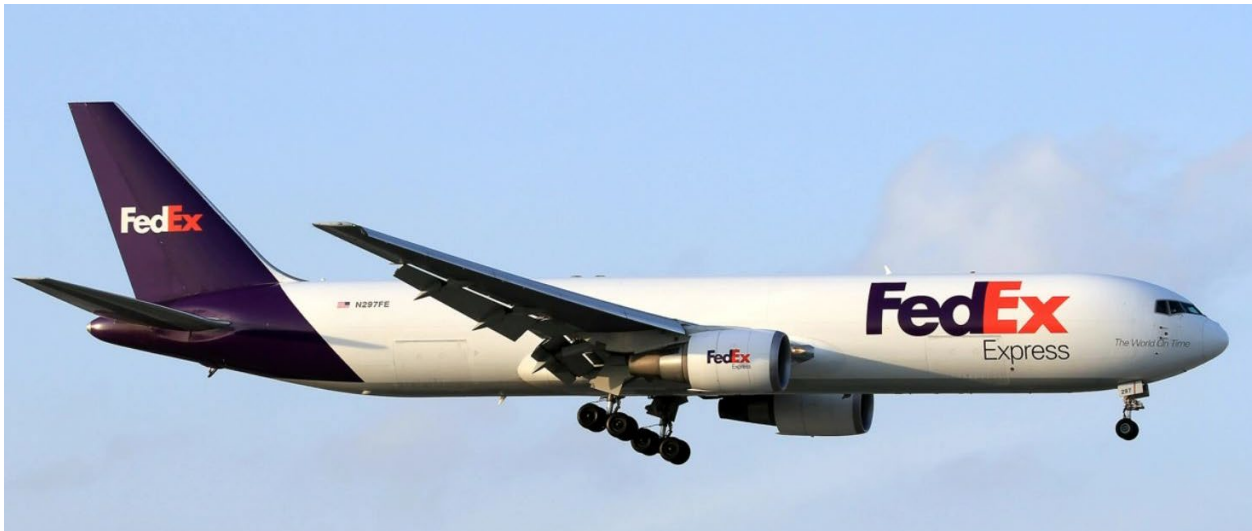
**Figure 2.** N297FE.

The Boeing 767 is a wide-body jet aircraft. It is 180 ft 3 in (54.9 m) long and 52 ft (15.8 m) tall at the tail. Figure 2 is a photograph of the FedEx 767 cargo aircraft involved in the runway incursion, N297FE.

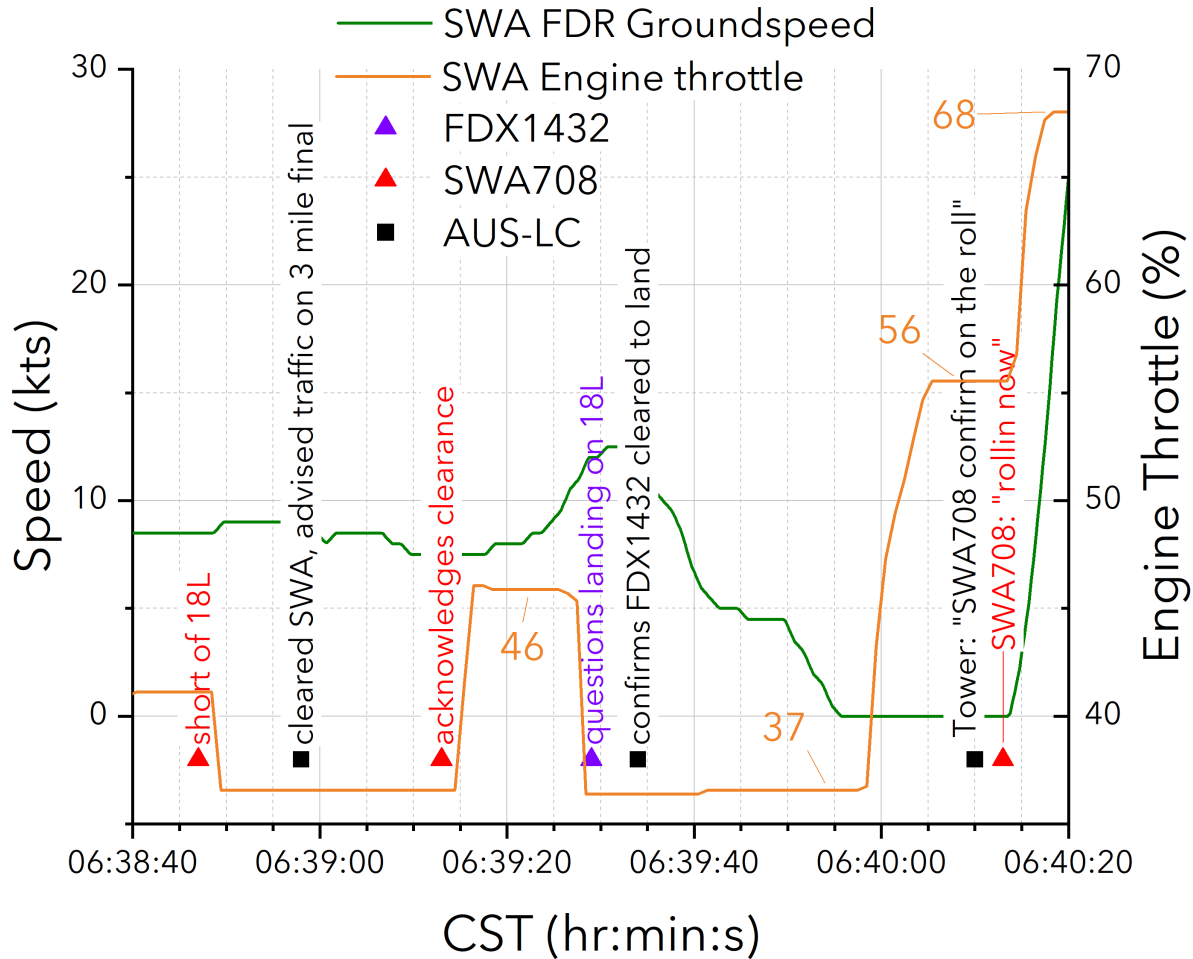
**Figure 6.** SWA708's FDR recorded groundspeed and engine throttle with selected ATC communications.

seconds while taxiing (Figure 6). The airplane was 400 feet from runway 18L. FDX1432 was 3.3 miles from the runway threshold and traveling at 126 kts groundspeed. FDX1432 was 1 minute 15 seconds from crossing the runway threshold.

SWA708 completed the turn onto the runway and stopped at 06:39:55 when FDX1432 was 33 seconds from the runway threshold and 8,000 ft from SWA708. SWA708's FDR groundspeed remained at zero for 19 seconds as engines were advanced from 37% to 56% (Figure 6). At 06:40:10, the controller asked if SWA708 was on the roll.

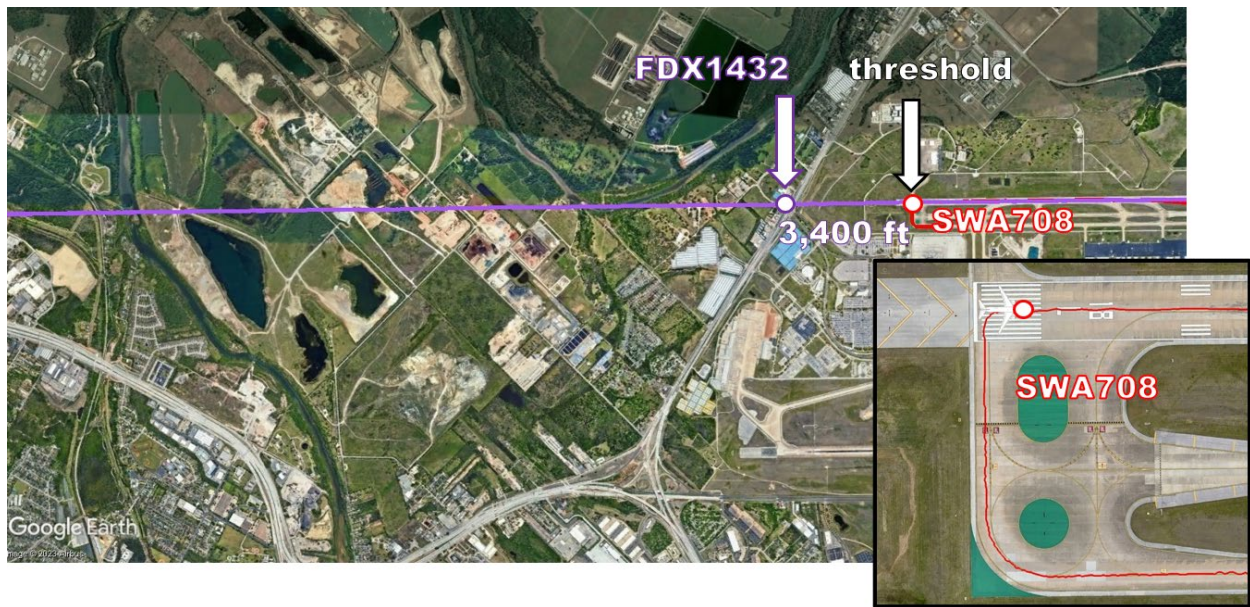
**Figure 8.** Airplane positions at 06:40:14 as SWA708 begins take-off roll.

The crew responded affirmative and the airplane's groundspeed increased from zero at 06:40:14 as throttles advanced to 68%. FDX1432 was 3,400 ft from SWA708 (Figure 8) and at an altitude of 270 ft agl. It was traveling at 140 kts of groundspeed and was 14 seconds from the runway threshold.

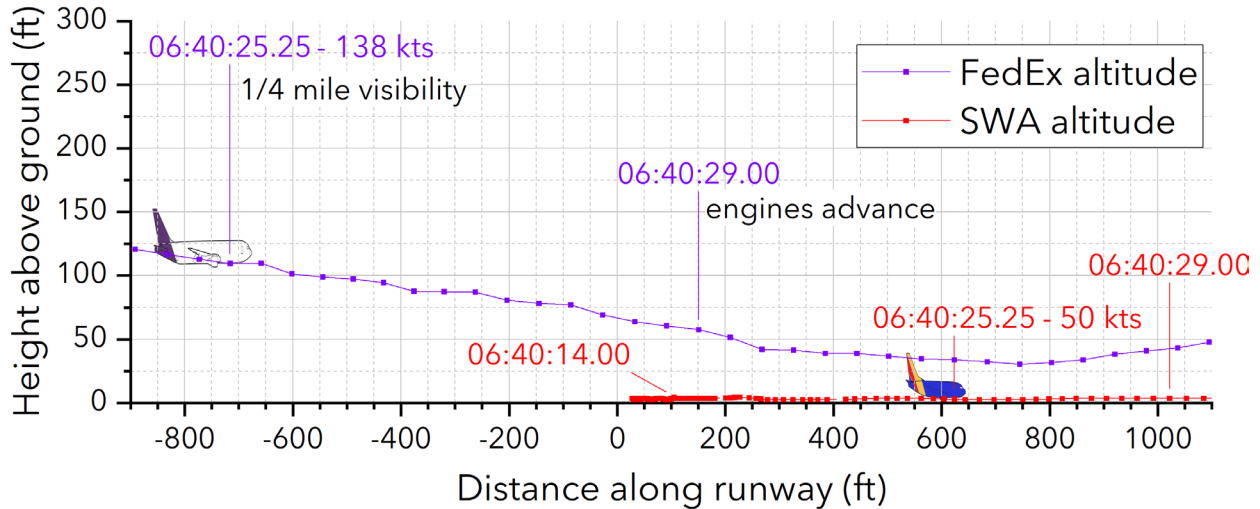
**Figure 9.** Airplane positions at 06:40:25.25, when the separation was ¼ mile, and 06:40:29 when the airplanes were 0.2 miles apart and the FDX1432 crew advanced the engines. Groundspeed is noted at 06:40:25.25. Horizontal and vertical scales are not the same. Airplane sizes are approximately to scale.

In interviews after the event, the FDX1432 crew reported seeing the shape of the Boeing 737 on the runway as they descended through the fog. As discussed in the Weather section, due to fog, vertical visibility was 200 ft agl and horizontal visibility was 1/4 mile decreasing to 1/8 of a mile. Figure 9 shows that at 06:40:25.25 the airplanes were within 1/4 mile of each other and FDX1432 was below 200 ft agl. It crossed the threshold to runway 18L at 06:40:28. At 06:40:29 the FDX1432 crew advanced the engines, initiating a go-around.

The airplanes shown in Figure 9 through Figure 11 are sized such that their length and height match the scale of the plot. However, due to the longer horizontal distances compared to the altitudes involved in these figures, the airplanes appear shortened compared to their heights. Figure 12 through Figure 14 have scales such that the horizontal and vertical dimensions are about equal and the drawing's aspect ratio is more consistent with the actual airplane. All airplane drawings are approximately positioned in relation to the airplanes' radio altimeters which are on the belly of the airplanes behind the nose. FDX1432's landing gear were down until 06:40:46 but are not shown in the figures as they were not considered in the separation calculations.

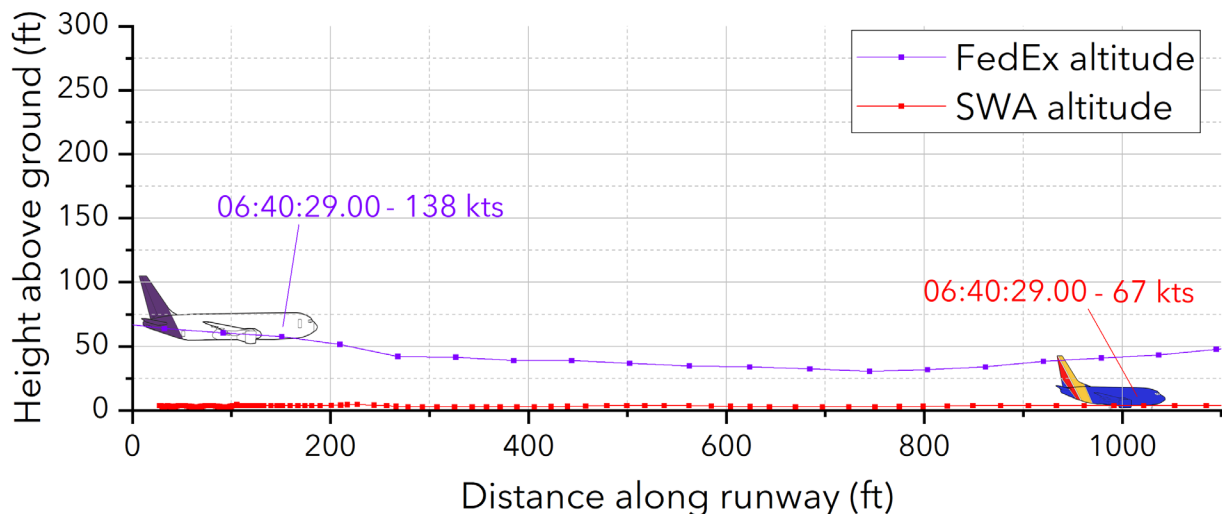
**Figure 10.** Airplane positions and groundspeed at 06:40:29 when FDX1432 advanced engine power for a go-around. Airplane sizes are approximately to scale.

The FDX1432 FDR recorded the engines advanced and the control column was pulled back at 06:40:29 (Figure 10) when the airplane was 150 ft beyond the threshold, at a height of 70 ft, and a groundspeed of 138 kts. SWA had accelerated to 67 kts groundspeed and was 1,020 ft down the runway. At this time, the horizontal separation (the nose of FDX1432 to the tail of SWA708) was 870 ft and vertical separation (the lowest point of FDX1432 to the top of SWA708’s tail) was 13 ft.

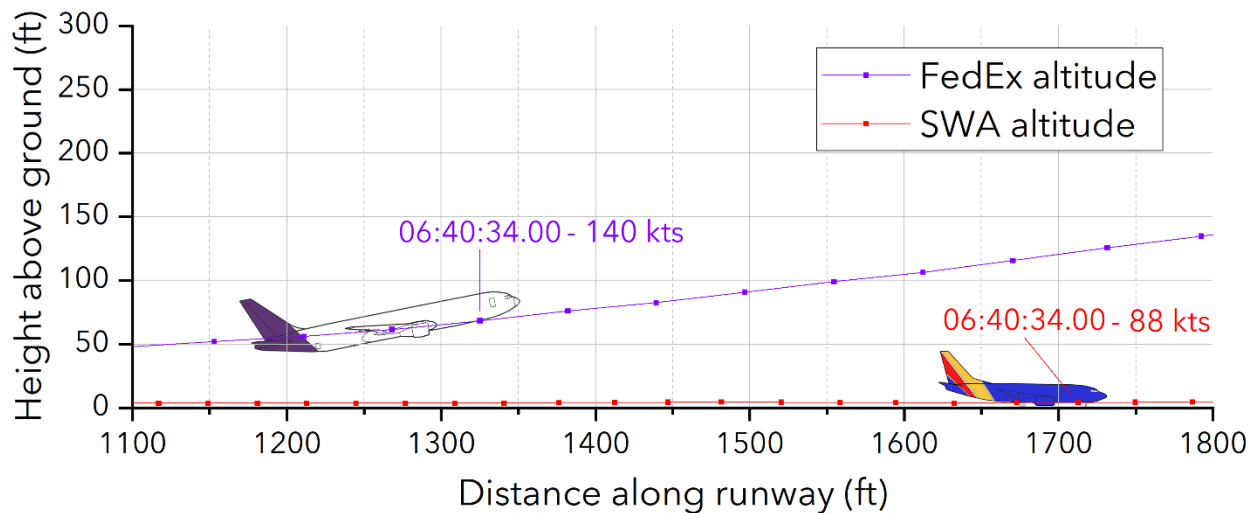
**Figure 12.** Airplane positions and groundspeed at 06:40:34. Airplane sizes are approximately to scale.

At 06:40:34, FDX1432 broadcast “FedEx is on the go”. FDX1432 was then 1,320 ft down runway 18L and climbing through 85 ft. SWA708 was 1,700 ft along the runway at a groundspeed of 88 kts and an indicated airspeed of 96 kts (Figure 12). Horizontal separation was 270 ft and the lowest point of FDX1432 was lower than the top of SWA708's tail.

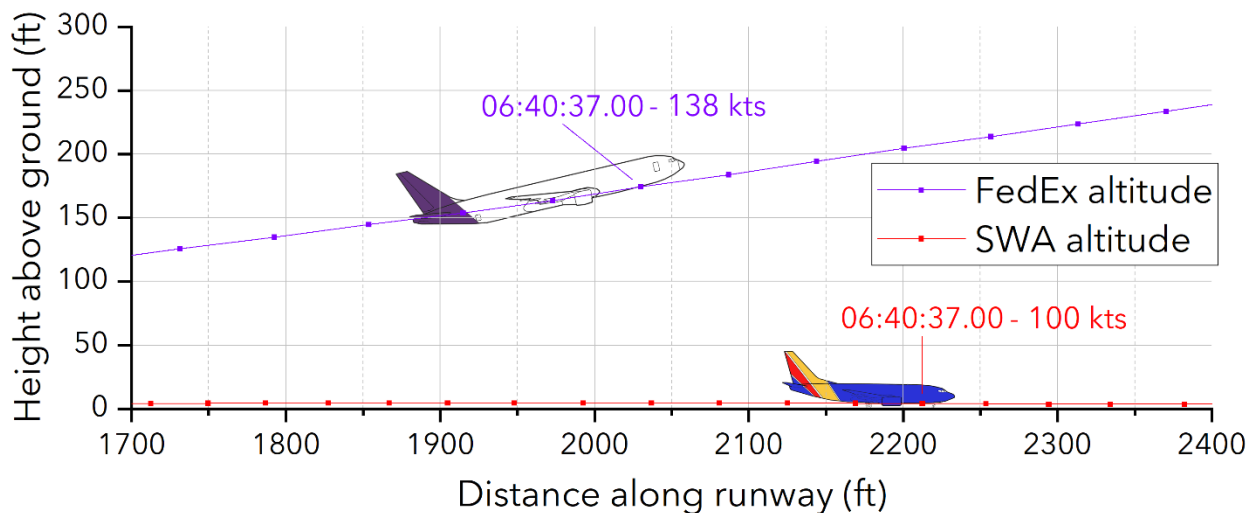
**Figure 13.** Airplane positions and groundspeed at 06:40:37 when the airplanes were at their closest point. Airplane sizes are approximately to scale.

At 06:40:37 the airplanes reached their point of minimum separation for the event. FDX1432 was 2,020 ft down the runway and climbing through 190 ft. SWA708 was 2,200 ft down the runway at a groundspeed of 100 kts and an indicated airspeed of 107 kts (Figure 13). FDX1432 was climbing at a rate of 2,000 fpm (Figure 16).

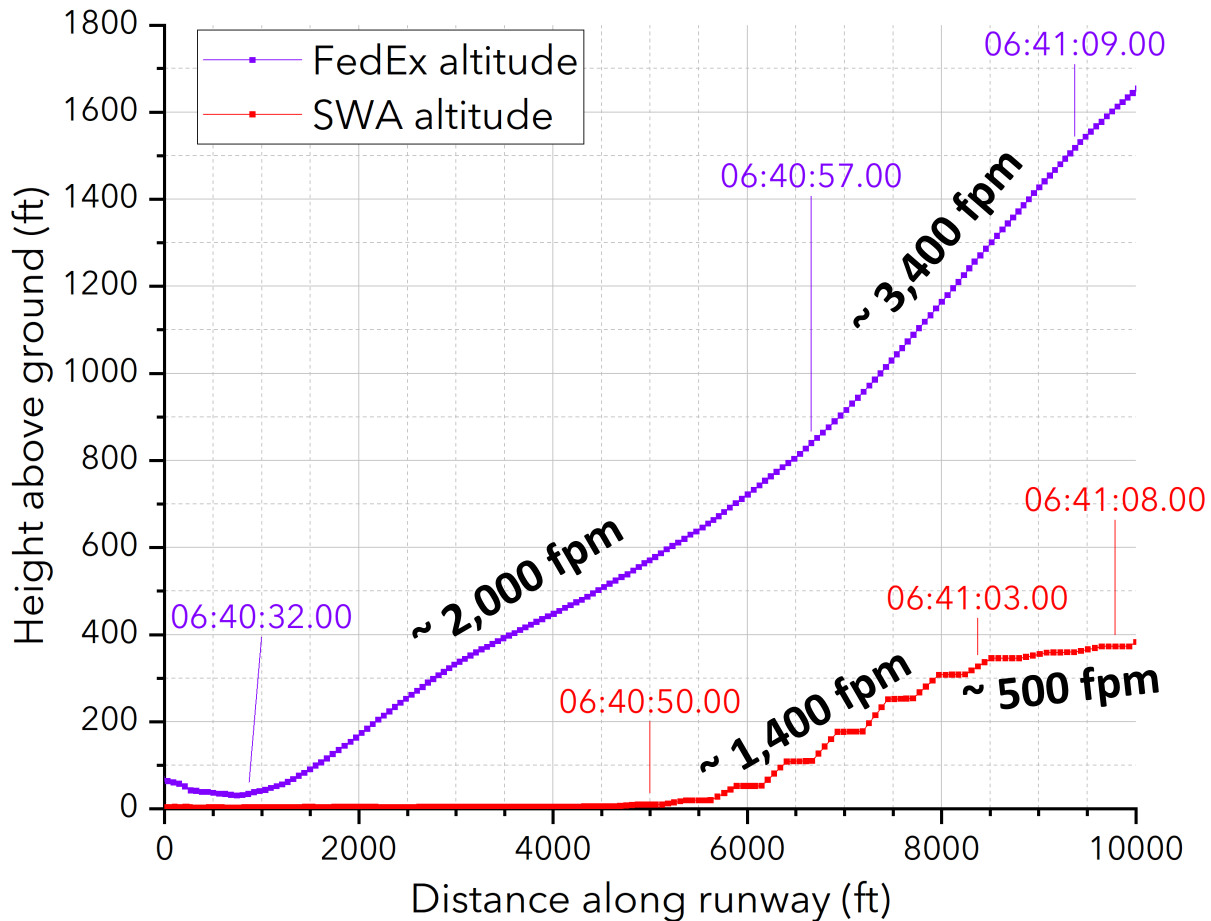
**Figure 16.** Airplane altitudes along the runway and rate of climb. The runway was 9,000 ft long.

FDX1432 and increasing. SWA708 received a traffic advisory from its Traffic Alert & Collision Avoidance System (TCAS) Computer at approximately this time [5]. In interviews, the SWA crew noted that after the TCAS alert they “shallowed” the climb (see Figure 16).

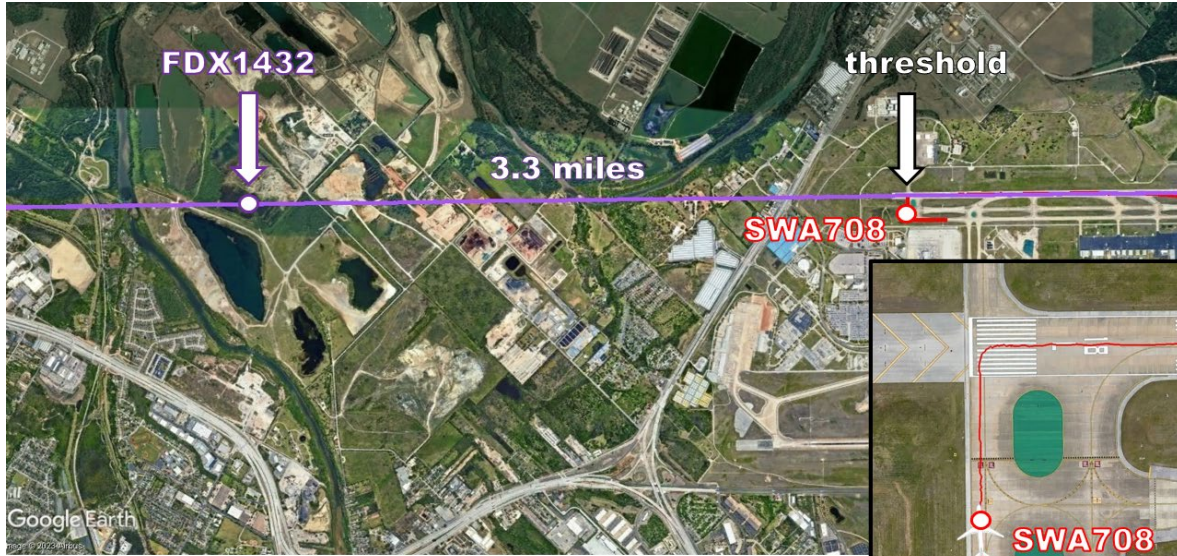
06:39:13

Time -75 s

SWA708: "okay that's one seven zero cleared for takeoff one eight left copy the traffic southwest seven zero eight"

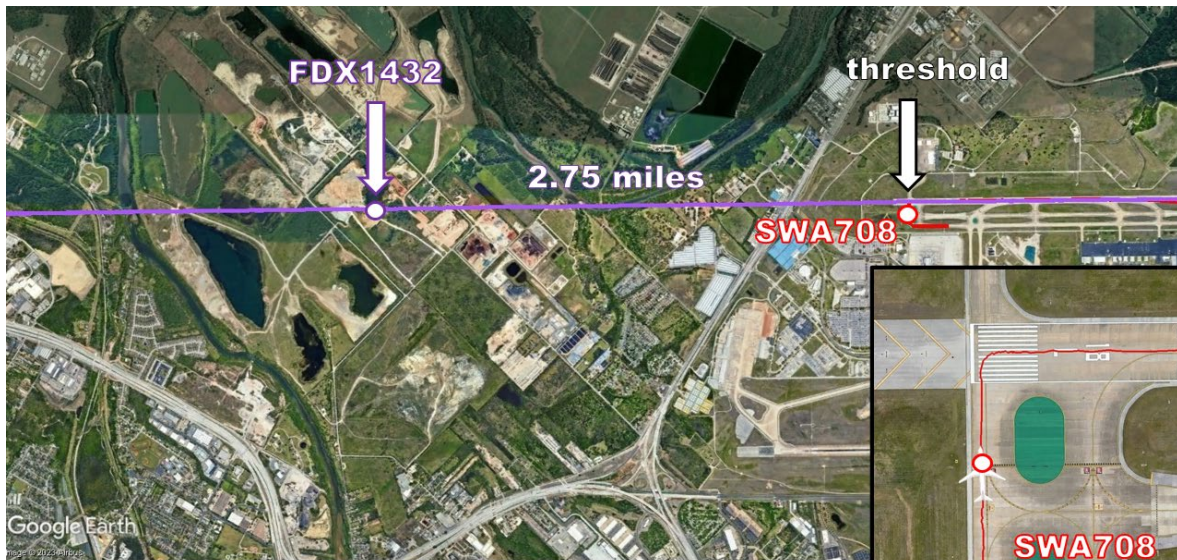
06:39:26

Time -62 s

SWA708 hold short line

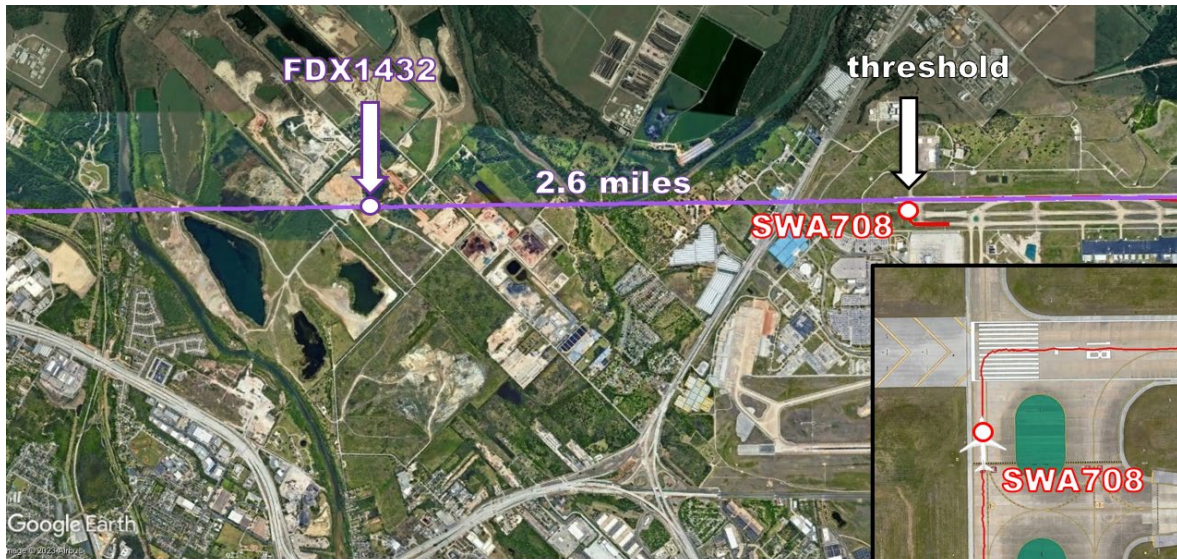
06:39:29

Time -59 s

FDX1432: "tower confirm uh fedex fourteen thirty-two heavy's cleared to land on the one eight left"

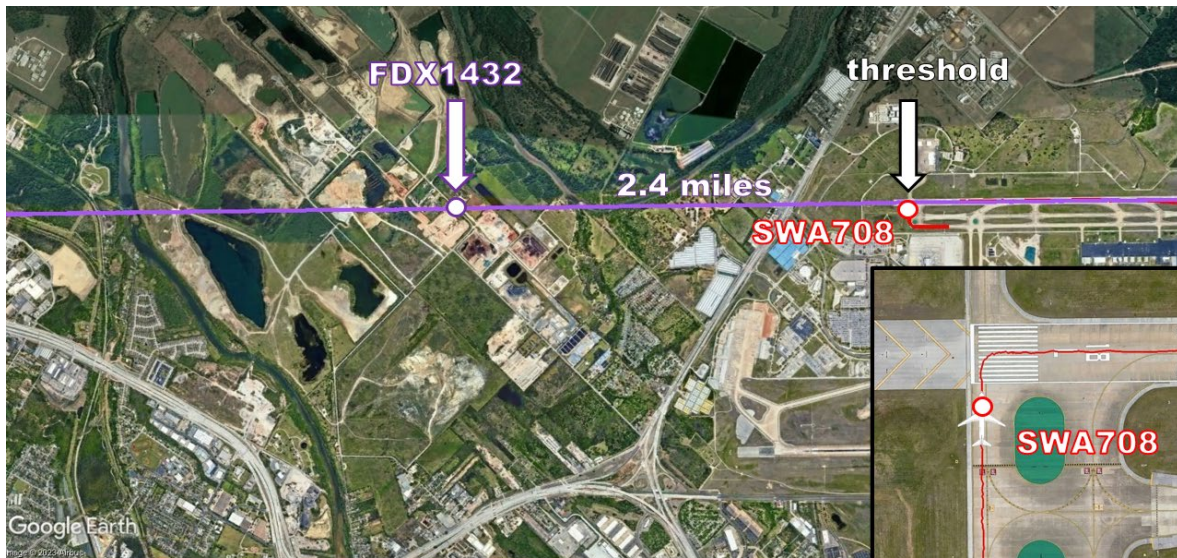
06:39:34

Time -54 s

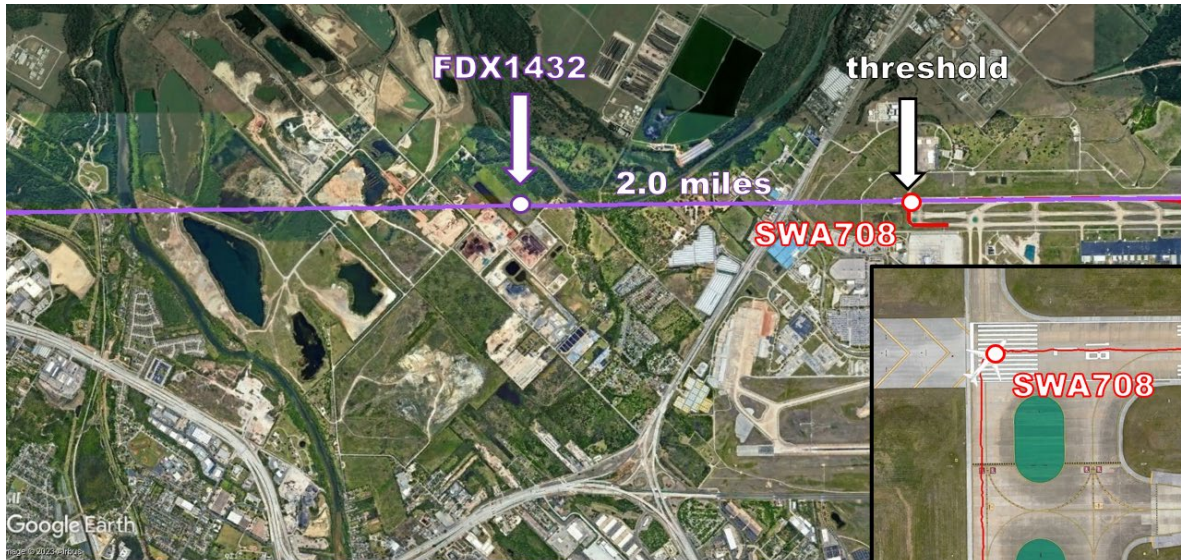
06:39:44

Time -44 s

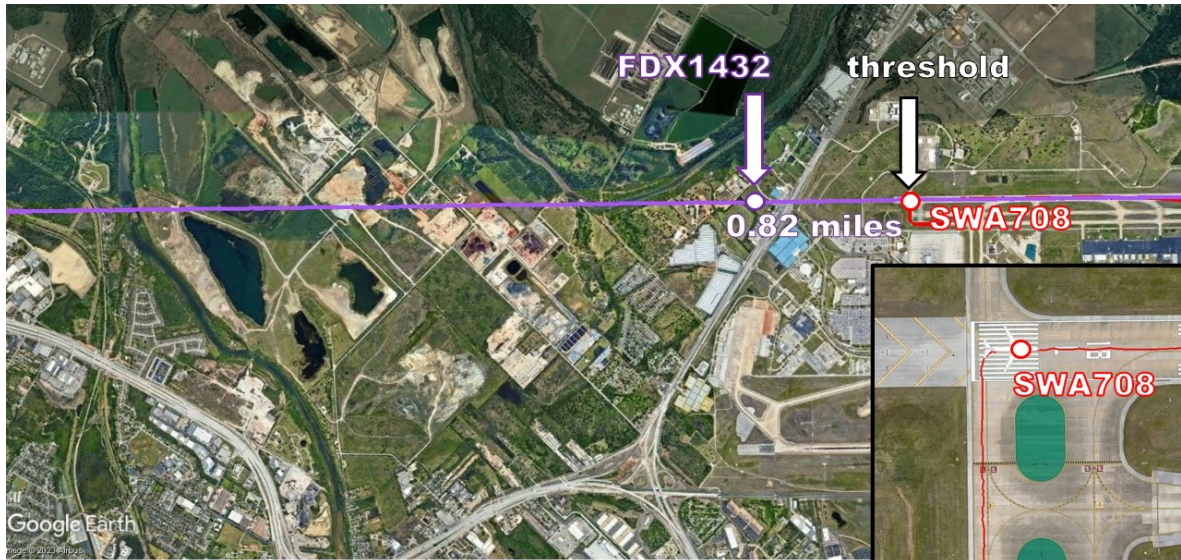
06:40:10

Time - 18 s
