# National Transportation Safety Board

DCA23FA149

## **PERFORMANCE ADDENDUM**

Location: Austin, Texas  
Date: February 4, 2023  
Time: 06:40 central standard time (CST)  
Airplane 1: Boeing 737-79P, N7827A  
Airplane 2: Boeing 767-32LF, N297FE

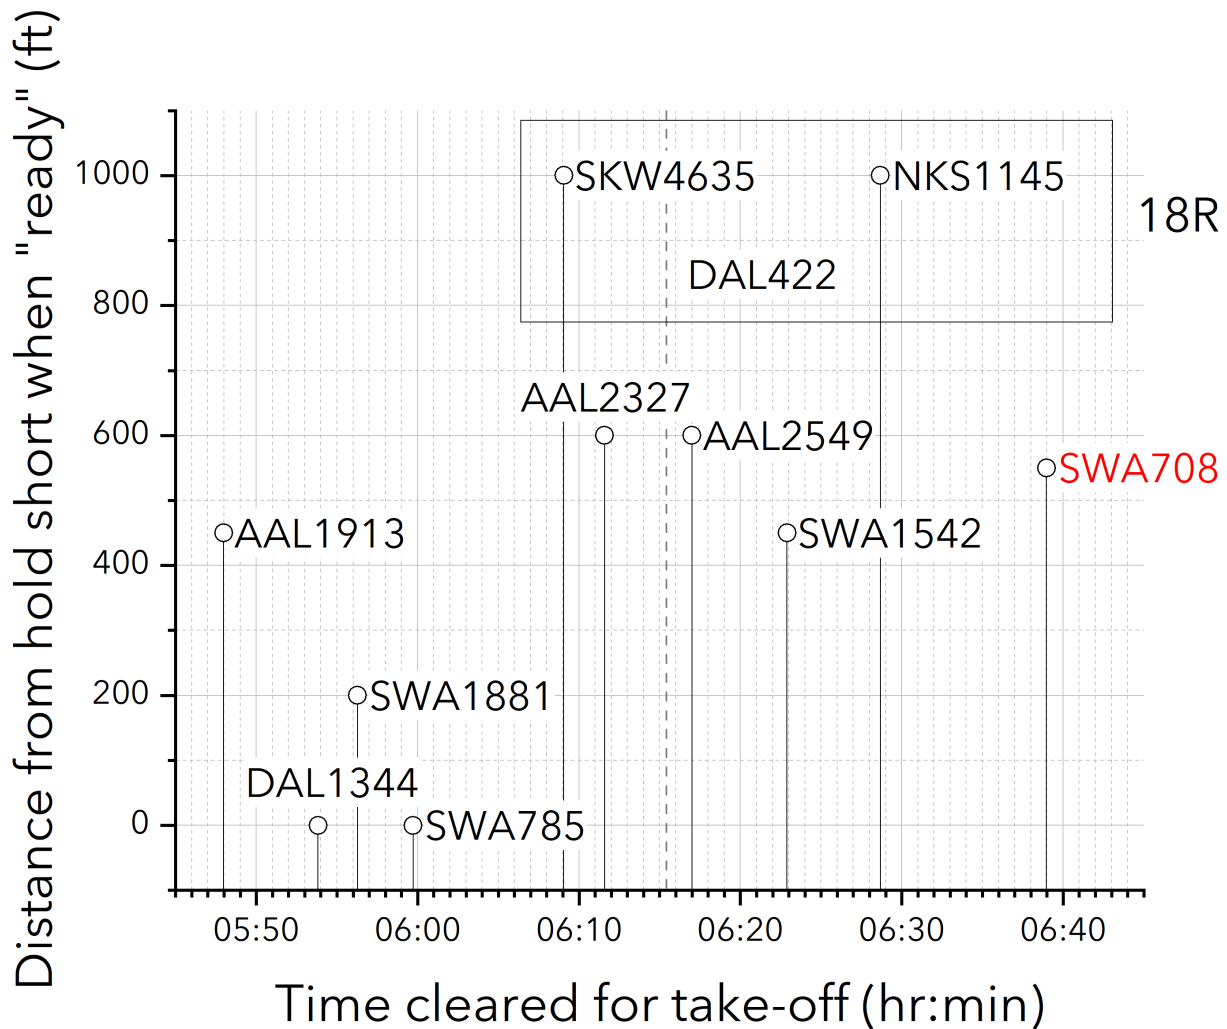
**Figure 2.** Time when each airplane was cleared versus the distance it was from the hold short line when ready for departure. Airplanes taking off from runway 18R are marked. SWA708 is shown in red.

Table 1 contains when, how, and where each airplane reported to ATCT that they were prepared for take-off. Two airplanes reported from the hold short line and the eight other airplanes reported between 200 ft and 1,000 ft before the hold short line. Some airplanes specified where they were on the airport surface when reporting and some did not. Figure 2 shows time of clearance versus distance from runway hold short when reporting ready. Of note, DAL422 did not report to ATCT that they were ready for take-off before they were provided clearance for take-off. Time between take-offs varied from one minute 30 seconds to ten minutes.

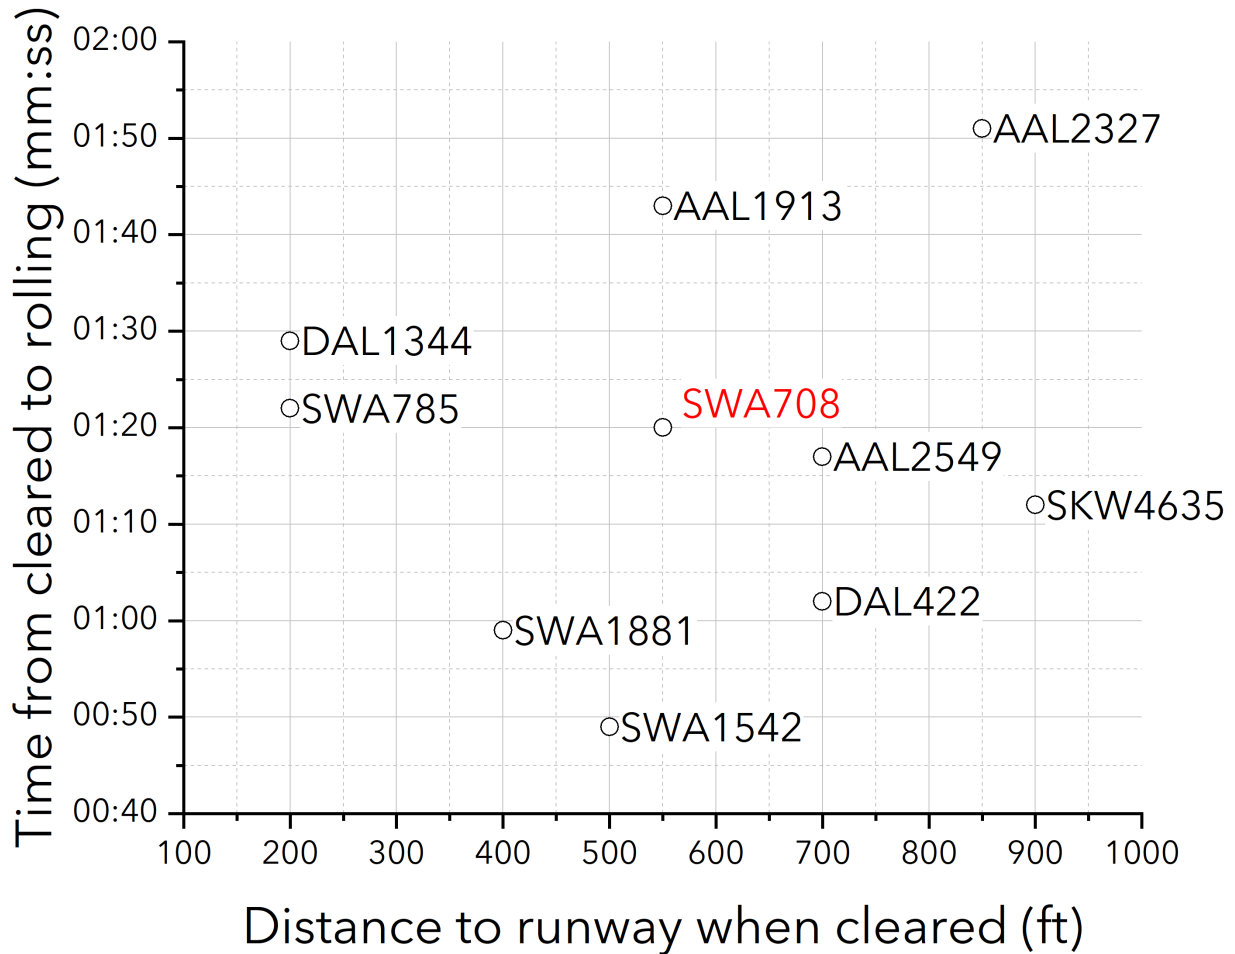
**Figure 3.** Distance to runway when cleared versus time from cleared to rolling. SWA708 is shown in red.

Figure 3 shows the distance to the runway when the airplane was cleared versus the time from cleared to on the take-off roll. There is no relationship between the distance to the runway when cleared and the time from clearance to take-off roll (defined as when acceleration on the runway exceeded 5 kts/s).

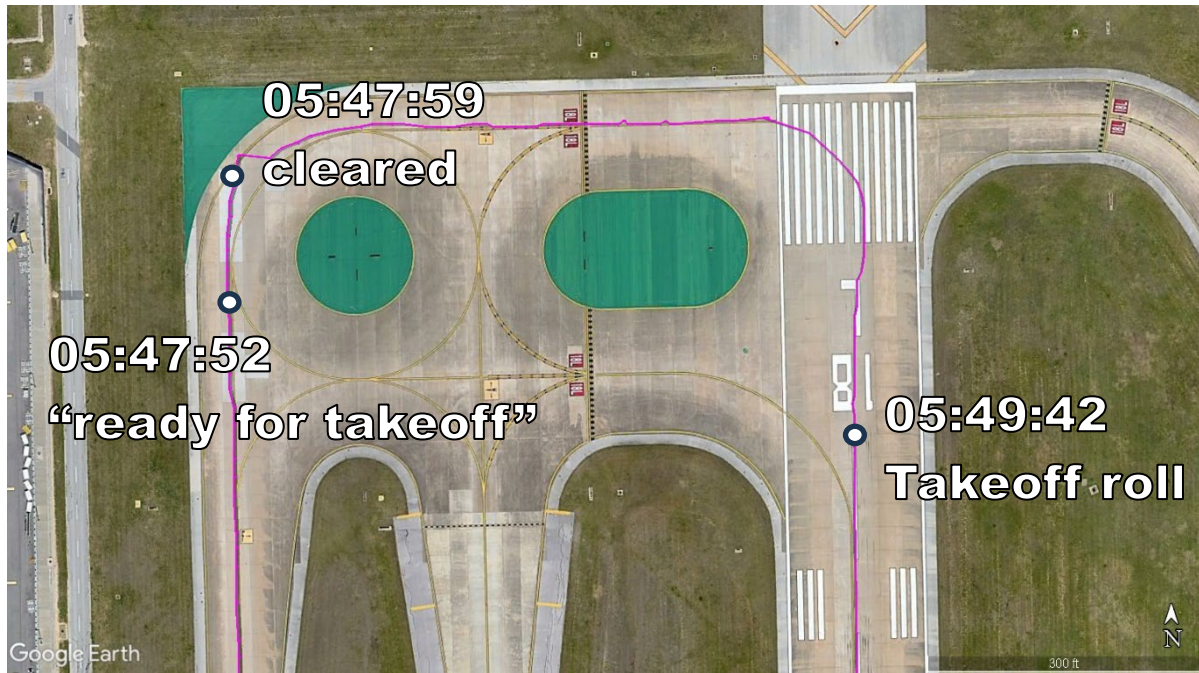
**Figure 4.** AAL1913's departure. Time was 1:43 from clearance to take-off roll.

Figure 4 through Figure 13 shows each airplane's taxi onto the runway with select ATC communications marked. Each airplane contacted ATCT to announce that they were prepared for departure, the location and time of which is marked on the figure. ATCT then cleared each airplane for take-off. Finally, on each figure, the time and location of the start of the take-off roll is marked.

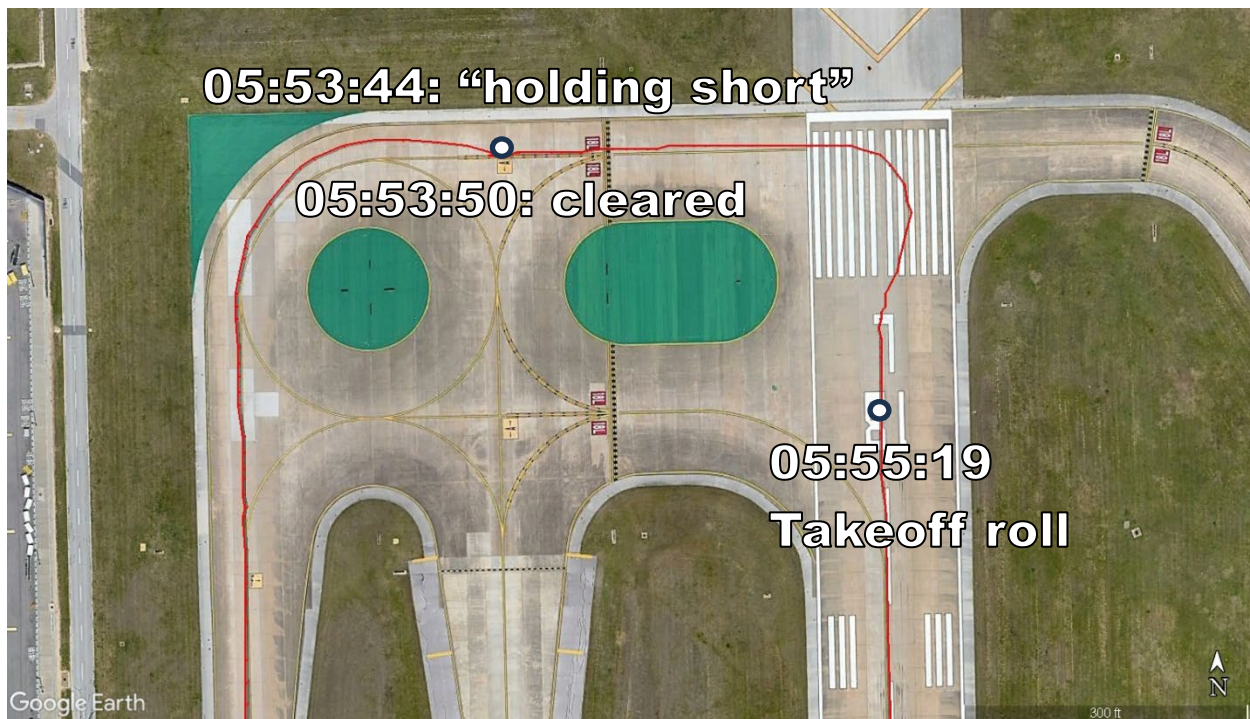
**Figure 5.** DAL1344's departure. Time was 1:29 from clearance to take-off roll.

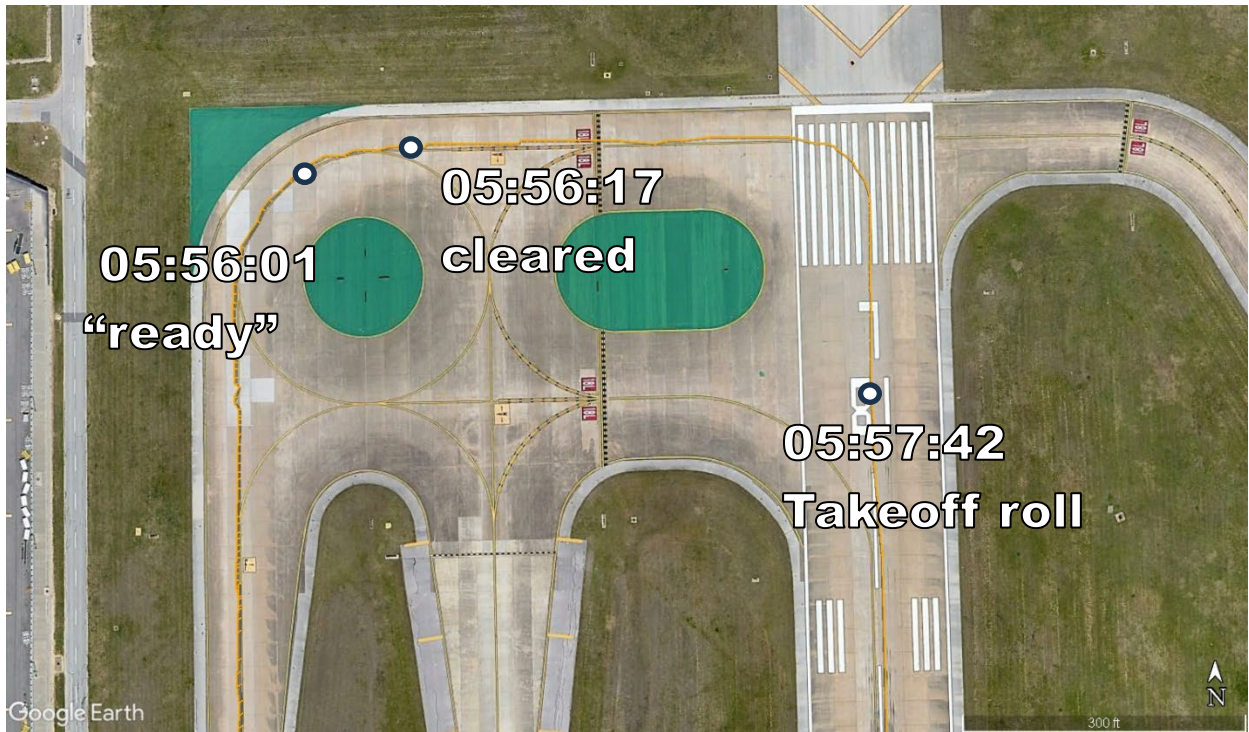
**Figure 6.** SWA1881's departure. Time was 0:59 from clearance to take-off roll.

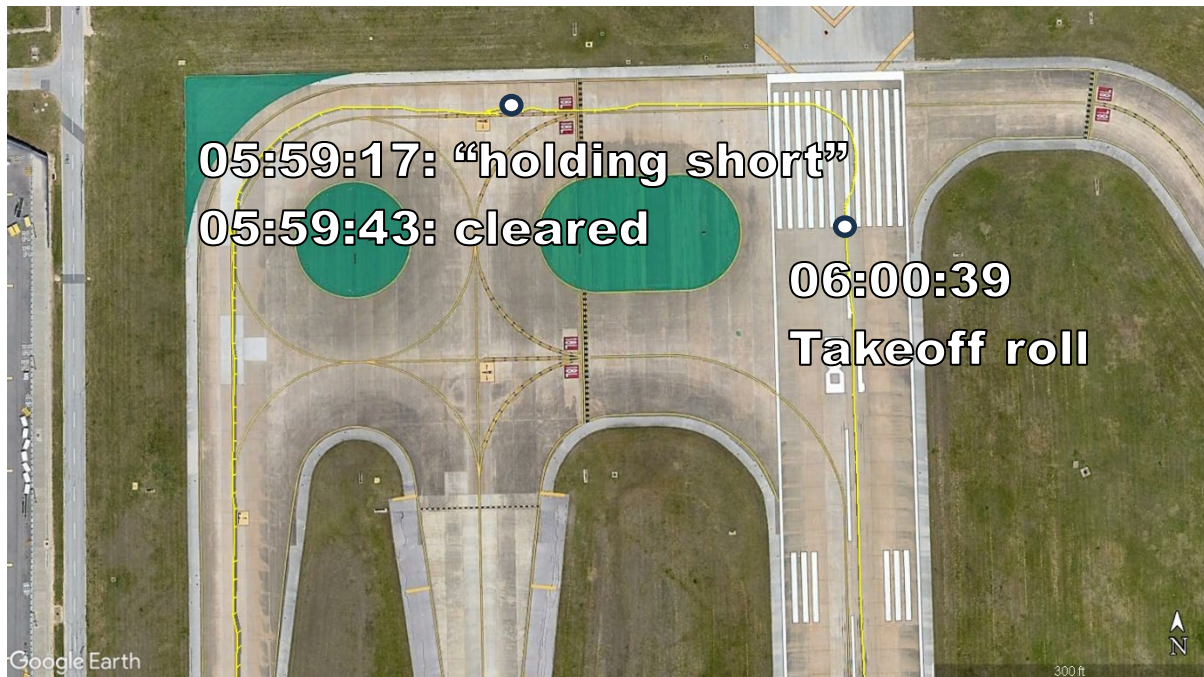
**Figure 7.** SWA785's departure. Time was 1:22 from clearance to take-off roll.

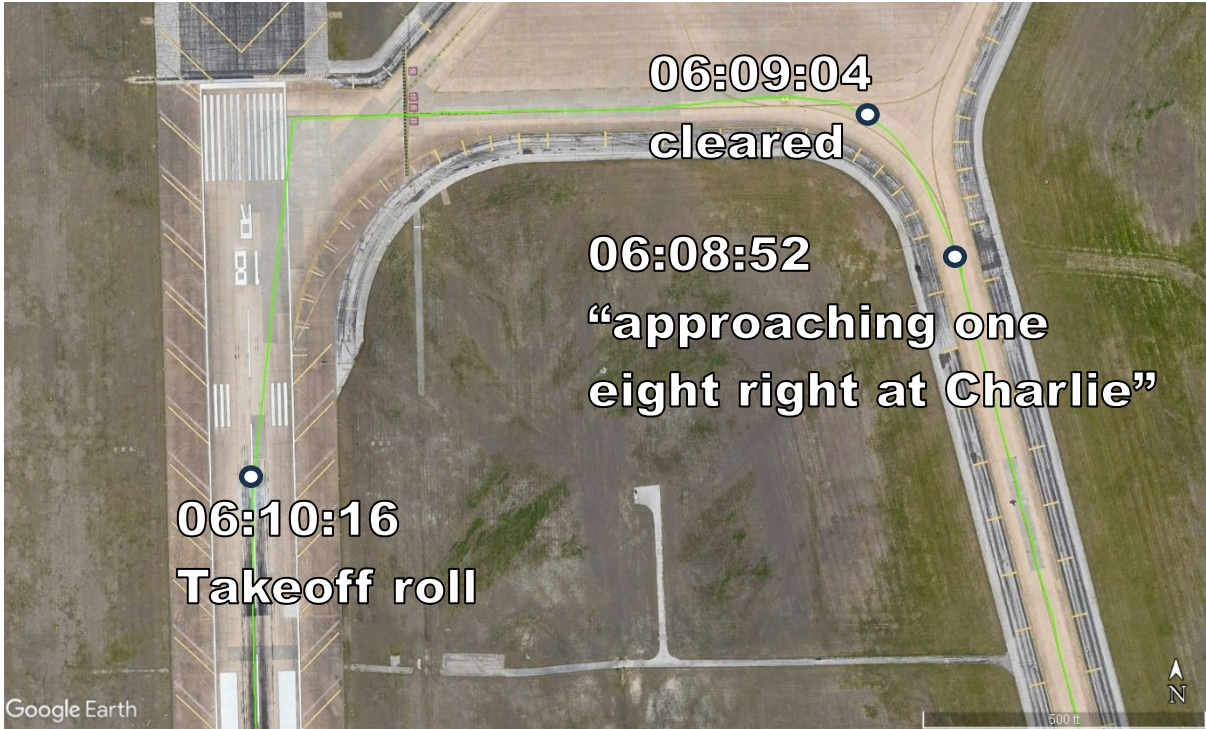
**Figure 8.** SKW4635's departure. Time was 1:12 from clearance to take-off roll.

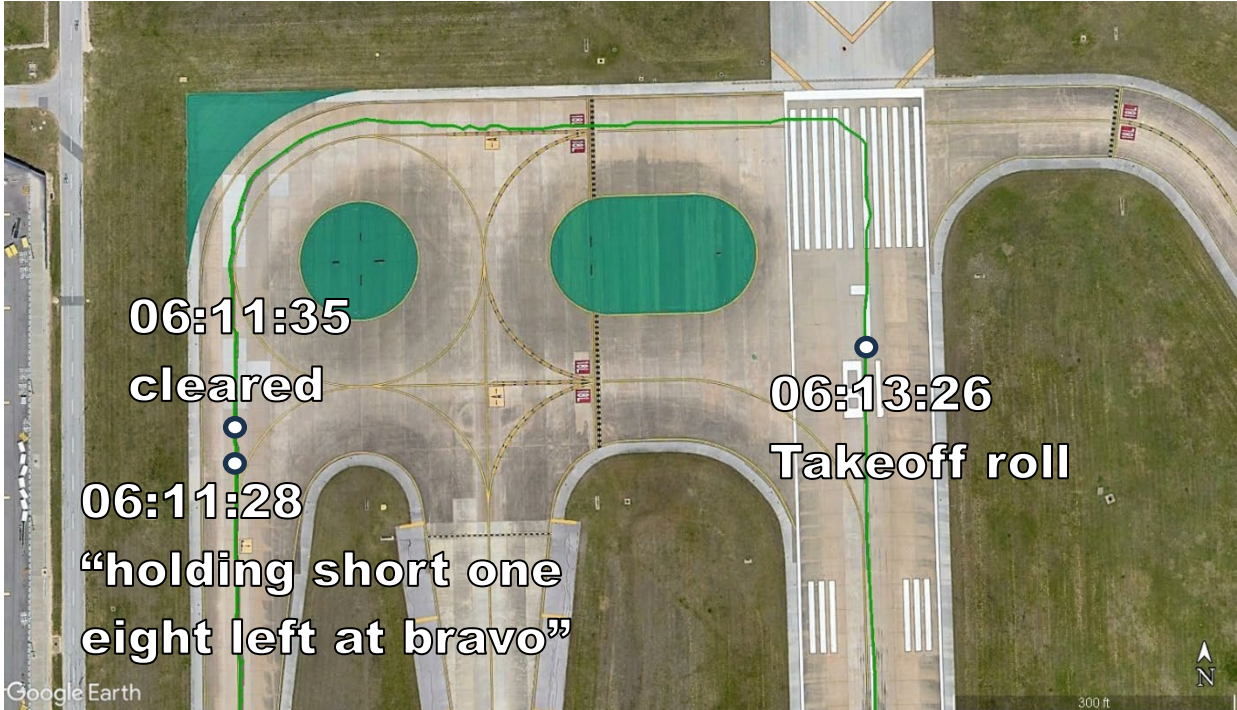
**Figure 9.** AAL2327's departure. Time was 1:51 from clearance to take-off roll.

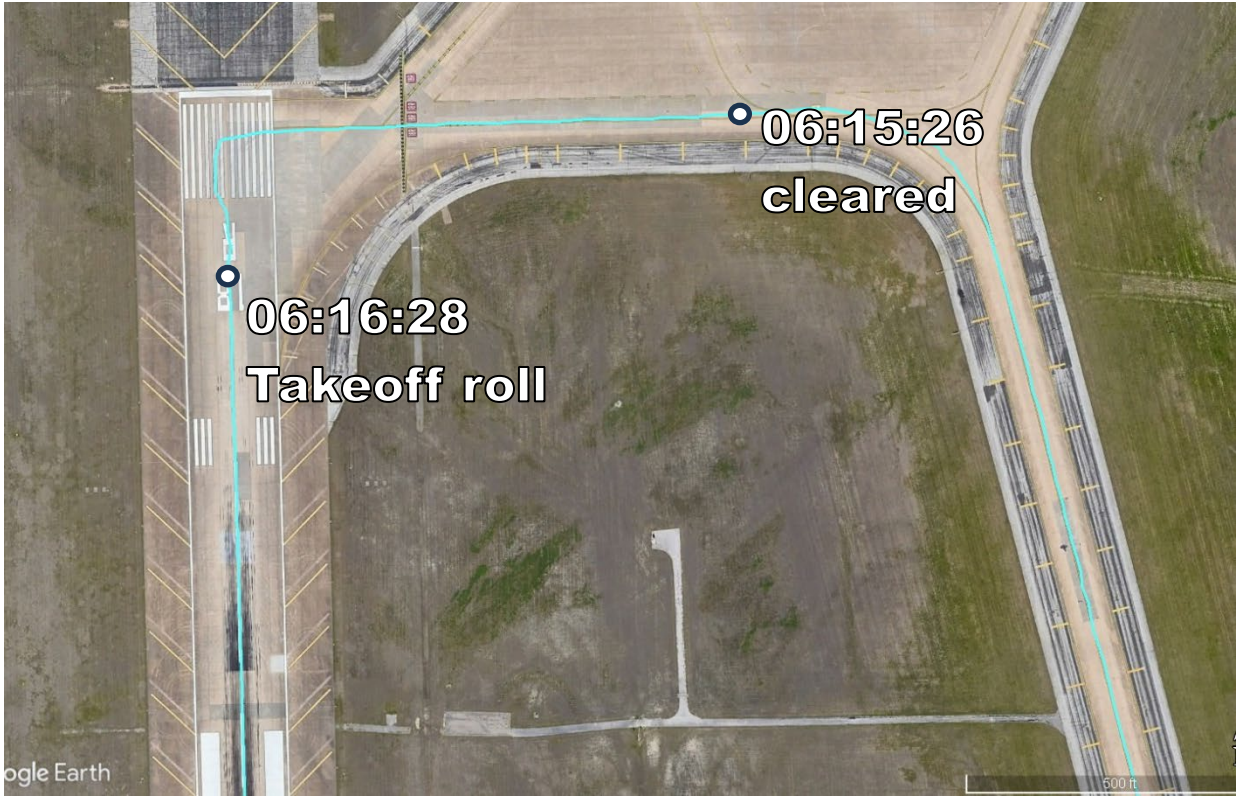
**Figure 10.** DAL422's departure. Time was 1:02 from clearance to take-off roll.

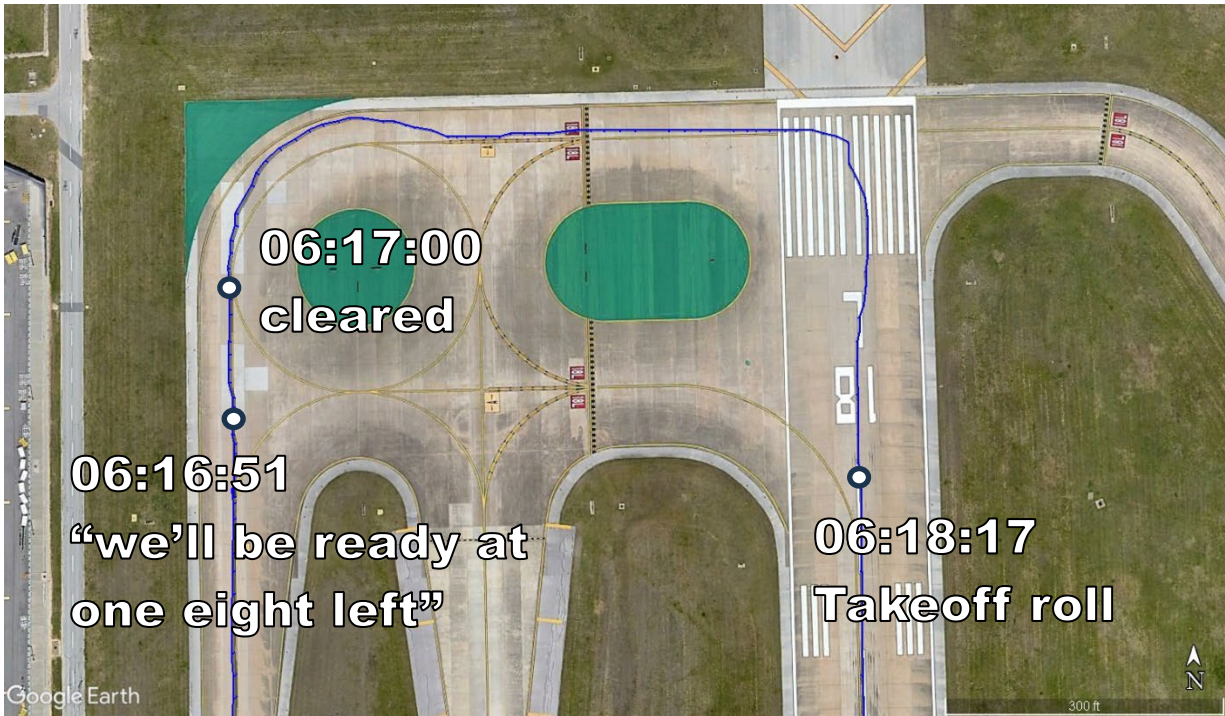
**Figure 11.** AAL2549's departure. Time was 1:17 from clearance to take-off roll.

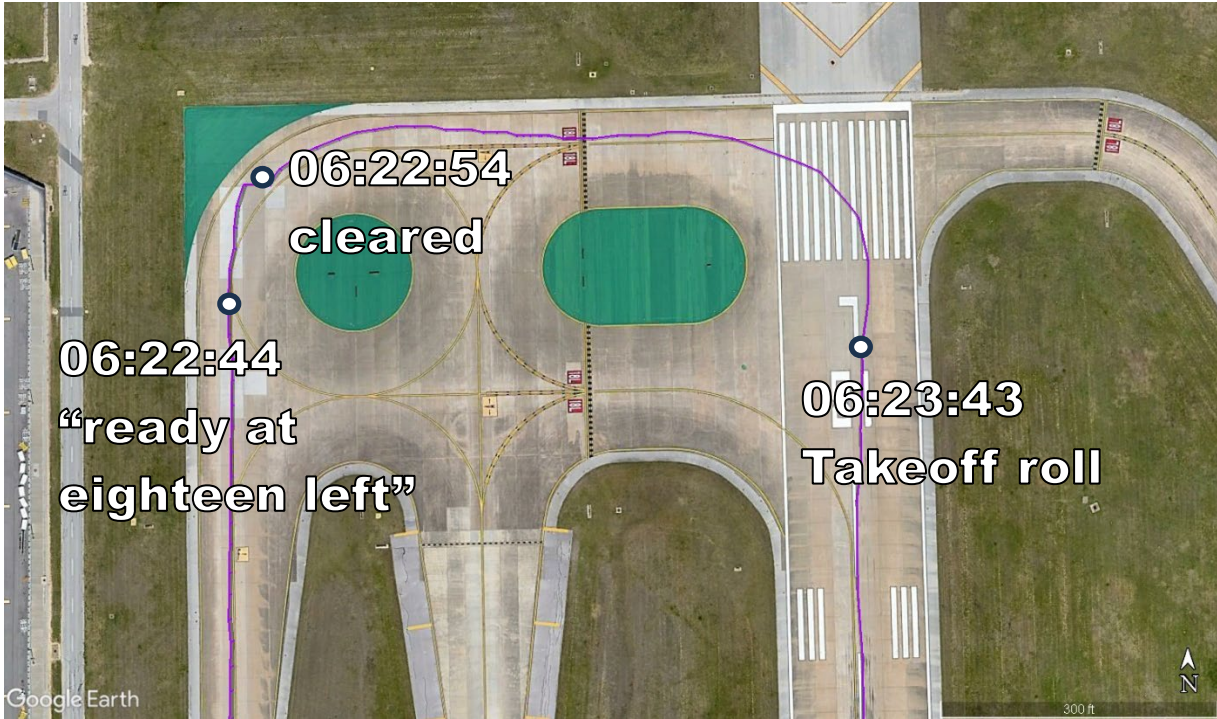
**Figure 12.** SWA1542's departure. Time was 0:49 from clearance to take-off roll.
