Winslow Griesser

PD San Juan Maritime and Divers Unit
Capt. Jose Delgado #3-592
Diver Rafael Quijano #878
Diver Catalino Ortiz #699
Diver Jonathan Morales #2023
Safety Wilfredo Quiñones #880
Boat Raptor (R-06)

Date: 08/10/2022
Time In: 4:16 pm approx.
Time out: 5:00 pm approx

Prepared by: SA [REDACTED]
CGIS RAO SAN JUAN [REDACTED]

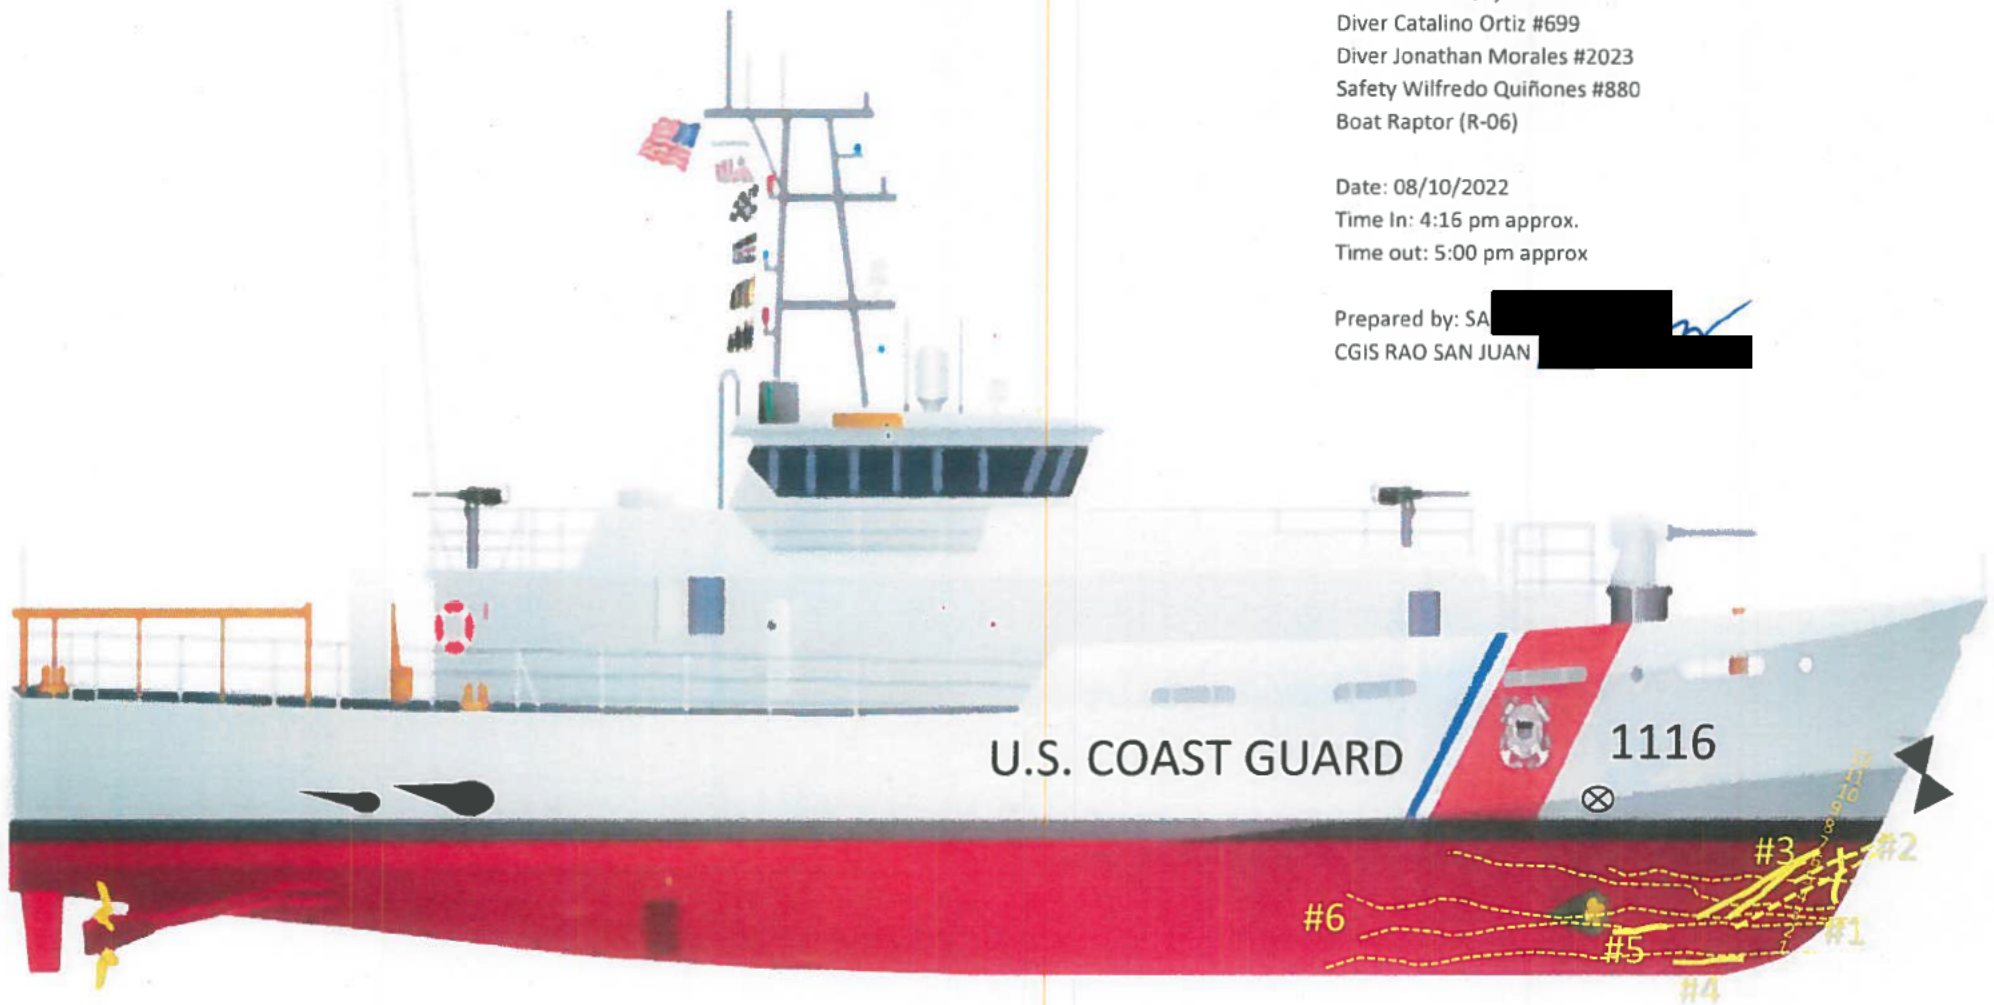
Starboard Side

- #1 Mark with a measurement of approx... 1'
- #2 (2) different marks with a measurement of approx... 2'
- #3 (2) different marks with a measurement of approx... 3' and the other 2'
- #4 Mark with a measurement of approx... 9"
- #5 Mark near thruster side with a measurement of approx... 1'
- #6 Multiple marks that start at the front of the Starboard side

No other damage on Hull Starboard side, stern or propellers where found on CGC WINSLOW GRIESSER during Divers inspection on 08/10/2022.

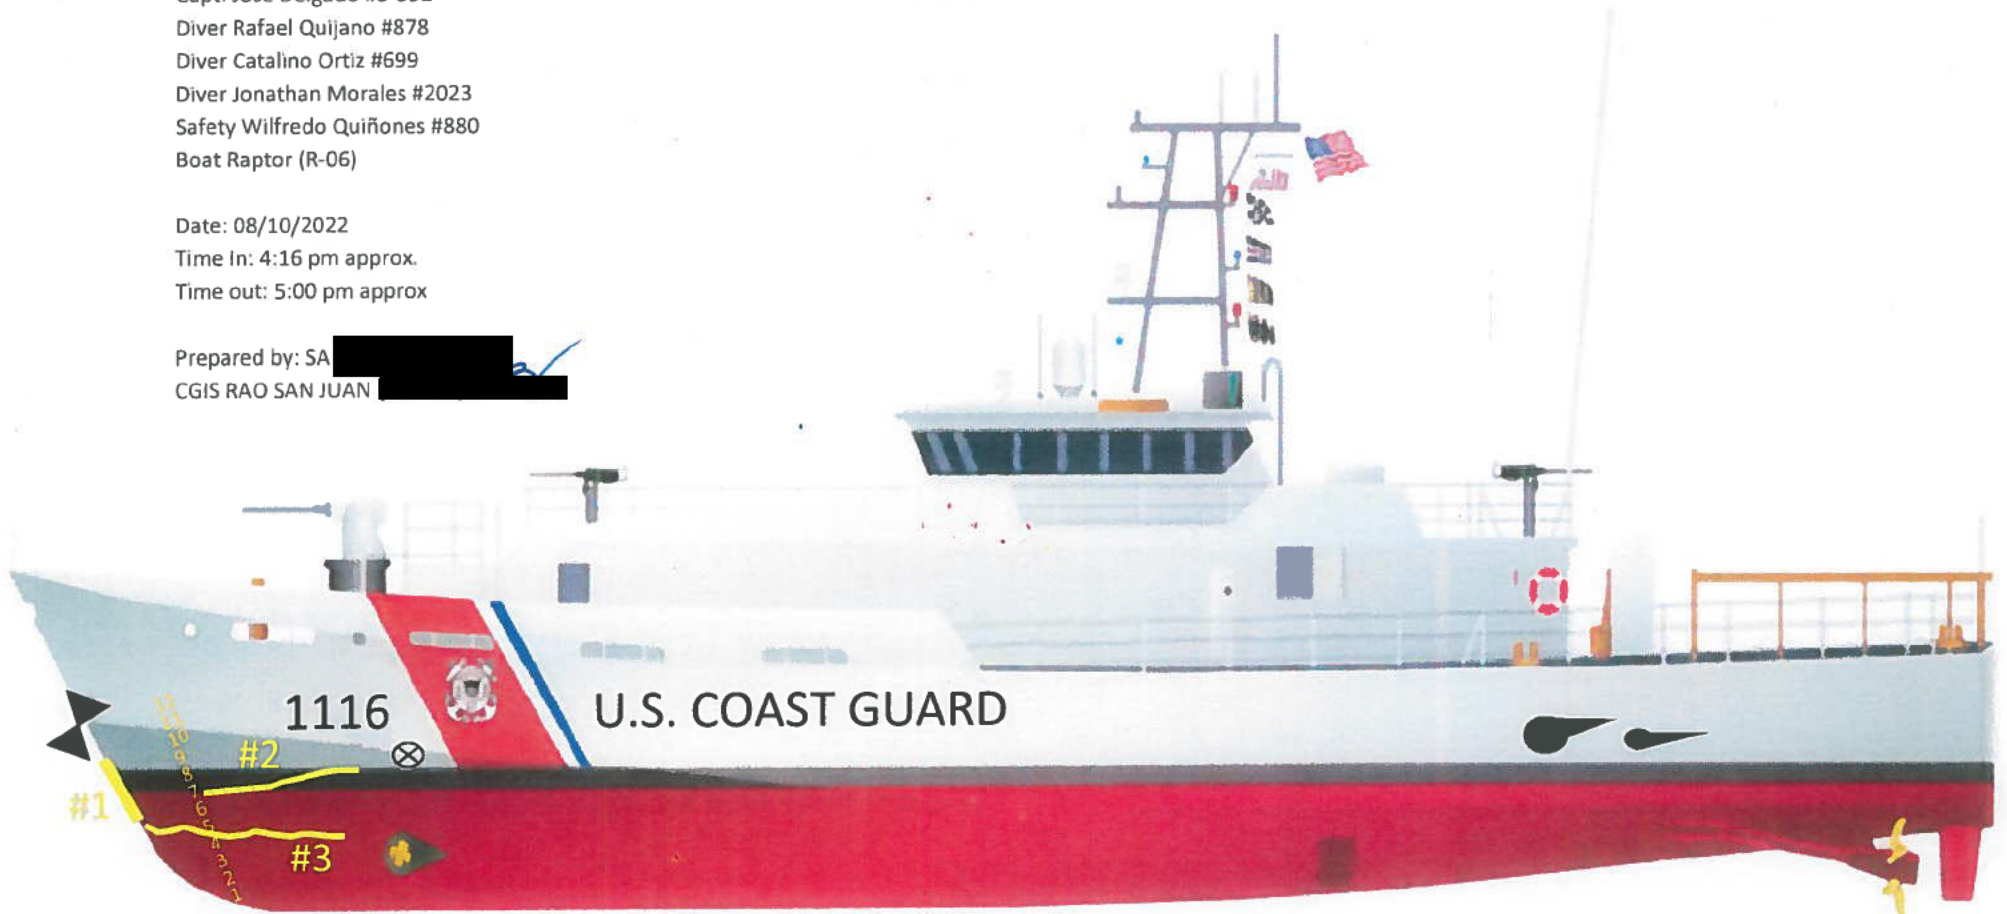
Port Side

- #1 Front
- #2 Mark starts at 8ft level with a measurement of approx... 3' 4"
- #3 Mark starts at 5ft level across 4ft level with a measurement of approx... 5' 5"

No other damage on Hull Port side, stern or propellers where found on CGC WINSLOW GRIESSER during Divers inspection on 08/10/2022.
