----- SYSTEMS GROUP CHAIRMAN'S FACTUAL REPORT -----

Location: Rome, Georgia
Date: March 14, 2016
Time: About 1508 local (EDT)
Aircraft: Raytheon Aircraft Company 400A
Registration: N465FL

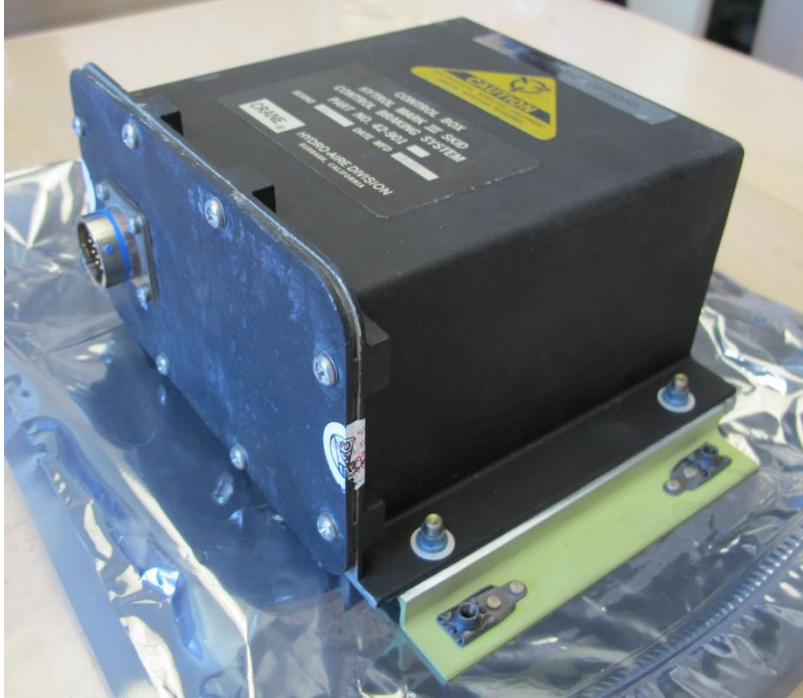
The unit was removed from its shipping container and visually inspected. The unit appeared to have no visible signs of damage, see Figure 2.

Figure 2 - Anti-skid control box from N465FL after unpacking at Crane Aerospace and Electronics

The unit was placed on a test bench and tested according to functional test procedure TP-42-901, Rev A, 1, released 08/26/2003. The unit passed all tests performed and the data sheets were retained by the NTSB.

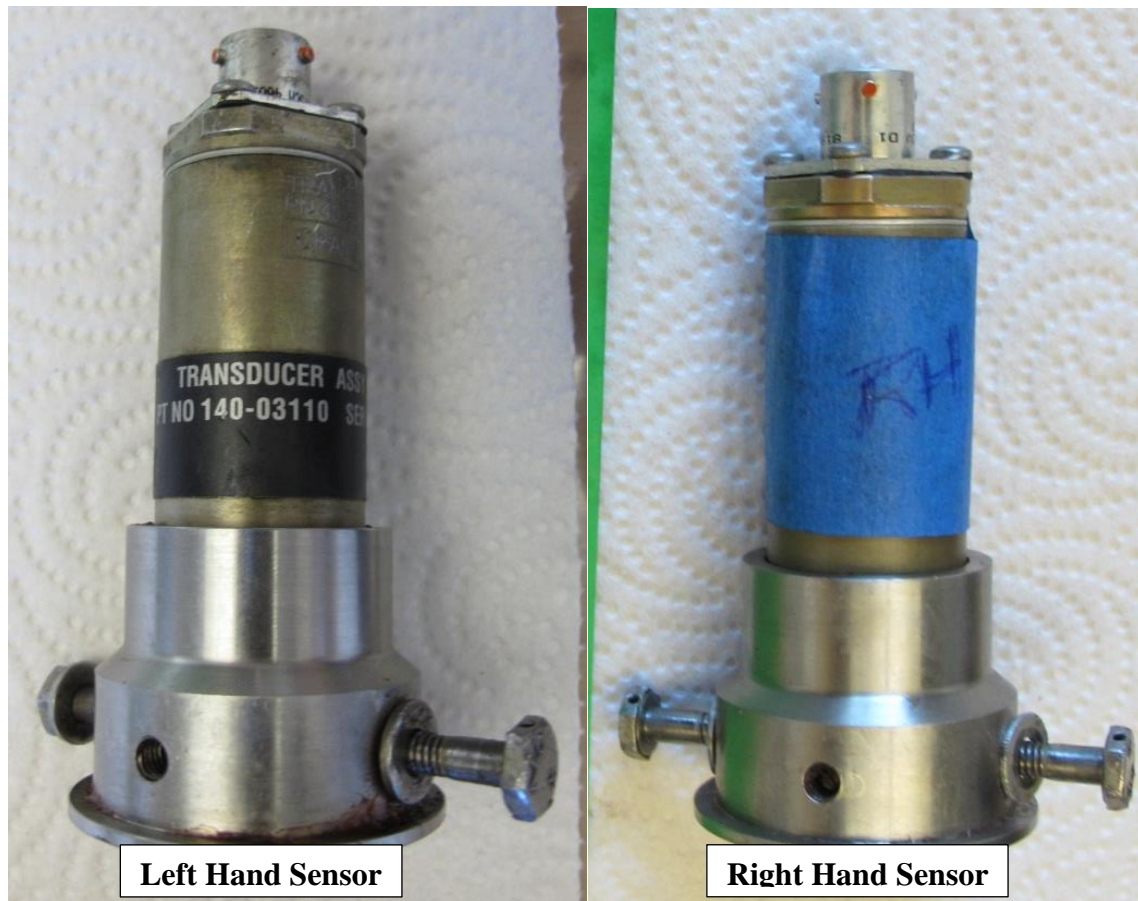
Each unit was removed from its shipping container and visually inspected. Each unit appeared to have no damage, see Figure 5.

Figure 5 - Wheel speed transducers from N465FL

The RH wheel speed transducer passed the functional test except for the voltage variation at 100 Hz. During the low speed (100 Hz) test, the frequency trace of the transducer output was inconsistent and variable. The transducer was then tested at 1200 Hz (highest speed) and the waveform stabilized. The waveform remained stable throughout the

remaining test points (200 Hz – 1200 Hz), except for the 100 Hz test point. The 100 Hz test is below the speed in which the antiskid system is operational in the aircraft.

During manual rotation of the RH transducer, a small area of non-smooth rotation could be felt when compared to the LH transducer. The transducer was disassembled and the seal at the rotor was found lifted slightly. The technician noted that new production transducers have an updated seal design. It was also noted that the bearing on the rotor shaft, when rotated by hand, exhibited a slight binding feel during rotation. No additional tests were performed on the disassembled transducer components.
