NATIONAL TRANSPORTATION SAFETY BOARD

Group Chairman's Factual Report

AIR TRAFFIC CONTROL

ERA19FA188

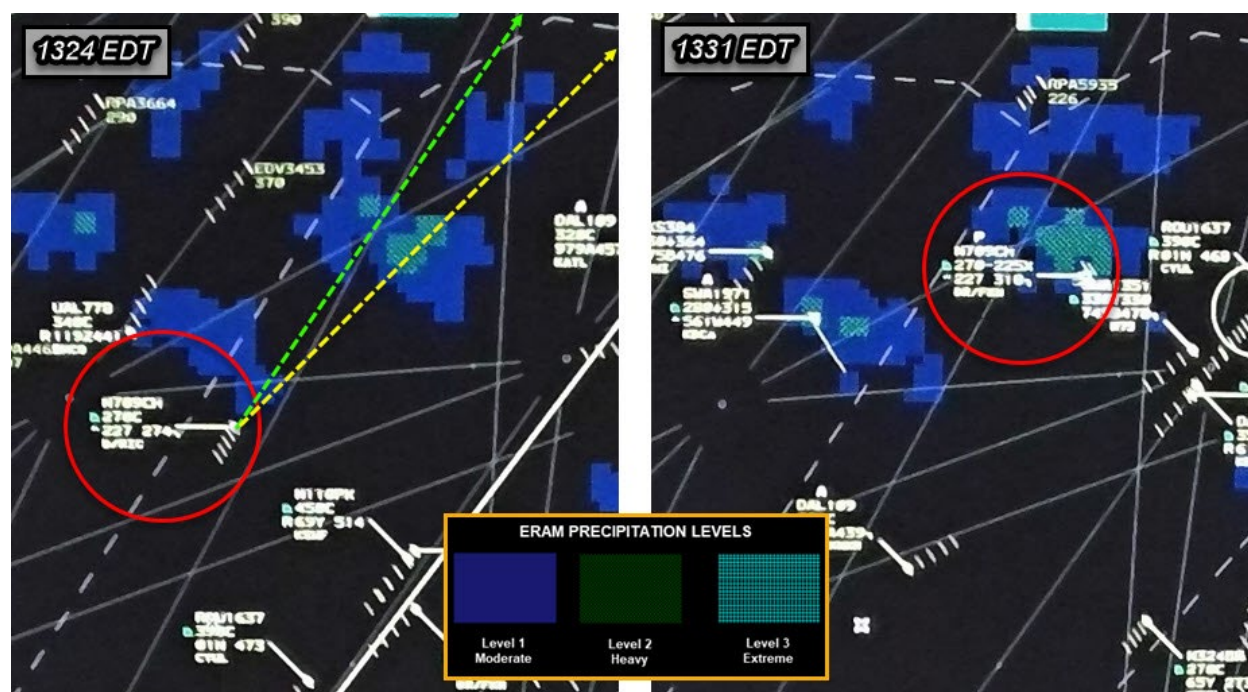
Figure 4. A comparison of ERAM screen captures taken at 1324 (left) and 1331 (right).

An ERAM playback of the services provided to N709CH by ZDC ARTCC was preserved. Screen captures were taken from this playback at one-minute intervals from 1315 through 1334 and illustrate the precipitation that was being displayed to the controller while providing services to the accident aircraft¹⁴. Figure 4 below shows the side-by-side screen captures taken at 1324 and 1331.

The image on the left shows N709CH (circled in red) at 1324 when the pilot accepted the ATC offered routing of direct FNK. The dashed green line was the flight track being flown (direct RIC), and the dashed yellow line was the flight track accepted (direct FNK).

The image on the right shows N709CH at 1331, just after loss of radio communications and in an area of level 2 to 3 (heavy to extreme) precipitation.
