National Transportation Safety Board

Performance Study

Specialist Report

Location: Big Grand Cay, Bahamas
Date: July 4, 2019
Time: 01:53 eastern daylight time (EDT)
Aircraft: Agusta AW139, N32CC
NTSB Number: ERA19FA210

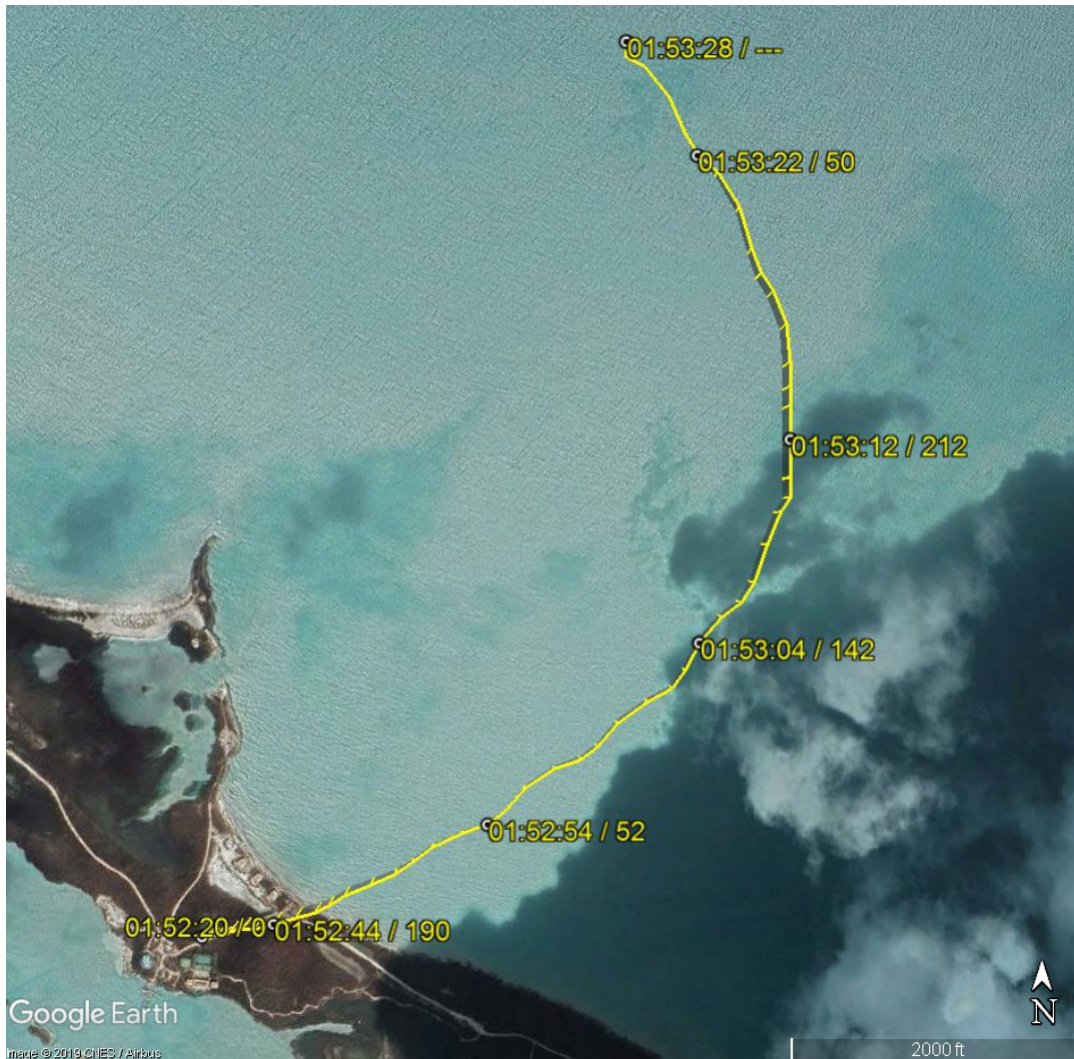
Figure 1 shows the flight, departing the helipad at 01:52:20 to the end of data at 01:53:28. Figure 2 shows the recorded longitudinal (N_x), vertical (N_z), and lateral (N_y) acceleration and the aircraft radio altitude above ground level (AGL). The altitude began to increase with takeoff at 01:52:20, and water impact was determined from the abrupt changes in acceleration parameters to be at or just after 01:53:22. The length of the flight was 62 seconds, and it covered approximately 1.4 NM.

Figure 1. Accident flight, with select times and radio altitudes annotated.

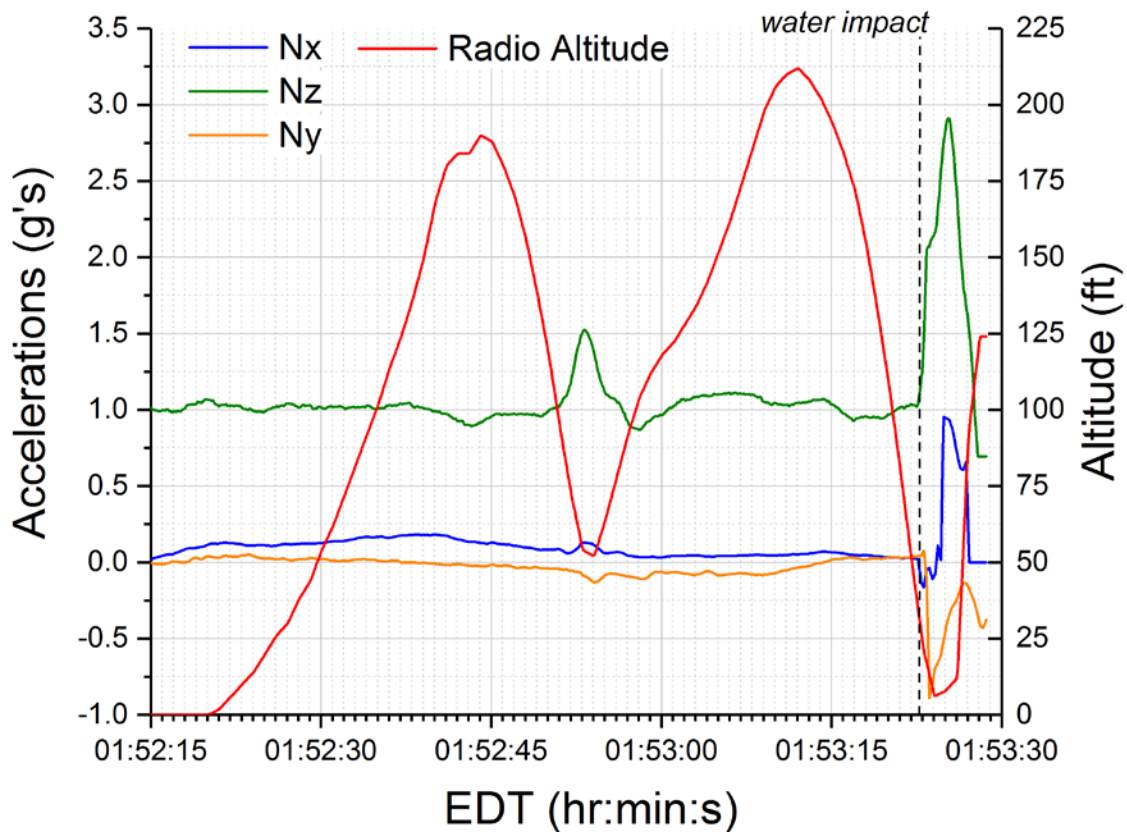
Figure 2. Accelerations and radio altitude from accident flight.

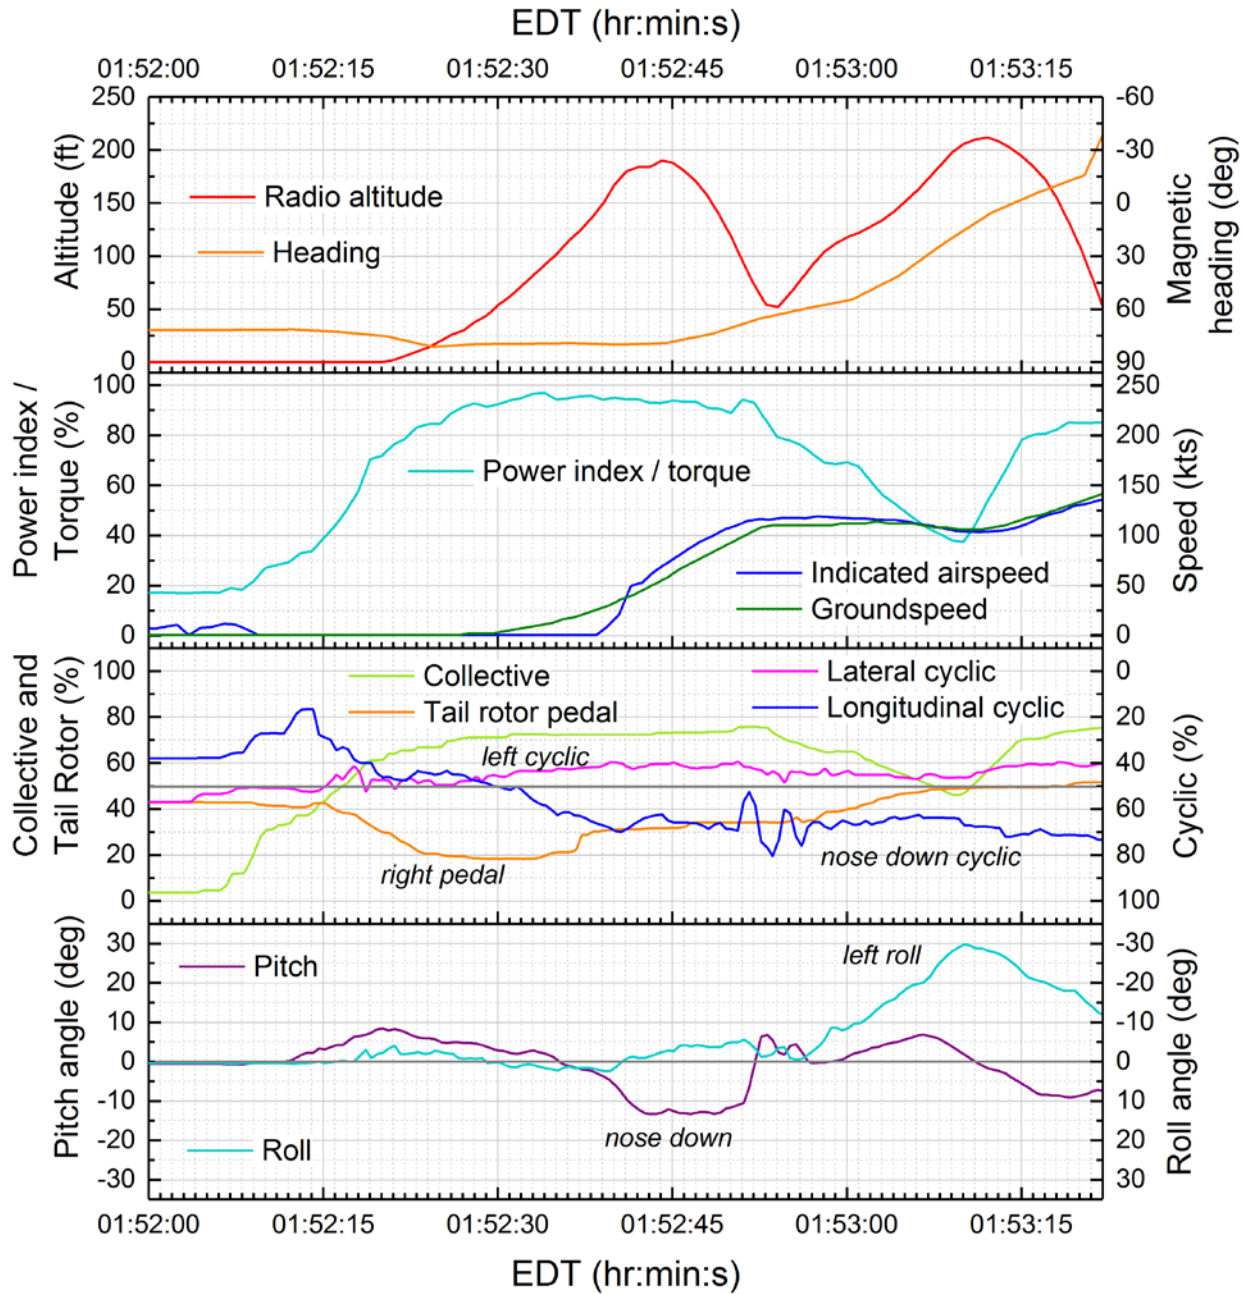
At 01:52:07, collective pitch was increased¹ and at 01:52:20 the aircraft began to climb away from the helipad (Figure 3). The longitudinal cyclic was advanced and at 01:52:30, at an altitude of 53 ft, the helicopter began gaining forward speed. Initially nose up, the aircraft was pitched nose down starting at 01:52:35. The helicopter climbed to an initial maximum altitude of 190 ft at a groundspeed of 55 kts, an indicated airspeed of 68 kts, and a collective position of 72%. At 01:52:44 the aircraft, now -13° nose down, began descending. Speed increased (groundspeed to 110 kts, airspeed to 116 kts) while collective remained relatively constant near 72%. During the initial climb and descent, the helicopter was on a heading of approximately 68°.

From 01:52:50 to 01:52:56, the longitudinal cyclic was reduced and advanced twice from a minimum value of 52% to a maximum of 80% (forward cyclic) before settling near 65%. The helicopter pitch went from -10° nose down at 01:52:51 to 6.8° nose up by 01:52:53. At 01:52:54, the aircraft began to climb again and by 01:52:57 the longitudinal cyclic was decreasing from 65% towards 60%. The speed dropped slightly to near 100 kts.

At 01:53:09, as the helicopter climbed, the longitudinal cyclic began to again advance forward as collective reached its minimum of 46%. Just after 01:53:11, the helicopter pitched nose down and collective began to increase at a rate of about 5% per second. The helicopter reached a maximum altitude of 212 ft at 01:53:12 while banking left 30°. At 01:53:15, when at 70%, the rate of collective increase slowed and collective remained below 76% for the duration of the flight.

The aircraft was losing altitude, gaining speed, and in a nose down attitude. At water impact (01:53:22), the helicopter was on a heading of about 330°, was -7° nose down, in a 12° left bank, and its groundspeed was 141 kts. The change in vertical acceleration at impact was about 2 g's in two seconds.

Figure 3. Flight profile, power, collective, tail rotor pedal, and cyclic inputs, and aircraft pitch and roll.

As seen in Figure 9, while the target vertical speed was 100 ft/min, as the helicopter transitioned from descending to ascending the helicopter’s actual vertical speed increased momentarily to nearly 1000 ft/min at 1:52:53. The PIC commented about an instrument display value of “300” shortly after the helicopter’s vertical speed passed 300 ft/min. With a target VS of 100 ft/min being commanded by the flight director, the autopilot began to lower the collective in response (Figure 3 and Figure 8) from 75% at 1:52:53 (altitude 53 ft) to 46% at 1:53:09 (altitude 200 ft). Airspeed

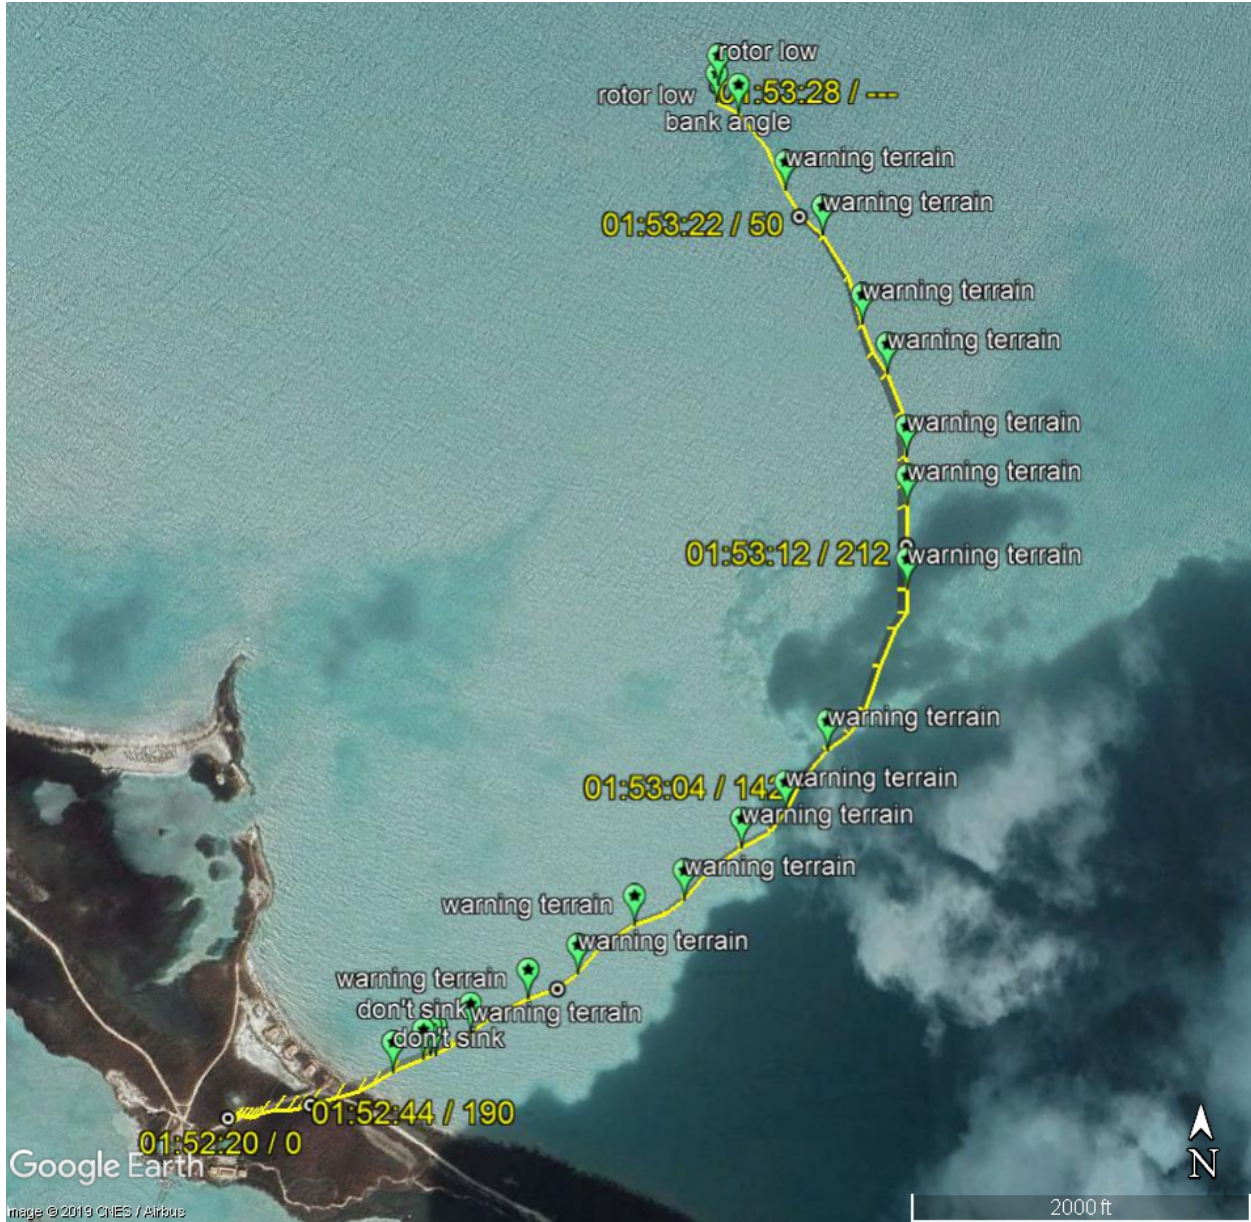
The CVR recorded the crew conversation and cockpit annunciations heard during the flight. Figure 4 shows just the cockpit annunciations on the flight path. Figure 5 shows some of the crew conversation and all the annunciations during the flight with altitude and groundspeed for

Figure 4. Annunciations on accident flightpath.

The first warning was at 01:52:48 when the enhanced ground proximity warning system (EGPWS) twice annunciated “don’t sink” as the helicopter’s descent rate passed 1000 ft/min. These were followed by “caution terrain” and “one fifty feet” at 01:52:49.4 and 49.5. During these initial annunciations ALTA (altitude acquire mode) was selected in the autopilot and the collective FTR (force trim release) was depressed, which will be discussed in greater detail in the *Auto pilot modes and power limitations* section. The EGPWS announced “warning terrain” eight times until the aircraft climbed above 150 ft again (01:53:04).

Just as the helicopter’s ascent slowed and it reached its maximum altitude, “warning terrain” annunciations resumed from 01:53:11.7 to after the impact with the water. The PIC asked for the helicopter heading three times during the second descent with no response. The final annunciations of “bank angle” and “rotor low, rotor low” occurred after the aircraft entered the water.

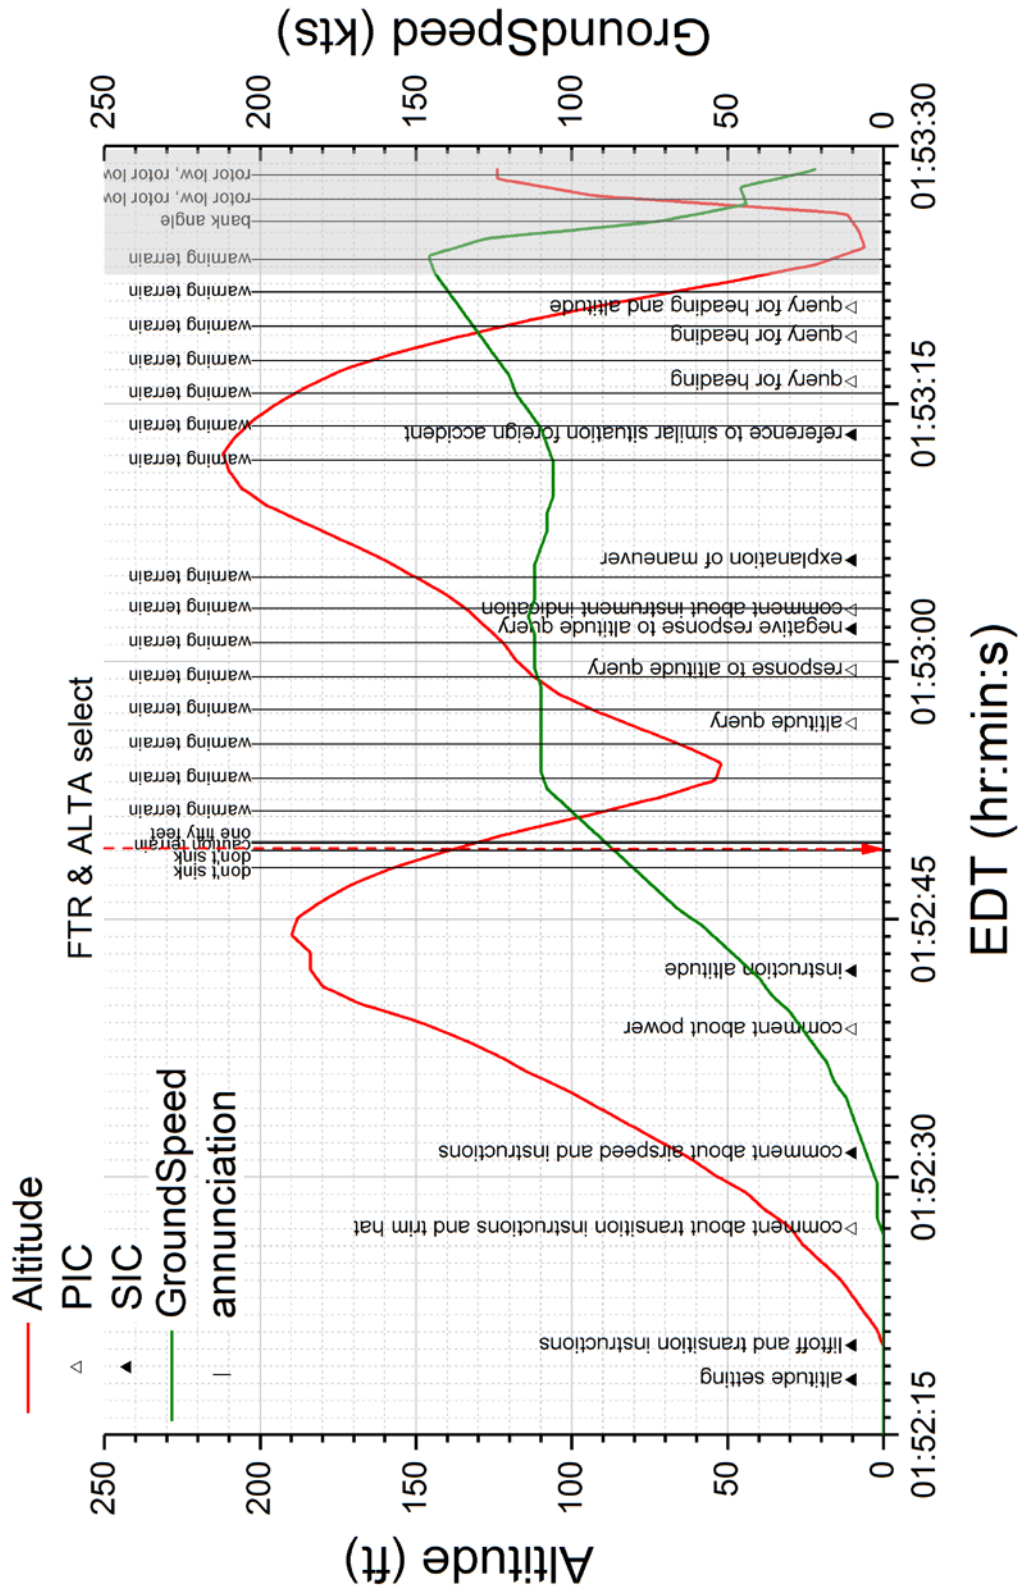
reference. The greyed-out area at the end was after the sudden increase in accelerations that indicated water impact. The pilot-in-command is noted as PIC and the co-pilot or second-in-command is noted as SIC. Commentary indicated that the PIC was flying the aircraft.

Figure 5. Annunciations and crew conversation with altitude and groundspeed.

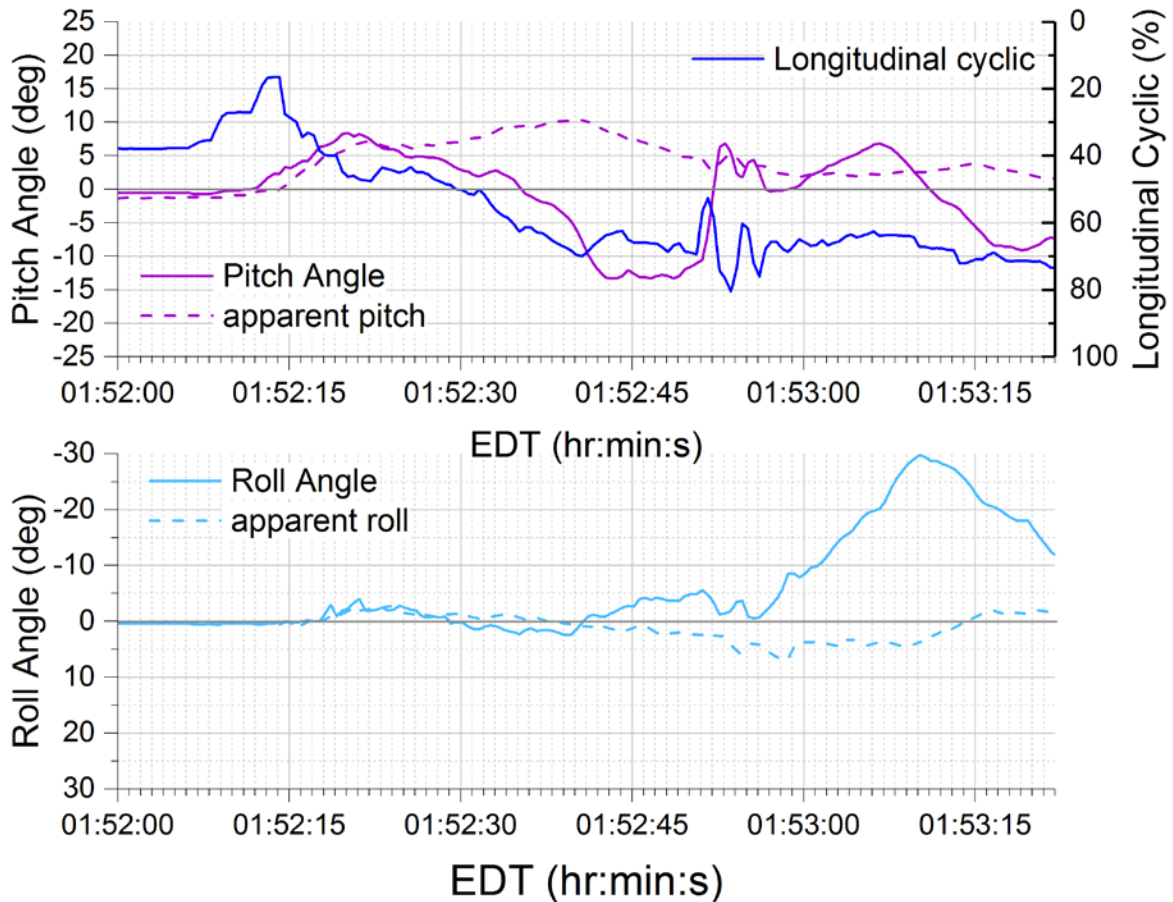
Figure 7 shows the actual pitch angle and calculated apparent pitch angle along with the longitudinal cyclic inputs. The helicopter began the initial climb nose up, but as the longitudinal cyclic was pushed forward, the nose lowered and the cyclic was commanding nose down by 1:52:32. However, due to the helicopter's increasing forward speed, the pitch angle had the potential to be misinterpreted to the point that the pilot could have perceived a nose up attitude for the entirety of the flight, even while nose down and descending rapidly. Despite the descents and nose down attitudes greater than -10° while approaching terrain, the longitudinal cyclic stayed forward throughout the flight and was only briefly less than 60% throughout the EGPWS warnings and descents.

Figure 7. Actual and apparent pitch angles with longitudinal cyclic inputs and actual and apparent roll angles.

Additionally, the apparent roll angle could have been interpreted as a slight right roll rather than a roll to the left. However, as later discussed in *Previous island take-offs* the helicopter's turn after take-off was consistent with prior flights and likely deliberate.

The longitudinal cyclic inputs were initially about average compared to earlier flights. The cyclic FTR was engaged for the entirety of the accident flight. While longitudinal input was not initially different from the prior ten flights, the combination of high collective input and increasingly forward longitudinal cyclic inputs lead to significant nose down attitudes during the flight that led to losses of altitude. A calculation of apparent pitch showed that it was possible for the pilots to have misinterpreted the helicopter's nose down attitude to be nose up for the entirety of the flight.

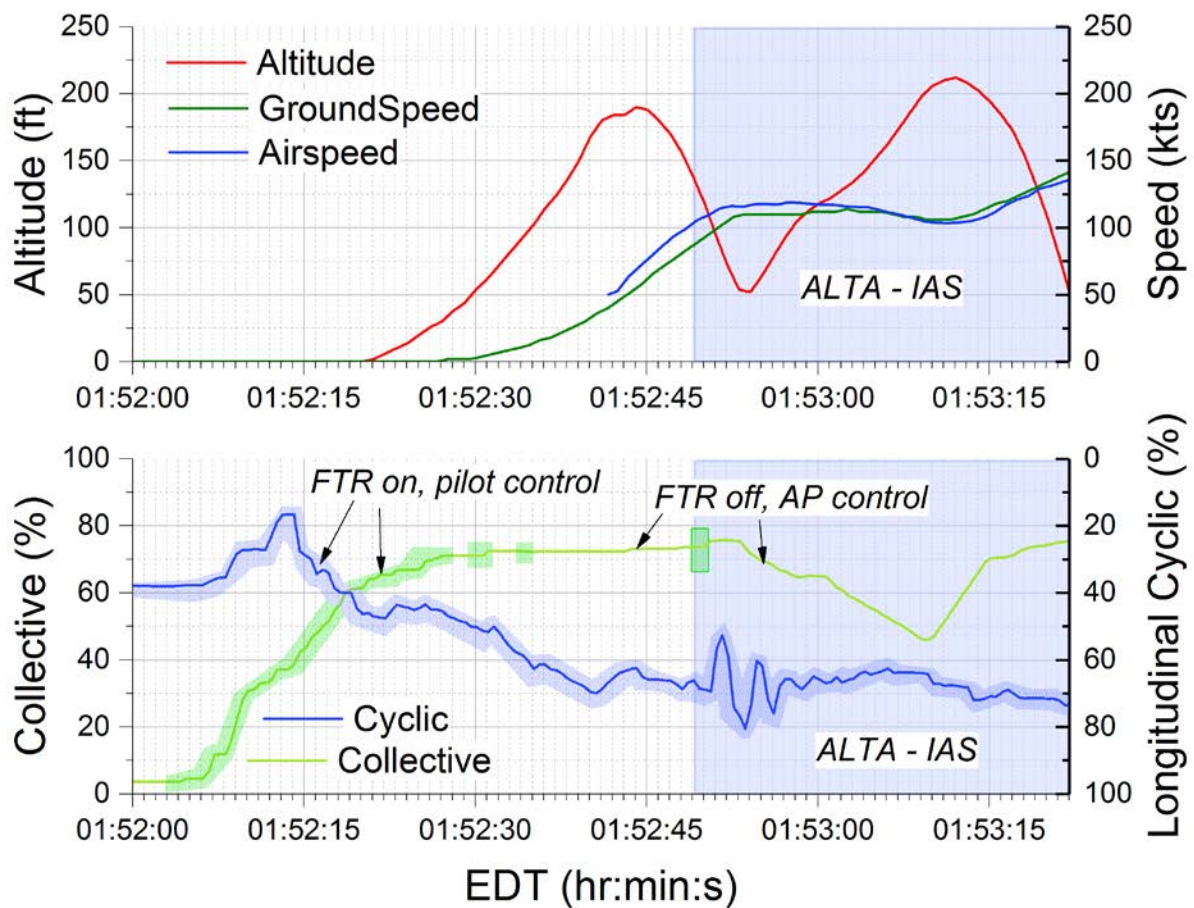
Figure 8 shows the flight profile, collective and longitudinal cyclic inputs, and FTR switch engagement and flight director mode selection. The FTR switch was engaged for pitch and roll for the entirety of the flight. Therefore, all cyclic inputs for the accident flight were controlled by the pilot flying. The collective FTR was engaged from about 01:52:03 until 01:52:28 as the collective was raised from 4% to 71%, at which point the aircraft was about 40 ft off the ground and moving forward with 2 kts of groundspeed. It was engaged twice more during the first ascent and the collective was adjusted to about 72%.

Figure 8. Altitude, speed, and controls with selected modes and FTR selection. When the collective and cyclic data is highlighted, the FTR has been engaged and the pilot is flying hands-on.

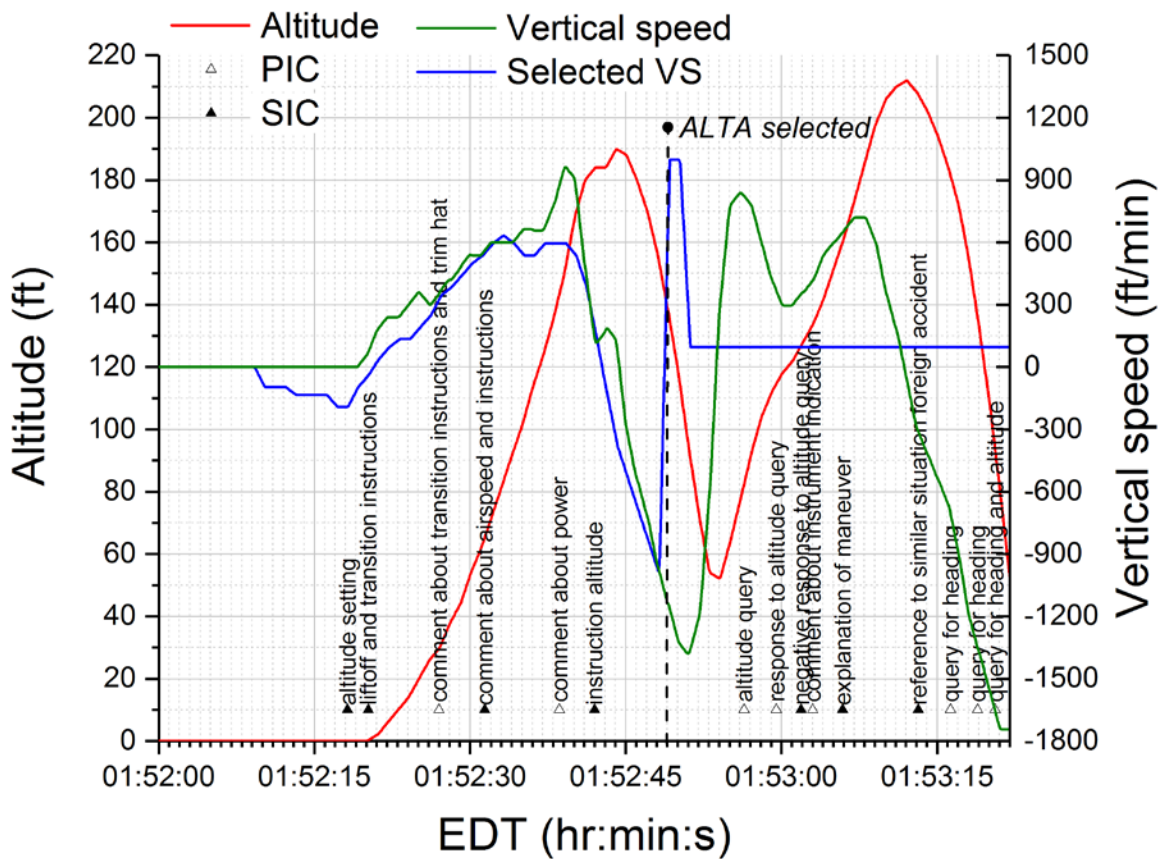
Before 1:52:49, the flight director was in standby mode. At 1:52:49, as the helicopter was descending, the ALTA (altitude acquire) mode became active for the collective and the IAS (indicated airspeed) mode became active for pitch, and the collective FTR was briefly engaged. When ALTA is selected IAS mode automatically engages. IAS mode is meant to generate pitch commands to maintain the airspeed existing at the time of engagement. However, since the pitch and roll FTR were engaged for the entirety of the flight, IAS did not control the airspeed and attitude, the pilot did. For the ALTA setting, the selected altitude was 1,000 ft and the usual rate of climb for this mode is 1000 ft/min. However, since ALTA mode was engaged when the collective FTR was briefly pressed during the descent it changed the mode settings. Specifically, since the helicopter was descending when the FTR was pressed, the ALTA rate of climb logic changed from 1000 ft/min to 100 ft/min (Figure 9).

Figure 9. Altitude, vertical speed, and selected vertical speed (target).

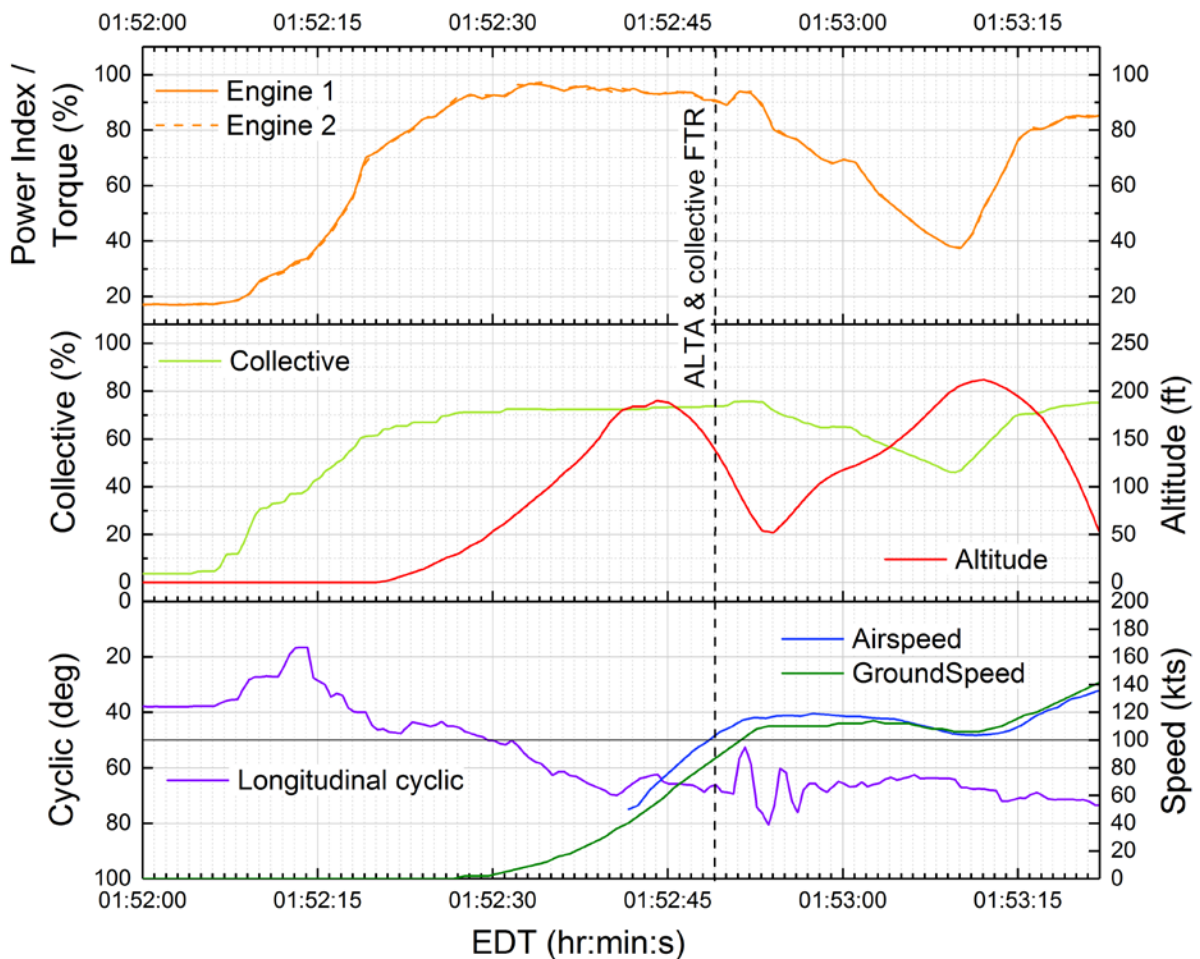
The autopilot responded to the loss of altitude by increasing collective at a rate of 5%/second until 1:53:15 when the collective was at 70%. At this point, the helicopter was 194 ft above ground level and descending at a rate of 700 ft/min. However, the power index (PI) shown in Figure 10 had reached 80% (here, PI was directly proportional to engine torque). Since the pilot was controlling the cyclic, which was at 70% nose down, the autopilot reduced the rate of collective increase to protect the engines from overtorque. The collective continued to increase, but the aircraft's descent was not arrested. At 1:53:22, when the helicopter impacted the water, the PI was 85%, the collective 75% (and increasing), and the longitudinal cyclic was 73%.

Figure 10. Power index and engine torque.

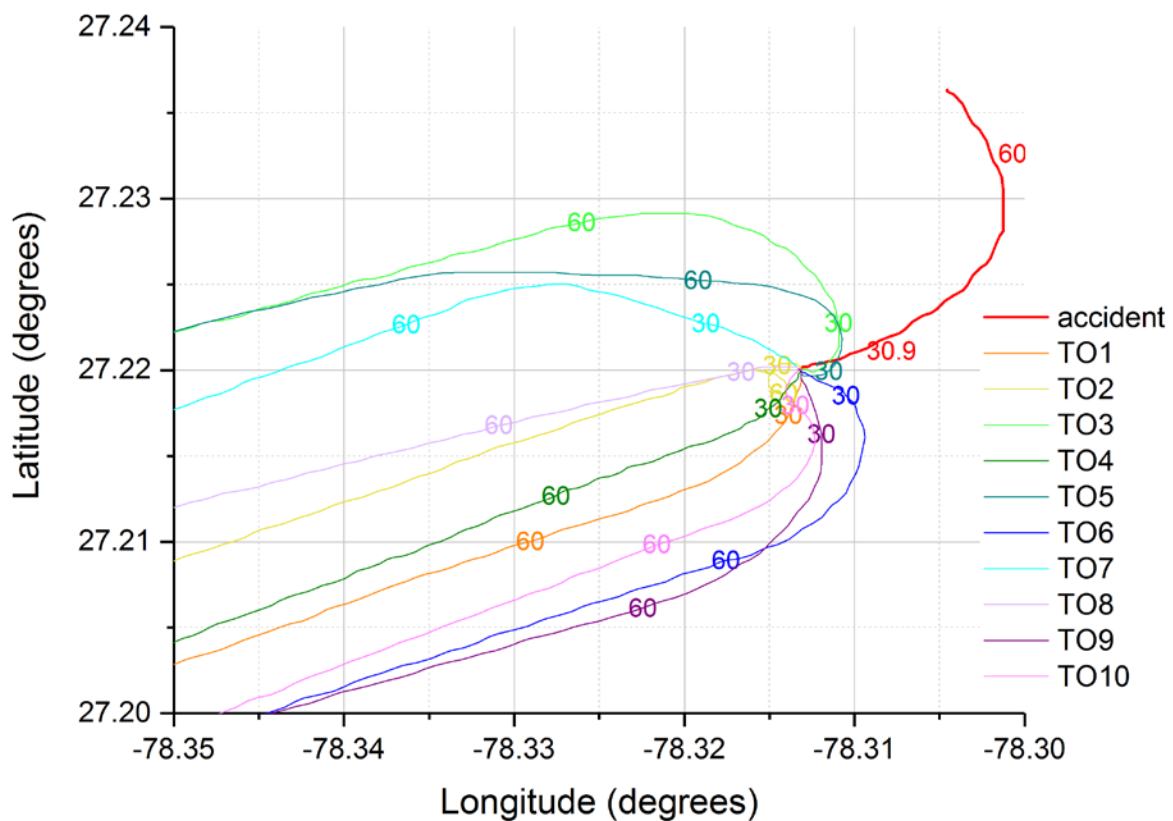
Ten prior take-offs from the island were recorded and are labeled TO1-TO10. Most of the take-offs began on headings between the accident heading of 80° and a heading of 180°, with two (TO7 and 8) on headings of 336° and 304° respectively. Within one minute after take-off, all prior flights had turned onto a south-westerly heading as shown in Figure 11. Five of the prior take-offs turned clock-wise, and five counter-clock-wise. The direction of the turn and crosswind direction² showed no correlation (Table 1). The accident flight stayed on the take-off heading for longer than the prior flights before beginning to turn. All of the prior flights were during the day.

Figure 11. Prior island takeoffs. 30 and 60 seconds after weight-off-wheels annotated on each flightpath.

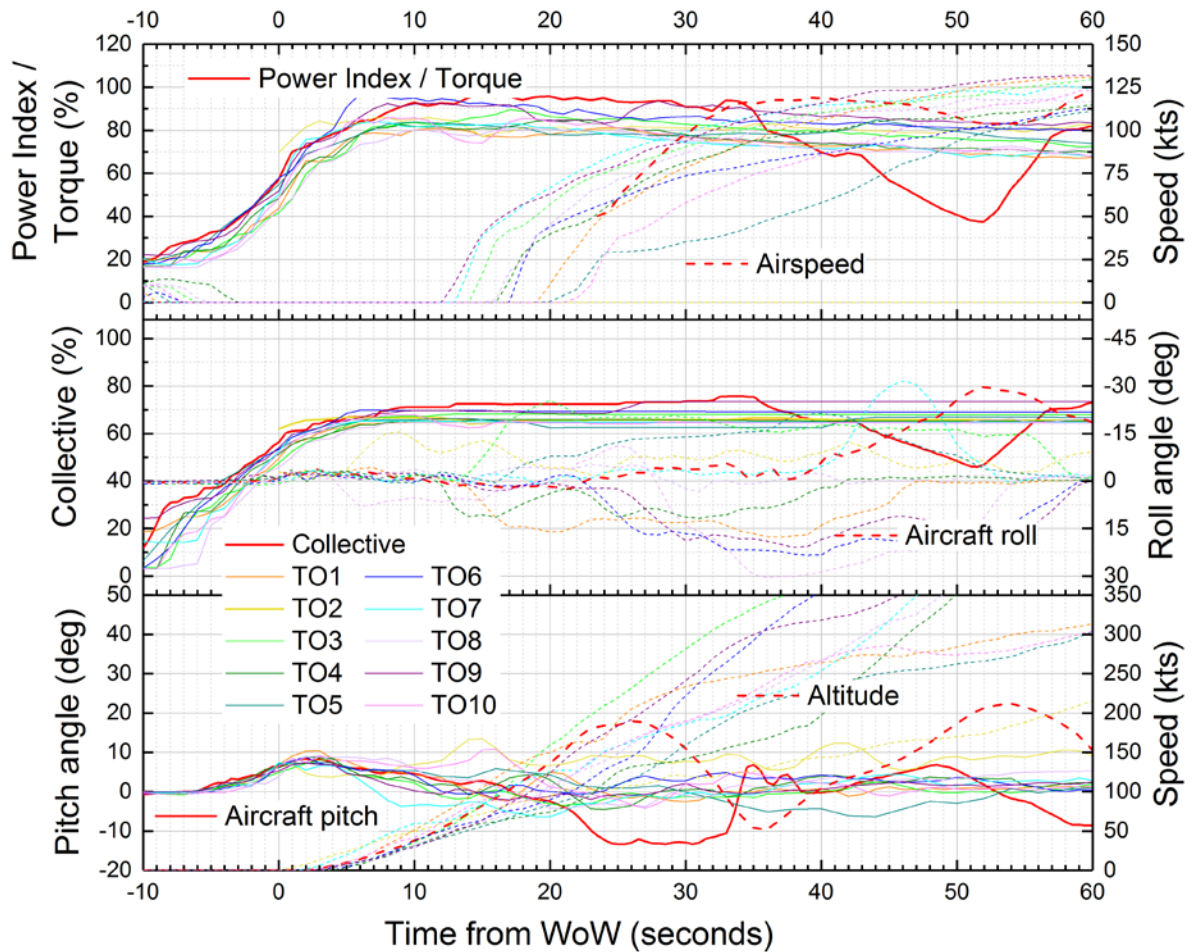
Figure 12 shows the first minute of flight for the ten prior take-offs and the accident flight. The initial altitude and speed gain of the accident flight were not unusual. However, the accident flight had the most collective input and highest power index for much of the first 30 seconds of flight. Additionally, the attitude of the accident helicopter was about 10° more nose down than any of the prior flights during each loss of altitude.

Figure 12. Prior island takeoffs, plus the accident takeoff in red. Power index, collective input, altitude, aircraft pitch and roll, and airspeed are plotted versus a standardized time.

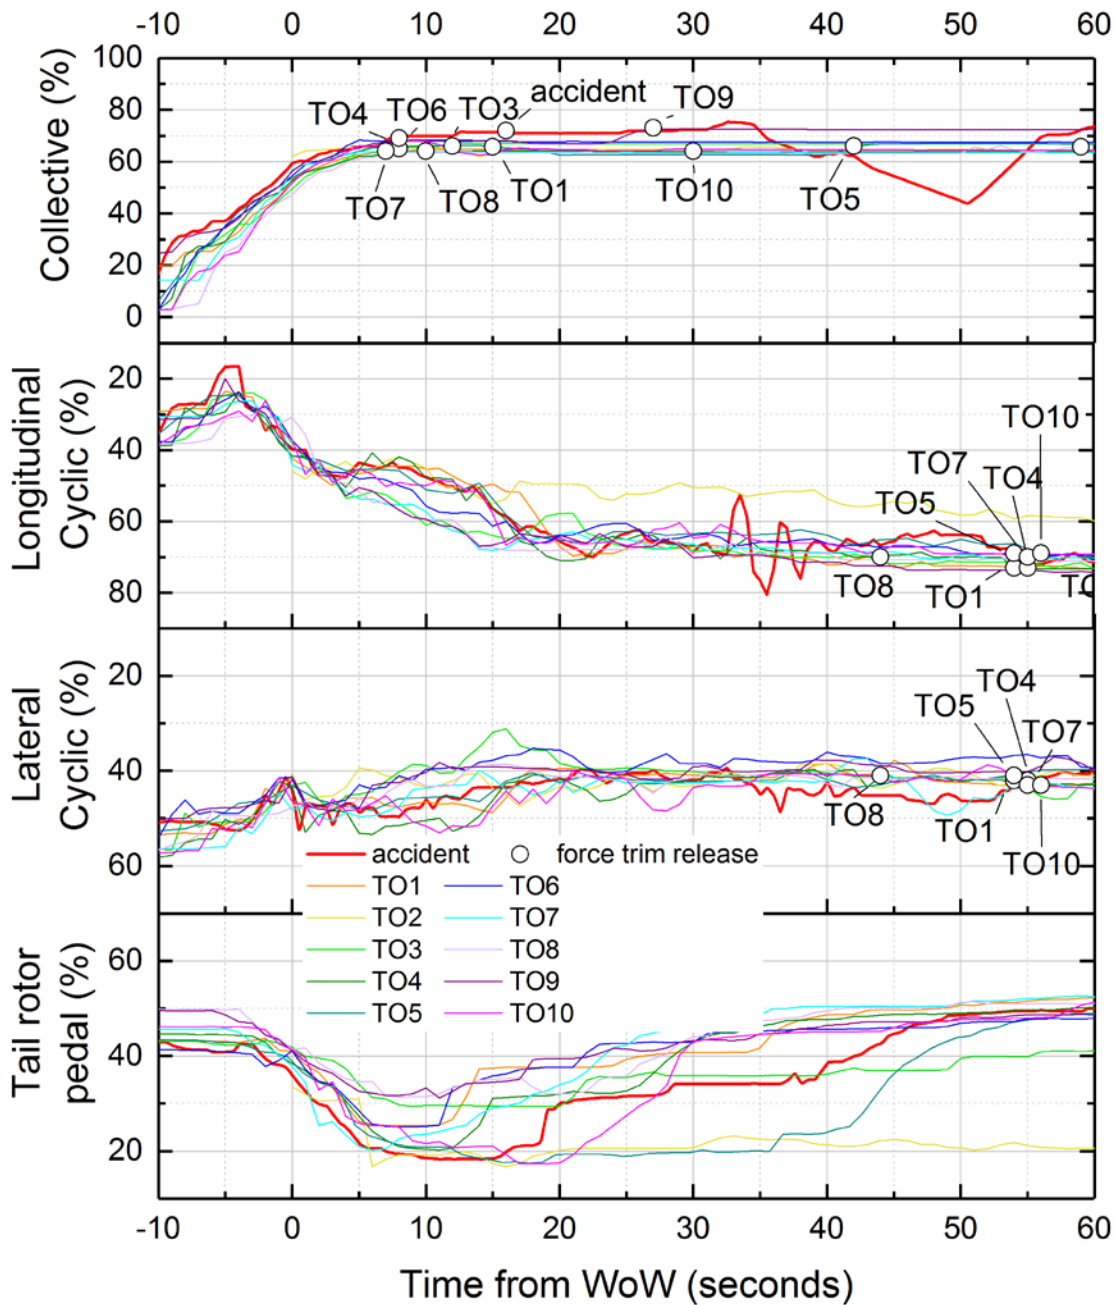
Figure 13 shows the control inputs for the flights. Cyclic input for the accident flight seemed generally similar to the ten prior flights. Right tail rotor pedal was applied for all flights, to counter the yaw imparted by the main rotor, which varied from 45% to less than 20%. All flights held a slight left cyclic (between 55% and 45%). The accident flight showed significant early right pedal input and the collective input, as earlier stated, was more than prior flights. The higher collective input and right tail rotor pedal would have demanded more power and was consistent with the high power index levels seen during the accident flight.

Figure 13. Control inputs of collective, cyclic, and tail rotor pedal for accident and prior island takeoffs. Force trim release disengagement (transferring the control to the autopilot) on collective and cyclic for each flight marked with an open circle.

Also shown in Figure 13 is the force trim release (FTR) disengagement for the flights. The collective FTR was generally disengaged after the collective had been raised to its flight position. Six of the ten prior flights and the accident flight released the collective FTR in the first 20 seconds

of flight. The flight director mode for the collective then transitioned to ALTA for all flights. The cyclic FTR was disengaged later, generally about 55 seconds into flight. The flight director mode for pitch transitioned to IAS, and the flight director mode for roll became heading select, which later transitioned to LNAV. The cyclic FTR was never disengaged on the accident flight.
