NATIONAL TRANSPORTATION SAFETY BOARD

Electronic Devices

Specialist's Factual Report
by Nick Swann

Location: Ocala, FL
Date: October 31, 2019
Aircraft: Beechcraft BE-58
Registration: N959CM
Operator: Private
NTSB Number: ERA20FA022

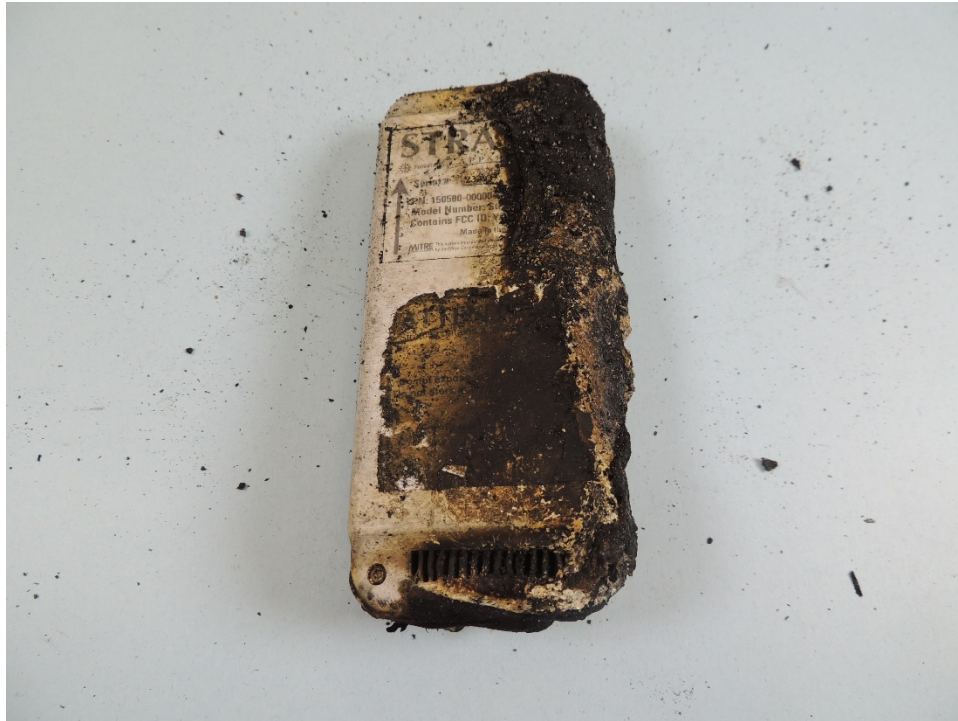
Upon arrival at the Vehicle Recorder Division, an exterior examination revealed the unit had sustained significant fire damage as shown in figure 1.

Figure 1. Exterior Damage to Appareo Stratus 2S.

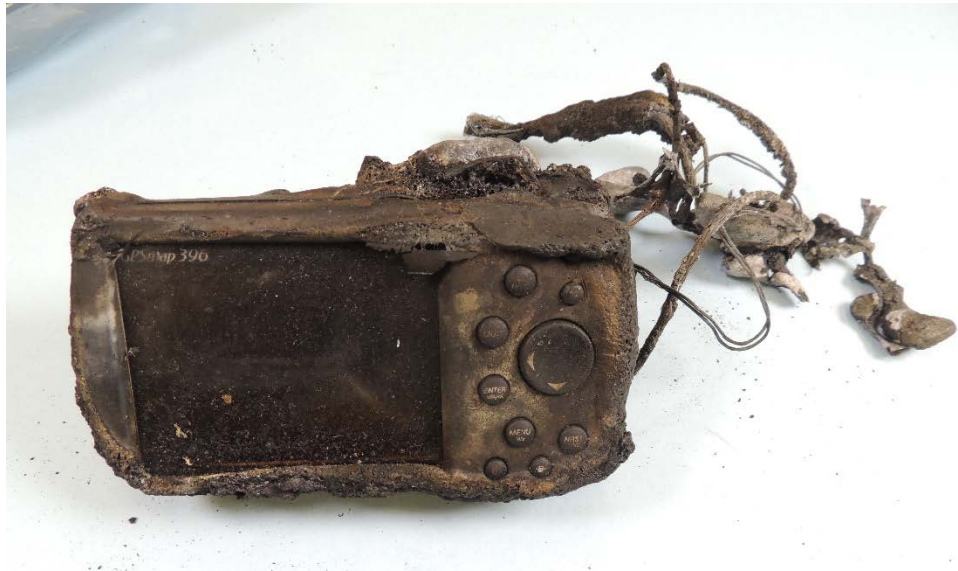
Upon arrival at the Vehicle Recorder Laboratory, an exterior examination revealed the unit had sustained significant fire damage as shown in figure 2.

Figure 2. Exterior Damage to Garmin GPSMAP 396.

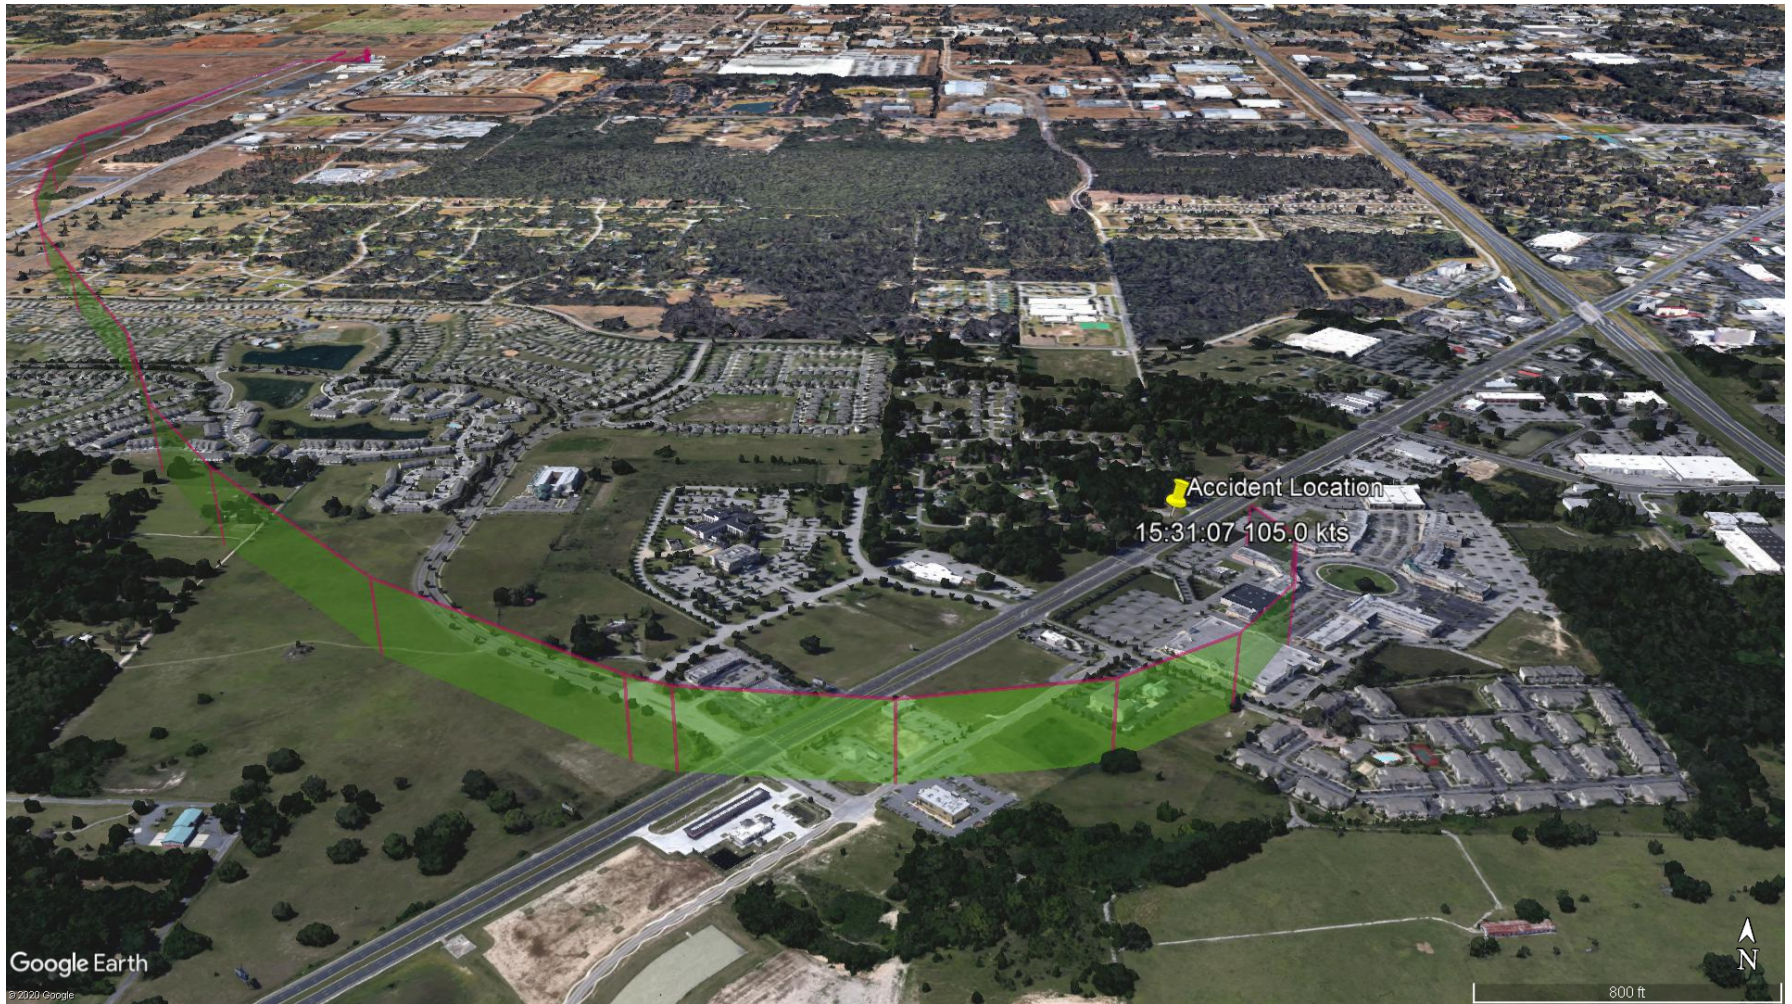
Figure 3 shows a Google Earth overlay of the accident flight. The track shows the airplane departing to the south from OCF and making a left turn eastward. The track then shows an approximately 180 degree turn to the left before the end of the recording. Lighting and weather conditions shown in the Google Earth overlay are not representative conditions at the time of the accident. Validated data parameters used in the following figure are included in attachment 1 on the docket.

Figure 3. Google Earth Overlay of Accident Flight.
