NATIONAL TRANSPORTATION SAFETY BOARD

Factual Report

METEOROLOGY

ERA20FA088

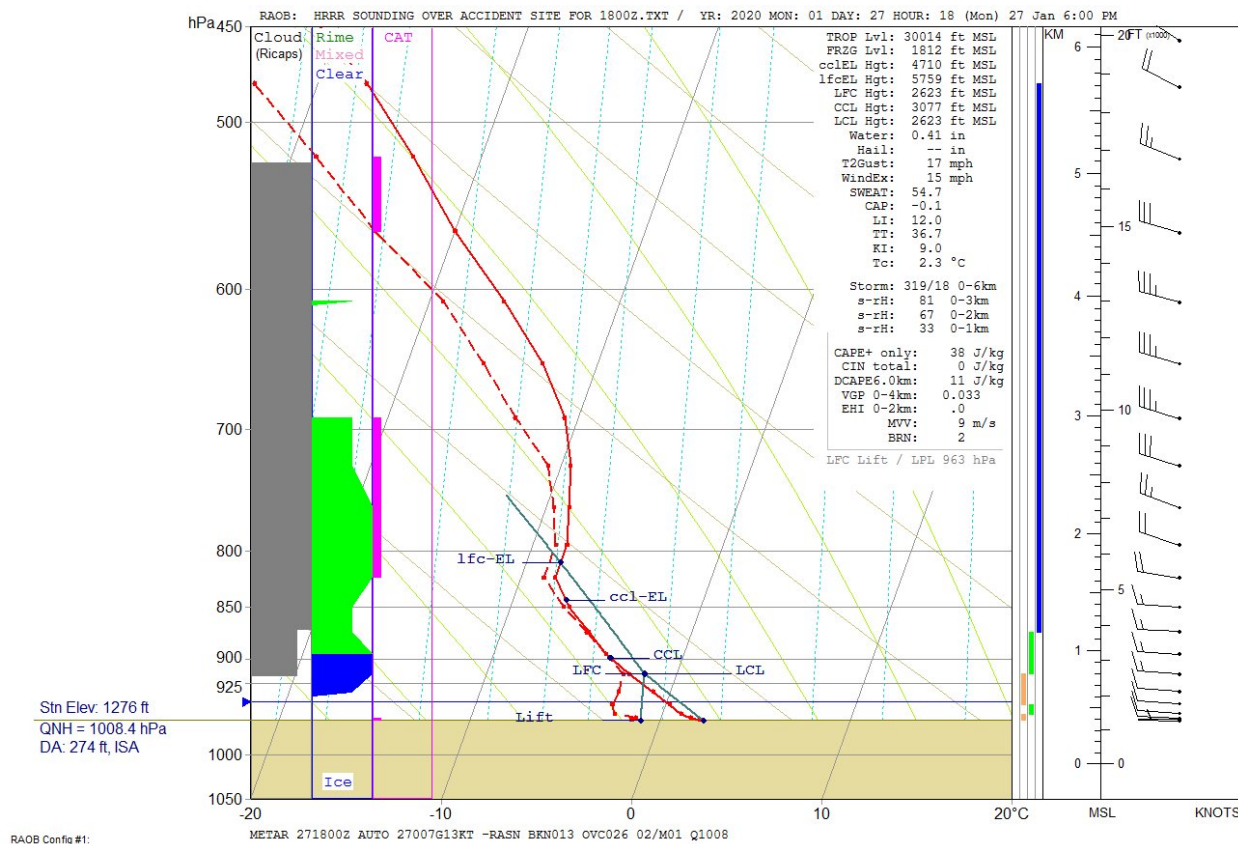
To determine the vertical structure and state of the atmosphere over the accident site a High-Resolution Rapid Refresh (HRRR)⁴ numerical model data was retrieved from the NOAA Air Resources Laboratory and plotted on a standard Skew T log P diagram⁵ using the complete Rawinsonde Observation RAOB program software⁶. Figure 4 is the HRRR 1300 EST numerical

model sounding over the accident site from the surface through 450-hPa or approximately 21,000 ft.

Figure 4 - HRRR numerical model sounding over the accident site at 1300 EST

The HRRR model estimated the elevation over the accident site as 1,276 ft with a near surface temperature of 2.3° C (36° F), a dew point of -1.0° C (30° F) and the relative humidity of 79%. The freezing level was at 536 ft agl (1,812 ft msl), with the entire depth of the sounding below freezing. The lifted condensation level (LCL)⁷ and the level of free convection (LFC)⁸ were identified at 1,347 ft agl (2,623 ft msl), and the convective condensation level (CCL) at 1,801 ft agl (3,077 ft msl). The sounding indicated a cloud layer from the LCL through 8,000 ft with a relative humidity greater than 95%. The RAOB algorithm supported structural icing in clouds with a mixture of clear to rime type icing from approximately 1,300 ft through 8,000 ft, with the potential for light to moderate intensities of icing. The precipitable water content was 0.41 inches. The atmosphere was characterized as stable with a Lifted Index⁹ of 12.0, except for the lowest 3,000 ft which depicted a conditional unstable to auto-convective lapse rate.

The HRRR wind profile indicated a surface wind from approximately 270° at 7 knots with the little variation in direction with height with slowly increasing wind speeds to 20 knots above 5,000 ft. The mean 0 to 6 kilometer or 18,000 ft wind was from approximately 290° at 24 knots. Except for a shallow layer between 4,000 and 7,000 ft of potential light turbulence, no strong vertical wind shears were noted for potential turbulence. The sounding's thermal and wind profile however, did support the potential of mountain wave development with the potential for a wave with the potential for moderate or greater turbulence near 6,000 ft.

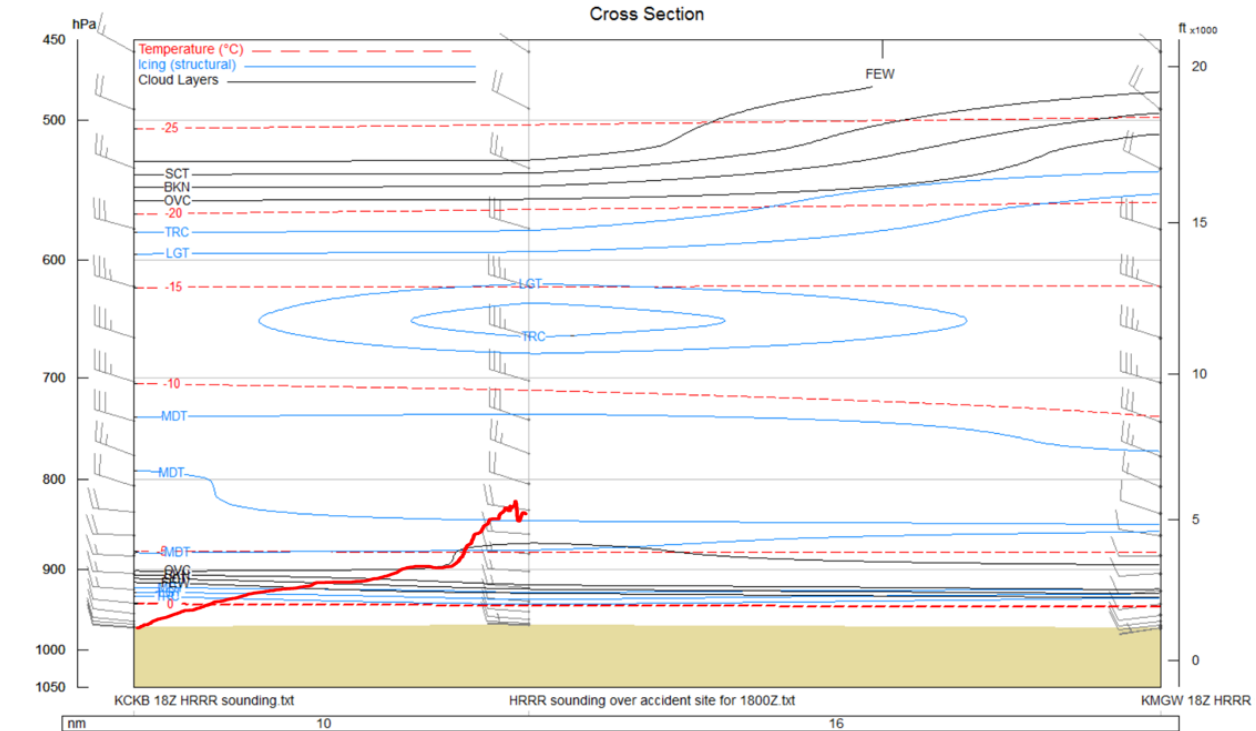
Figure 6 is a cross section sounding created using HRRR soundings over KCKB, the accident site (above), and over KMGW at 1300 EST. The extent of the clouds are provided in black, icing intensity in blue, with isotherms or lines of equal temperature in red dashed lines. In addition, the approximate flight profile of N214K has been added in bold red located in the bottom left side of the image. The cross section shows the accident airplane departing from KCKB and climbing into the overcast layer of clouds and into moderate icing conditions, with the temperature less than -5° C.

Figure 6 - Cross section from KCKB to KMGW at 1300 EST with flight profile

The flight track depicted the accident airplane departing and climbing northeast bound reaching approximately 5,500 ft at 1253:44 EST before turning back southwestward and rapidly descending. At 5,500 ft the sounding indicated a temperature of -8.2° C, a dew point of -8.8° C, a relative humidity of 95%, and a wind from 280° at 18 knots. At that level the sounding depicted a moderate rime icing potential and the potential for mountain wave turbulence in the clouds.

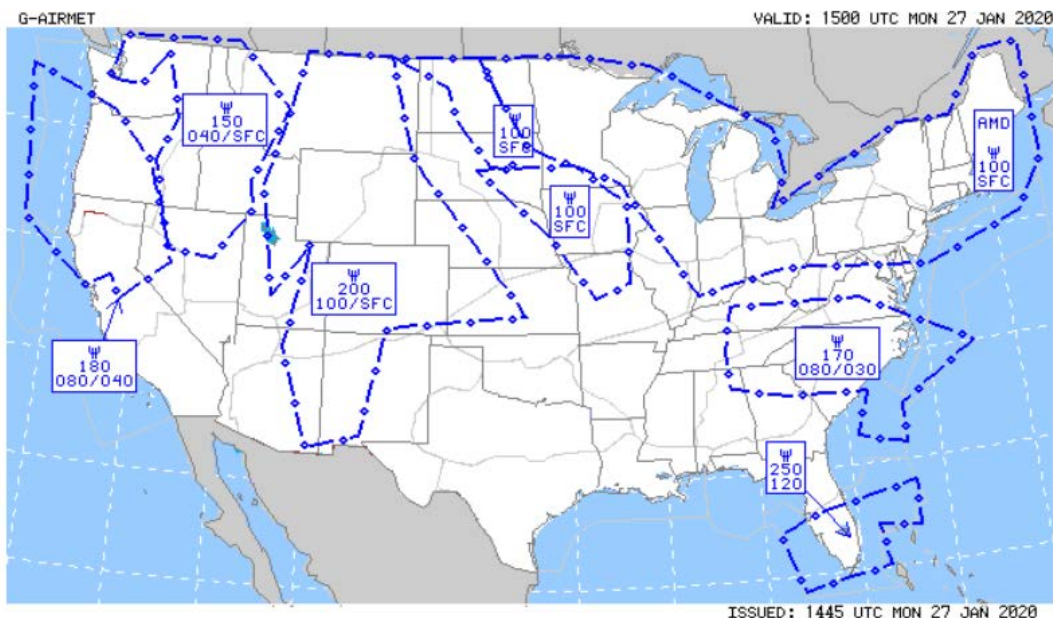
ZULU 2020-01-27 15:00:00

Figure 13 - G-AIRMET Zulu for moderate icing conditions from the surface through 10,000 ft

During the period the NWS did not issue any SIGMETs, Convective SIGMETs or CWA's for any severe conditions. However, the NWS had a series of G-AIRMETs current for IFR conditions, mountain obscuration, moderate turbulence between 3,000 ft and 10,000 ft, and moderate icing conditions from the surface through 10,000 ft. Figures 11-13 are the depiction of the G-AIRMETs current during the period.
