# **NATIONAL TRANSPORTATION SAFETY BOARD**

## **Aircraft Performance ADS-B Study**

Location: Windsor Locks, Connecticut  
Date: October 2, 2019  
Time: 09:53 Eastern Daylight Time (EDT)  
(13:53 Universal Coordinated Time (UTC))  
Aircraft: Boeing B-17G, registration N93012  
NTSB#: ERA20MA001

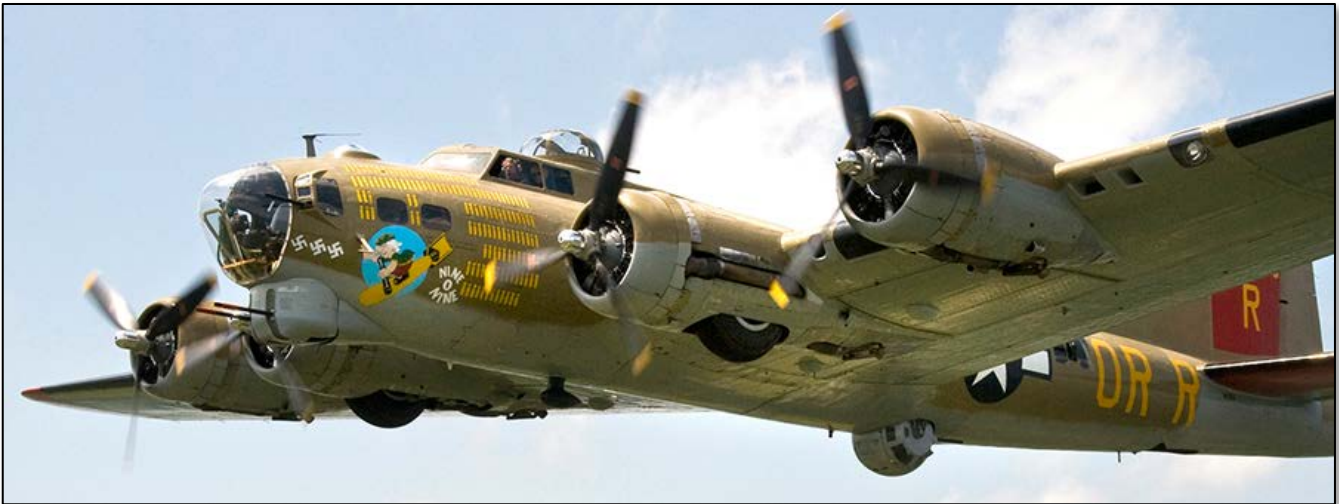
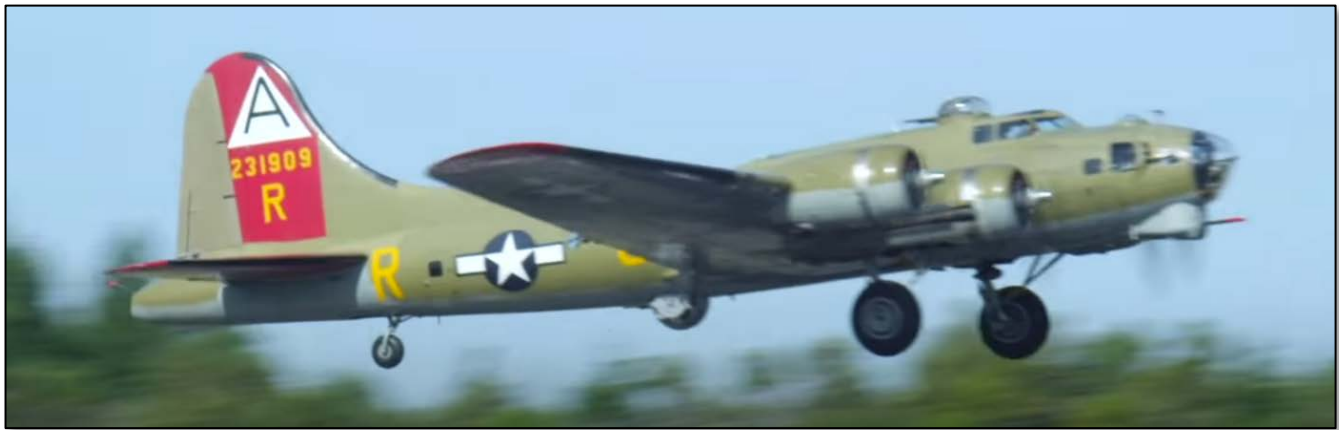
Figure 1. Boeing B-17G Specific Engine Flight Chart, from Reference 1.

The airplane is powered by four Wright R-1820-97 radial engines equipped with turbosuperchargers to boost manifold pressure for takeoff and high-altitude flight. Each engine produces 1,380 shaft horsepower (SHP) in the “war emergency” condition (with a carburetor modification that N93012 did not have), 1,200 SHP in the takeoff condition, 1,000 SHP in the maximum continuous power condition, and 650 SHP in the maximum cruise condition. Operation at 1,200 SHP and higher is limited to 5 minutes duration (see Figure 1, from Reference 1).

Figure 1 is the “Specific Engine Flight Chart” from the B-17G Flight Handbook. It lists the power output of an individual engine under various conditions. The maximum possible power output is 1,380 SHP in the “war emergency” condition, corresponding to 2,500 RPM and 54” Hg manifold pressure (MP), but this condition can only be achieved with a carburetor modification that N93012 did not have. Normal takeoff power is 1,200 SHP at 2,500 RPM and 47.5” Hg MP.

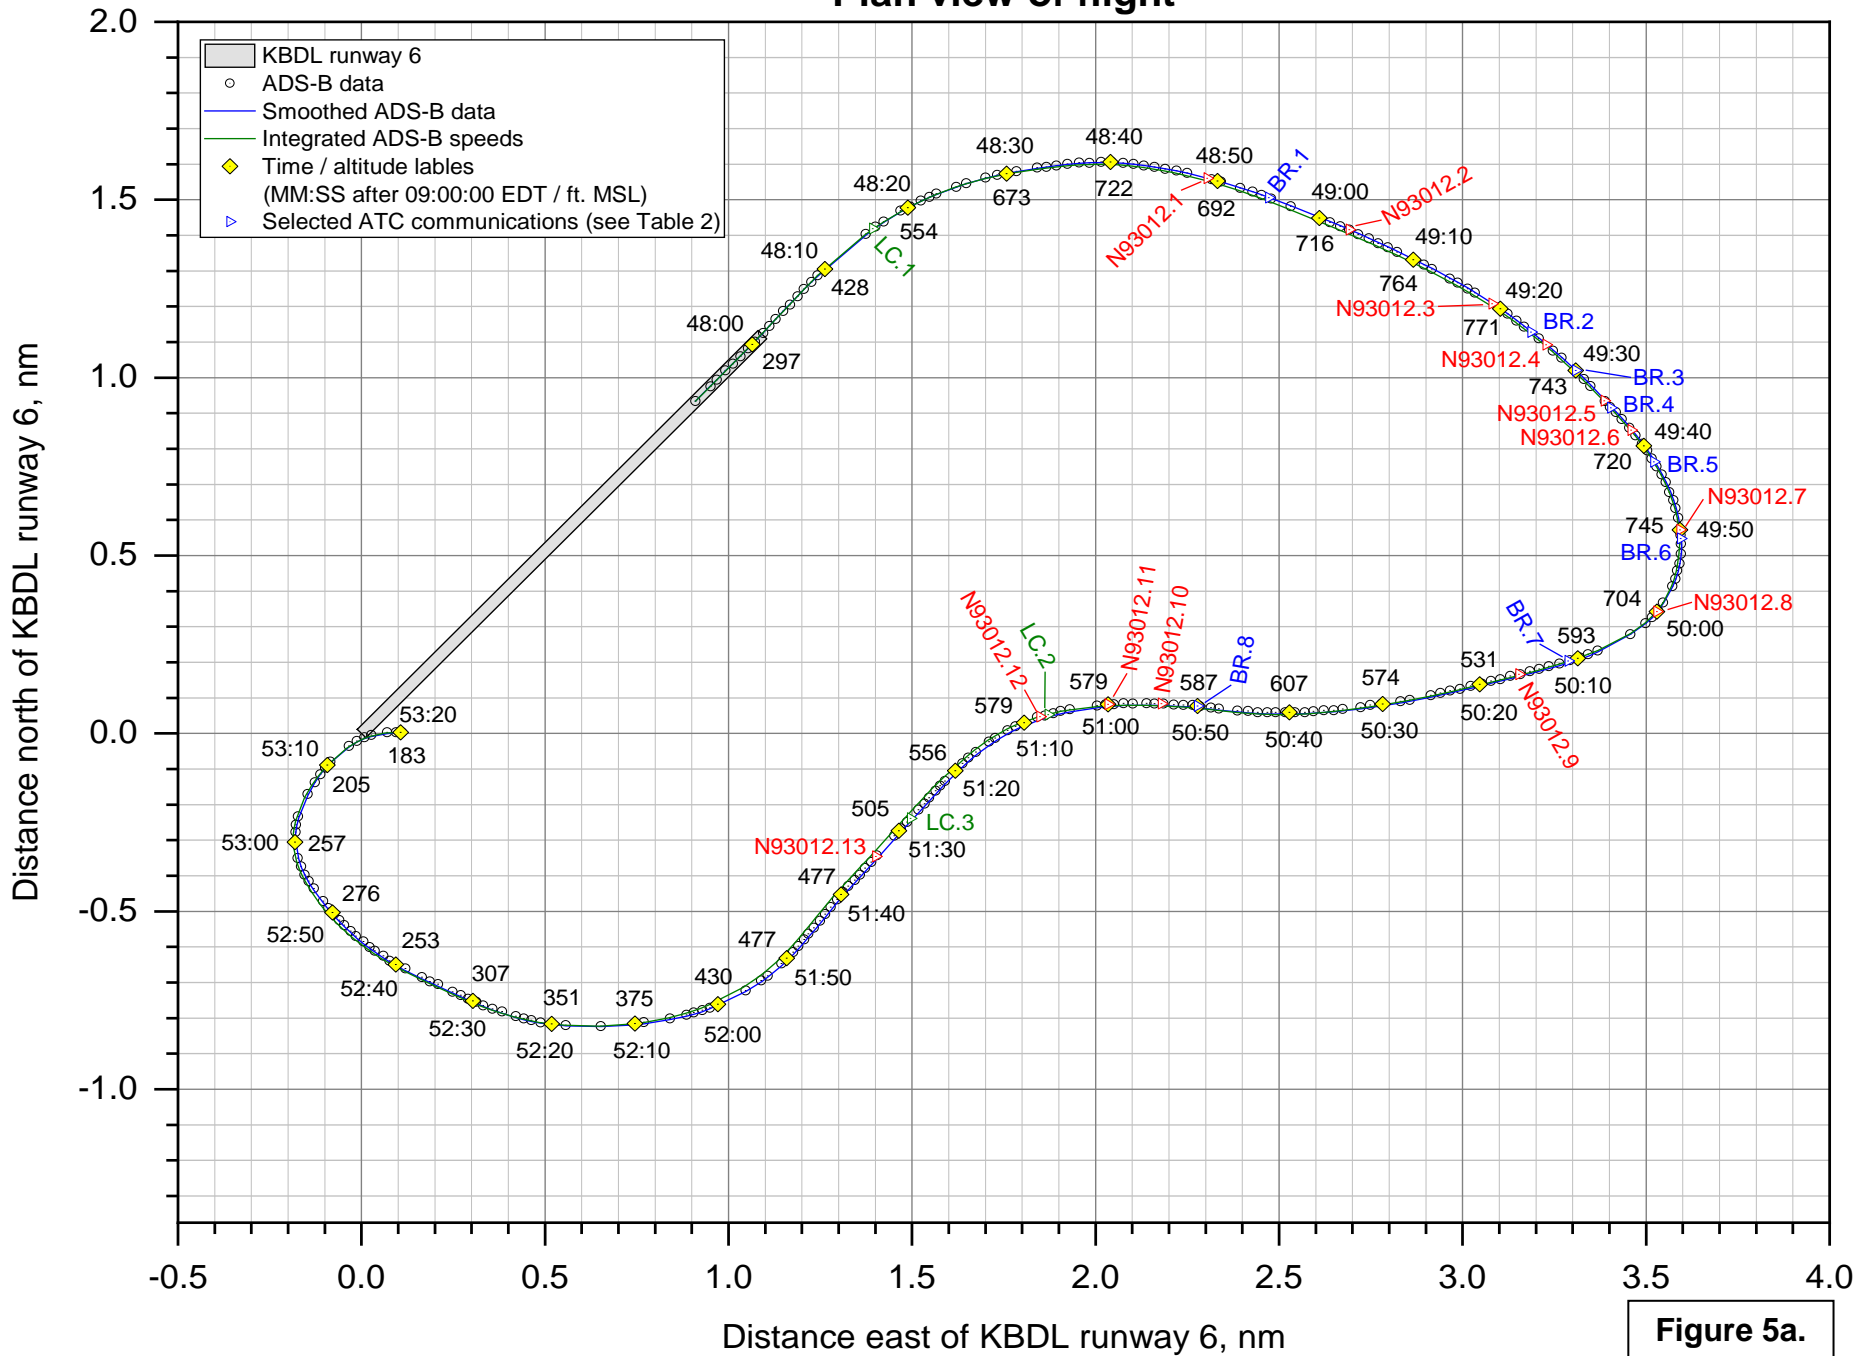
Figure 5a.

Figures 5 & 6 show plan views of the ADS-B data plotted in terms of nautical miles north and east of the runway 6 threshold. Figure 5a shows the entire flight over a simple grid background, and Figure 5b shows the same data over a *Google Earth* satellite image background. Figure 6 shows an expanded view of the portion of the flight near the runway 6 threshold over a *Google Earth* background. The labels in Figures 5 and 6 indicate the time and airplane altitude corresponding to the location of the labels along the flight path. Additional labels indicate the airplane location at the time of selected radio communications between N93012 and Air Traffic Control (ATC), as documented in the transcripts provided by the FAA (References 7 and 8). Each communication is identified by a code – for example, “N93012.1,” “BR.2,” etc. – that identifies the originator of the transmission (source) and the transmission number from that source. The source and content of the communication corresponding to each code are presented in Table 2.

Note that as depicted in Figure 5b, at 09:51:10, N93012 was essentially on a right base leg for runway 33, and had more than enough energy for an approach and landing on that runway. Runway 33 was closed except for taxi operations, per Notice to Airmen (NOTAM) BDL 09/166. However, the pilot did not ask ATC if runway 33 was available for emergency use.

The north and east velocities recorded in ADS-B files are themselves filtered by aircraft avionics prior to broadcast over the ADS-B system, and so in general a very smooth ground speed can be obtained by combining these velocities. Interestingly, however, in this case the recorded ADS-B speeds are not as smooth as the speeds observed in other cases, and in fact contain obvious unrealistic “spikes” (see, for example, Figure 13 at 09:51:22). Consequently, in this *Study* the smoothed GPS positions are used to compute ground speed, ground track, and other performance parameters. The east and north positions obtained from integrating the recorded ADS-B north and east speeds are shown for comparison with the recorded positions in Figures 5 and 6.

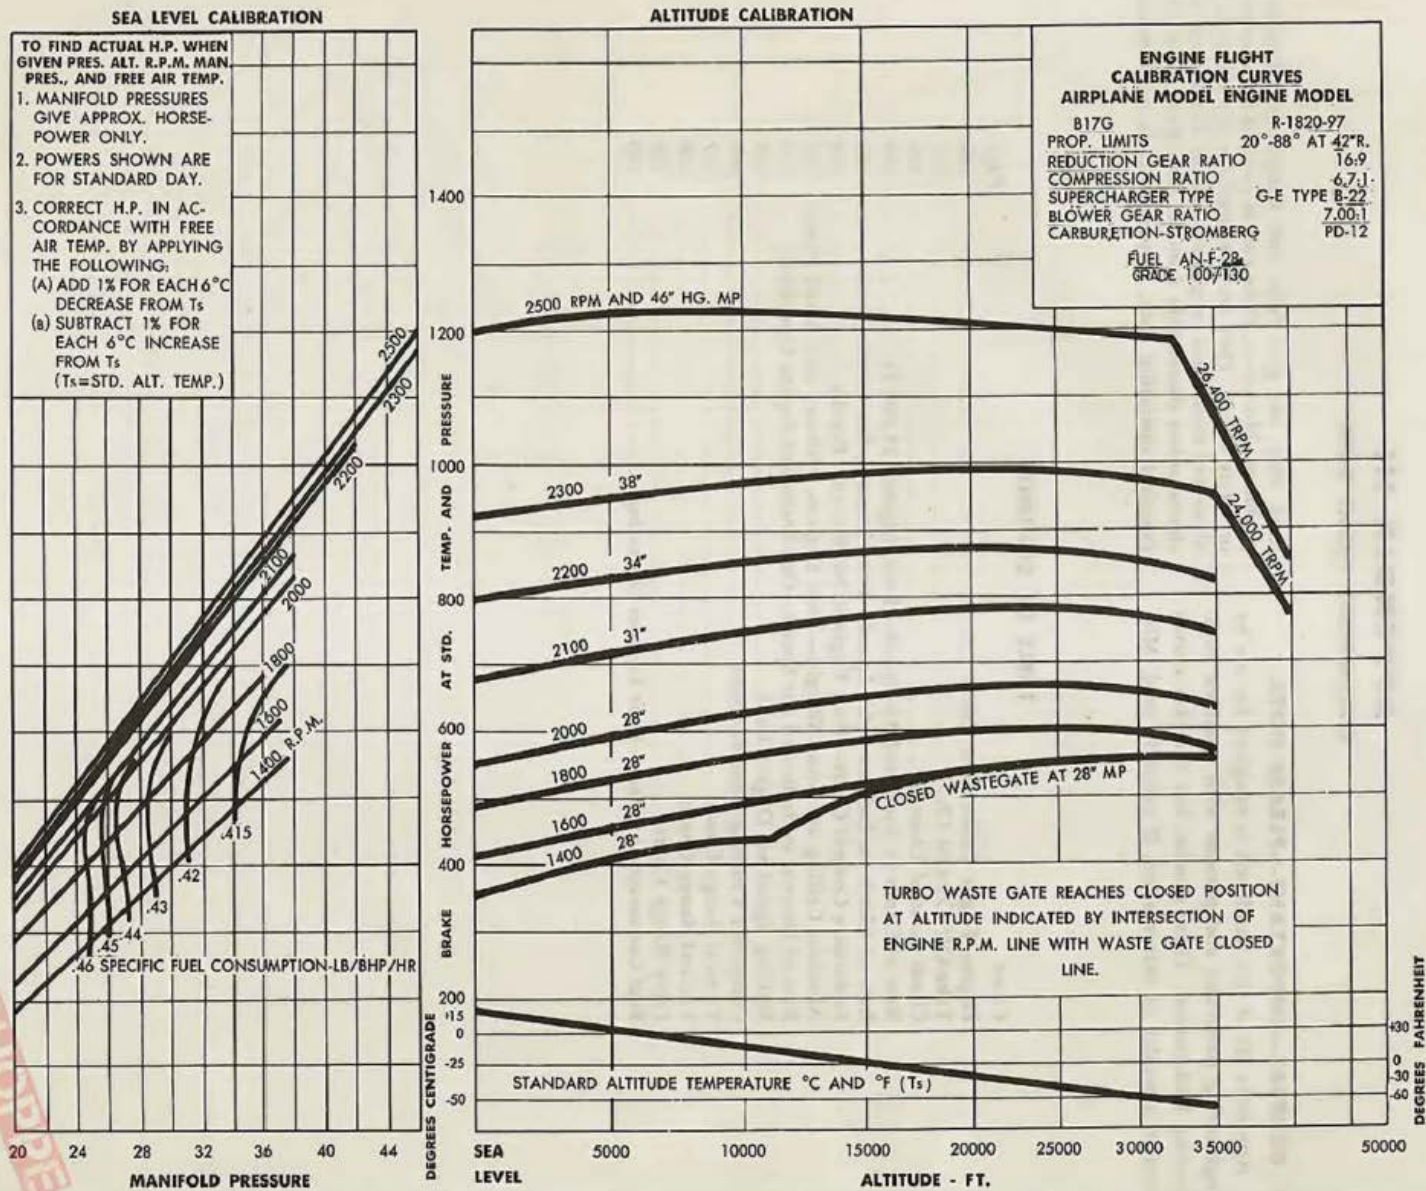
Figure 10. Engine flight calibration curves, from Reference 1.

Figure 92—Engine Flight Calibration Curve

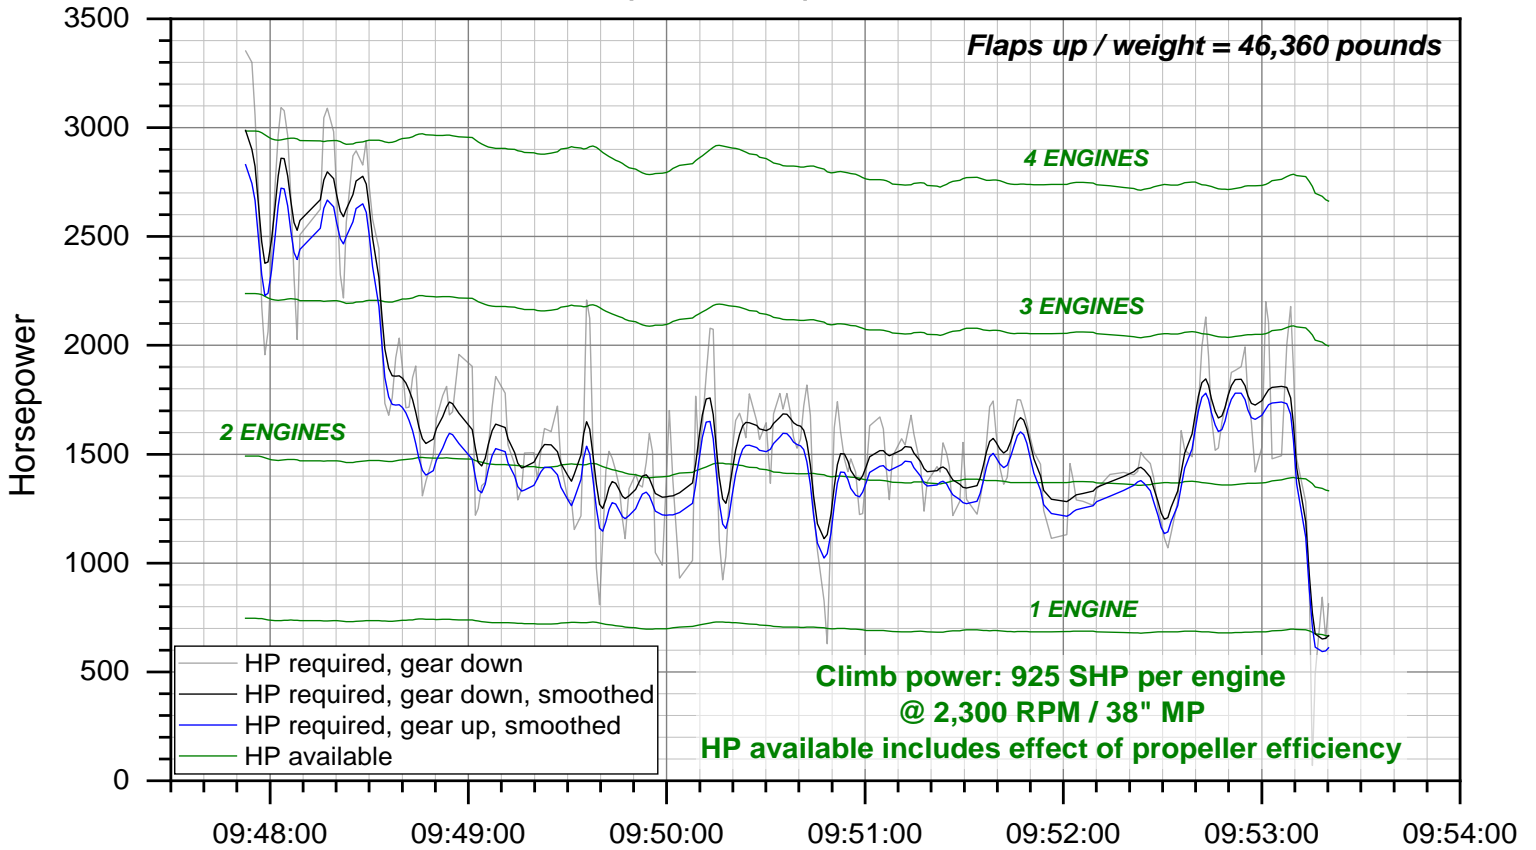
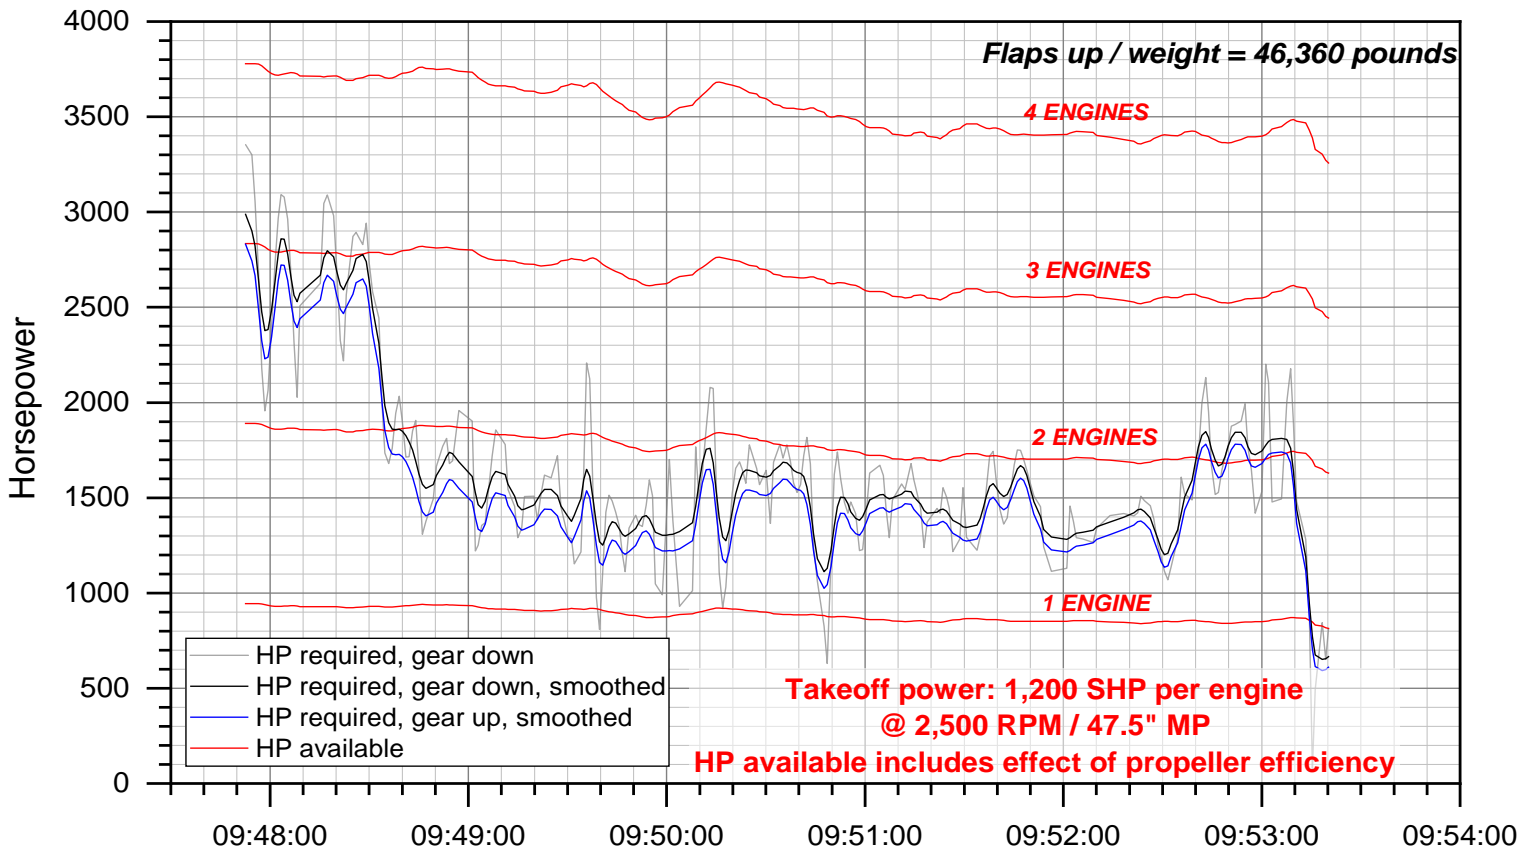
**Figure 15.**

power was the result of the failure of engine #4 (as seems likely) and, possibly, a reduction of power on engine #3, then additional sources of drag might have been present that are not accounted for in the power required calculation, and that would act to increase the power required. These drag sources include propeller drag from the failed engine (which can be reduced, but not eliminated, by feathering the propeller), and trim drag due to rudder deflection and possibly sideslip required to compensate for the asymmetric thrust from the left and right side engines. Consequently, the actual power required in the period after 09:48:30 might be greater than that shown in Figure 15.

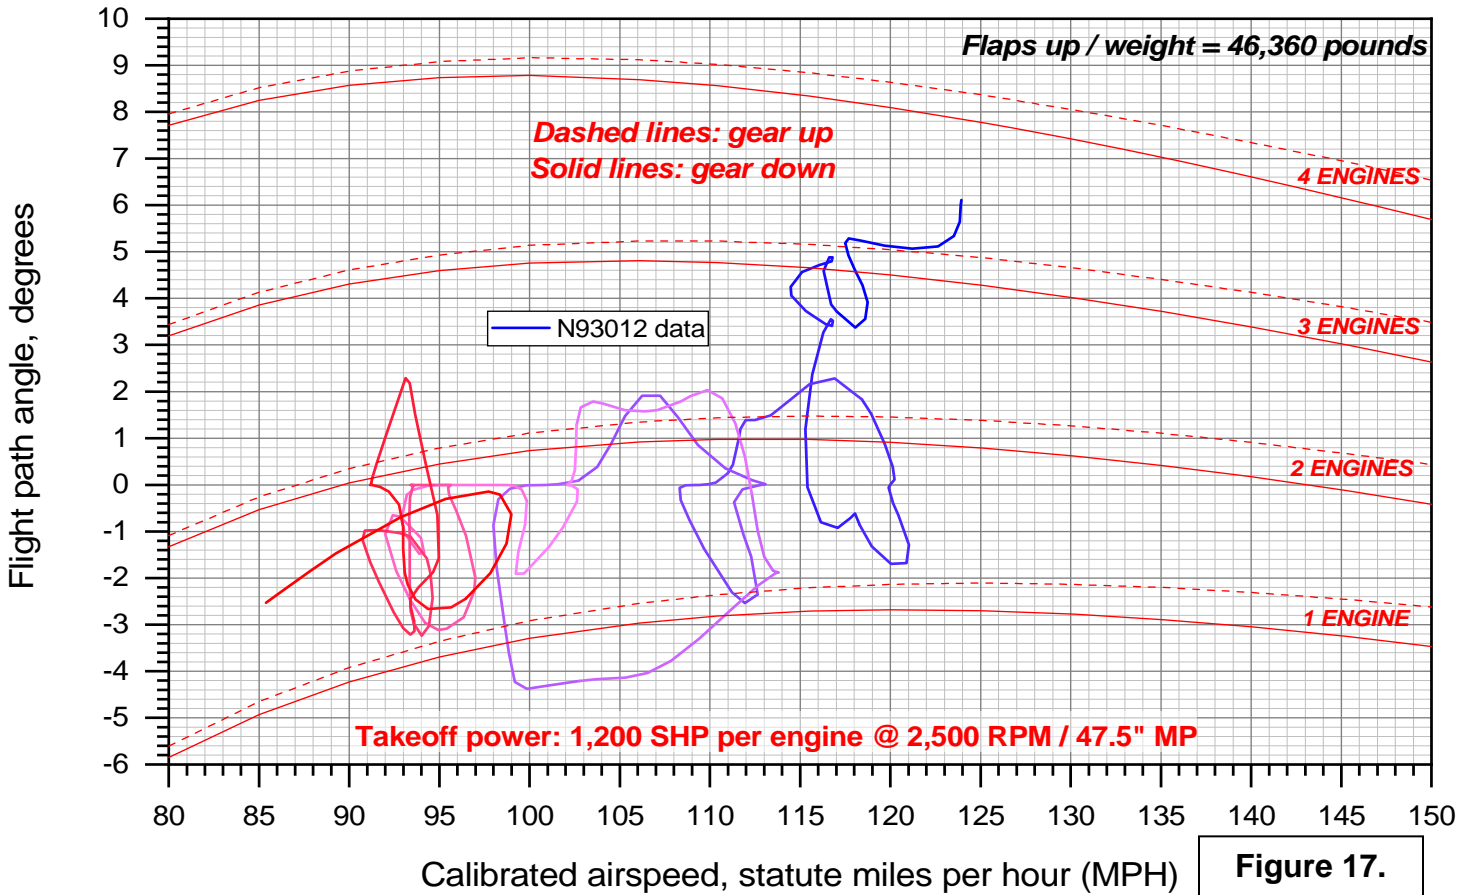
**Figure 17.**

Maximizing  $\gamma$  would have maximized the altitude at which the airplane would have arrived at the runway following the turn back to the airport.  $\gamma$  and  $RC$  are plotted as a function of airspeed in Figures 17 and 18, respectively. Note that the airspeeds for maximum  $\gamma$  and  $RC$  are different (consistent with the different “best angle of climb” and “best rate of climb” speeds found in pilot operating handbooks). Note also that the speeds for maximum  $\gamma$  and  $RC$  depend on the number of engines operating; this is the result of the different slopes of the thrust vs. airspeed lines shown in the bottom plot of Figure 16 for different numbers of operating engines. With 4 operating engines, maximum  $\gamma$  is obtained with the gear up at about 100 to 105 MPH, and maximum  $RC$  is obtained at about 120 MPH. With 3 operating engines, maximum  $\gamma$  is obtained with the gear up at about 105 to 113 MPH, and maximum  $RC$  is obtained at about 115 to 120 MPH. At lower speeds, the drag due to lift (induced drag) increases, and the airplane operates “on the back side of the power curve.” At higher speeds, drag increases due to increased dynamic pressure.

The multi-colored lines in Figure 17 and 18 show the  $\gamma$  and  $RC$  achieved by N93012 as a function of airspeed. The color of the line indicates the time corresponding to each data point, per the color table in the plots. Figures 18 and 13 indicate that from about 09:51:00 onwards, the airplane was operating at or below 100 MPH, and below the airspeed for maximum  $\gamma$ , which would have been about 115 MPH for the 2 engines at climb power condition that most closely matches the computed power being delivered to the airplane. Figure 17 also indicates that with 2 engines at climb power, the airplane might just have been able to maintain level flight ( $\gamma=0$ ) by flying with the gear up at about 115 to 120 MPH. The airplane would not be able to maintain level flight at that power level with the gear down, at any speed.

Figures 17 and 18 are constructed using the flaps up drag polar derived from the Flight Handbook rate of climb chart. Again, this data does not account for possible propeller drag due to an engine-out condition, or trim drag resulting from the rudder and sideslip angle required to compensate for asymmetric thrust. Accounting for these items would decrease the  $\gamma$  and  $RC$  values plotted in the Figures. As noted above, the aerodynamic characteristics of the B-17G required to estimate these quantities cannot be determined from information published in the Flight Handbook.

Figure 17 also indicates that with two engines at full takeoff power, the airplane could climb ( $\gamma>0$ ) at airspeeds between 90 and 140 MPH, even with the landing gear down. Even considering added drag due to the engine-out condition and trimming for asymmetric thrust, Figure 17 suggests that,
