NATIONAL TRANSPORTATION SAFETY BOARD

Specialist's Factual Report

METEOROLOGY

ERA21FA234

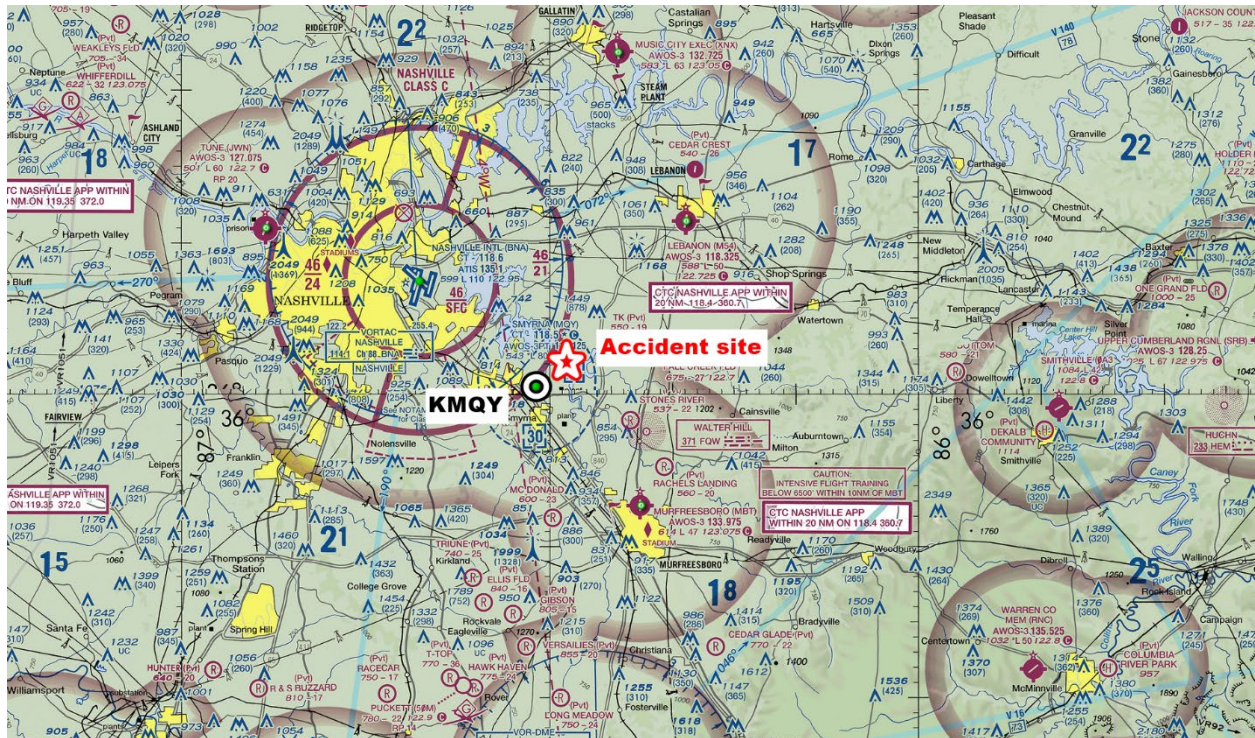
Figure 5 – Sectional map of the accident area with the locations of the accident site and surface observation site.

The area surrounding the accident site was documented using official Aviation Routine Weather Reports (METARs) and Specials (SPECIs). The following observations were taken from standard code and are provided in plain language. Figure 5 is a local sectional chart with the accident site and the closest weather reporting location marked.

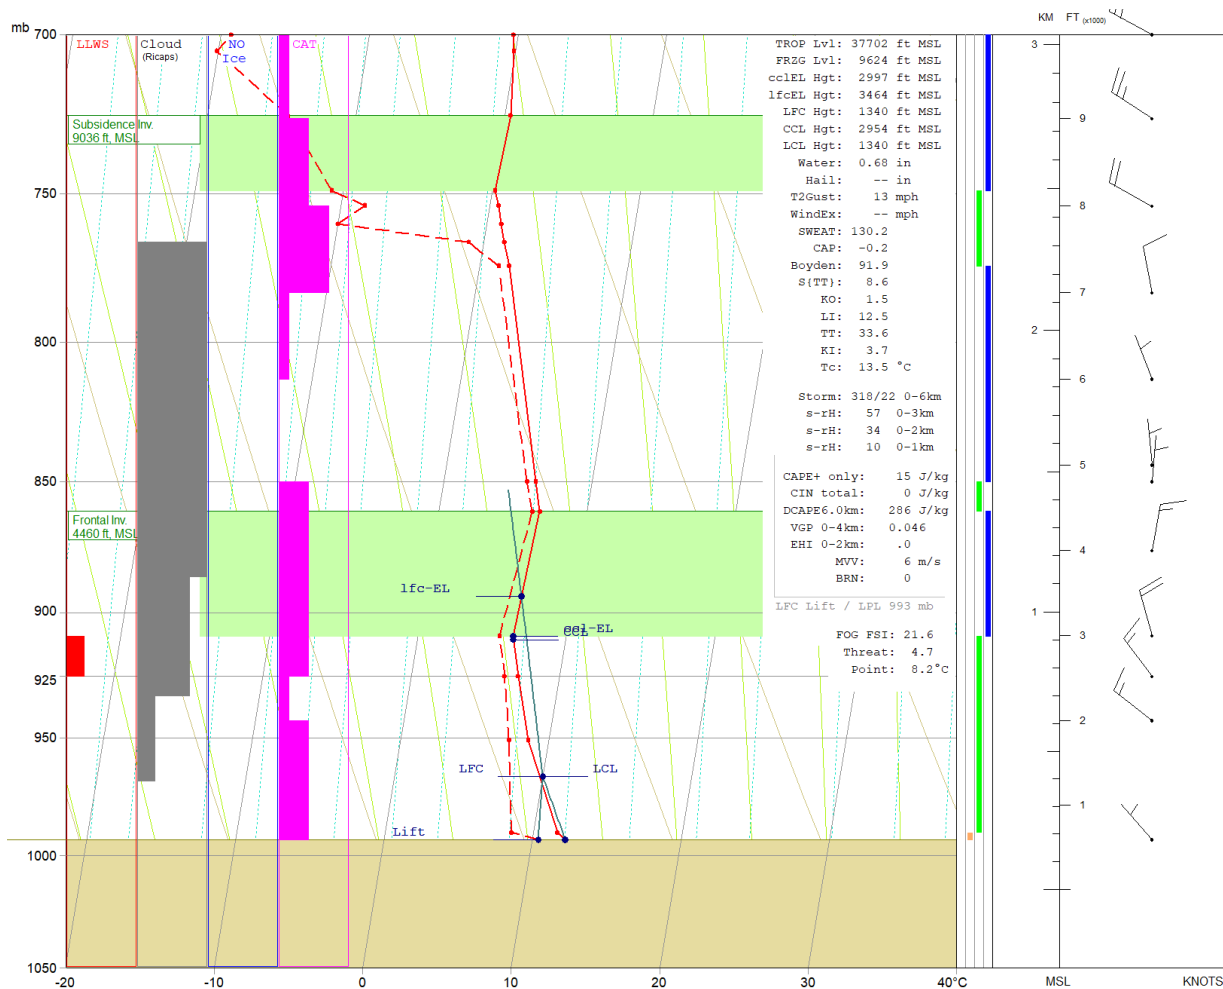
Figure 6 – 0700 CDT KBNA sounding.

The 0700 CDT KBNA sounding for the accident site indicated a conditionally unstable environment from the surface through 3,000 ft msl. A stable environment was in place between 3,000 ft and 4,500 ft msl below the frontal inversion¹⁴ at 4,460 ft msl. A subsidence inversion was located at 9,036 ft msl. Clouds were indicated by RAOB to be present from 1,300 ft msl (~700 ft agl) through 8,000 ft msl. No icing potential was indicated by RAOB below 10,000 ft msl.

The 0700 CDT KBNA sounding wind profile indicated a near surface wind from 320° at 6 knots with the wind remaining out of the northwest to north through 10,000 ft msl. The wind speed increased to 15 knots by 2,000 ft msl with the wind speed to 30 knots by 10,000 ft msl. RAOB indicated the possibility of light low-level wind shear (LLWS) between 1,750 ft and 2,250 ft agl. RAOB indicated the possibility of light to moderate clear-air turbulence in several layers between the surface and 10,000 ft msl.

Nashville, Tennessee (KBNA) was the closest site with an upper air sounding and was located 11 miles west-northwest of the accident site at an elevation of 591 ft and had a station ID of 72327. The 0700 CDT KBNA sounding was plotted on a standard Skew-T Log P diagram⁹ with the derived stability parameters included in figure 6 with data from the surface to 700-hPa (or approximately 10,000 ft msl). These data were analyzed using the RAOB¹⁰ software package. The sounding depicted the lifted condensation level (LCL)¹¹ and the level of free convection (LFC)¹² at 749 ft agl (1,340 ft msl), and the convective condensation level (CCL)¹³ at 2,363 ft agl (2,954 ft msl). The freezing level was located at 9,624 ft msl. The precipitable water value was 0.68 inches.
